51968-01885 Version 12

## Recall: Front Passenger's Airbag Inflator May Produce Excessive Pressure After Long-Term Exposure To High Absolute Humidity

Supersedes 14-046, dated December 19, 2015 to revise the information highlighted in yellow

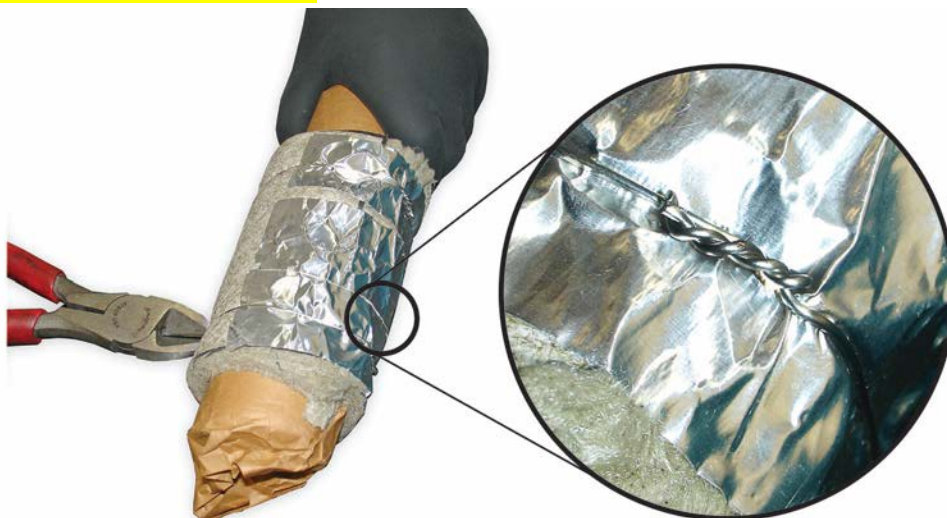
- Wear disposable gloves and protective glasses. The insulation is not toxic or dangerous, but some people may be sensitive to the insulation.
- Dispose of the insulation and wrapping paper to avoid getting the insulation dust/fibers on you or the airbag assembly.
- Do not reuse the insulation or wrapping paper. You do not need to wrap the inflator being removed from the vehicle when it is returned.
- Cut the wires off from the opposite side from where they are tied (twisted) together.

NOTE: Do not cut the insulation.

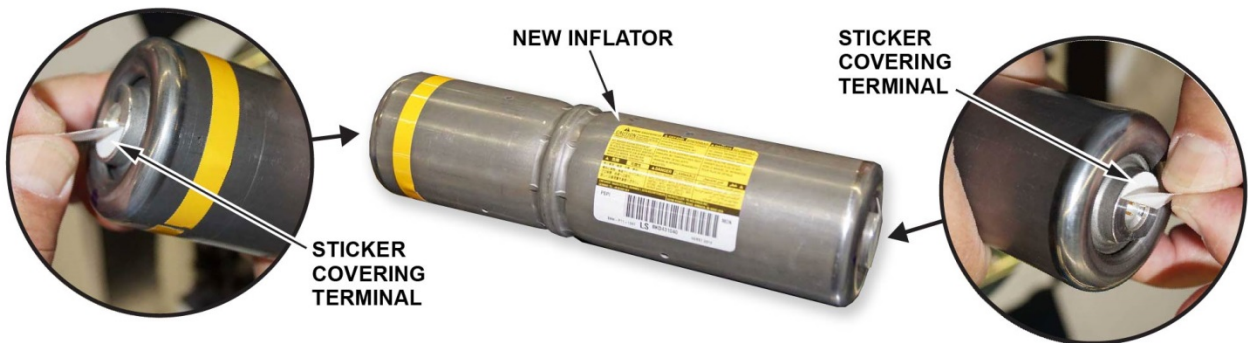
16. Remove the stickers covering the terminals on both sides of the new inflator.
