04135 Version 5

## Safety Recall: Takata Front Passenger's Airbag Inflator (Phase 1)

Supersedes 16-029, dated July 12, 2016 to include Passenger Inflator Kit Part Numbers

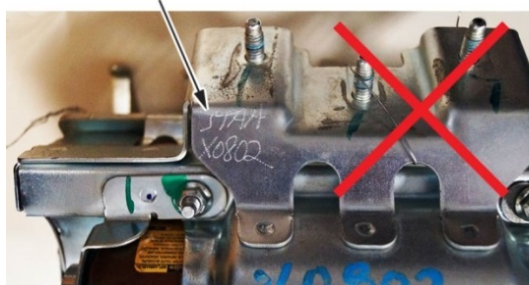
HAND ENGRAVING

- If there is nothing unusual about the airbag or the inflator, go to step 6.
- If there are any unusual markings, like an incorrect label or a model year written in marker, the airbag and inflator may not be the correct airbag and/or inflator for the vehicle or it may be a counterfeit part. For more information about counterfeit airbags, you can refer to [safercar.gov](http://safercar.gov), enter keywords **MANAGING COUNTERFEIT**, and select **Recommended Dealer Guidance for Managing Counterfeit Air Bags** from the list. **If you suspect that the airbag or inflator is counterfeit, do not continue this procedure.** Contact your DPSM for assistance.
