# Compliance Recall

## Code: 69CR

| Subject | Automatic Locking Retractor (ALR) Seat Belt Retractors | | | | |

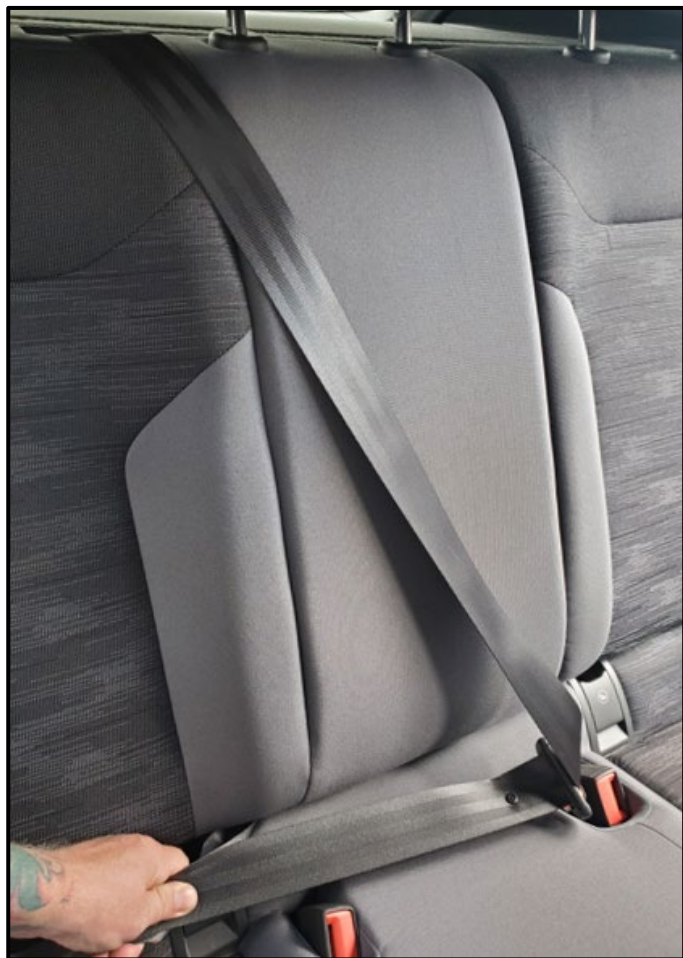
### Testing the Automatic Locking Retractor (ALR) function on the rear center seat belt:

- Fasten and buckle seat belt over an empty seat.
- Extract 200 - 250 mm lower belt webbing, fold and fix with your hand (as shown).
- The seat belt remains buckled and the lower seat belt webbing remains held.

- Pull the webbing all the way out of the seat belt retractor. This will activate the ALR.
- Slowly retract the webbing back into the seat belt retractor. You will hear a ratcheting sound.

- Pull on the belt with uniform and steady pressure and verify the belt cannot be pulled out of the seat belt retractor.
- If the seat belt locks so the webbing cannot be pulled out of the retractor:

- Unfasten the seat belt and repeat the tests 5 times in succession.
- If the seat belt retractor locks without releasing for all tests:
  - No further work is required.

- Proceed to Section D.
- If the seat belt retractor does not lock during any of the tests:
  - The affected seat belt must be replaced.
  - Proceed to Section C.

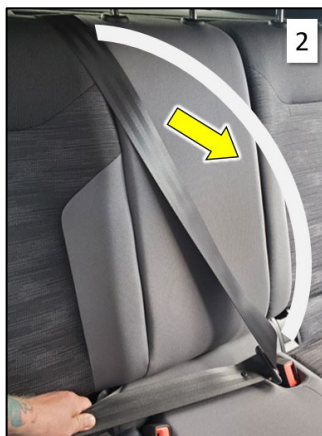
**Step 2)** Pull webbing all the way out of seat belt retractor to activate ALR.

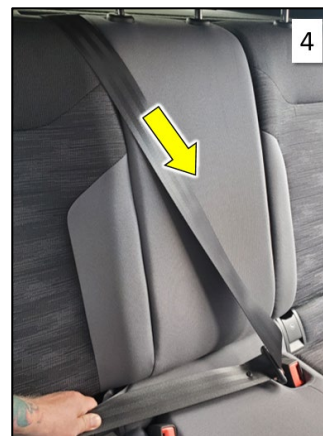
**Step 4)** Pull on the seat belt and verify it is locked and cannot be pulled out of the seat belt retractor.

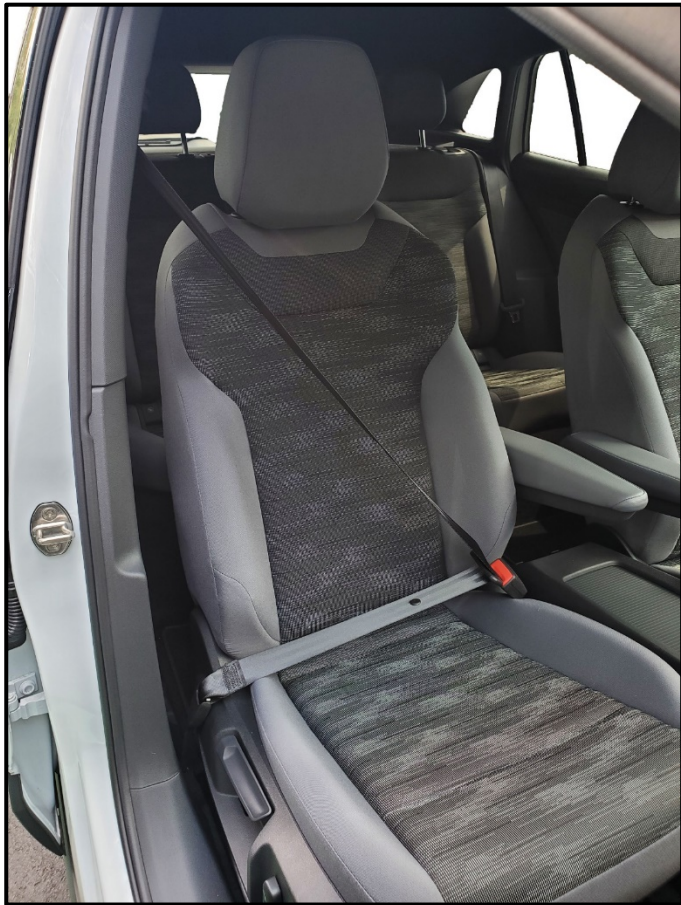
**Testing the Automatic Locking Retractor (ALR) function on the front passenger seat belt:**

- The seat must be empty.
- Fasten and buckle seat belt over the empty seat.
- The seat belt remains buckled.
- Pull the webbing all the way out of the seat belt retractor. This will activate the ALR.
- Slowly retract the webbing back into the seat belt retractor.
- You will hear a ratcheting sound.
- Pull on the belt with uniform and steady pressure and verify the belt cannot be pulled out of the seat belt retractor.
- If the seat belt locks so the webbing cannot be pulled out of the retractor:
  - Unfasten the seat belt and repeat the tests 5 times in succession.
- If the seat belt retractor locks without releasing for all tests:
  - No further work is required.
  - Proceed to Section D.
- If the seat belt retractor does not lock during any of the tests:
  - The affected seat belt must be replaced.
  - Proceed to Section C.

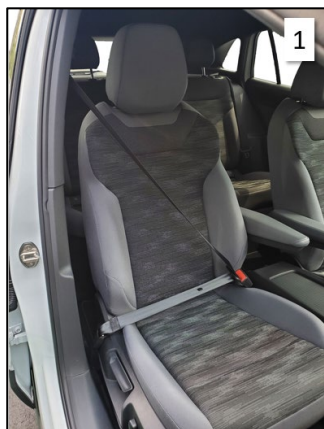
**Step 1)** Fasten seat belt over an empty seat.

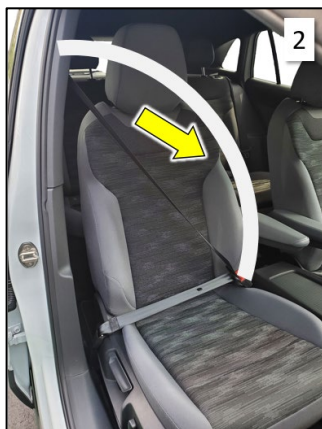
**Step 2)** Pull webbing all the way out of seat belt retractor to activate ALR.

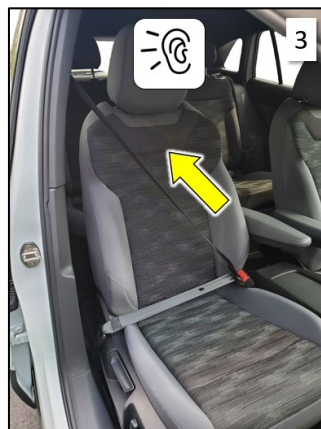
**Step 3)** Slowly retract the webbing all the way back into the seat belt retractor while the seat belt remains buckled. You will hear a ratcheting sound.

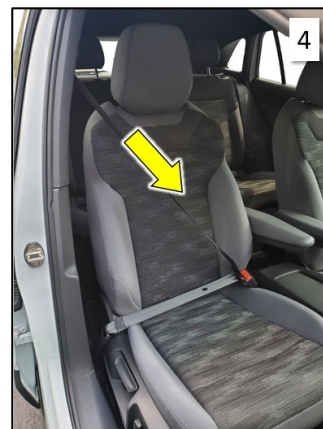
**Step 4)** Pull on the seat belt and verify it is locked and cannot be pulled out of the seat belt retractor.
