SSE

Build your digital industry

September, 2015

Predictive Analytics for Model-Based Condition Monitoring

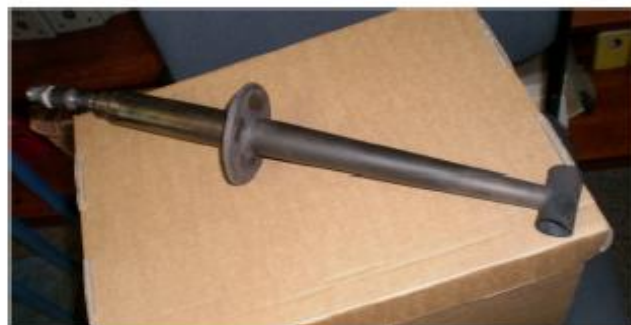
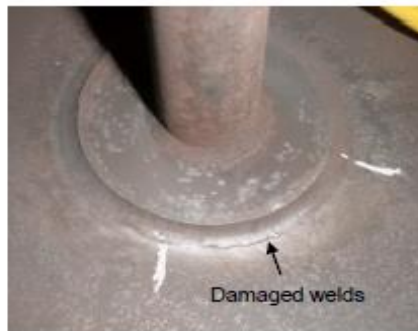
Swirl analysis to isolate a thermocouple fault

Results of site investigation;
Thermocouple retrieved
from gas path and welds
inspected

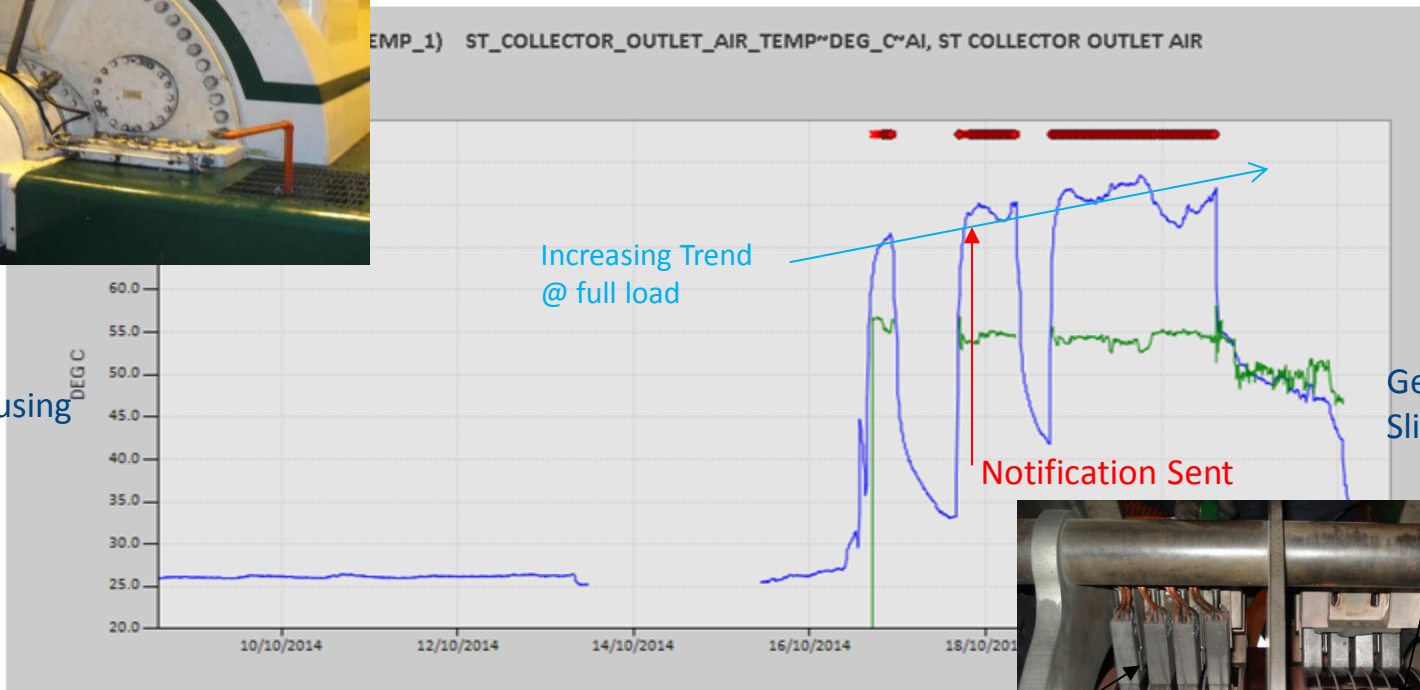
Generator collector outlet air temp indicating high

The EPC team notified site engineers that the collector outlet air temperature on the ST generator was higher than expected following return to service of the unit.

Normal operational temperature of the generator collector outlet air is approximately 55 degrees Celsius.

Excursion temperature reached 70 degrees Celsius with an increasing trend.

TEMP_1) ST_COLLECTOR_OUTLET_AIR_TEMP~DEG_C~AI, ST COLLECTOR OUTLET AIR

Site engineering investigated the issue and found that the door hatch to the inlet air filters had not fully sealed. This was allowing the inlet air to bypass the collector housing, resulting in a temperature rise at the collector outlet.

The defect was corrected by site engineering and the collector outlet air temperature returned to normal.

Site engineering installed new instrumentation to the enclosure. The alarm is set at 5% above normal running temperature, ~ 58deg c.

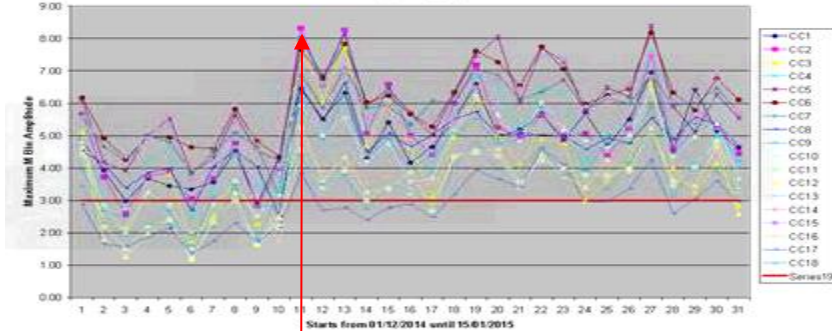
Maximum M Bin Amplitude < 90 MW for starts between 01/12/14 - 15/01/15
(After Sync)

Maximum M-Bin Combustion Dynamics Amplitude for each start

Excursion Starts

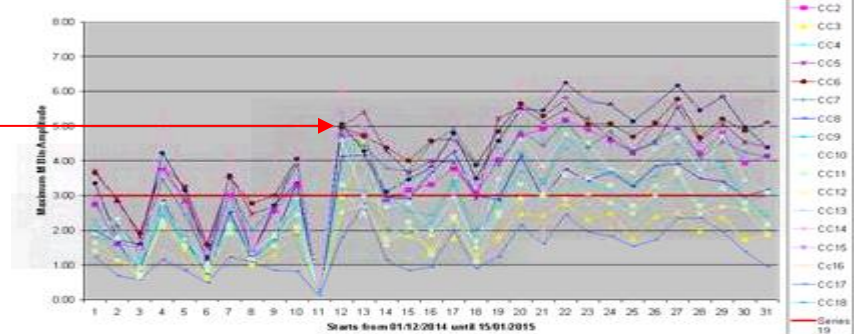
Duration M Bin Amplitude > 3 Psi for < 90 MW for starts between 01/12/14 - 15/01/15
(Before De-Sync)

Duration for M-Bin Combustion Dynamics excursion for each start
