Technical Service Bulletin

46 Brake noise analysis and handling

46 19 03 2034181/16 January 15, 2019. Supersedes Technical Service Bulletin Group 46 number 16-50 dated September 23, 2016 for reasons listed below.

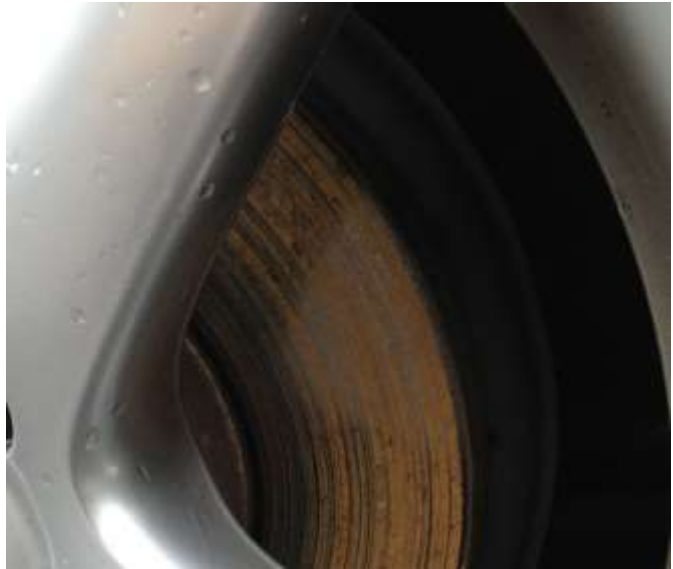
5. Discs are covered with rust. Rust can form when the vehicle has not been driven for a long period of time (Figure 1).

Figure 1. Disc covered with rust.

1. **Check the overall condition of the brakes** to determine if the brake noise is caused by one of the causes listed in the *Technical Background* section of this bulletin. If the noise is not a result of one of these causes, proceed with the following steps 2-4.

4. Clean the brake pads and discs:

A). With careful consideration of the traffic situation, perform up to 5 ABS stops from speeds above 50 mph. Between each ABS stop, allow the brake components to cool by driving the vehicle for more than one minute at speeds greater than 50 mph.

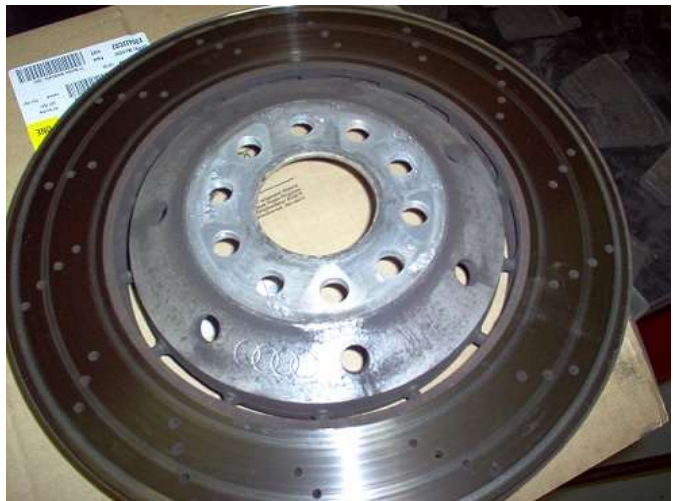
6. Discs are grooved (Figure 2).

Figure 2. Grooved disc.

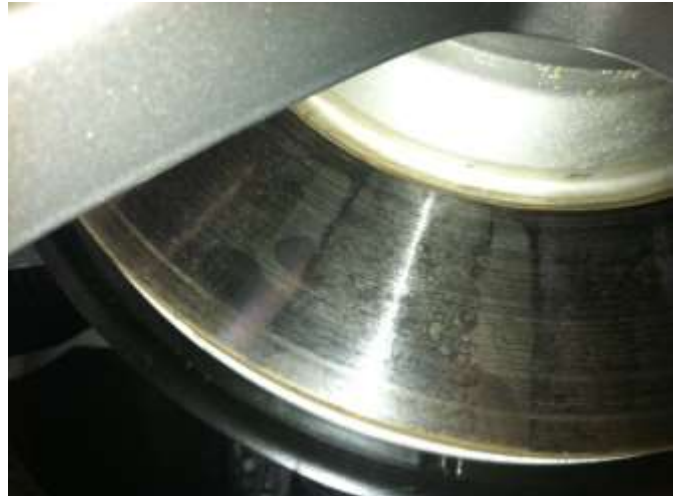
7. There is chemical contamination on the braking surface of the brake disc due to wheel or tire cleaner being sprayed directly onto the brake disc (Figure 3 and Figure 4).

Figure 3. Discoloration on the brake disc due to chemical contamination from cleaner that was sprayed directly onto the disc.

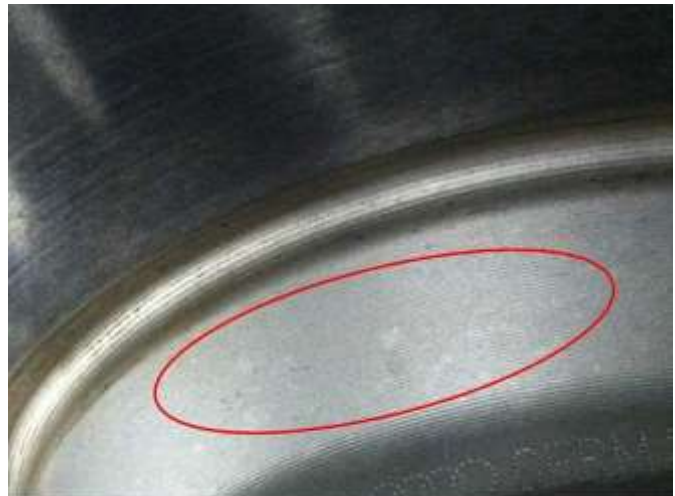
Figure 4. Small spots and discoloration due to chemical contamination from cleaner that was sprayed directly onto the disc.

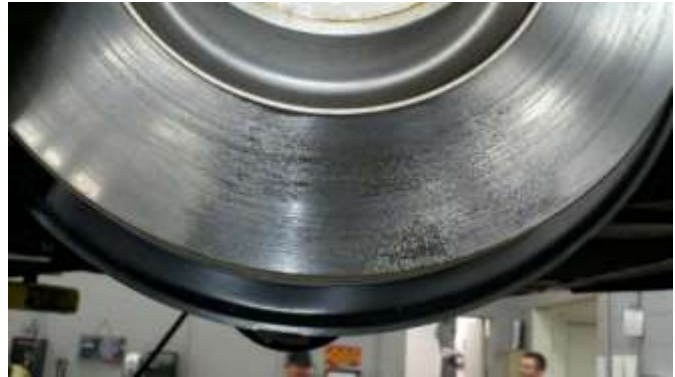
8. There are “pad marks” on the brake disc as a result of brake pad material transferring to the discs (Figure 5). Pad marks can occur when a vehicle has been parked for long periods of time in a wet or snowy environment.

Figure 5. Brake pad material has transferred to the discs.
