## UPDATE FROM WARRANTY OPERATIONS

## V08/V11/V16 3.0L Diesel Emission Campaigns

### Frequently Asked Questions

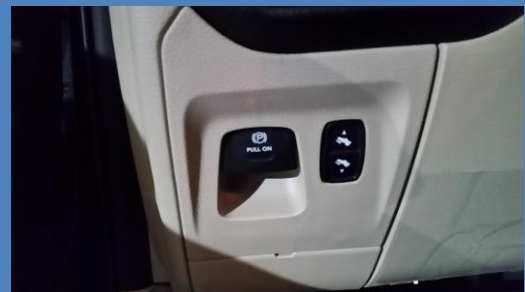
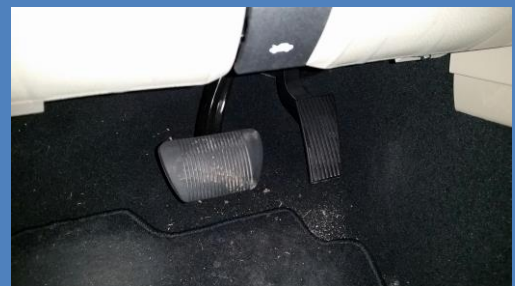
The new Electric Parking Brake TNF Labor Operations can be found in the Labor Operations link in DealerCONNECT, under the “85 Special Services LOPS” in the following categories:

- **85-41-04 Electric Parking Brake**
  - 00– Electric Park Brake System
- **85-41-05 Brakes**
  - 02 – No Repair / Trouble Not Found Brakes

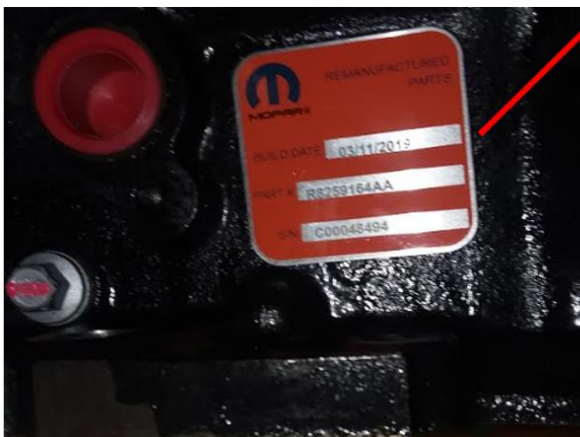
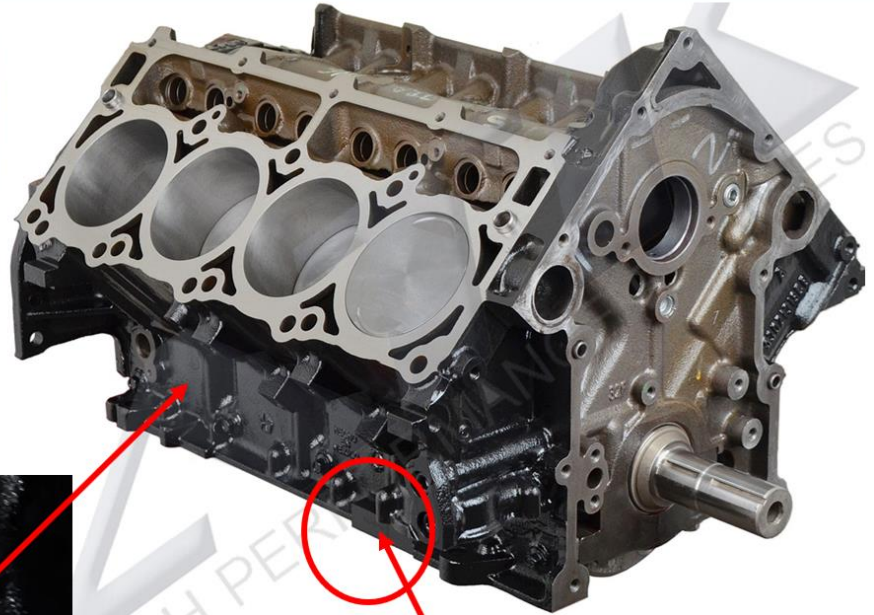
OE Engine Part Number Location

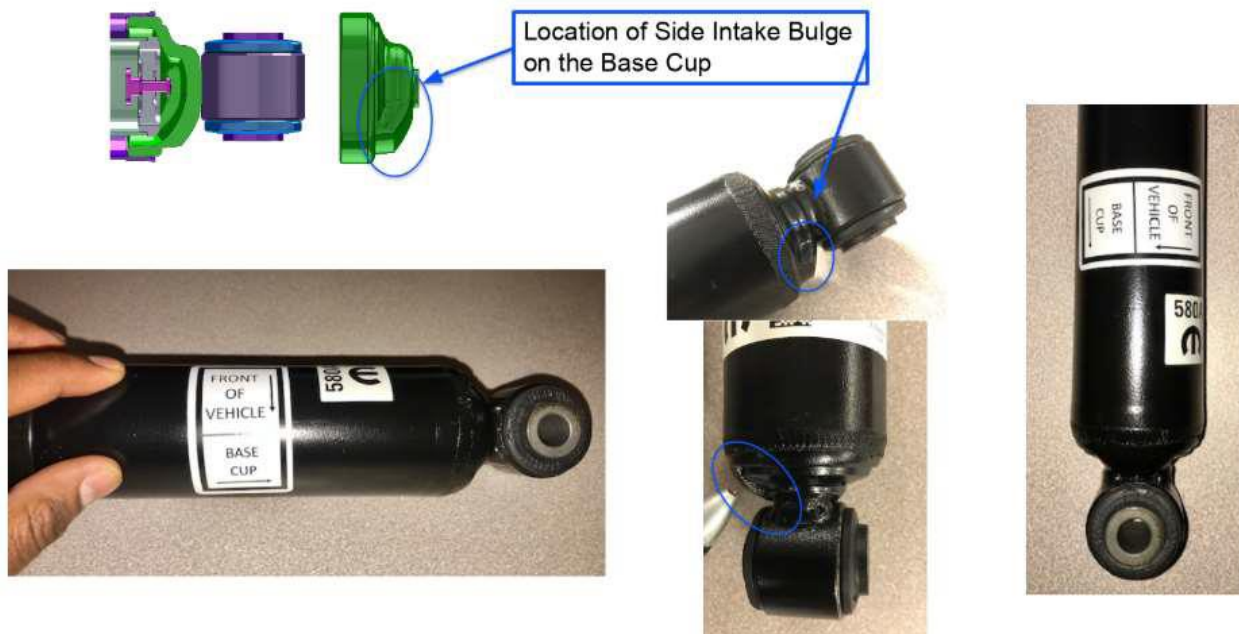
On New Wranglers or Gladiators that experience a shimmy in the steering wheel after hitting an irregularity in the road surface such as an expansion joint, pothole, bump, etc., the steering damper must be replaced with an AE level part or newer. Also the damper must be installed in a certain orientation.

AE level dampers have an orientation direction. (See the images below for orientation.) Also, please reference the *JL Steering Damper Installation TIPS Video* located in the Service Library in DealerCONNECT.

The damper must be installed with the “Bulge” on the bottom and the arrow pointing to the front of

the vehicle. The damper will only operate correctly in this orientation.

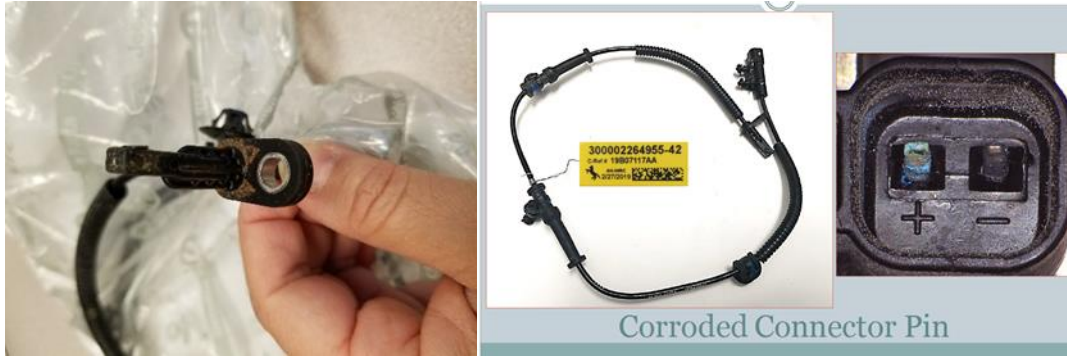
Corroded Connector Pin

If the ABS light is on and diagnosis leads to the wheel speed sensor, be sure to check the electrical connections. There have been reports of wheel speed connectors not fully latching, allowing water to enter the connector and corrode the pins on the wheel speed connector.

In addition, check the tone wheel as well before replacing the wheel speed sensors. The wheel speed sensors returned are covered in rust (see pictures). This can cause the sensor to not read the tone wheel. If there is rust on the tone wheel,

If that is the case, the wire harness should be replaced and NOT the sensor. A new sensor with the old harness will cause a shop comeback for the same issue. Wheel speed sensors that are returned and found to be in good working order will be charged back as an over repair.

simply clean it off and reinstall the sensor after cleaning and test the system again for a good reading. In all cases this will correct the issue in the first visit.

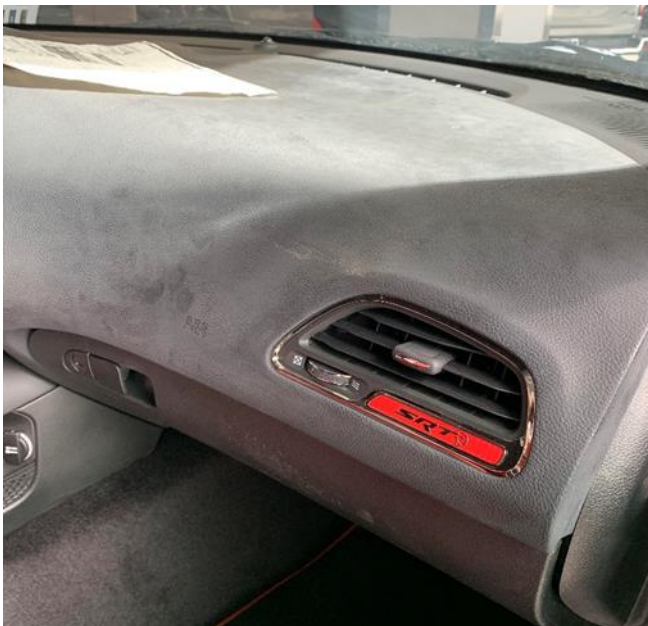
Over time on new vehicles the vinyl on door trim panels and the Instrument panel will exhibit a condition called Vinyl Gassing which can cause a “dusty” appearance to the surface (see below). This is a normal part of the vinyl curing process

and can be cleaned with MOPAR Total Clean PN 04897840AD, or MOPAR Interior Cleaner PN 05003240AC, during the New Vehicle Prep process in the last step of the process “Clean Vehicle Interior”. Replacement of parts is not required, only a good cleaning.

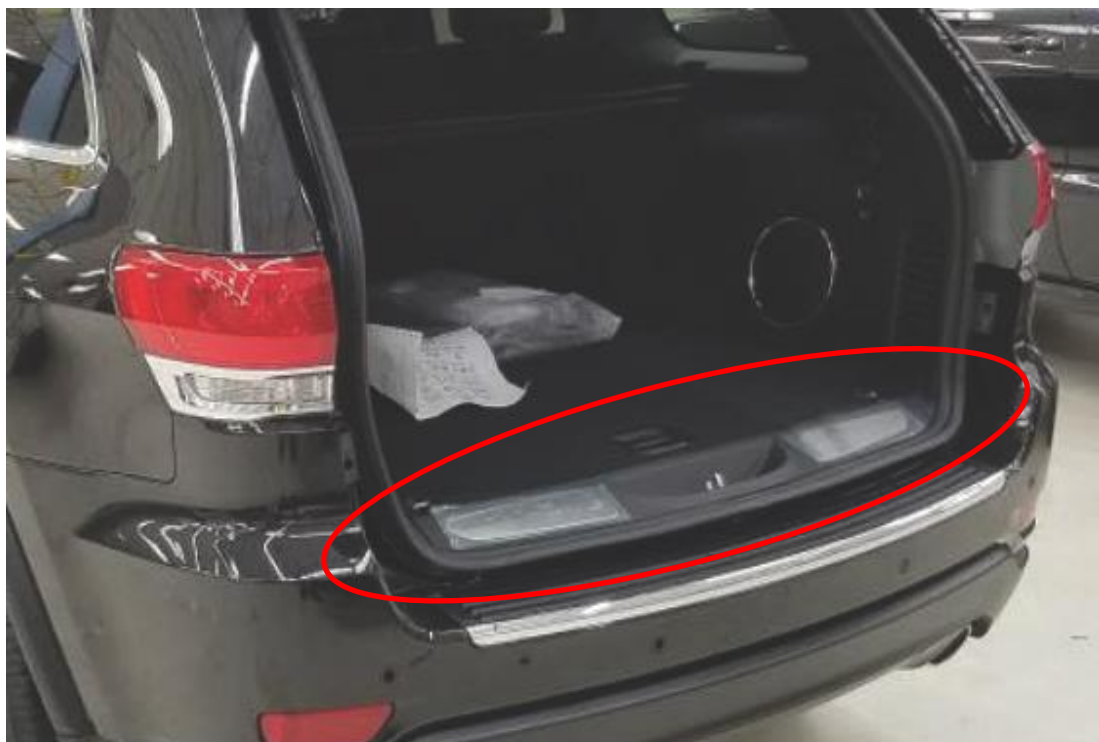
On May 25, 2019, the aluminum scuff plate on the Limited Grand Cherokee will change to a "Mold in color" scuff plate the same as the base models. Be aware that before thinking this is a "Shortage or Error" in the build, check the build date on the vehicle. Vehicles built prior to May 25, 2019, will have the aluminum scuff plate (see picture

below), and vehicles built after will have the Mold in color scuff plate. Warranty claims filed for installation of the silver scuff plate on Limited Grand Cherokees built after the end date of May 25, 2019 will be charged back with no appeal allowed.

WK – Change out the aluminum scuff plate on Limited class vehicles to the plastic Mold in color scuff plate found on the base models

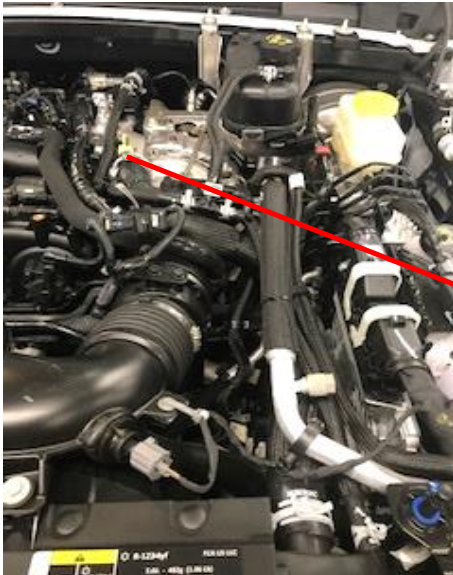
Under-hood View of Upper Radiator  
Hose Clamp Grenade Pin Still Attached.

Clamp in question is on the upper radiator hose next to the turbo charger.

In the example below, where a “Grenade Pin” was not pulled to release a hose clamp, or the clamp pin was not disengaged, if the narrative only said “hose leak”, we would not know which hose. (as there are many) Instead, you might say “upper radiator hose next to the turbo charger, clamp pin still engaged.”

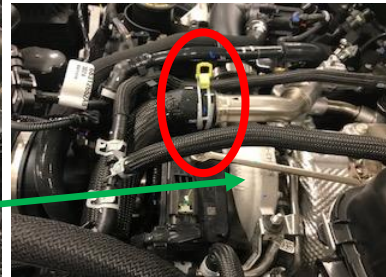
Clamp viewed from left fender.

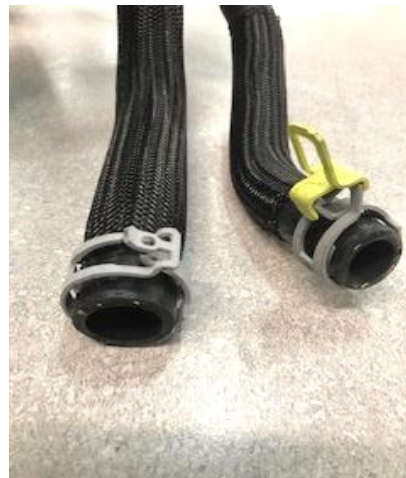
“Clipless” Mubea clamp on left / “Grenade Pin” Mubea clamp on right. Both clamps are un-sprung. Specifying where on the hose (i.e., at the turbo charger), and what type of clamp, helps us understand where and what the issue is.

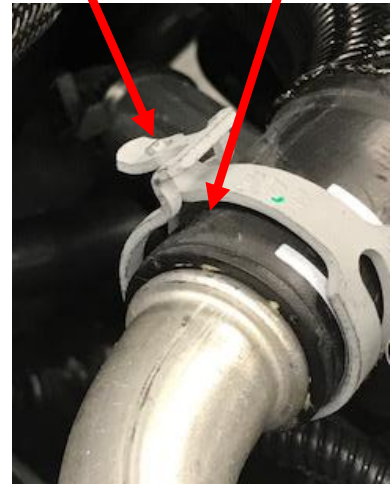
Clamp Pin Engaged / Clamp Gapped To Hose

**CUSTOMER CLAIMS  
VEHICLE LEAKS COOLANT  
DUE TO CLAMPS NOT SPRUNG**
