ProJet® CJP 660

Troubleshooting Guide

P/N 09915

Revision C

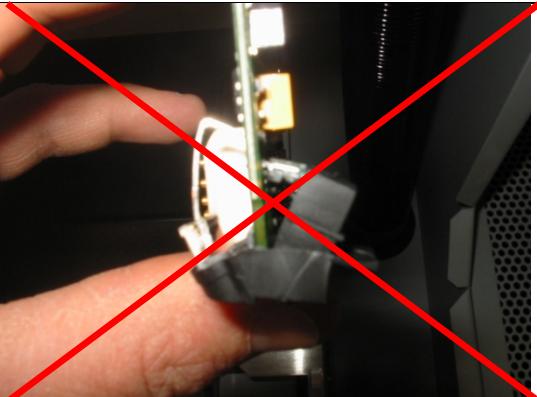
*Bad pogo card sensor
Figure 9*

40008: AUTOALIGN	Pogo Card is crooked or sensor is not snapped in	Realign the pogo card	(Figure 9 and 9.1)
After performing the above step try performing a service print head and an alignment. Watch the alignment pattern for print quality. If the machine performs both tasks the problem should be solved.			
40008: AUTOALIGN	Bad Pogo PCB	Replace Pogo PCB	Pogo PCB Removal and Replacement
After performing the above step try performing a service print head and an alignment. Watch the alignment pattern for print quality. If the machine performs both tasks the problem should be solved.			
40008: AUTOALIGN	PC104+ Failed	Replace PC104+ PCB	E-Box Field Repair Procedure
Stripy printing is one of the most common causes of this error. The key to troubleshooting this error is defining the problem that you are dealing with. You must differentiate weather the problem is caused by stripy printing or an axis problem. When this error is encountered the machine will do a stripe test over the alignment pattern. If that stripe test looks good then the problem may be related to a dirty sensor window or movement problems with the indicated axis.

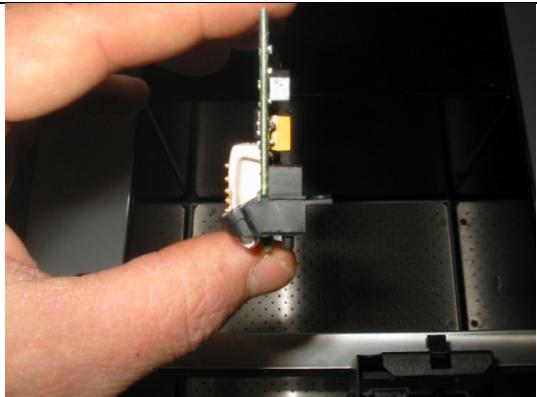
*Good pogo card sensor
Figure 9.1*

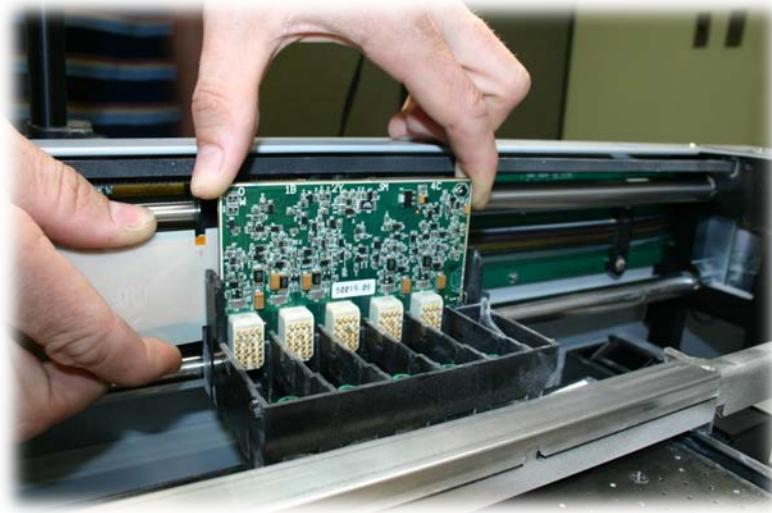
Step 1: Remove the Pogo PCB

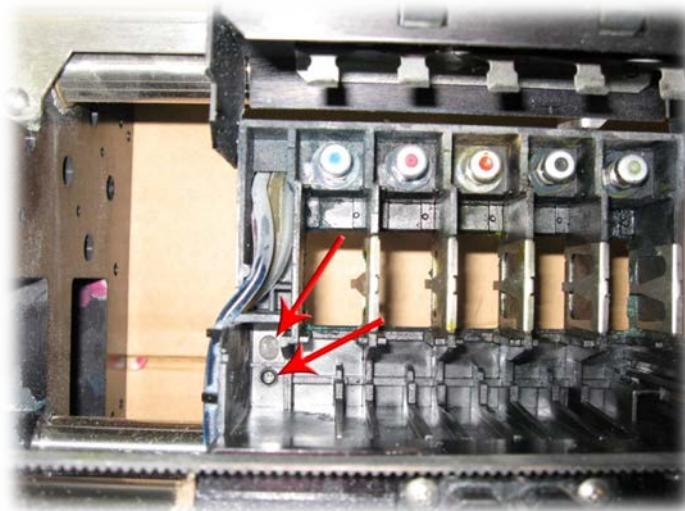
Step 2: Clean the alignment window in the Carriage with alcohol and a cotton swab. Make sure you can see clearly through the window when done and that no liquid remains.

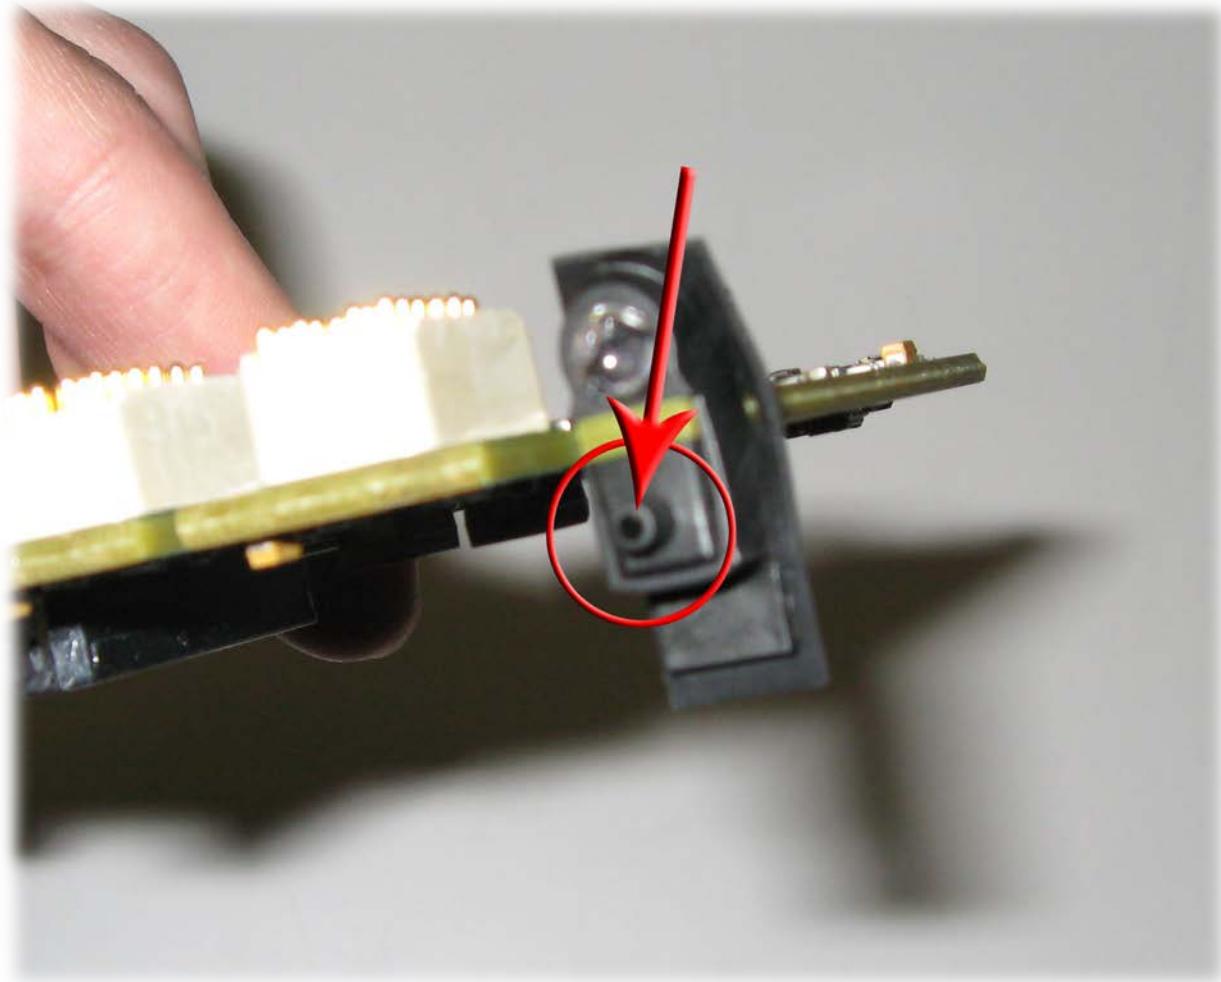
Step 3: To clean the alignment sensor on the Pogo PCB you can submerge that side of the Pogo in a cup of alcohol. Shake the Pogo dry once you are done and allow it to air dry to 15 minutes.

The area to clean is indicated above with the red arrow.

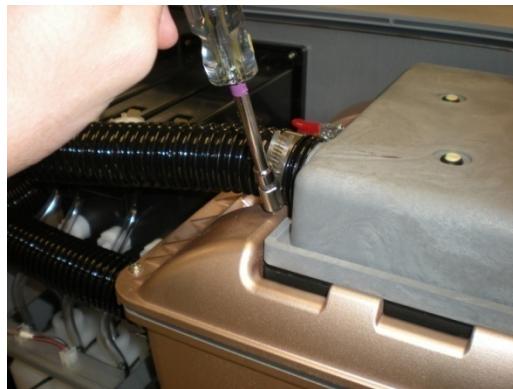
1. Disconnect the vacuum hose from the filter cleaner.

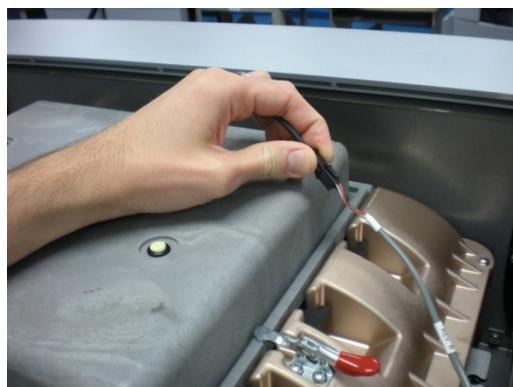
2. Disconnect the electrical cable from the filter cleaner.

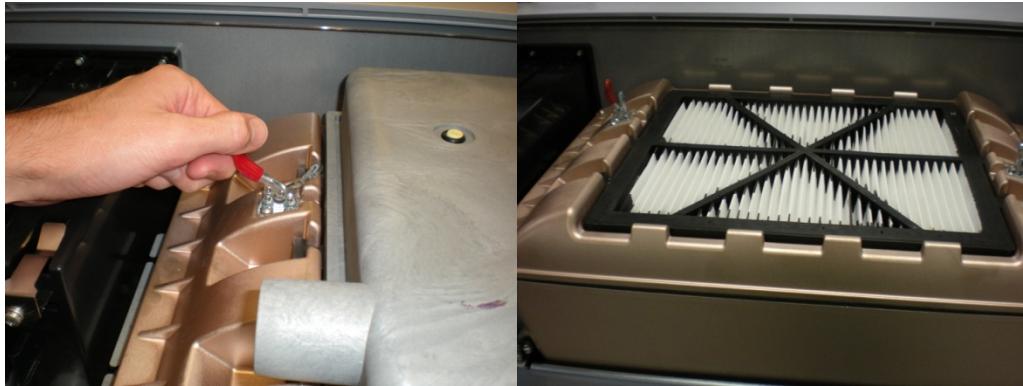
3. Read the load cell LBS. Make a note of the weight.
4. Unlatch the filter cleaner and set it aside.

5. Read the load cell LBS. The weight should drop by between 3.0 and 3.7 LBS from the reading in step 4. This is the weight of the filter cleaner.

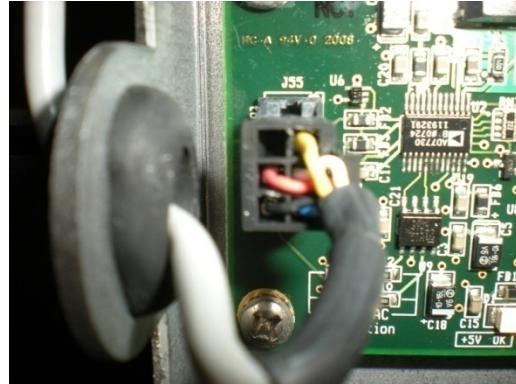
Loose wires can also cause bad readings. Make sure that all 5 pins from the load cell wire are pushed all the way into the connector. Make sure none of the wires look damaged.
