SUBJECT: **GHG17 Heavy Duty Engine Platform 1-BOX<sup>™</sup> Aftertreatment System (ATS) Wire Harness**

## ISSUE

For GHG17, the main Aftertreatment Control Module (ACM) harness shifted from a Daimler Trucks North America (or vehicle OEM) part to a Detroit<sup>™</sup> part. There are two main issues with the 1-BOX<sup>™</sup> ATS harness. Reference Figure 1.

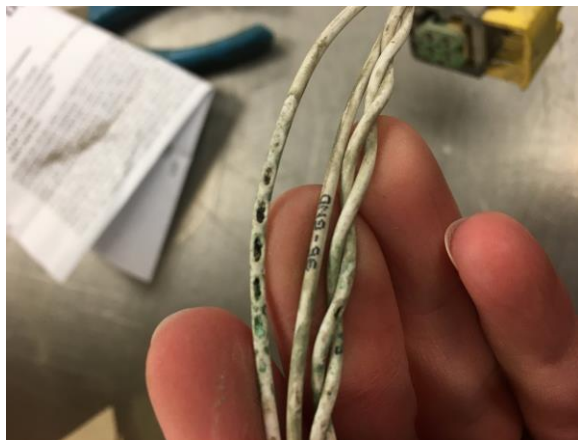
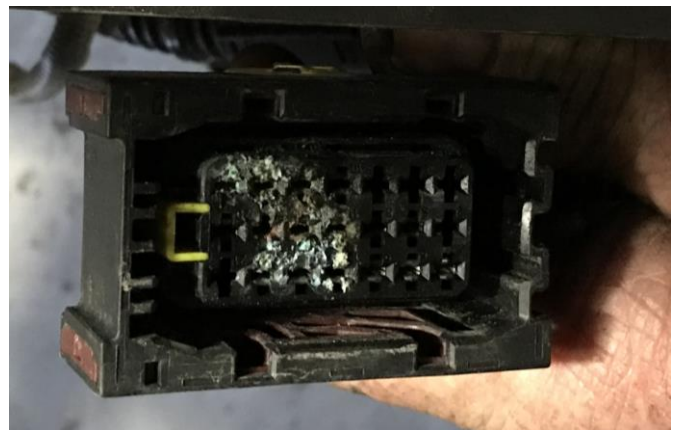
**Figure 1 – GHG17 1-BOX<sup>™</sup> ATS Wire Harness**

- Harness shows chaffing on the branch to the 21-pin connector and Soot Sensor
- Harness and ACM show corrosion at the 21-pin connector

The chaffing is caused by vibration and dirt collecting inside the harness conduit. The water intrusion at the 21-pin connector is a secondary failure due to chafing and water entering the harness wiring.

Anti-chaffing tape should be applied to the current ATS harness, or to a new replacement harness if it does not have the tape. See the Repair Procedure section for instructions on installing the tape.

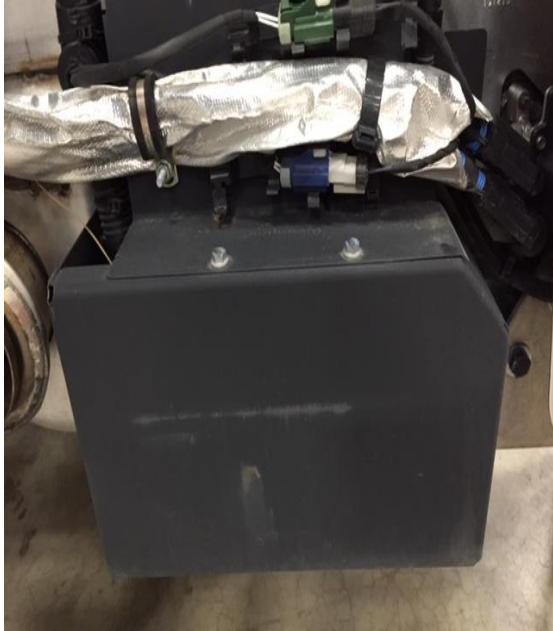
**Figure 2 – ACM Cover**

4. Remove the six bolts securing the ACM protective cover to the ATS. Reference Figure 2.

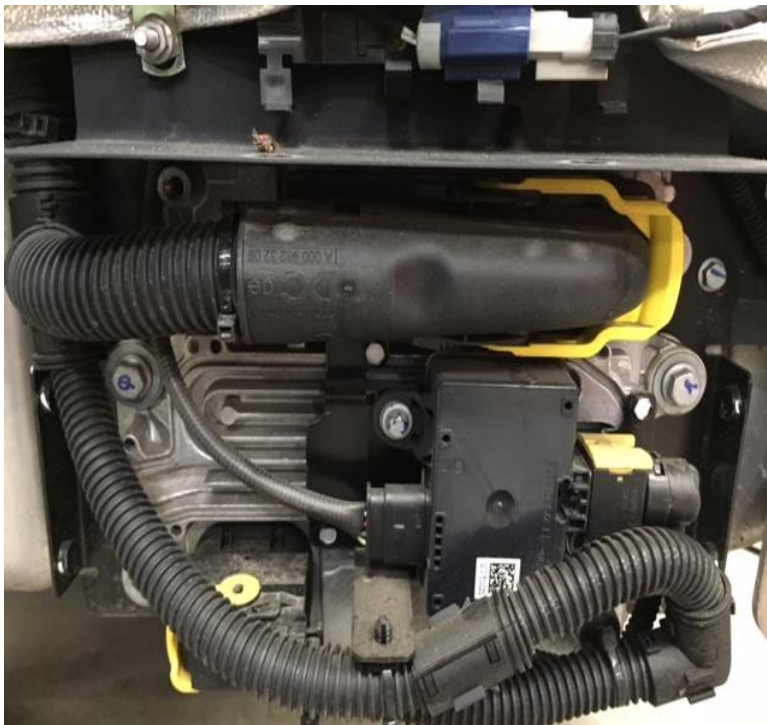
**Figure 3 – Harness Routing and Zip Tie Location**

5. Note the location of the zip ties securing the wiring harness to the ATS and the harness routing location. Remove the zip ties securing the wiring harness to the ATS. Reference Figure 3.

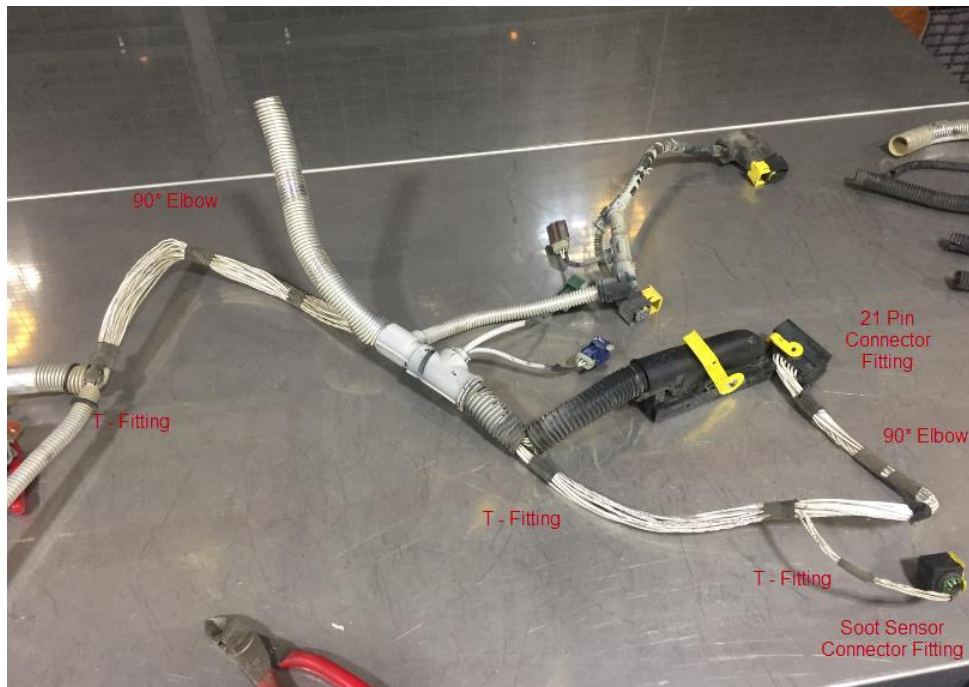
**Figure 4 – Harness Clip Removal**

6. Remove the following plastic connector clips. Reference Figure 4.

- Two 90-degree elbows
- Three T-fittings
- 21-pin connector fitting
- Soot Sensor fitting

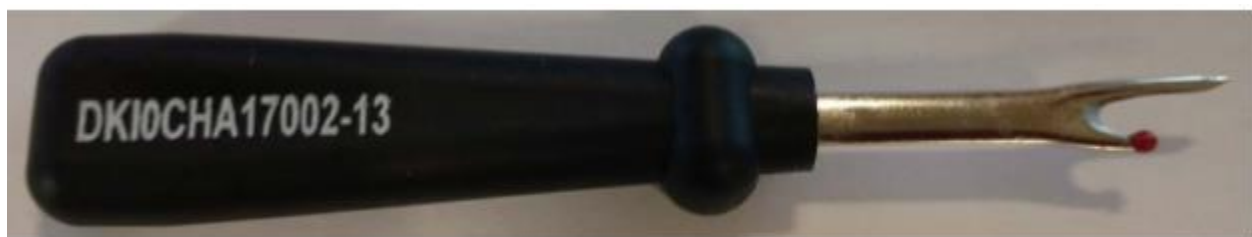
**Figure 5 – Harness Fiber Tape Wrap Cutting Tool**

7. Remove the convoluted tubing using scissors or tool DK10CHA17002-13 from the Chassis Terminal Extraction Tool Kit DK10CHA17002. Take care not to cut the wire harness. **DO NOT USE A RAZOR BLADE.** If using the Harness Fiber Tape Wrap Cutting Tool, use the sharp end to make an incision in the tubing, and then insert the blunt end to cut the tubing. Reference Figure 5.

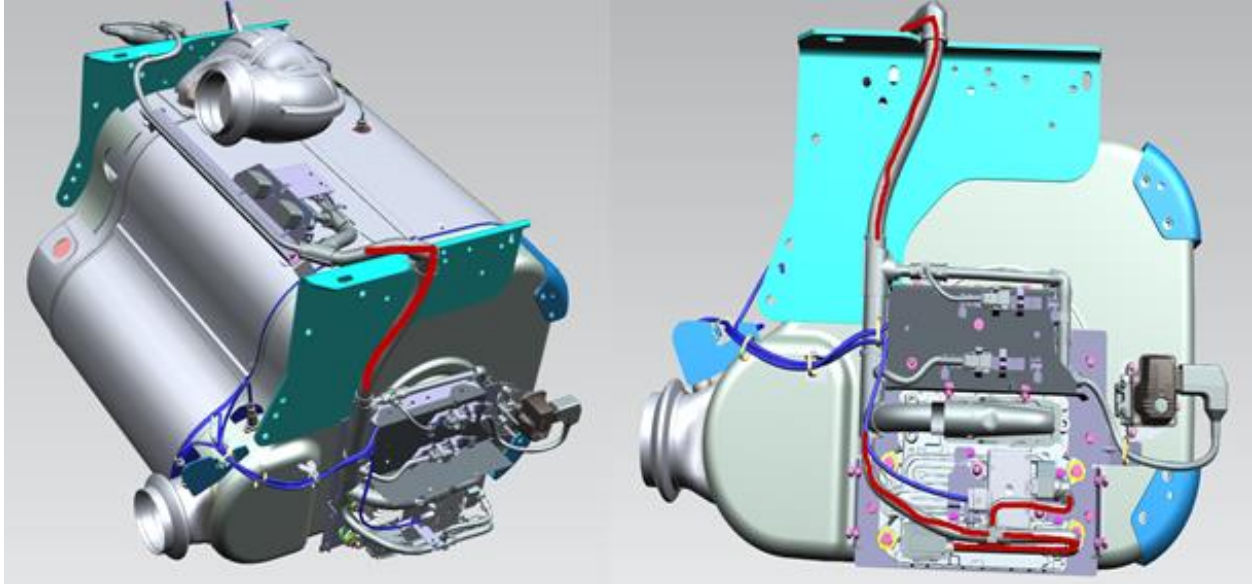
**Figure 6 – Convoluted Tubing Removal**

8. Carefully remove all convoluted tubing shown in red below. Reference Figure 6.

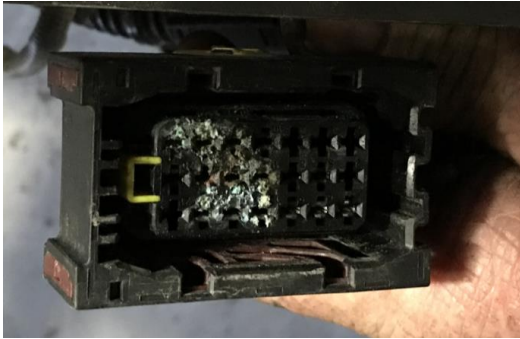
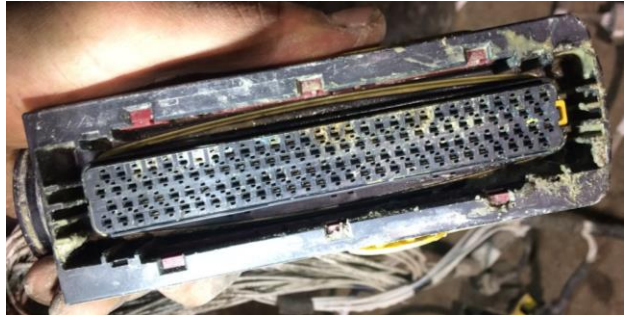
**Figure 8 – ATS Harness 21-pin and 120-pin Connector Inspection**

10. Inspect the ATS harness 21-pin and 120-pin connectors for excessive corrosion. Reference Figure 8. Is excessive corrosion present at one or both connectors?
- Yes; replace the ATS harness. Reference the removal and installation sections for the 1-BOX™ Aftertreatment Harness in the *GHG17 Heavy Duty Workshop Manual* (DDC-SVC-MAN-0190). Instructions for adding anti-chaffing tape are further below.
  - No; the harness will be reused.

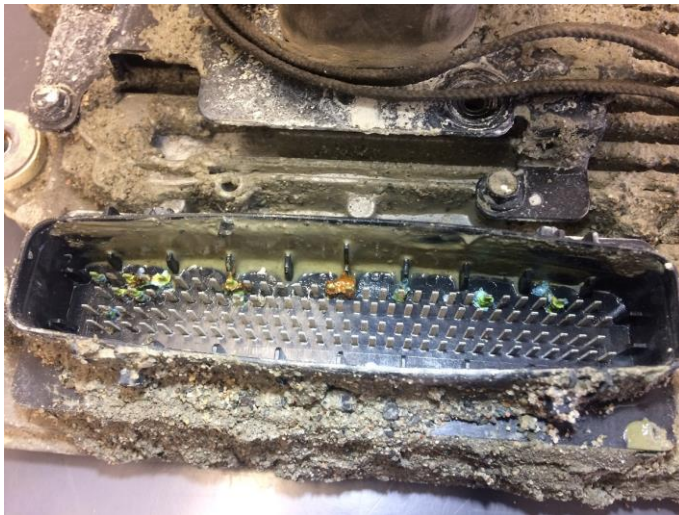
**Figure 9 – ACM 21-pin and 120-pin Connector Inspection**

11. Inspect the ACM 21-pin and 120-pin connectors for excessive corrosion. Reference Figure 9. Is excessive corrosion present at one or both connectors?
- Yes; replace the ACM. Reference the removal and installation sections for the 1-BOX™ Aftertreatment Control Module in the *GHG17 Heavy Duty Workshop Manual* (DDC-SVC-MAN-0190). Go to step 13.
  - No; go to step 12.

12. If light corrosion is present in the ACM 21-pin and 120-pin connectors, clean them with commercially available electrical contact cleaner and an insulative nylon brush such as Techni-Stat Insulative Brush P/N: 758PR499 (reference Figure 10) or Techni-Tool ESD Brush P/N: 758PR121. Gently blow out the connector with compressed air until dry.

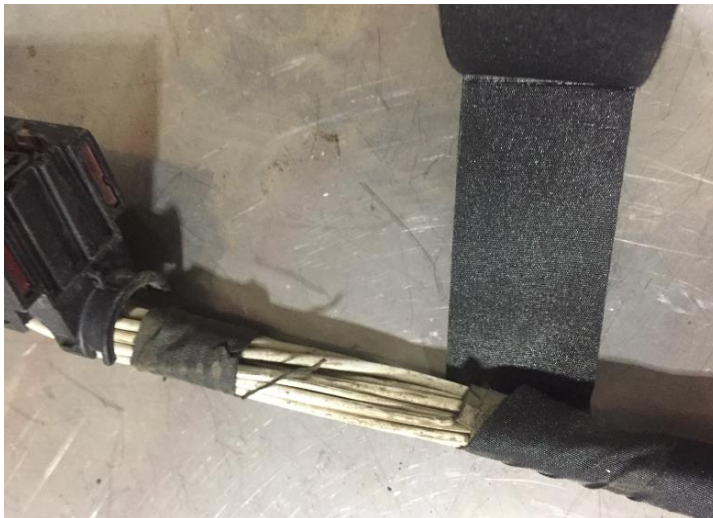
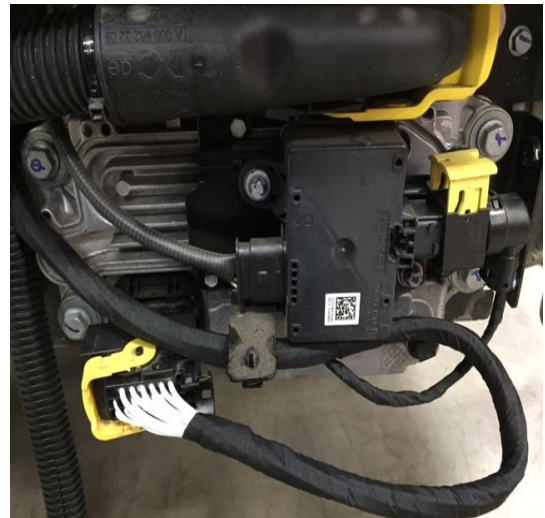
**Figure 11 – Anti-Chaffing Tape Installation**

13. If reusing the existing ATS harness or installing a new ATS harness P/N: A4721503620, install anti-chaffing tape around all exposed wires as shown in Figure 11. **Overlap the tape by 50%** and proceed to step 14. If installing a new ATS harness P/N: A4721504320, note that it already comes with anti-chaffing tape under the loom and proceed to step 15.

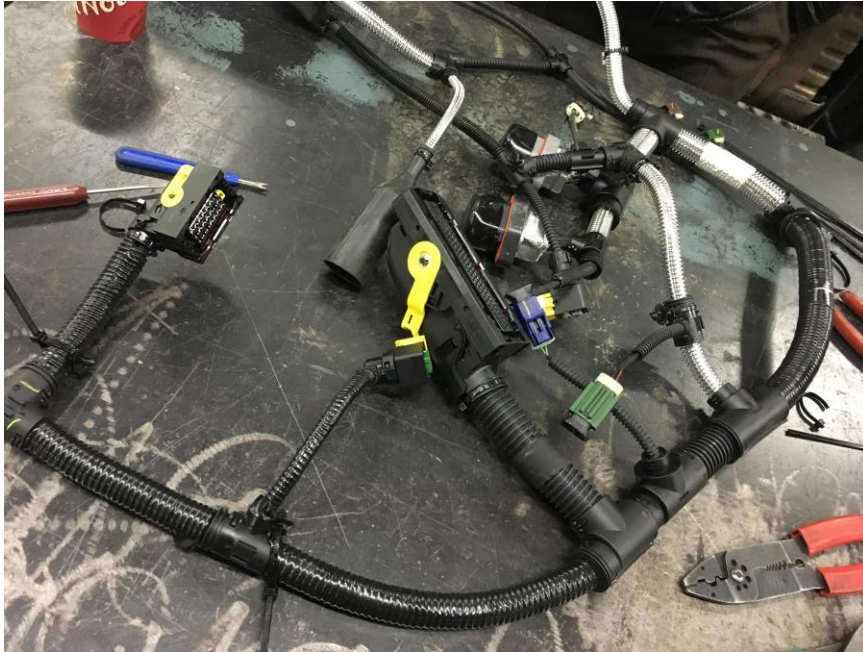
**Figure 12 – Tape Installation**

14. Reinstall the convoluted tubing and install existing elbows, tees and connector fittings. Fully apply electrical tape around the convoluted tubing. Reference Figure 12.

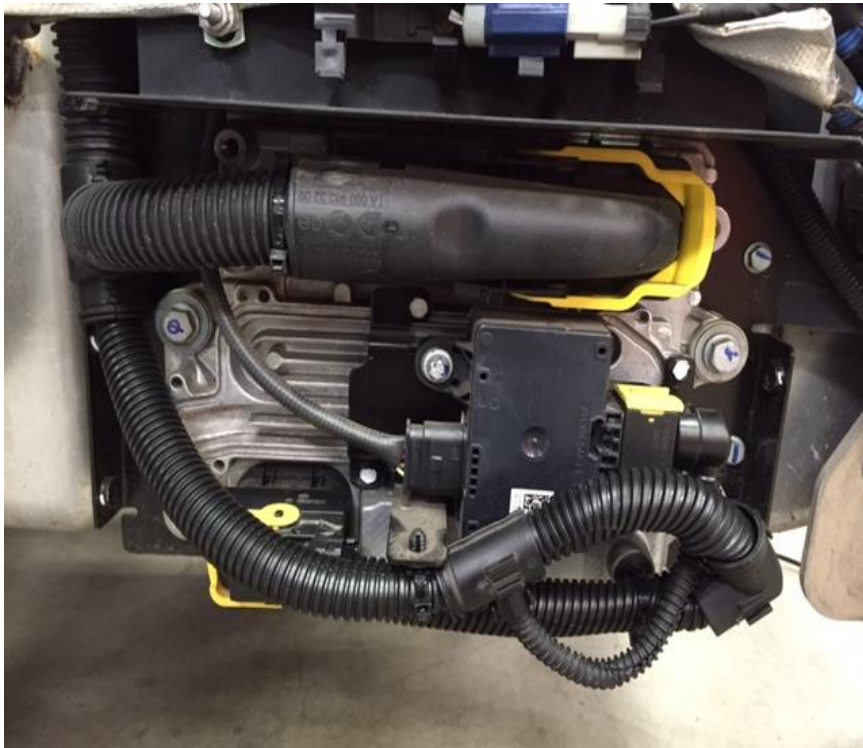
**Figure 13 – Zip Tie Location**

15. Connect the 120-pin and 21-pin electrical connectors and make sure the latches are fully closed. Connect the soot sensor electrical connector. Install new zip ties in the original locations, securing the harness to the ATS. Reference Figure 13.

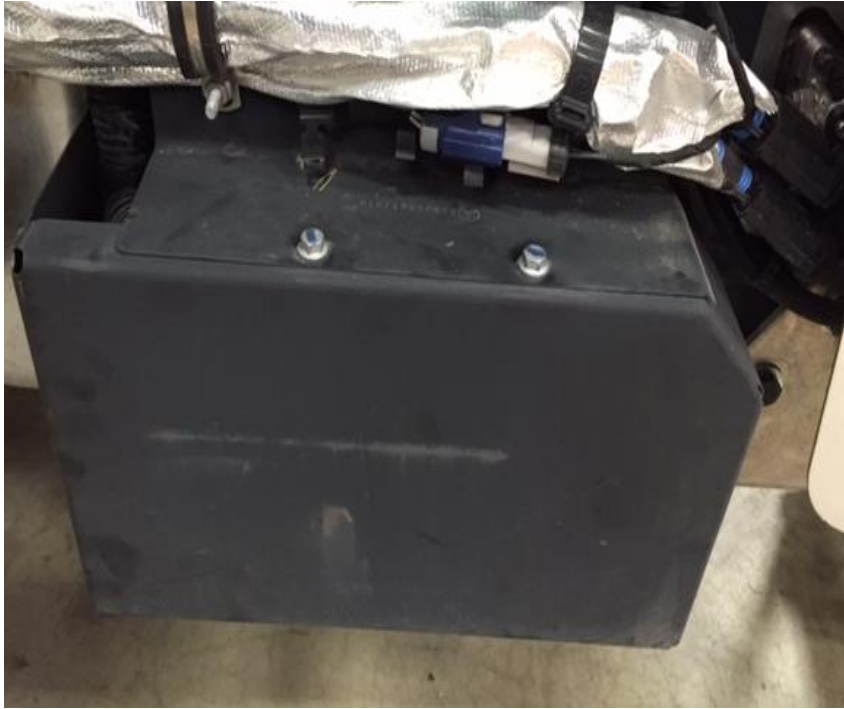
**Figure 14 – ACM Cover Installation**

16. Install the ACM protective cover and hand-tighten the bolts. Torque the bolts to 10 N·m (7.4 lb·ft). Reference Figure 14.
