## PRODUCT CAMPAIGN BULLETIN

**APPLICABILITY:** 2005-2006 model year Baja  
 2009-2012 model year Legacy  
 2009-2012 model year Outback  
 2009-2012 model year Forester  
 2006-2012 model year Tribeca  
 2006-2011 model year Impreza (including WRX and STI)  
 2012 model year WRX and STI

**NUMBERS:** TKA-17R  
 TKB-17R  
 TKC-17R

**SUBJECT:** Takata Front Passenger Airbag Inflator Replacement

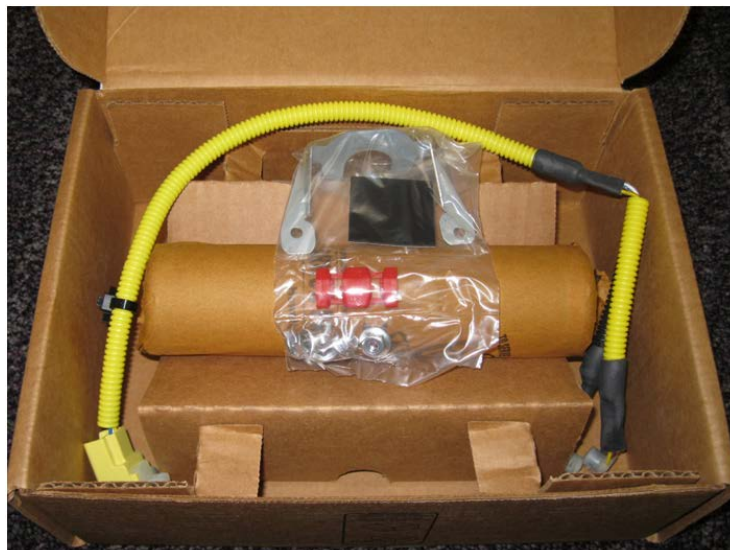
- 4 Self-Locking nuts
- New Inflator (yellow tape applied to one end to identify it as the replacement part)
- New Inflator Harness
- Electro-Tap (red shorting crimp connector)
- New Stopper Plate with D-Shaped hole
- Self-Adhesive Foam Protector
- Shipping Documentation

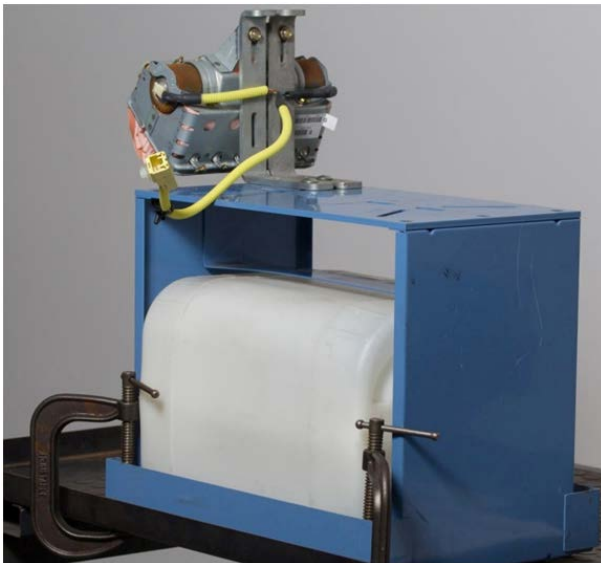
**IMPORTANT:** The removed airbag module must be mounted to the Airbag Deployment Fixture (part number J-39401-B) as shown in the photo below to better secure it during the inflator and wiring harness component replacement procedures. When mounting the module to the fixture, pay close attention to the harness routing as shown in the photo below. Always perform this work in an area away from others to reduce chances of inadvertent injury should any deployment occur. Take your surroundings into account to avoid possible hazards should inadvertent deployment occur or sources of static or other electricity that could potentially induce such a deployment.

**STEP 2-** Remove both sides of the harness from the retainer bracket holders then secure the airbag module to the Airbag Deployment Fixture as shown in the photos below.

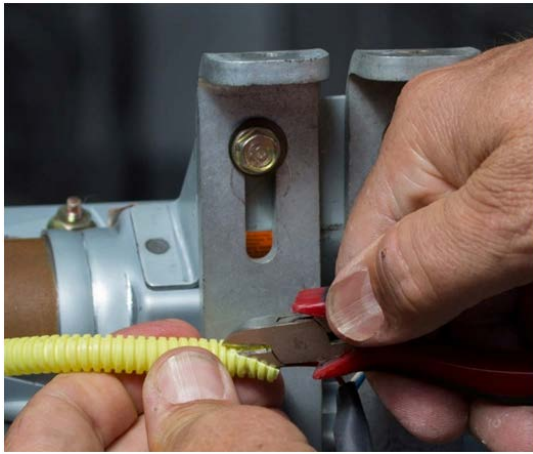
**STEP 3- CAREFULLY** cut the yellow harness cover (approximately 1 1/2 inches) enough to expose the 2 yellow and red wires inside and provide enough room to install the Electro-Tap (shorting) connector using a scissor or wire cutter (no knives or razors).

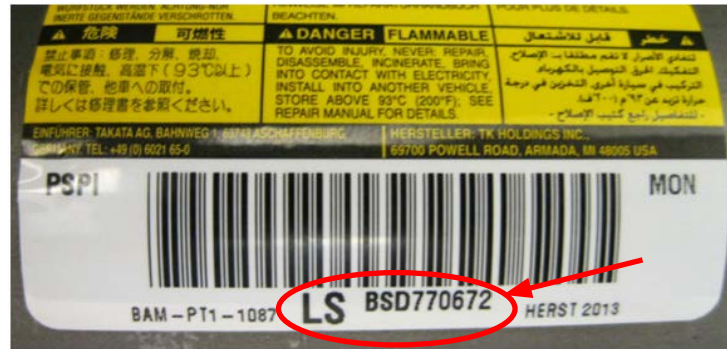
**STEP 7 - VERY IMPORTANT:** Record the **11-digit alpha-numeric serial number** for **both the new and the removed inflators** on the hard copy of the Repair Order. This information will be required for completion of the Part Return Notice which will be forwarded by the retailer to the PCC.

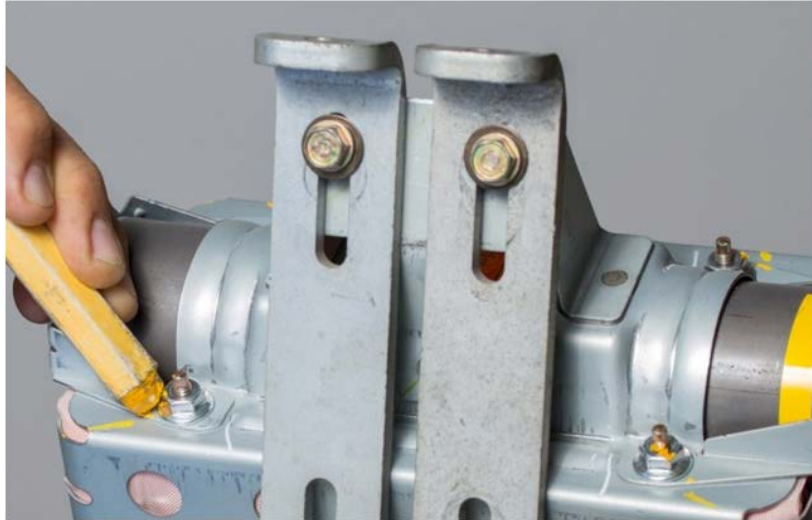
**STEP 9-** Once all 4 **NEW** nuts are in place, **torque to 31 - 38 inch pounds in the sequence shown above.** Use a marker to mark the nuts after torquing to indicate they have been fully tightened.

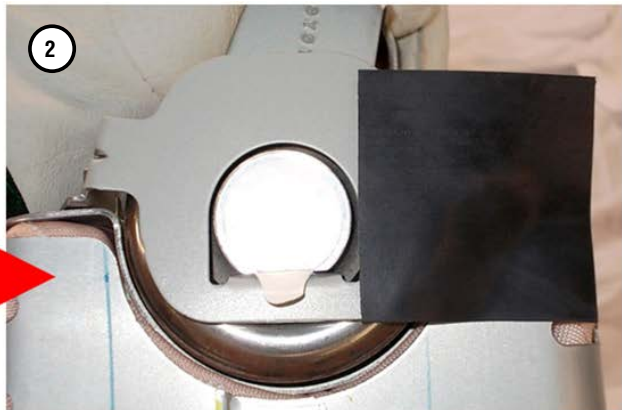
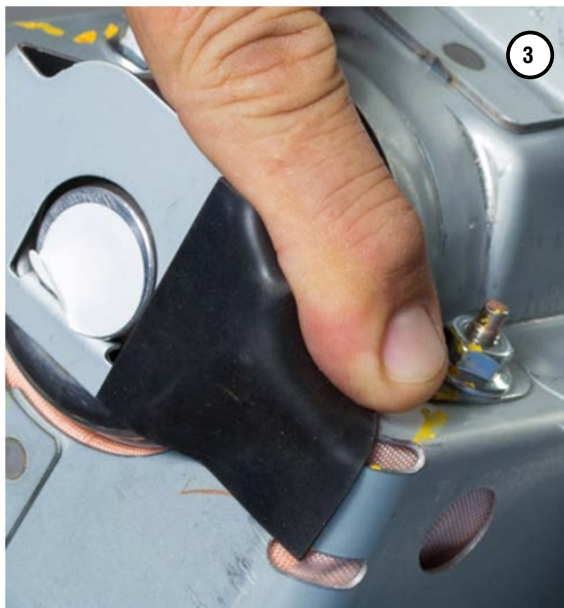
**STEP 10-** Install the black foam self-adhesive protector onto the D-Shaped stopper and mounting bracket positioned as shown in the photo sequence below. Once adhered in place on the new stopper plate, fold over the excess as shown. Always make sure the placement area for the protector is free of any grease or dirt before application.

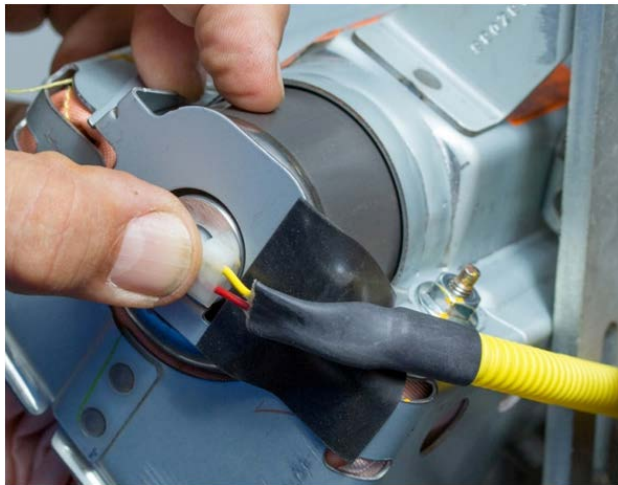
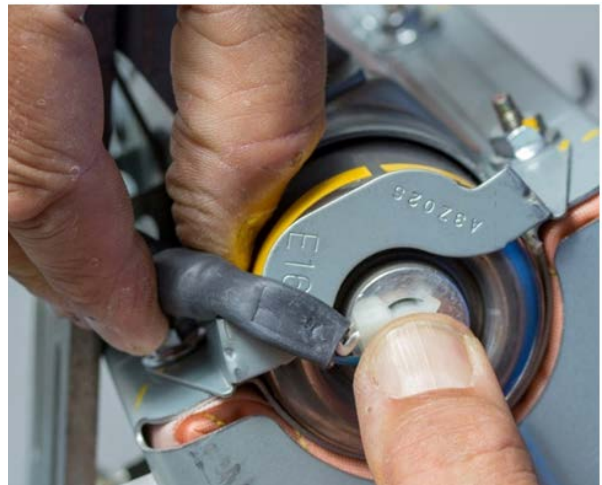
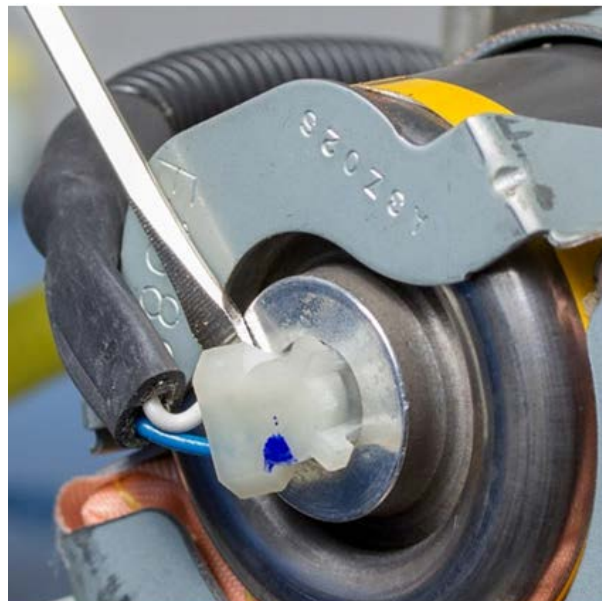
**STEP 11-** The new inflator wiring harness has 2 “sides” with round 2-pin connectors on both ends. The side with the yellow corrugated tube and red / yellow wires will connect to the end of the inflator with the D-Shaped wiring harness connector boss, new stopper plate and foam protector as shown below. Peel off the white dust cover from the D-Shaped end of the inflator **ONLY**. **IMPORTANT: NEVER PEEL BOTH THE WHITE DUST COVERS OFF AT THE SAME TIME!** CAREFULLY align the pins with the female terminals of the harness connector (red / yellow wires) as shown in the photos below. Once pin alignment is confirmed, push down firmly to engage the connector’s 3 locking tangs into the locking groove inside the connector boss. Confirm the connector is locked by prying up **LIGHTLY** with a small flat-blade screwdriver. Repeat the procedure on the opposite end with the blue / white wires.

**VERY IMPORTANT:** When connecting the new harness to the inflator, both sides of the harness **MUST** be routed toward the module’s mounting brackets as shown in the photos below.

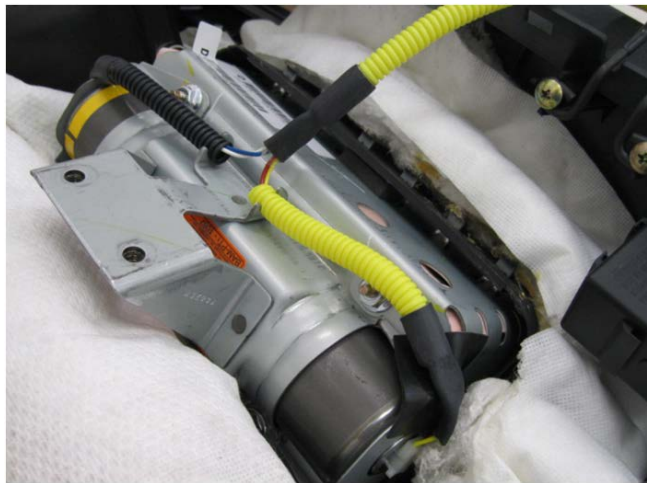
**STEP 13- CAREFULLY** reinstall the airbag module assembly into the instrument panel as shown below.

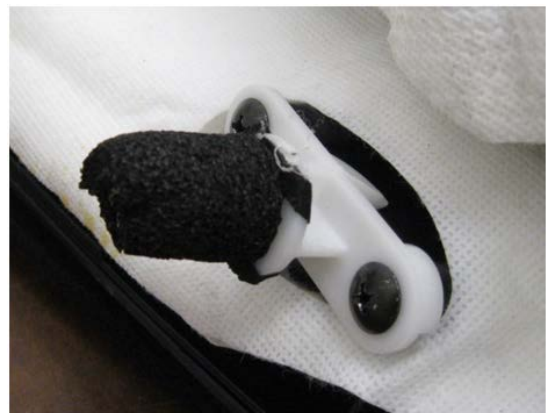
**STEP 14-** To eliminate a possible source of a rattling sound from the dash, wrap the 2 hooks and locator pin with non-woven material, p.n. SOA963W110 (or an equivalent self-adhesive foam) as shown below.

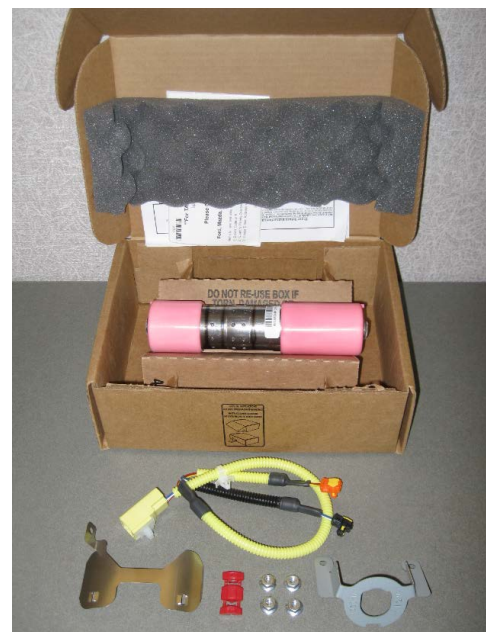
- 4 Self-Locking nuts
- New **Type 2** Inflator (pink collars on each end identify it as the replacement part)
- New Inflator Harness
- 1 new Stopper Plate (A)
- Heat Insulating Plate
- Electro-Tap (red shorting crimp connector)
- Shipping Documentation

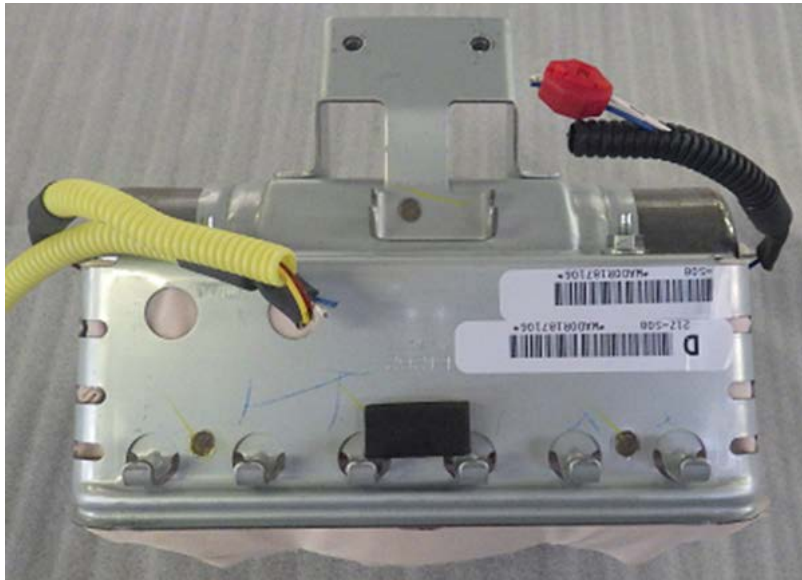
**STEP 6-** Once the Electro-Tap connector is fully crimped in place, cut the white and blue wires **on the body harness connector side** of the Electro-Tap connector.

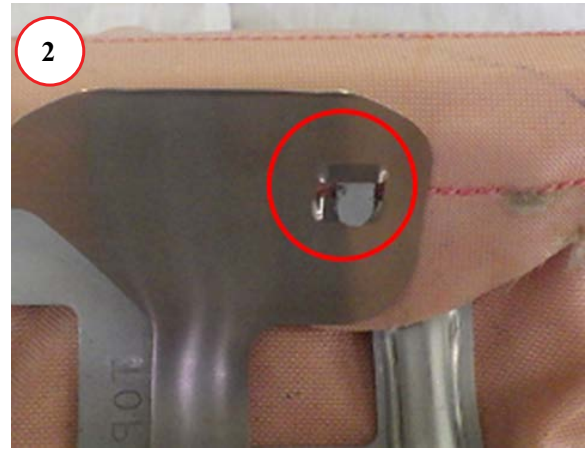
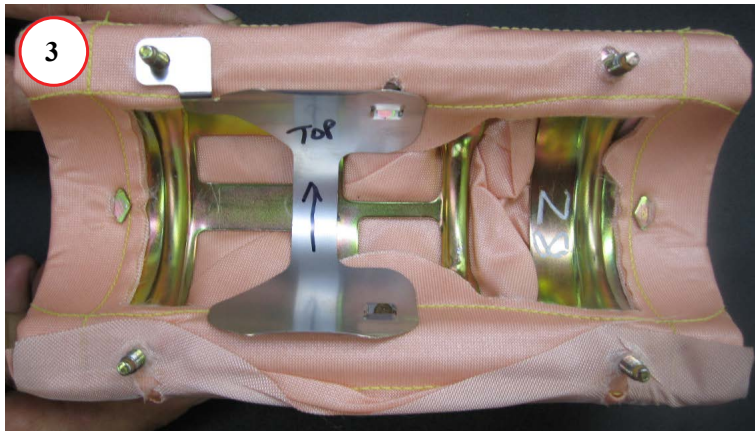
**STEP 11- CAREFULLY** Install the heat insulating plate into the back (inflator) side of the airbag as shown in photo 1 below. **The plate can only be installed in one direction.** Make sure the 2 retaining claws come through the corresponding holes in the insulator plate as shown in photo 2. The airbag is ready to refit to the mounting bracket in photo 3 and is being reinstalled in photo 4.

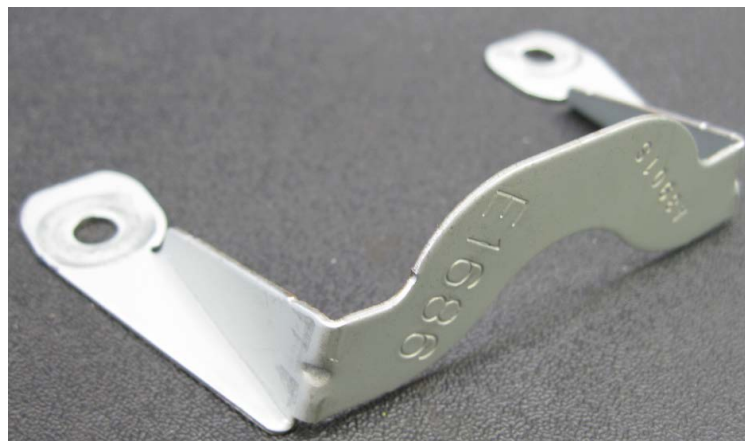
**STEP 14-** Install the original stopper plate onto the opposite end of the mounting bracket / inflator in the same manner as described in STEP 13 above. Rotate the inflator as needed to insure there is no gap between the collar and stopper plate. **NOTE:** Stopper plates only fit one way as their holes are offset.

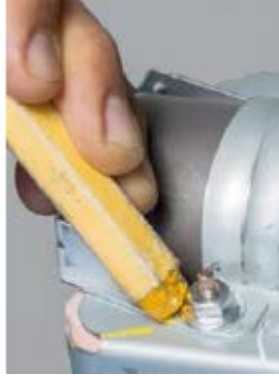
**STEP 15-** Reinstall the 4 **NEW** self-locking nuts. **SLOWLY** tighten (to prevent over-tightening) then torque the nuts to 31-38 inch-pounds. When complete, use a marker to indicate they have been fully tightened.

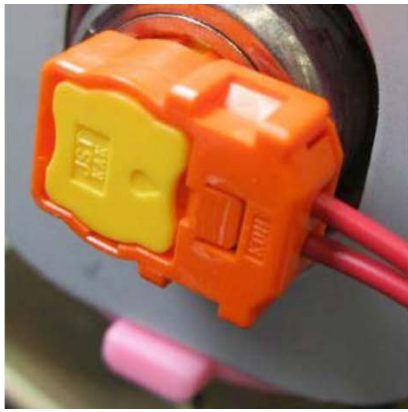
**IMPORTANT: NEVER PEEL BOTH THE WHITE DUST COVERS OFF AT THE SAME TIME!**

Once alignment is confirmed, push down firmly to engage the connector. When fully seated, press down on the yellow tab locking the connector to the inflator.

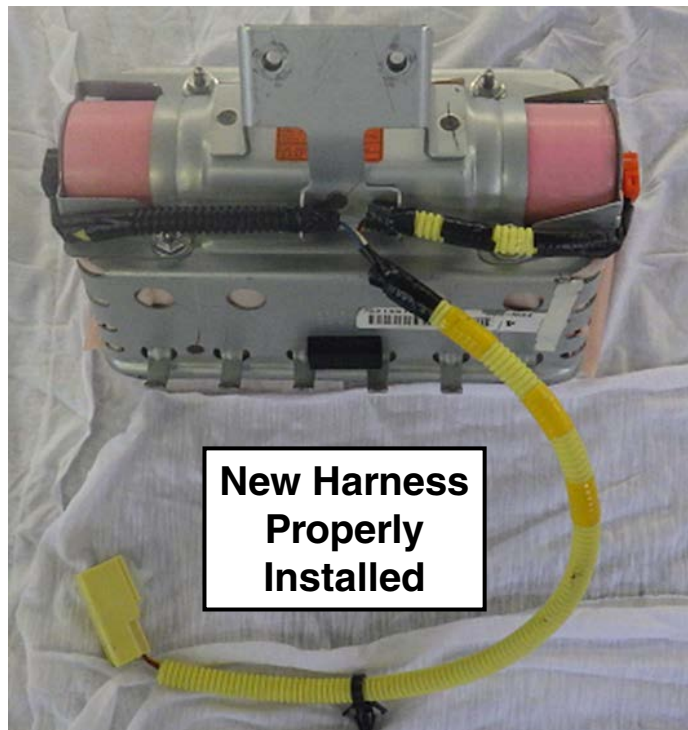
**VERY IMPORTANT:** After connecting the new harness to the inflator, **both sides MUST be routed as shown** in the “New Harness Properly Installed” photo below.

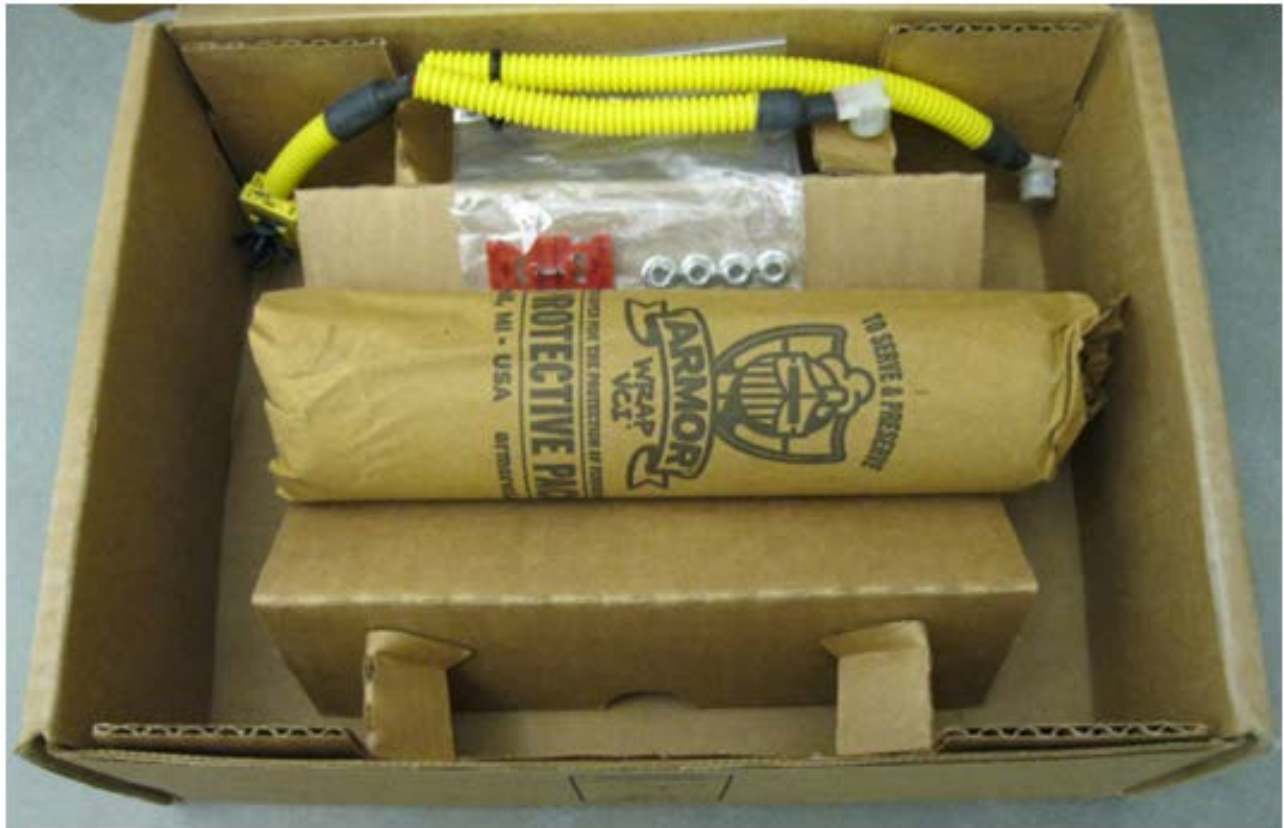
- Open the Kit Box and confirm all the necessary components are included:
  - 4 Self-Locking nuts
  - New Inflator (yellow tape applied to one end to identify it as the replacement part)
  - New Inflator Harness
  - Electro-Tap (red shorting crimp connector)
  - Shipping Documentation and Instructions

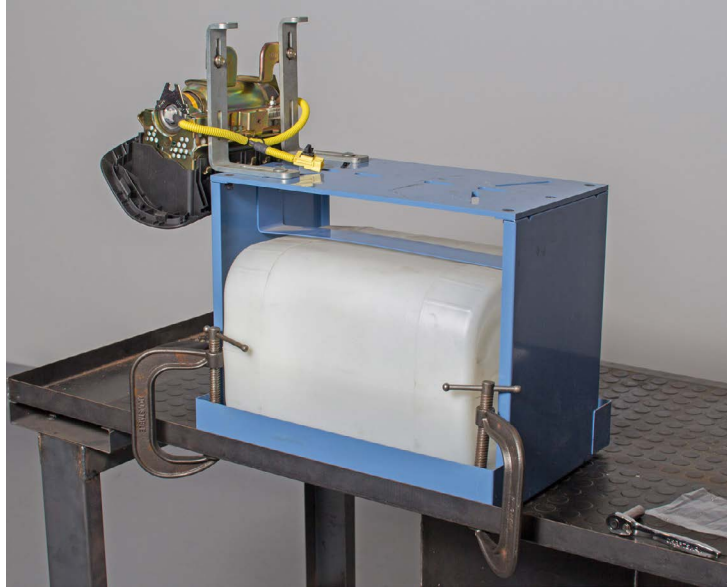
- **IMPORTANT: The removed airbag module must be mounted to the Airbag Deployment Fixture (part number J-39401-B) as shown in the photo below to better secure it during the inflator and wiring harness component replacement procedures.**

When mounting the module to the fixture, pay close attention to the harness routing as shown in the photo below. Always perform this work in an area away from others to reduce chances of inadvertent injury should any deployment occur. Take your surroundings into account to avoid possible hazards should inadvertent deployment occur or sources of static or other electricity that could potentially induce such a deployment.

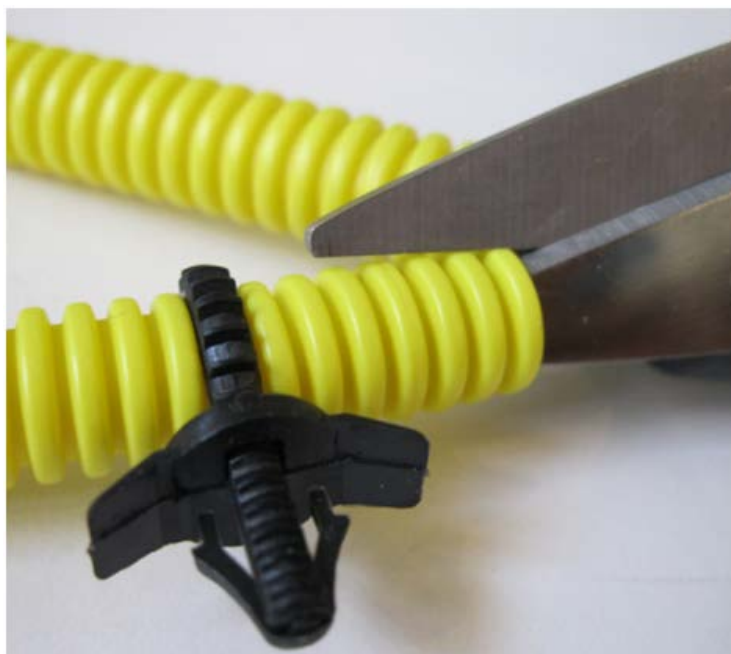
**STEP 3- CAREFULLY** cut the yellow harness cover (approximately 1 1/2 inches) enough to expose the 2 yellow wires inside and provide enough room to install the Electro-Tap (shorting) connector using a scissor or wire cutter (no knives or razors). **TAKE YOUR TIME AND BE CAREFUL TO NOT CUT THE 2 YELLOW WIRES!**

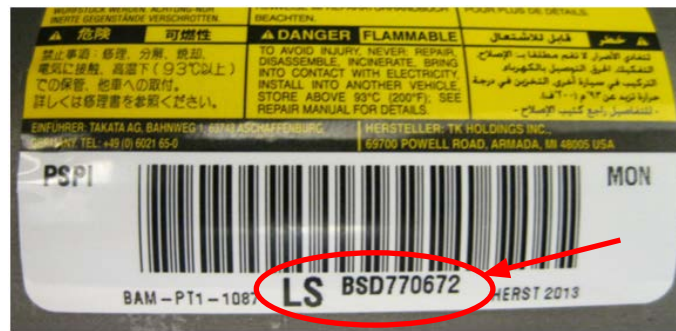
**STEP 8- VERY IMPORTANT:** Record the **11-digit alpha-numeric serial number** for both the **new and the removed inflators** on the hard copy of the Repair Order. This information will be required for completion of the Part Return Notice which will be forwarded by the retailer to the PCC.

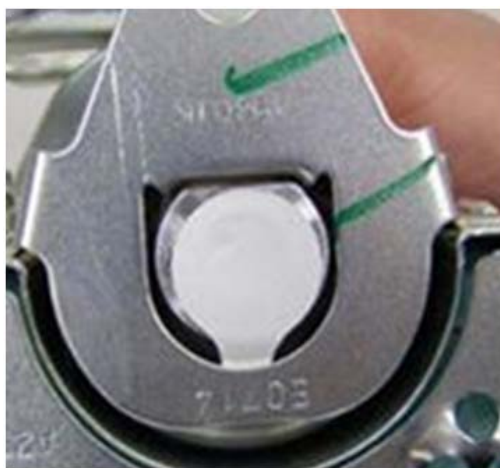
**STEP 9-** Install the new inflator into the mounting bracket so the yellow taped end aligns with the removed stopper plate. Make sure the “D-shaped” portion of the inflator harness connector boss aligns with the “D-shaped” portion of the hole in the end of the mounting bracket as shown below. When properly installed, the end of the inflator will be seated tight against the mounting bracket. Do not peel the white harness connection dust cover at this time.

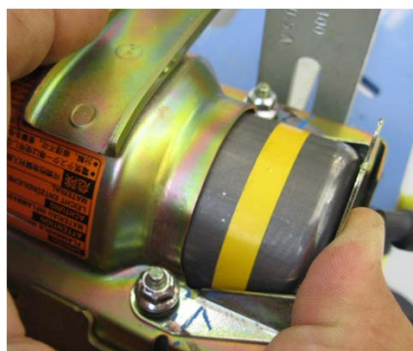
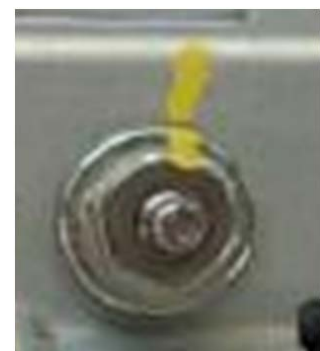
**STEP 10-** As shown below, install but **do not fully tighten** 2 of the NEW self-locking nuts while holding the stopper plate tight against the inflator. Remove the nuts still installed on the mounting bracket and replace them with 2 NEW self-locking nuts. Once all 4 NEW nuts are in place, **torque to 31 - 38 inch pounds in the sequence shown below**. Use a marker to mark the nuts after torquing to indicate they have been fully tightened.

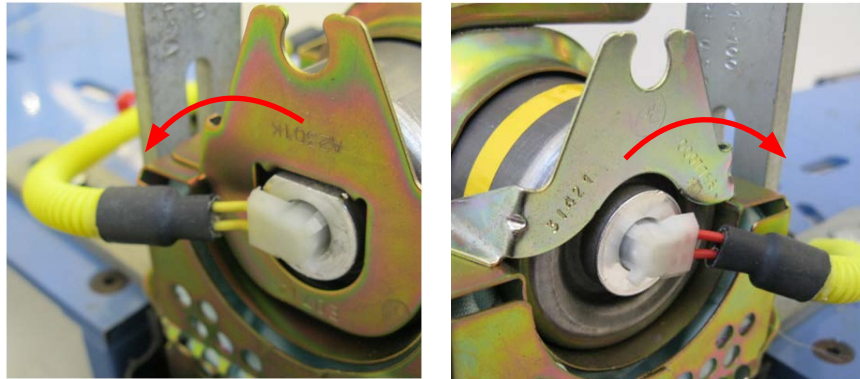
**STEP 11-** The new inflator wiring harness has a “long side” and a “short side” with round 2-pin connectors on both ends. The short side with red wires will connect to the end of the inflator with the round wiring harness connector boss, yellow tape and removable stopper plate. **VERY IMPORTANT: When connecting the new harness to the inflator, both sides of the harness MUST be routed toward the module’s mounting brackets as shown in the photos below.**

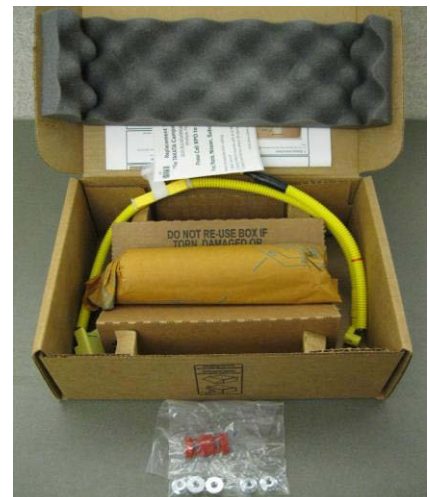
- 5 Self-Locking nuts
- New Inflator (yellow tape applied to one end to identify it as the replacement part)
- New Inflator Harness
- Electro-Tap (red shorting crimp connector)
- Shipping Documentation

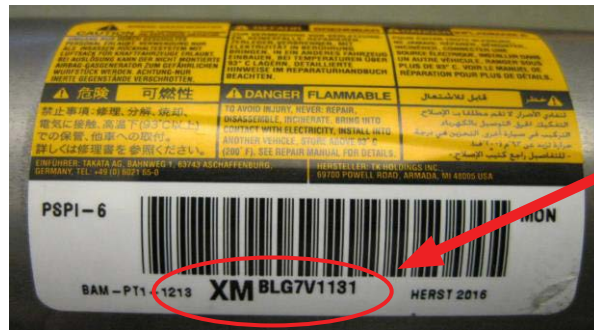
**STEP 9 - VERY IMPORTANT:** Record the **11-digit alpha-numeric serial number** for both the **new and the removed inflators** on the hard copy of the Repair Order. This information will be required for completion of the Part Return Notice which will be forwarded by the retailer to the PCC.

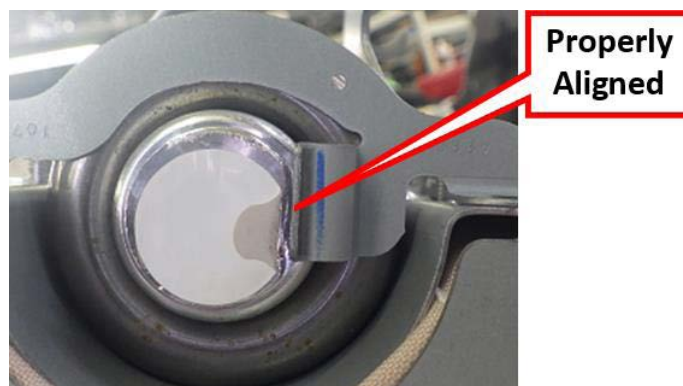
Make sure the “D-shaped” portion of the inflator harness connector boss aligns with the “D-shaped” portion of the original stopper plate as shown below. **Do not peel the white harness connection dust cover at this time.**

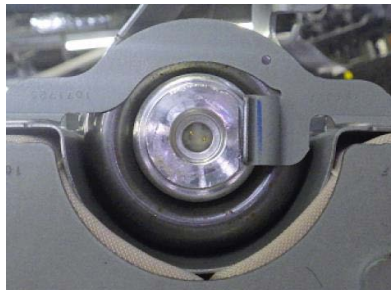
**STEP 12-** Peel the white dust cover from the d-shaped end of the new inflator. The new inflator wiring harness has 2 “sides” with round 2-pin connectors on both ends. The “short” side with the yellow tape and red / yellow wires will connect to the end of the inflator with the D-Shaped wiring harness connector boss as shown below. Peel the white dust cover from the D-Shaped end of the inflator **ONLY**.

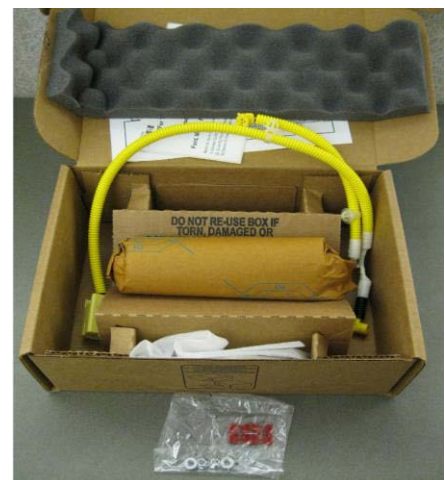
- 4 Self-Locking nuts
- New Inflator (yellow tape applied to one end to identify it as the replacement part)
- New Inflator Harness
- Electro-Tap (red shorting crimp connector)
- Shipping Documentation

**NOTE:** The contents of both kit part numbers are virtually identical except for the vinyl tape color (black / white).

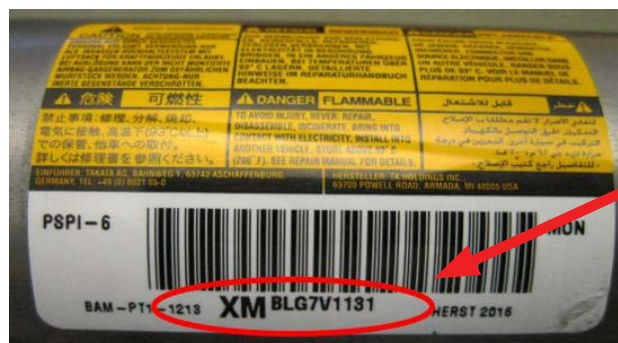
**STEP 9 - VERY IMPORTANT:** Record the **11-digit alpha-numeric serial number** for both the **new and the removed inflators** on the hard copy of the Repair Order. This information will be required for completion of the Part Return Notice which will be forwarded by the retailer to the PCC.

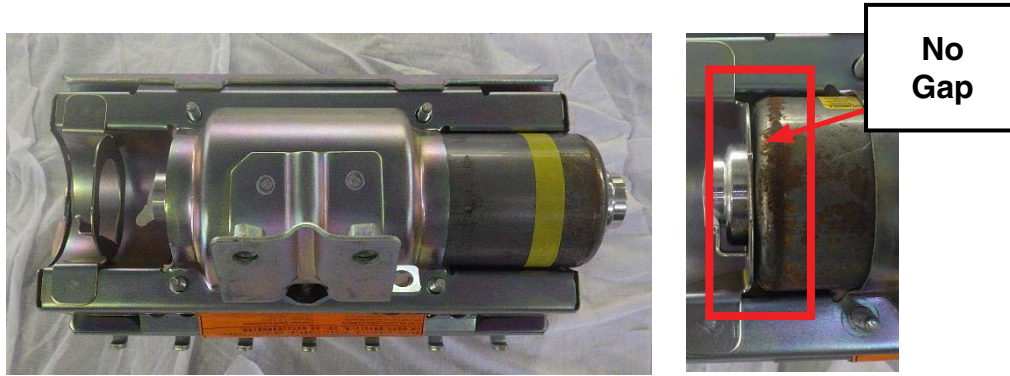
the stopper plate when reinstalled on the mounting bracket. When properly installed, both ends of the inflator will be seated tight against the stopper plates with no gaps.

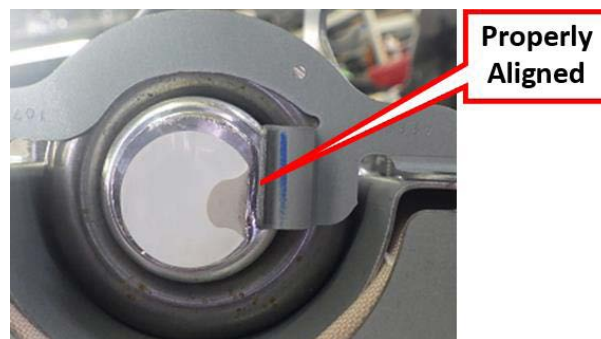
Make sure the “D-shaped” portion of the inflator harness connector boss aligns with the “D-shaped” portion of the original stopper plate as shown below. Do not peel the white harness connection dust cover at this time.

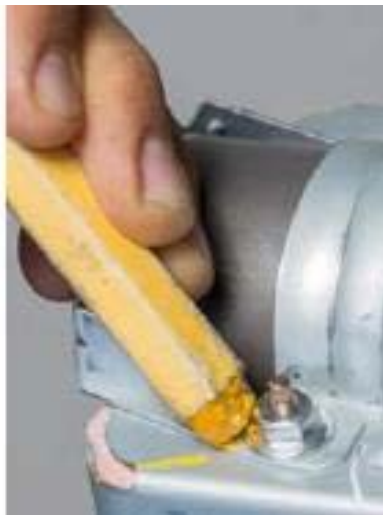
**STEP 11-** Reinstall the original stopper plate and the 4 **NEW** self-locking nuts. **SLOWLY** tighten (to prevent over-tightening) then torque the nuts to 31-38 inch-pounds. When complete, use a marker to indicate they have been fully tightened.

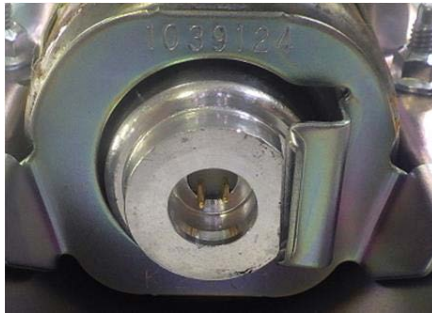
**STEP 12-** Peel the white dust cover from the d-shaped end of the new inflator. The new inflator wiring harness has 2 “sides” with round 2-pin connectors on both ends. The “long” side with the yellow / red wires will connect to the end of the inflator with the D-Shaped wiring harness connector boss as shown below. Peel the white dust cover from the D-Shaped end of the inflator **ONLY**.

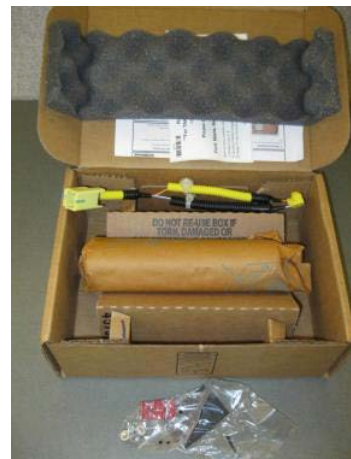
Open the Kit Box and confirm all the necessary components are included:

- 4 Self-Locking nuts
- 1 ½” X 2 ¼” piece of self-adhesive sponge tape
- New Inflator (yellow tape applied to one end to identify it as the replacement part)
- New Inflator Harness
- Electro-Tap (red shorting crimp connector)
- Shipping Documentation

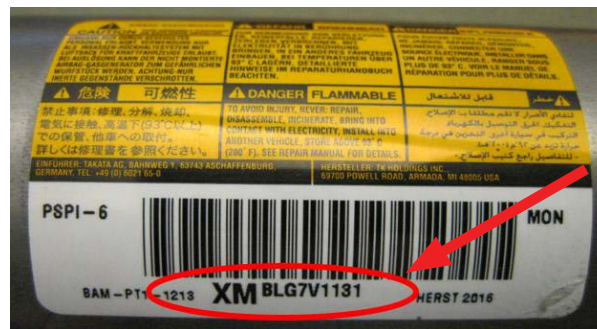
**STEP 8 - VERY IMPORTANT:** Record the **11-digit alpha-numeric serial number** for both the **new and the removed inflators** on the hard copy of the Repair Order. This information will be required for completion of the Part Return Notice which will be forwarded by the retailer to the PCC.

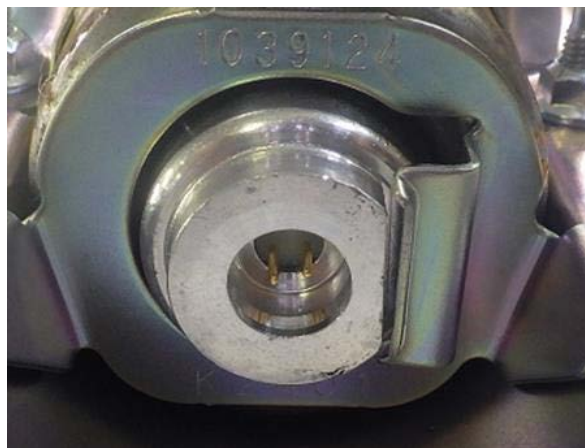
**STEP 11-** Peel the white dust cover from the d-shaped end of the new inflator. The new inflator wiring harness has 2 “sides” with round 2-pin connectors on both ends. The side with the yellow harness tube and red / yellow wires will connect to the end of the inflator with the “D-shaped” wiring harness connector boss as shown below. Peel the white dust cover from the “D-shaped” end of the inflator **ONLY**.

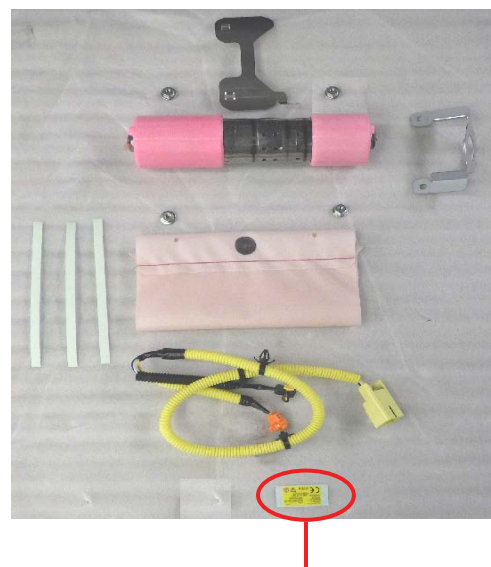
**IMPORTANT:** **DO NOT destroy or damage the Kit Box as it MUST be used for the original inflator’s return shipping.** Open the Kit Box and confirm all the necessary components are included:

- New Self-Locking nuts (4)
- New Inflator (pink caps on both ends identify it as the replacement part)
- New Inflator Harness
- Electro-Tap (red shorting crimp connector, not shown)
- Black Thermal Insulator
- Stopper Plate
- Protective Sheet
- Anti-Wrinkling Tapes (3)
- Shipping Documentation

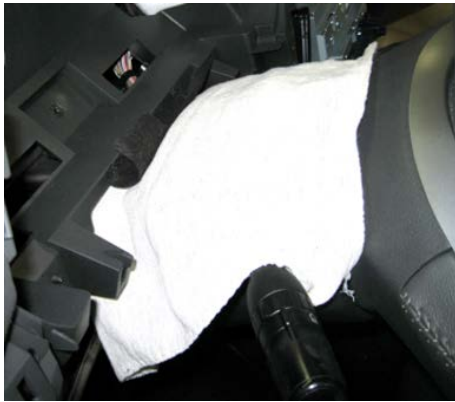
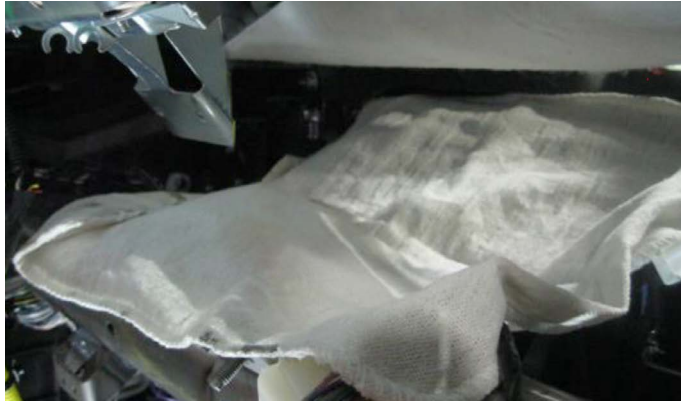
- **IMPORTANT:** Always cover the steering column cover to protect it along with the top of the HVAC blower case to keep out any removed hardware (e.g. airbag module retaining bolts) with clean shop cloth.

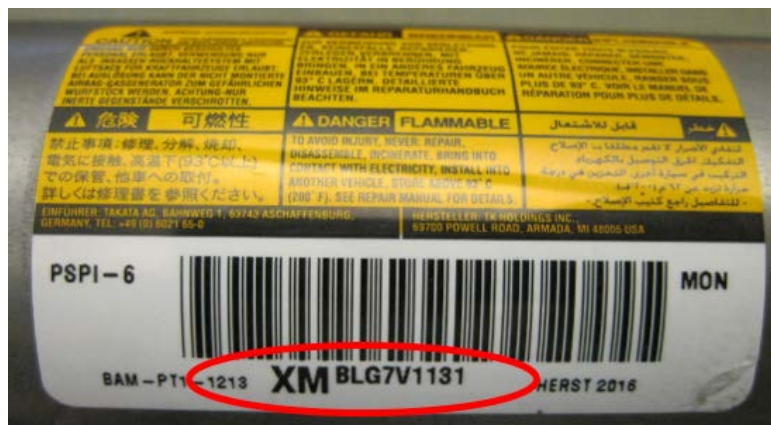
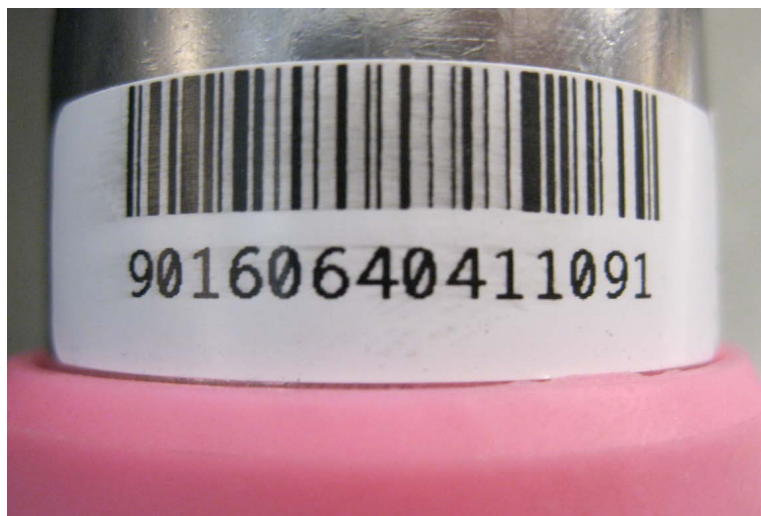
**STEP 9- VERY IMPORTANT:** Record the serial number **for both the new and the removed inflators** on the hard copy of the Repair Order. This information will be required for completion of the Part Return Notice which will be forwarded by the retailer to the PCC. Place the removed inflator in the kit box for return.

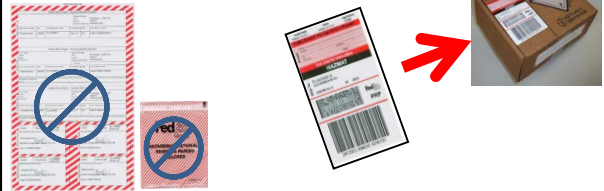
1. Peel off the backing of the FedEx Ground PRP Shipping label and affix to top of box to left of the Class 9 label.
  - Use the scribe line on the box as a guide
  - The FedEx Ground PRP Shipping label must not touch any portion of the printing to the right of the scribe line.
2. Discard the remaining Documentation
3. **Do Not** contact FedEx
