**MODEL: 2017 & 2018 Z900 & 900 ABS (ZR900AHFL/BHFL/BJF/BJFL)**

## FRAME INSPECTION & REPAIR

### RECALL

### **NHTSA RECALL NO. 17V-703**

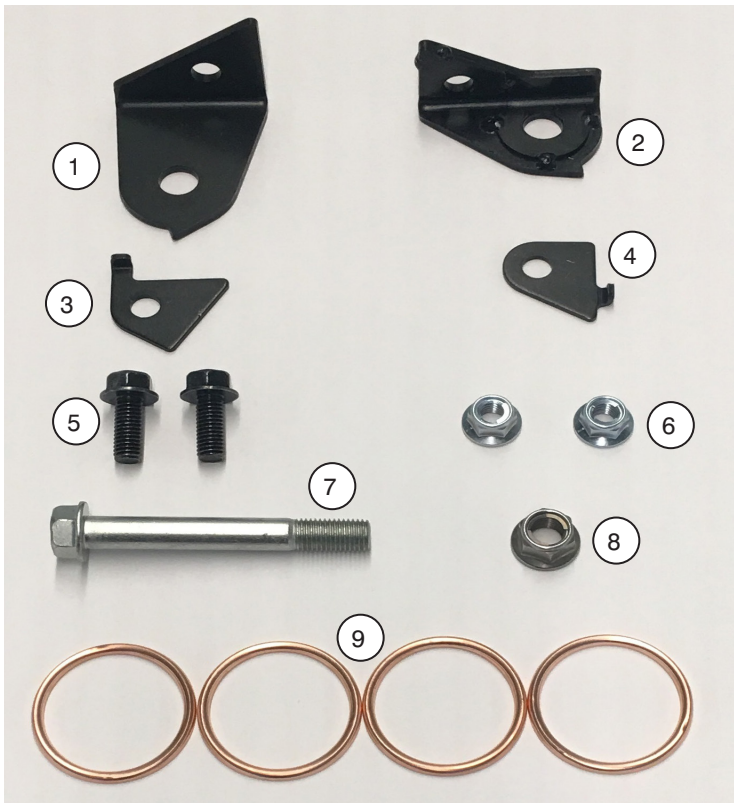
| KIT, BRACKET: 99999-0648 | | | | |

| KIT, BRACKET: 99999-0648 | | | | |
|---|---|---|---|--|
| 1 | 1 | Bracket, Left | | |
| 2 | 1 | Bracket, Right | | |
| 3 | 1 | Washer, Left | | |
| 4 | 1 | Washer, Right | | |
| 5 | 2 | Bolt, Flanged | | |
| 6 | 2 | Nut | | |
| 7 | 1 | Bolt | | |
| 8 | 1 | Nut | | |
| 9 | 4 | Gasket | | |

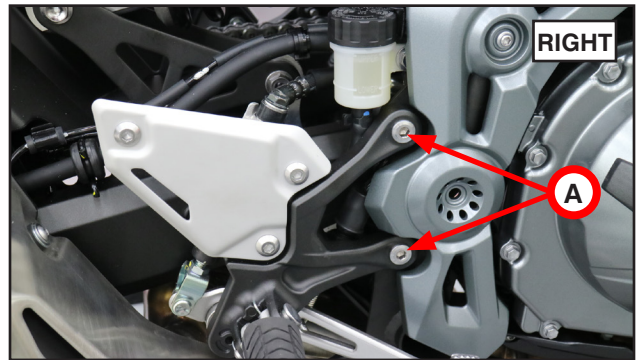
- Remove the right front footpeg bracket bolts [A] to access the rear shock absorber tie rod.

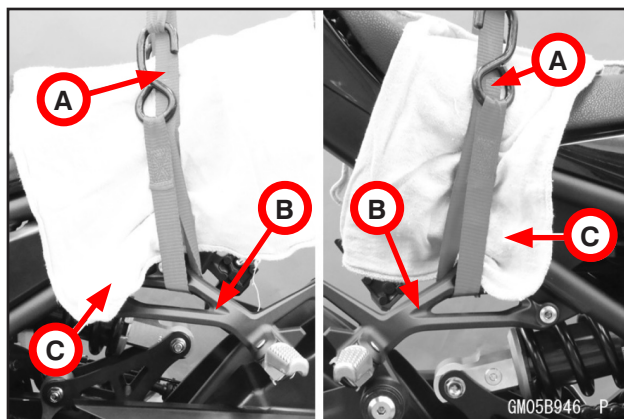
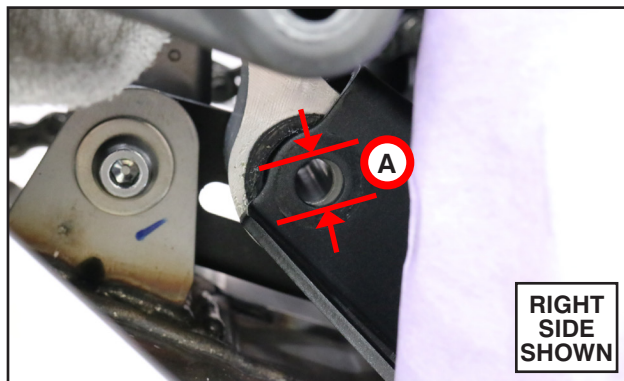
- Remove and discard the tie rod nut, bolt and washer
  - Measure the elongation length [A] of the left or right tie rod installation hole in the frame along the same line as the centerline of the tie rod.
- ★ If the hole measures **16mm or less** in diameter, proceed to the “**Install Brackets**” section of this bulletin.
- ★ If the hole measures **over 16mm** in diameter or has visible cracks, proceed to the “**Replace Frame**” section of this bulletin.

- o Only replace the frame if the hole [A] in the frame bracket measures over 16mm in diameter or has visible cracks.

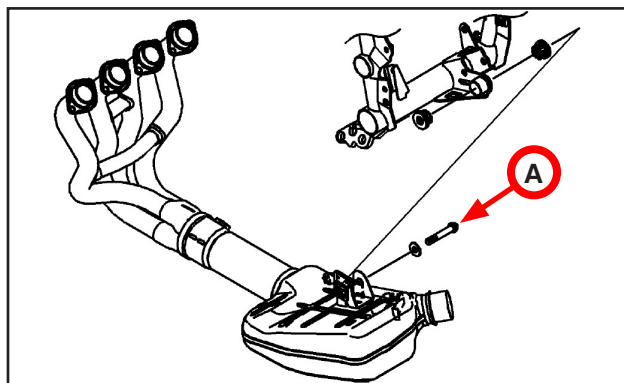
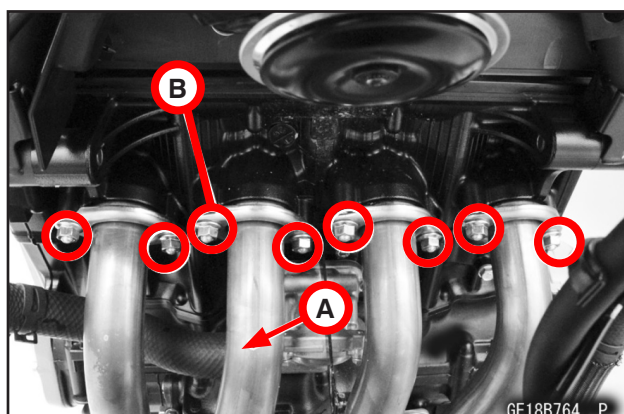
- Remove and retain the premuffler chamber mounting bolt [A].
- Remove and retain the eight exhaust pipe [A] holder nuts [B].

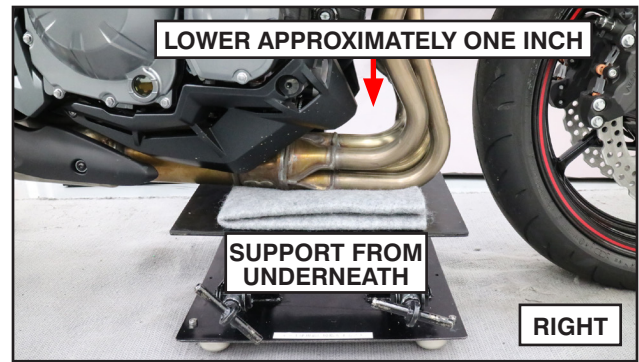
- Lower the exhaust pipe approximately one inch and support the exhaust pipe from underneath.

- o *While lowering the exhaust pipe, work carefully to prevent contact between the exhaust pipe and radiator, and oxygen sensor and cover.*
- o *The wiring harness connected to the oxygen sensor will become tight and could break if the exhaust is not supported.*

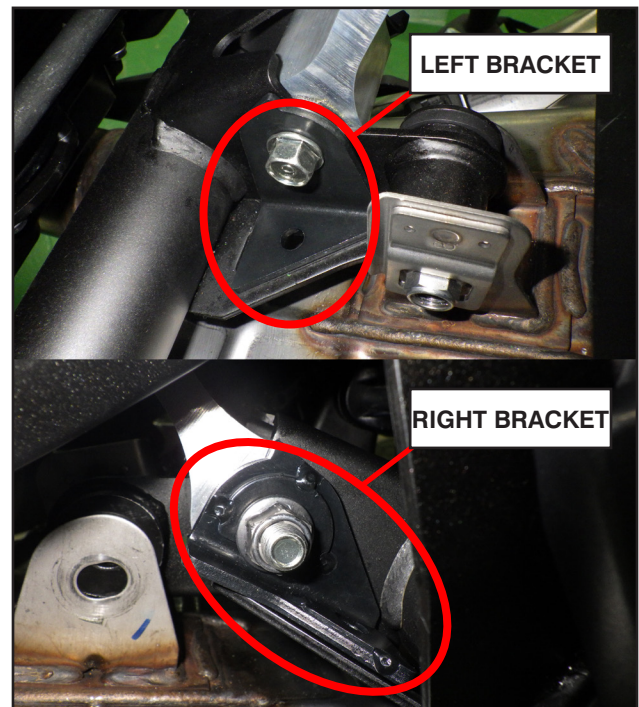
- Position the left and right brackets on top of the frame on each side of the tie rod
- Install the bolt from the left side of the vehicle through the brackets, frame and tie rod.
- Lightly tighten the nut and bolt temporarily.

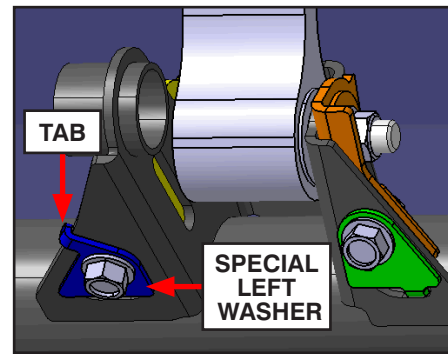
- Position the special left washer from the repair kit along the bottom of the frame bracket as shown.

- o *The tab on the special washer should touch the edge of the frame.*
- Install a new bolt from the bottom.
- Install a nut on the bolt and lightly tighten temporarily.

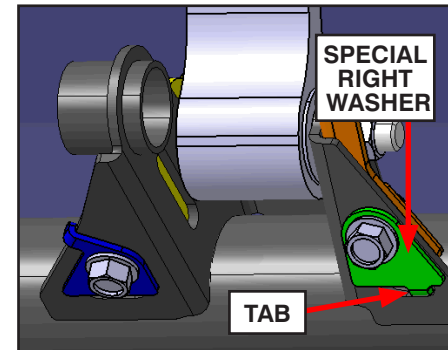
- Install the special right washer from the repair kit

- o *The tab on the special washer should touch the inside edge of the frame hole.*
- Install a new bolt from the bottom.
- Install a nut on the bolt and lightly tighten temporarily.

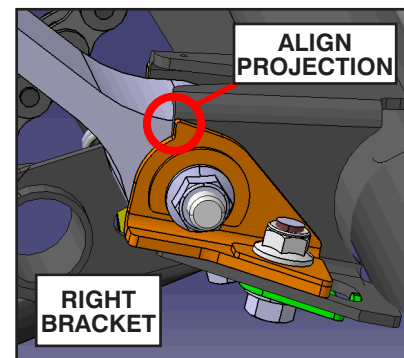
- Align the right bracket projections with the frame edge as shown.

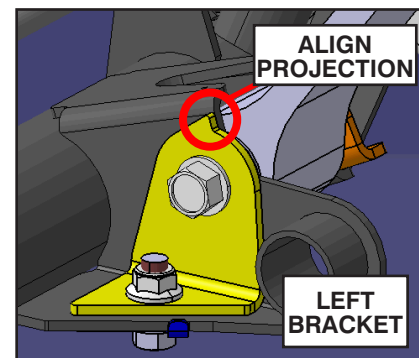
- Align the left bracket projections with the frame edge as shown.

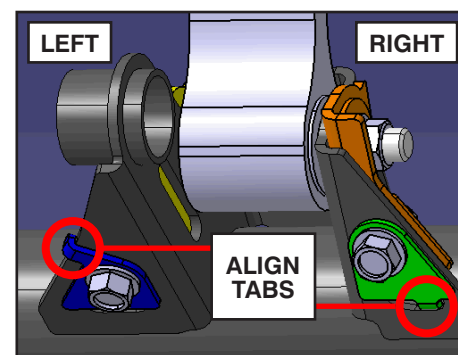
- Verify that the tabs on the left and right special washers remained aligned as shown.

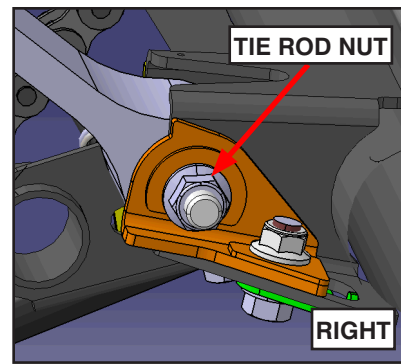
- Tighten the tie rod nut to 44 N•m (4.5kgf•m, 32 ft•lb).

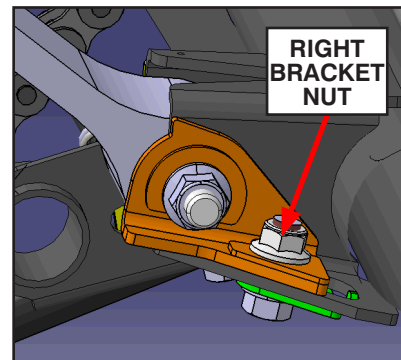
- Tighten the right bracket nut to 25 N•m (2.5kgf•m, 18 ft•lb).

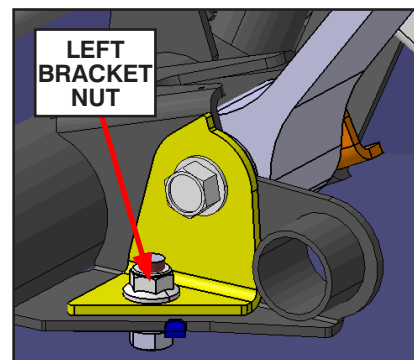
- Tighten the left bracket nut to 25 N•m (2.5kgf•m, 18 ft•lb).

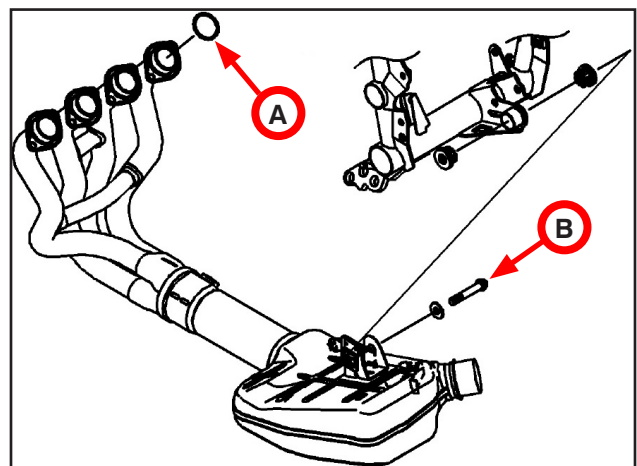
- Replace the four exhaust pipe gaskets [A] with the new ones from the repair kit as outlined in the service manual
- Install and lightly tighten the exhaust pipe holder nuts.
- Install and lightly tighten the premuffler chamber mounting bolt.

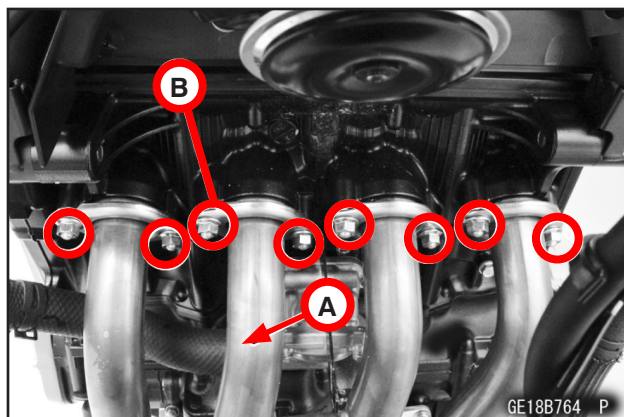
- Tighten the eight exhaust pipe [A] holder nuts [B] to 20 N•m (2.0kgf•m, 15 ft•lb).
- Tighten the premuffler chamber mounting bolt to 34 N•m (3.5kgf•m, 25 ft•lb).

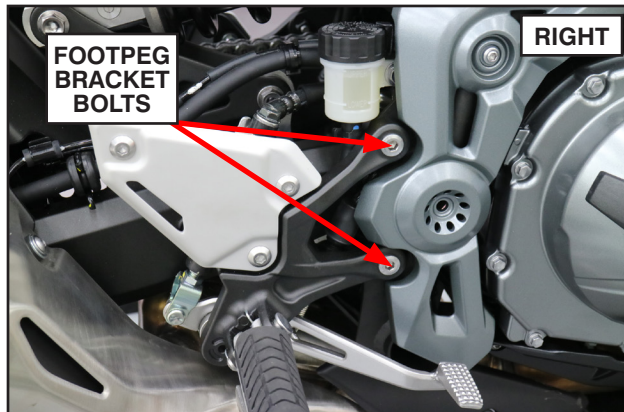
- Install the right front footpeg bracket and tighten the bolts to 25 N•m (2.5kgf•m, 18 ft•lb).

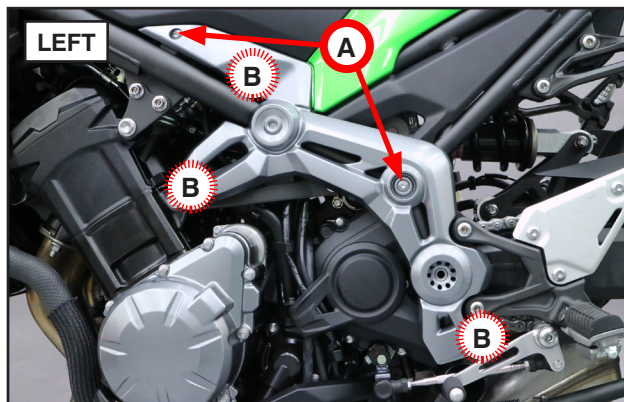
- Remove and retain the left and right frame cover bolts [A] and washers.
- Remove the left and right frame covers outward to clear the projections [B] on the back of the covers.

- o Left side shown. Right side similar.

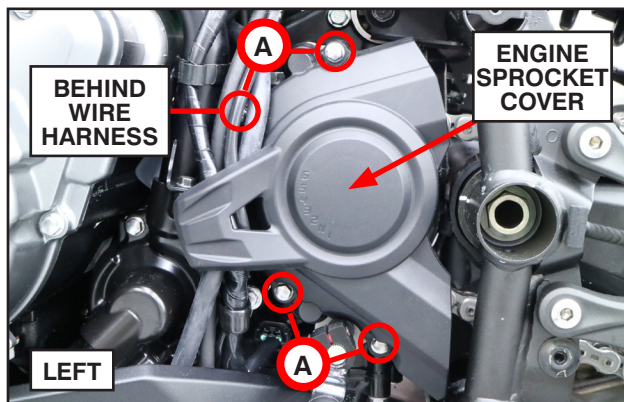
- Remove and retain the engine sprocket cover bolts [A].
- Remove the engine sprocket cover.

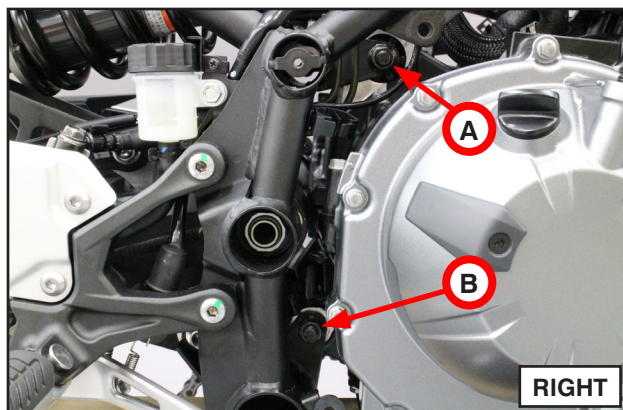
- Tighten the middle rear engine mounting nut [A] and lower rear engine mounting nut [B] to 44 N•m (4.5 kgf•m, 32 ft•lb).

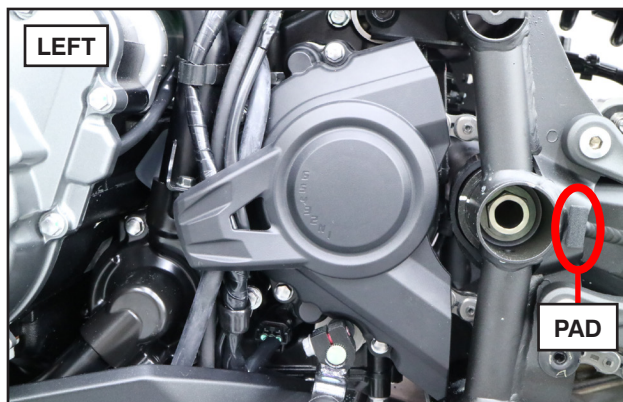
- Install the engine sprocket cover.
- Verify that the pad is in place on the frame. Install only if it is missing.
- Tighten the engine sprocket cover bolts to 9.8 N•m (1.0 kgf•m, 87 in•lb).

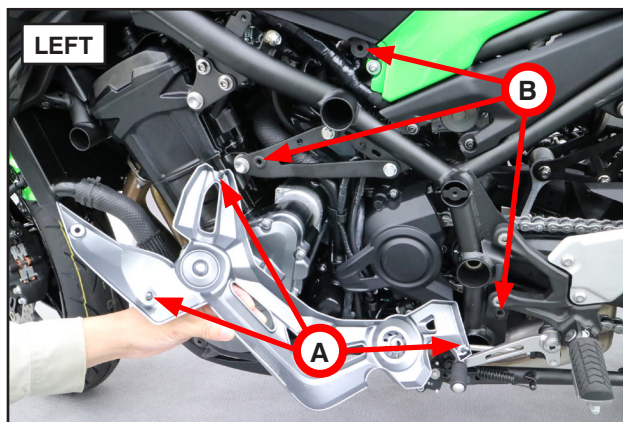
- Install the left frame cover by inserting the projections [A] of the frame covers into the grommets [B] on the frame.
- Tighten the frame cover bolts to 2.2 N•m (.22 kgf•m, 20 in•lb)

- o Left side shown. Right side similar.

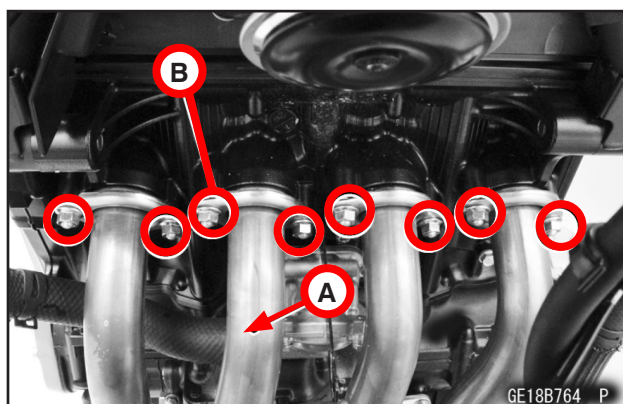
- Thoroughly warm up the engine, wait until the engine cools down, retighten the exhaust pipe [A] holder nuts [B] to 20 N•m(2.0 kgf•m, 15 ft•lb).
- Proceed to the “Warranty Information” section in this bulletin.

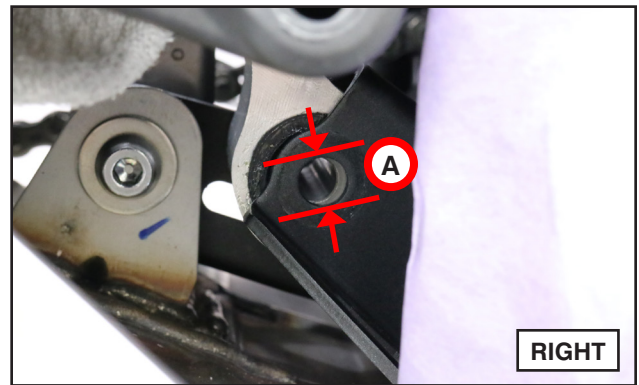
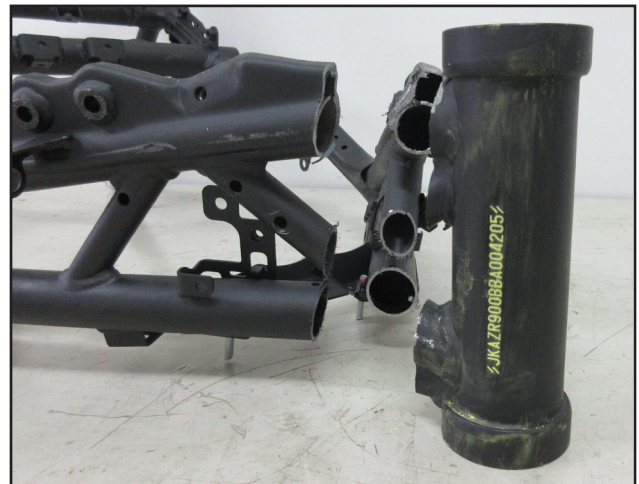
- Replace the frame with a new one.
- After installing all components on the replacement frame, use an appropriate cutting tool to remove the steering head with the VIN from the old frame. Ensure the VIN is not damaged during removal.
- Dispose of the remainder of the frame in accordance with all local laws and regulations. Return the "VIN" portion of the frame with a copy of your work order and the warranty claim to the following address:

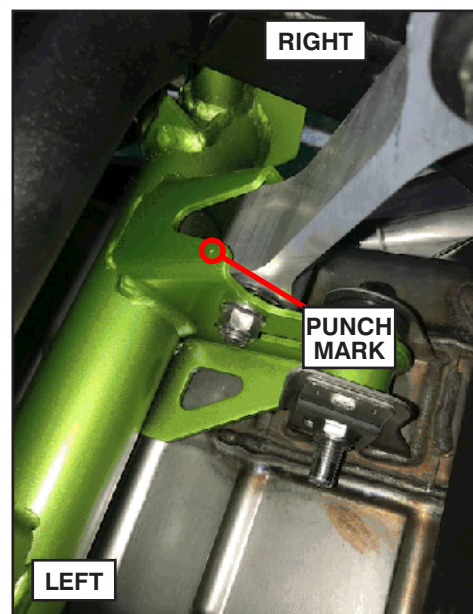
Vehicles that required frame replacement can be identified by a punch mark on the upper left side of the tie rod bracket on the frame.
