CRITICAL AREAS RECONNAISSANCE REPORT

Bethel Ave Property
Port Orchard, WA

Prepared by
Ecological Land Services
1157 3rd Avenue South, Suite 220A • Longview, WA 98632
(360) 578-1371 • Project Number 3170.01

LU20-CUP-03

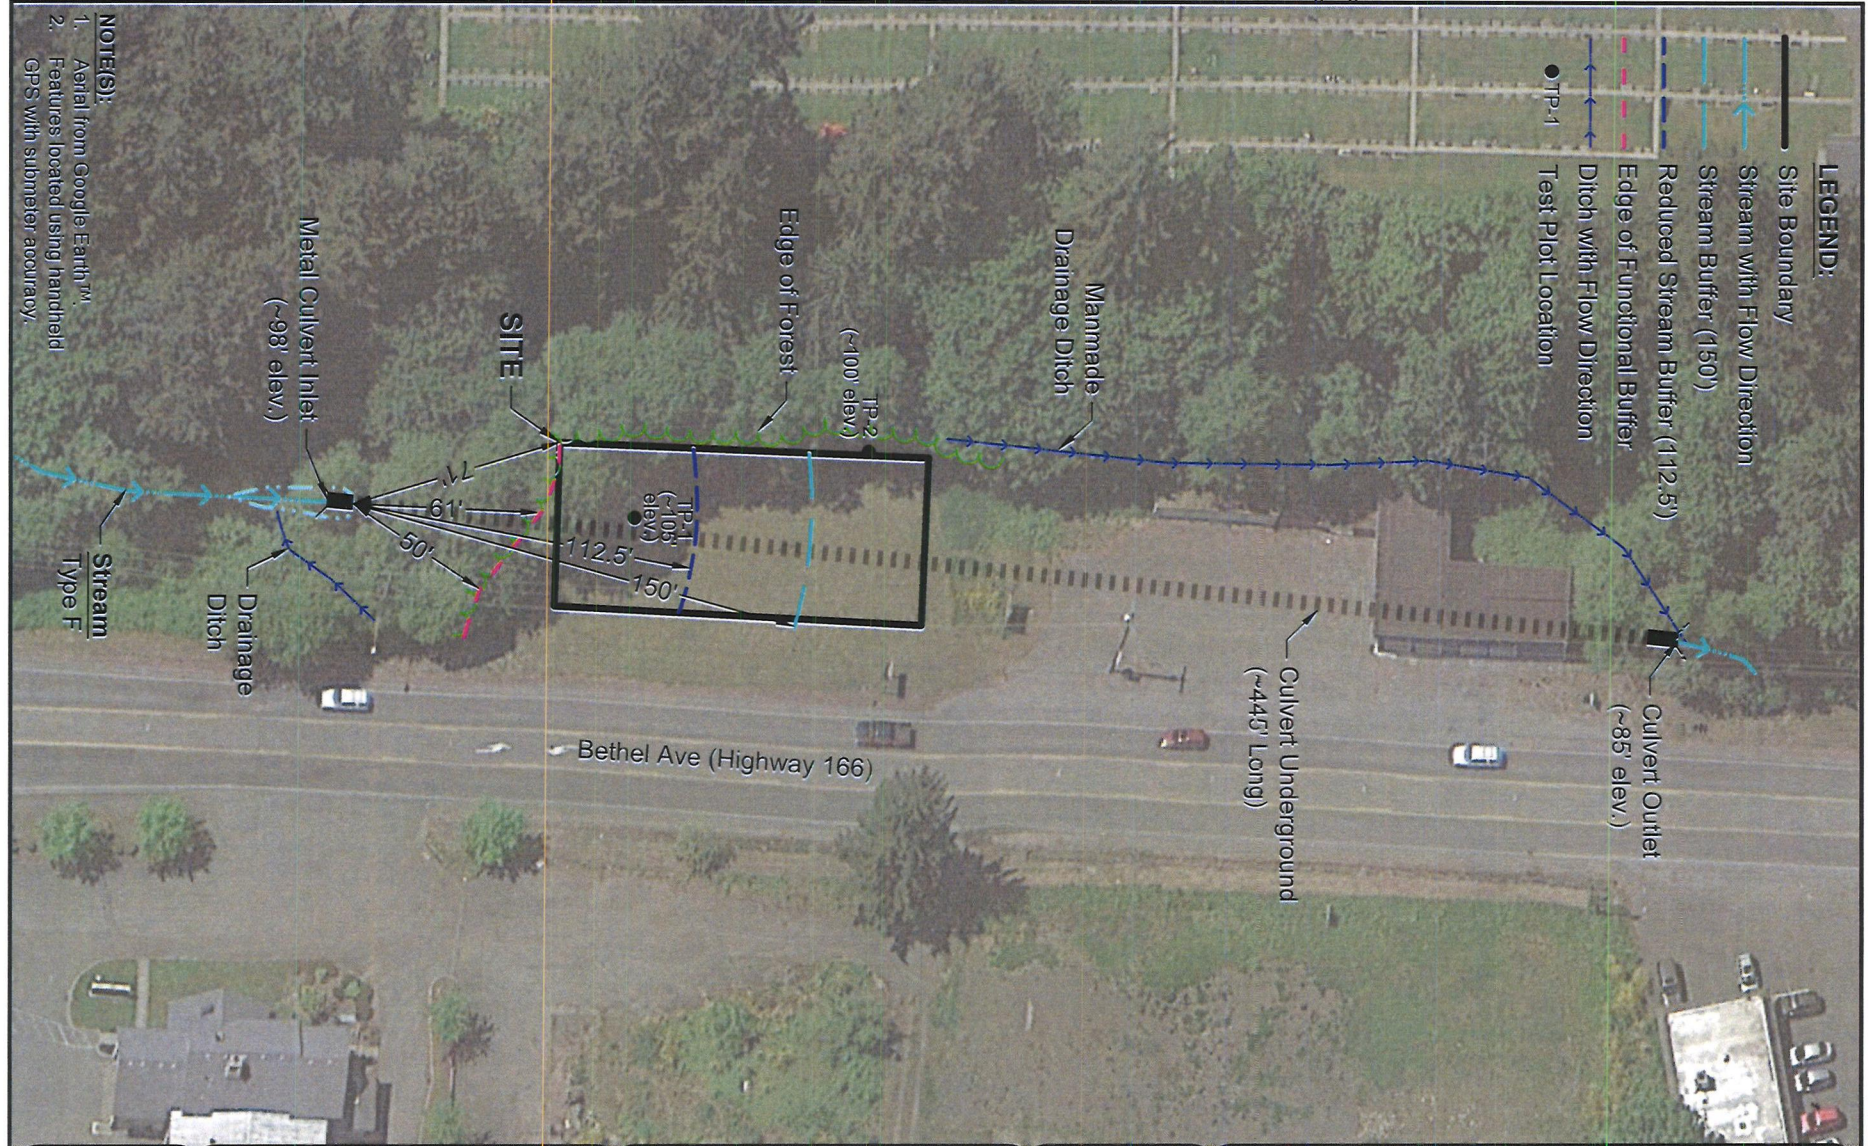
Figure 2
 SITE MAP
 Bethel Ave Property
 Kelsiana Marshall
 Kitsap County, WA
 Section 25, Township 24N, Range 1E, W.M.

To determine the presence or absence of critical areas on the lot, ELS biologists collected vegetation, soils, and hydrology data at two test plots to determine if wetland conditions existed onsite (Figure 2). The data collected showed that no critical areas were present onsite.

The standard 150-foot buffer and 15-foot building setback extend onto the south end of the lot (Figure 2). However, the entirety of this lot is cleared and is approximately ten feet higher than the stream channel, which flows through the culvert beneath the lot. The slope and break in vegetation separate the existing buffer into functional and non-functional areas. The tree line ends near the south lot boundary, which is where the functional buffer for the stream also ends. The vegetation on this lot does not provide function for the stream because it consists entirely of mowed grass and does not provide any blocking of light or noise or the ability to filter pollutants from upslope. The project proposes to build a small coffee stand on the lot and because this lot is already cleared, no vegetation removal (other than removal of lawn grasses) will be required. This stream is highly constricted by culverts. Traffic from Bethel Avenue also creates light and noise impacts and generates pollutants that are routed to this stream. The addition of a small coffee stand in the non-functional portion of buffer consisting of mowed grass will not have negative impacts on the stream or the forested section of the buffer.

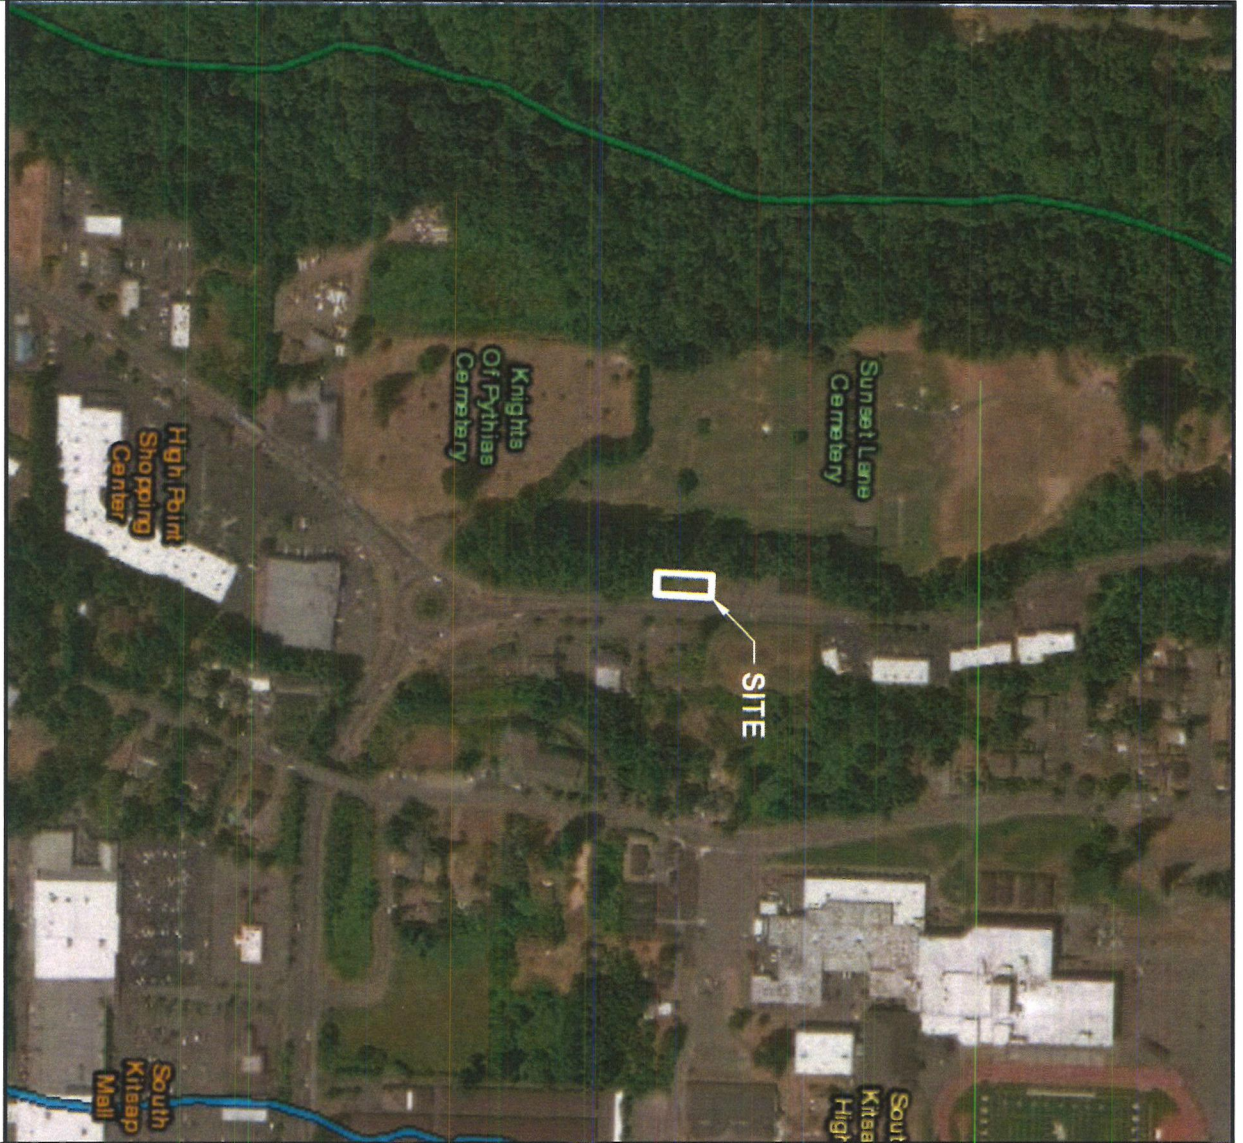
Figure 4
NATIONAL WETLANDS INVENTORY MAP
 Bethel Ave Property
 Kelsiana Marshall
 Kitsap County, WA
 Section 25, Township 24N, Range 1E, W.M.

National Wetlands Inventory (NWI) (USFWS 2020) maps no wetlands or riparian areas on or within 300 feet of the lot (Figure 4).

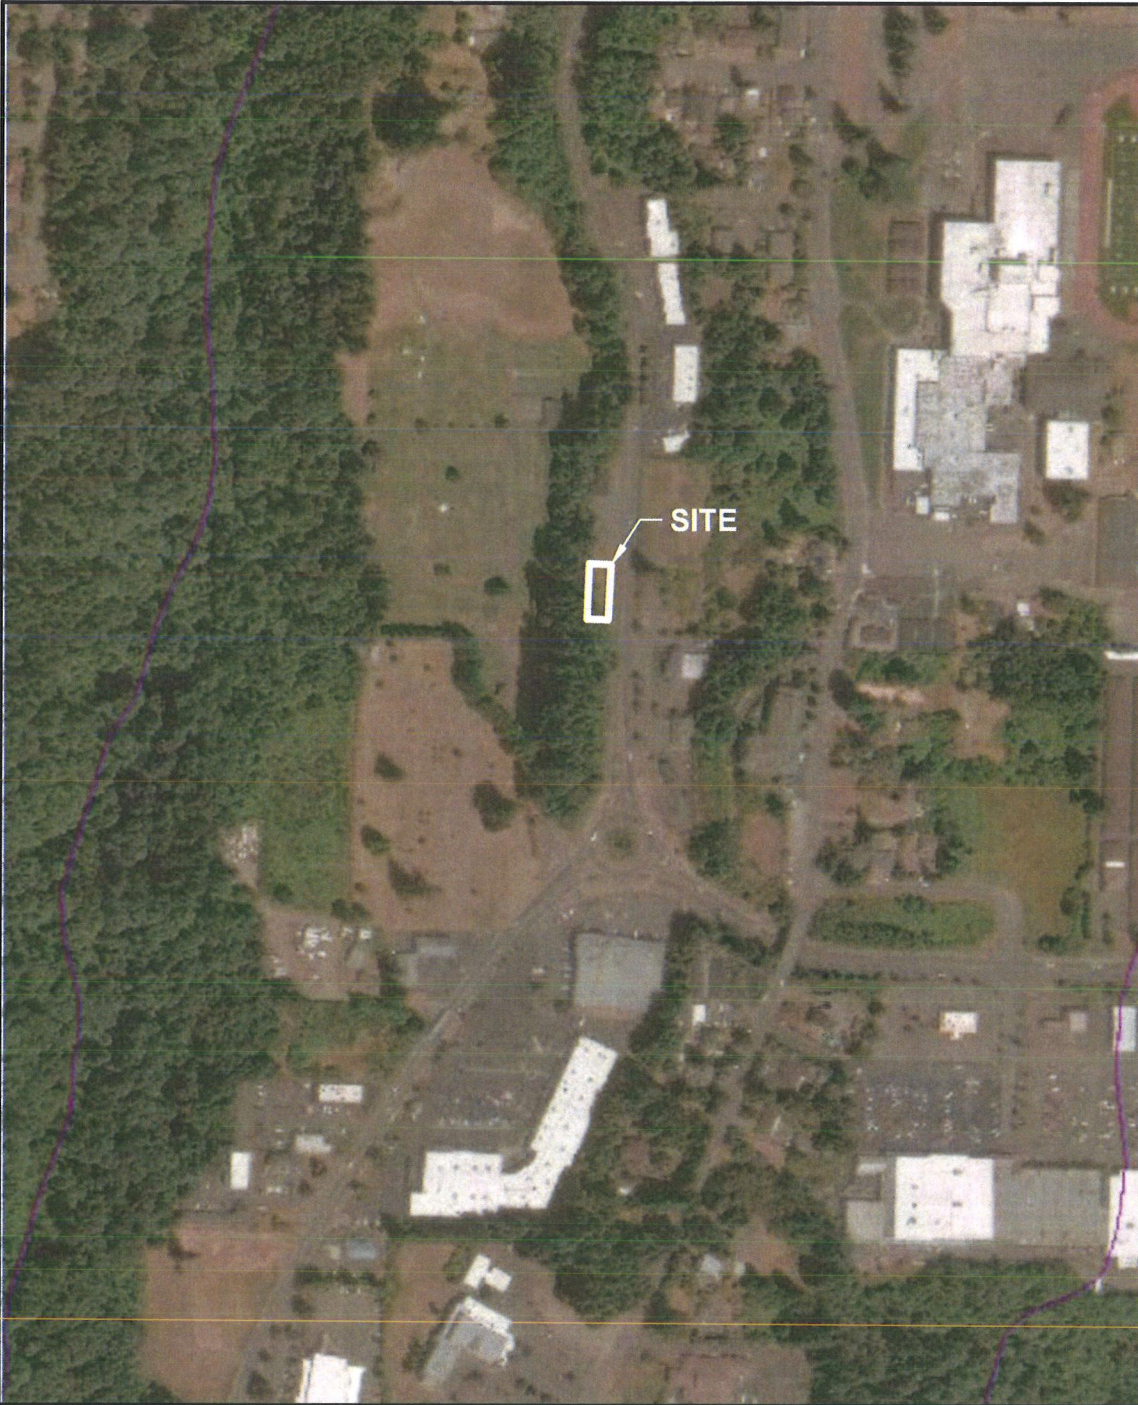
Figure 6
PRIORITY HABITAT AND SPECIES MAP
Bethel Ave Property
Kelsiana Marshall
Kitsap County, WA
Section 25, Township 24N, Range 1E, W.M.

The Washington Department of Fish and Wildlife (WDFW) Priority Habitats and Species (PHS) website shows no priority habitats or species on or within 300 feet of the lot (Figure 6).

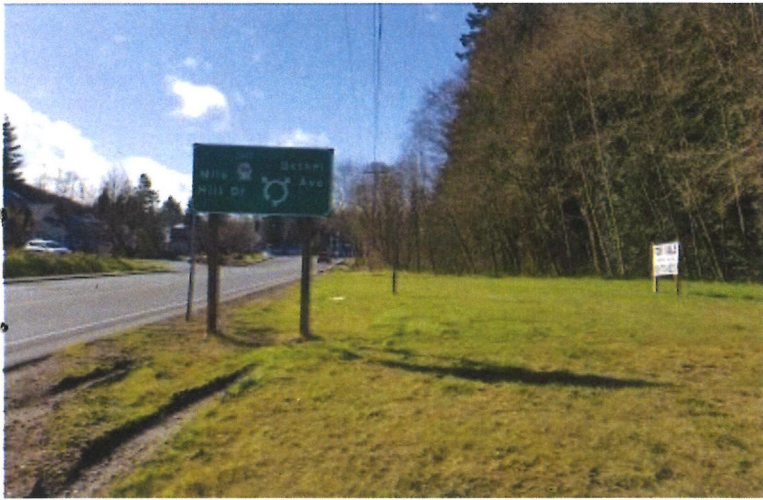
Photo 1 was taken from the north end of the lot looking south at the eastern side of the lot and Bethel Avenue. The lot is level and vegetated by mowed grasses. The stream and culvert are present in the background of the photo south of the lot.

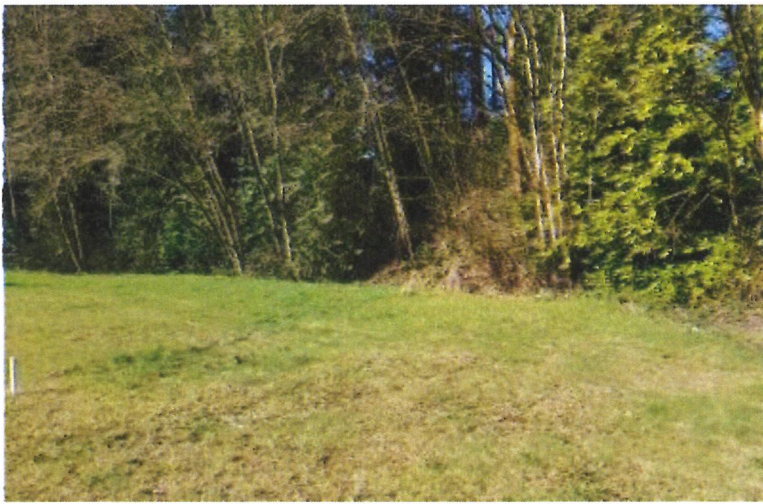
Photo 2 was taken from the same location as Photo 1 looking southwest across the rest of the lot. The topography slopes up west of the western lot line and is vegetated by mixed forest.

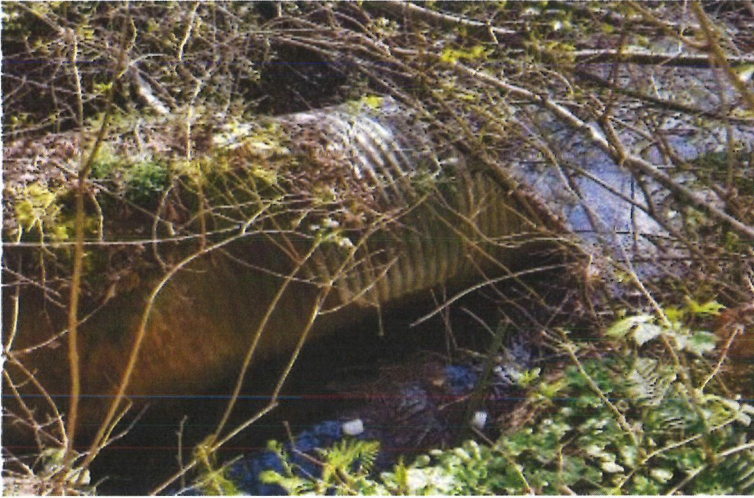
Photo 3 was taken approximately 67 feet south of the southern lot line where a large culvert, approximately 5 feet in diameter, is present. A stream, which flows to the north, enters this culvert.

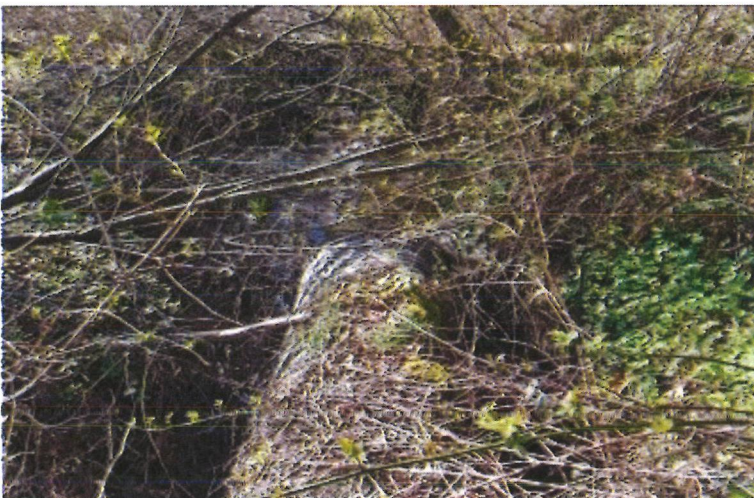
Photo 4 was taken from the same location as Photo 3. The culvert is plugged with debris, so the stream channel has widened around the culvert and eroded some of the soil around it.

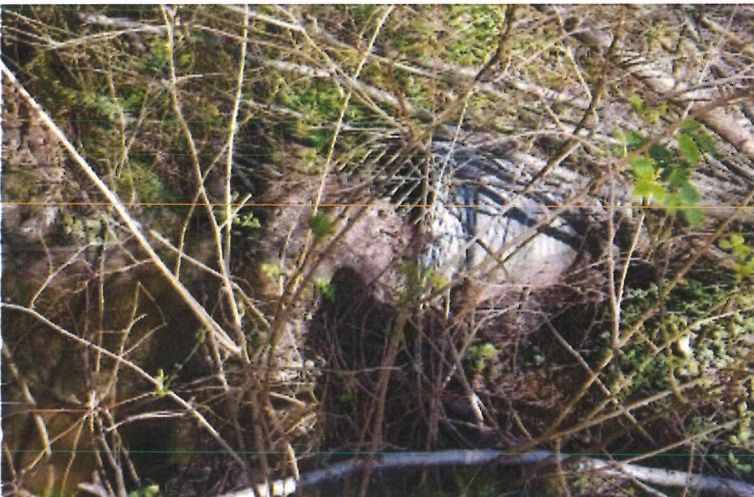
Photo 5 shows the opening of the culvert. A trash rack covers the opening and is clogged with debris. The culvert continues underground and day-lights approximately 445 feet to the north. Fish passage appears to be impossible through the clogged culvert.

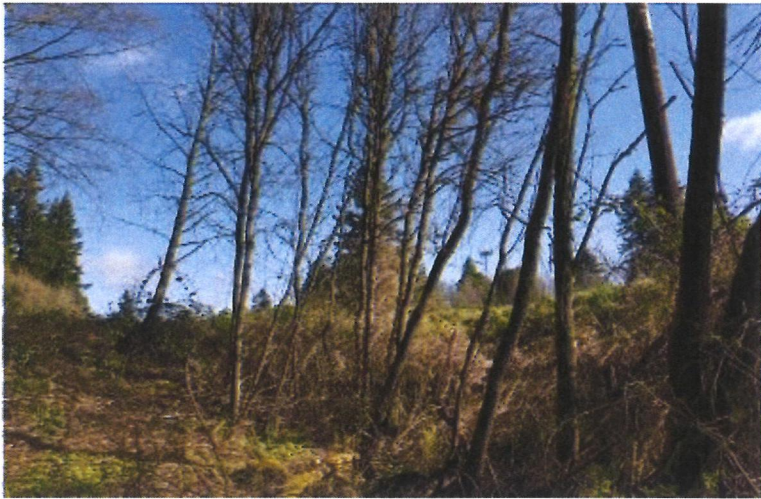
Photo 7 was taken from the culvert and looks north toward the lot. The functional area of the 150-foot buffer ends at the top of the bank where the tree line ends.

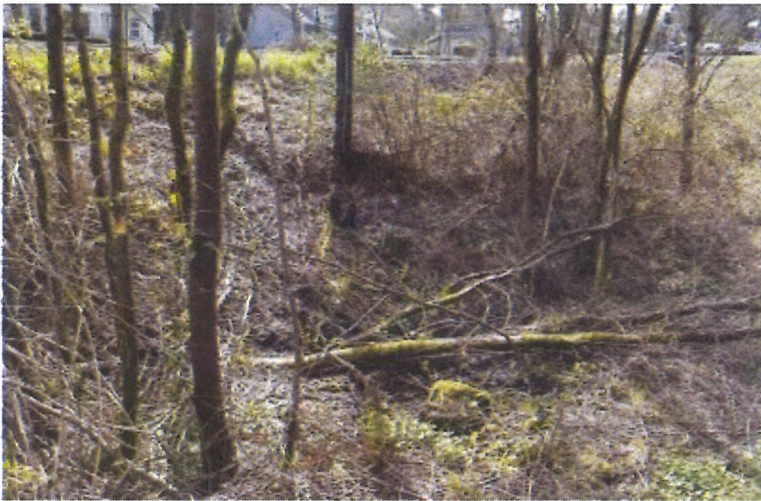
Photo 8 was taken midway up the bank seen in Photo 7 and looks to the southeast showing Bethel Avenue in the background. The stream channel and culvert are out of the photo to the right.

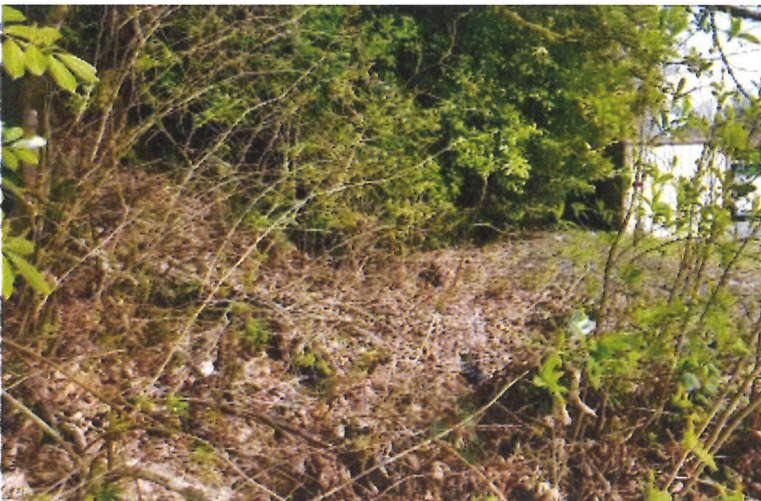
Photo 9 was taken from the manmade ditch offsite, near the northwest lot corner. This ditch appears to continue to the north.

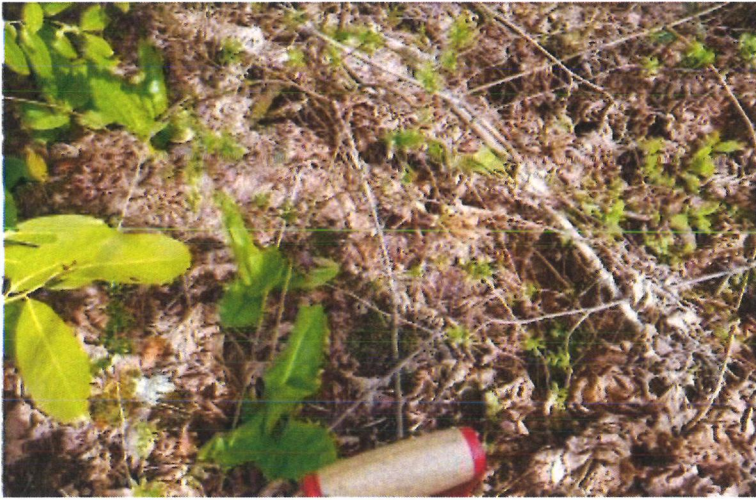
A small area (less than 20 square feet) of the offsite manmade drainage ditch appeared to be saturated and contained skunk cabbages, which typically grow in wetlands. However, per *POMC 20.162.048(1)* “*Wetlands do not include those artificial wetlands intentionally created from nonwetland sites, including, but not limited to irrigation and drainage ditches...*”. This manmade drainage ditch appears to have been dug in an upland area northwest of this lot to convey water from offsite impervious surfaces and should not be considered a wetland.

Photo 10 was taken from the manmade ditch offsite. Several small skunk cabbages were growing in this ditch in an area less than 20 square feet.

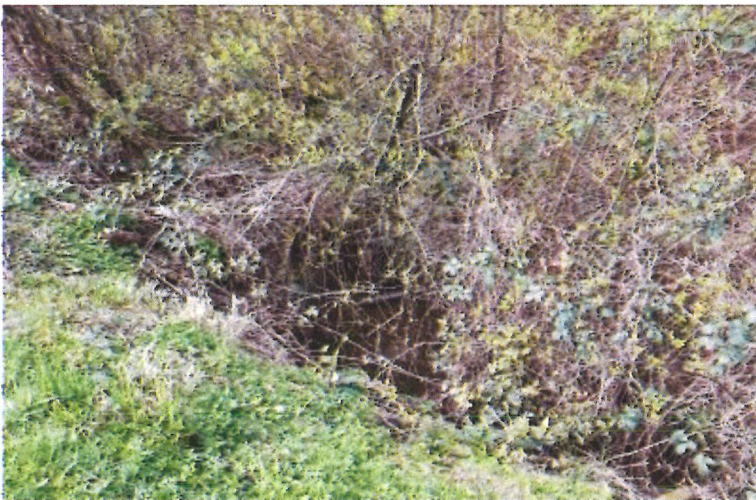
Photo 11 was taken near the outlet of the culvert looking west where the stream daylights, approximately 445 feet north of the culvert inlet. A culvert begins at the end of this stream and conveys water under Bethel Road.

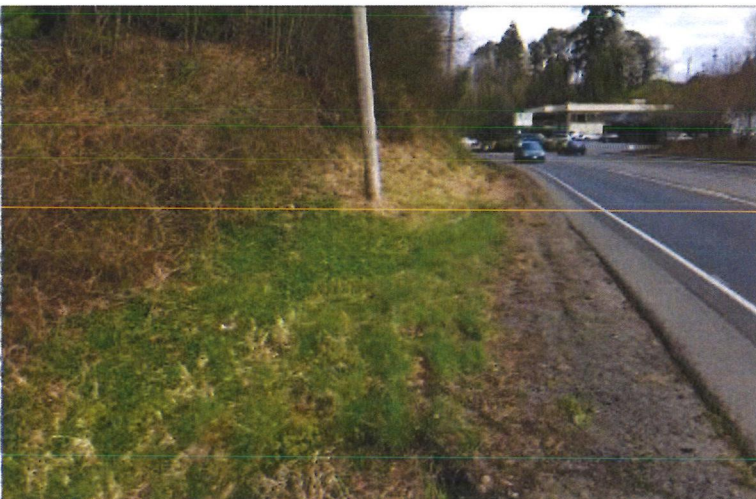
Photo 12 was taken from the same location as Photo 11 looking north down Bethel Avenue. The stream channel disappears again, most likely because it goes beneath Bethel Avenue.
