# SERVICE BULLETIN

## SB1354

| <b>BULLETIN TYPE</b> | : Safety Recall NHTSA 16V-144 |
| <b>SUBJECT</b> | : <b>To inspect J-Bracket for missing welds on Recaro drivers' seat and replace J-Bracket if necessary</b> |

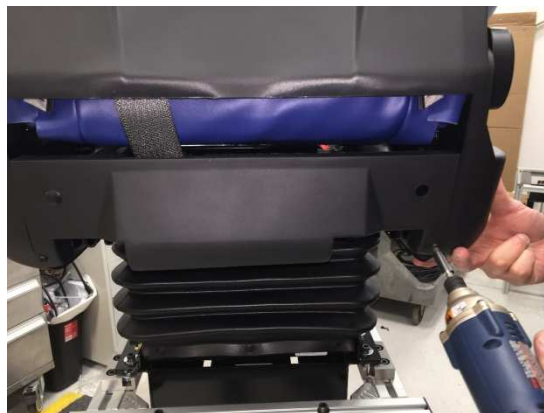
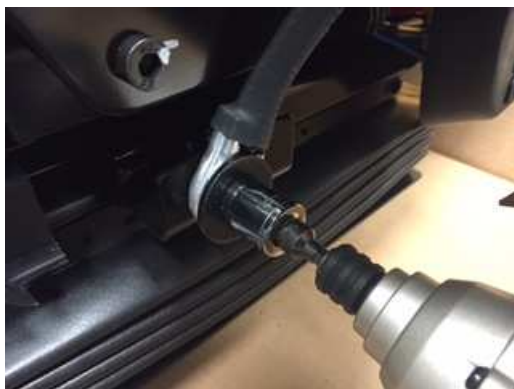
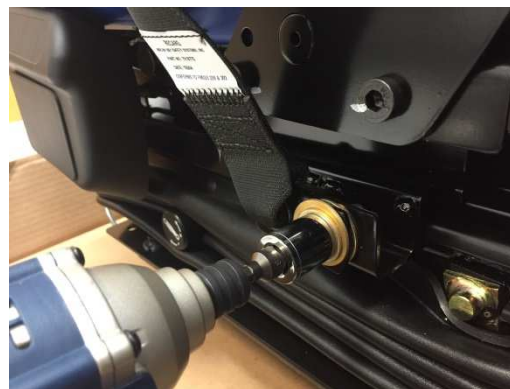
- If J-bracket(s) need to be replaced, remove the 2 hole plugs and 4 screws in the rear trim panel and the mounting screw from the rear corner panel(s). Remove the recliner handwheel.

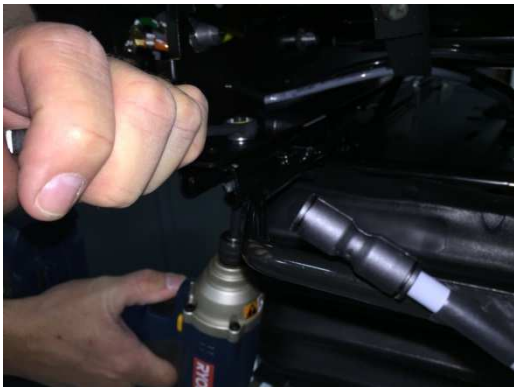
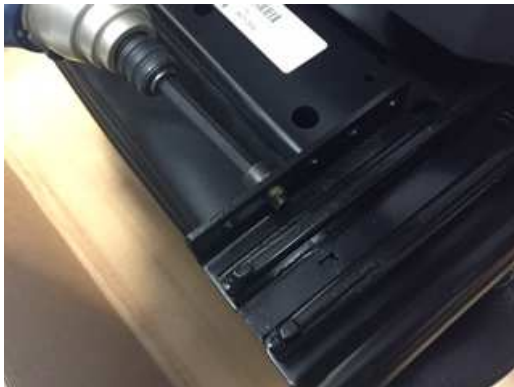
| STEP | PICTURES / DESCRIPTIONS | Special Criteria |
|---|---|---|
| 3. | <p>Remove the belt buckle (or belt retractor/3pt anchor) from the bad J-bracket with a 5/8 socket. Set the removed components aside.</p> | |

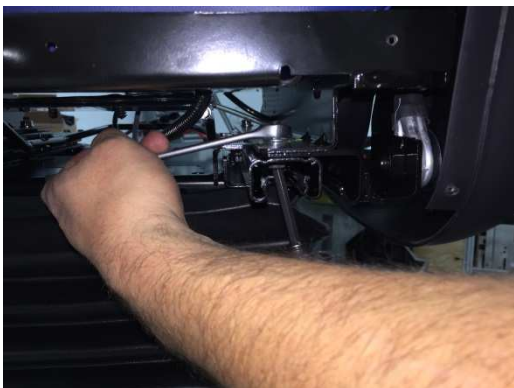
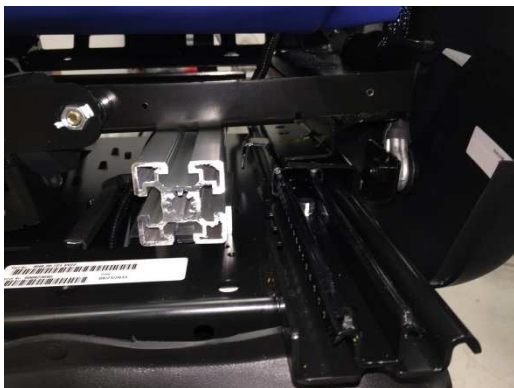
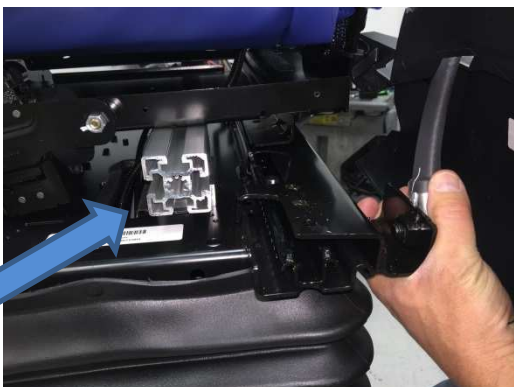
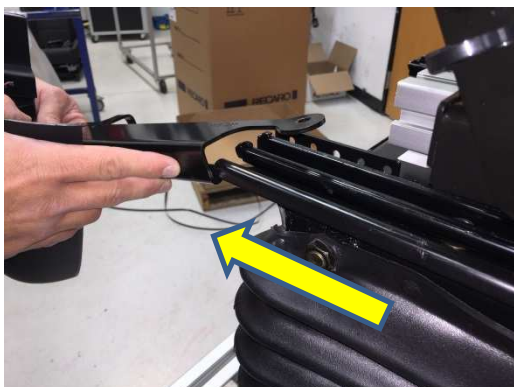
| STEP | PICTURES / DESCRIPTIONS | Special Criteria |
|---|---|---|
| 4. | <p>Position the seat back to “full forward”. Unfasten the front track bolt from the cushion frame using a 6mm hex bit and a 13mm wrench. Check the rear of seat for a track stop bolt. If present, remove it with the 6mm hex bit.</p> | |

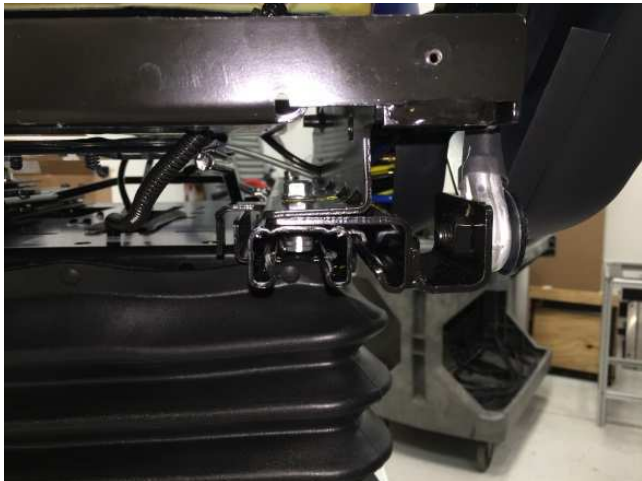
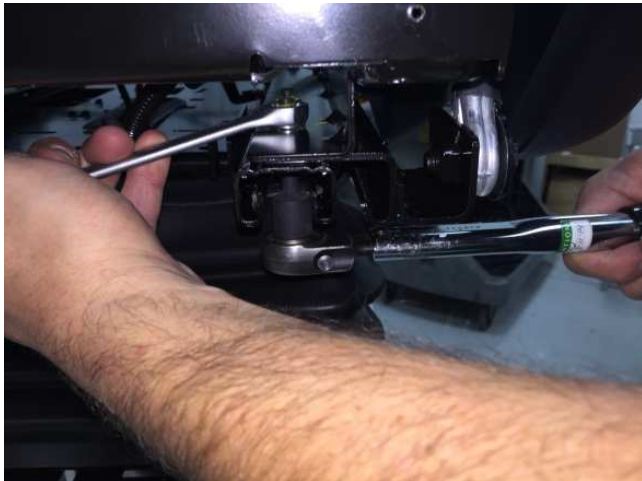
| STEP | PICTURES / DESCRIPTIONS | Special Criteria |
|---|---|---|
| 5. | <p>Position the seat to “full rear”. Unfasten the rear track bolts from the cushion frame using an 6mm hex bit and a 13mm wrench. Place a 2 inch block between the cushion frame and suspension to create just enough clearance to remove the J-bracket by sliding it rearward along the path of the track.</p> <div style="display: flex; justify-content: space-around;"> </div> | |

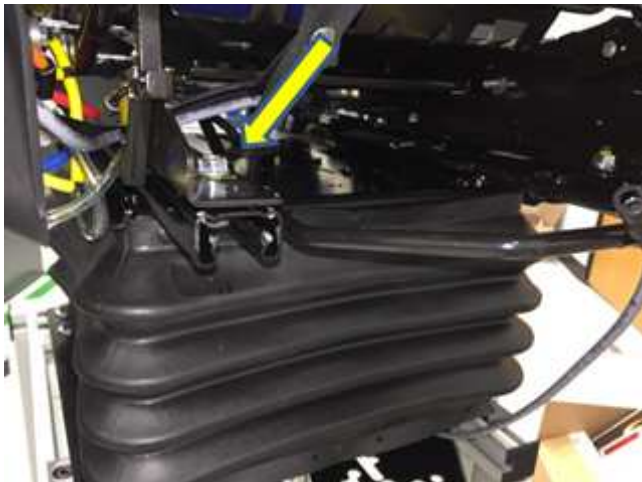
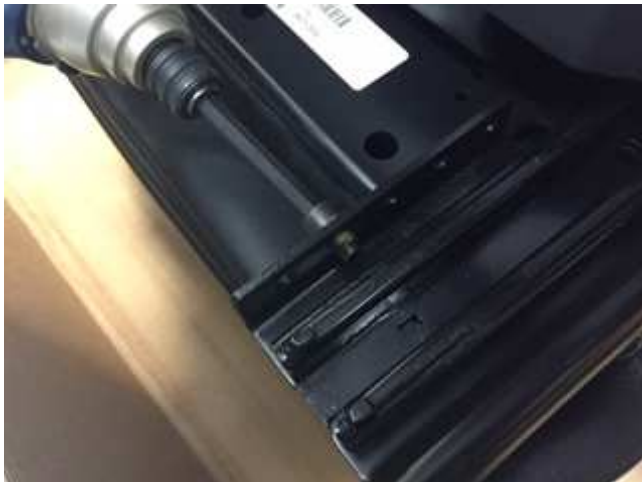
| STEP | PICTURES / DESCRIPTIONS | Special Criteria |
|---|---|---|
| 6. | <p>Position the replacement part utilizing the same path and aligning all the mounting holes. Obtain replacement M8 bolts. Place rear fasteners thru the mounting holes from below and start the flange nuts by hand. Torque to 22 Nm.</p> <div style="display: flex; justify-content: space-around;"> </div> | |

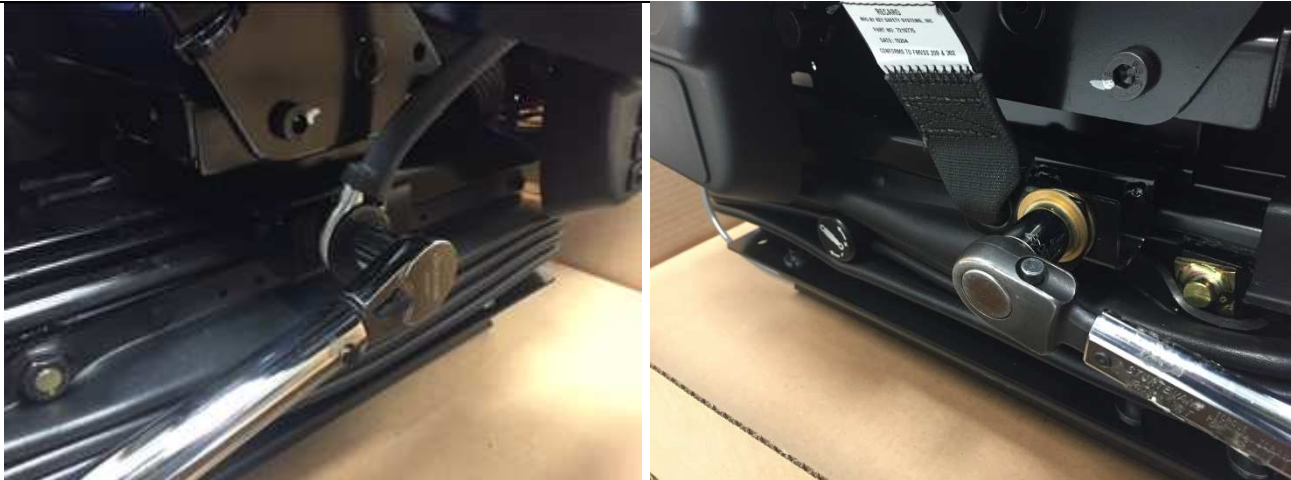
| STEP | PICTURES / DESCRIPTIONS | Special Criteria |
|---|---|---|
| 9. | Route the buckle through the rear trim panel. Hand start the seat belt buckle bolt into the replacement J-Bracket part now in the seat. Torque to 50 Nm. | |

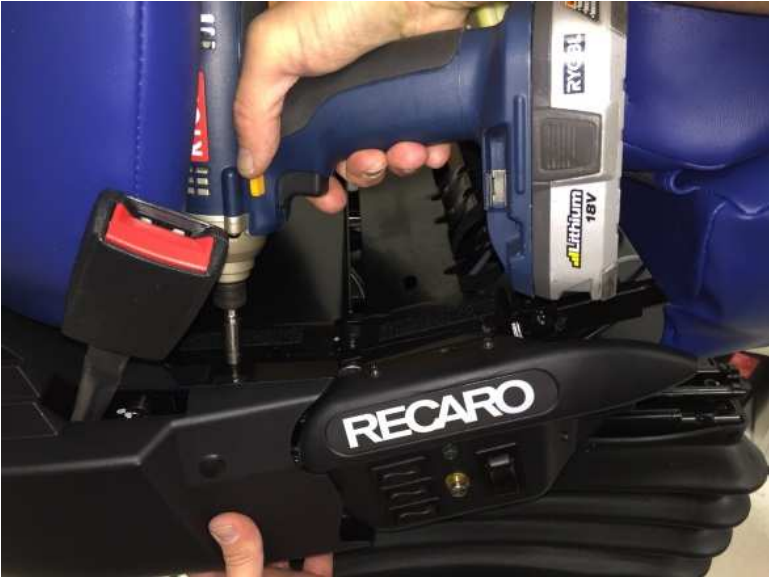
| STEP | PICTURES / DESCRIPTIONS | Special Criteria |
|---|---|---|
| 11. | Replace the corner panel(s) in original position and secure with the mounting screw(s) previously removed. | |
