**TVA Kingston Fossil Fuel Plant Release Site  
On-Scene Coordinator Report Addendum for the  
Time-Critical Removal Action**

**Addendum No. 01**

**Harriman, Roane County, Tennessee**

**Tennessee Valley Authority**

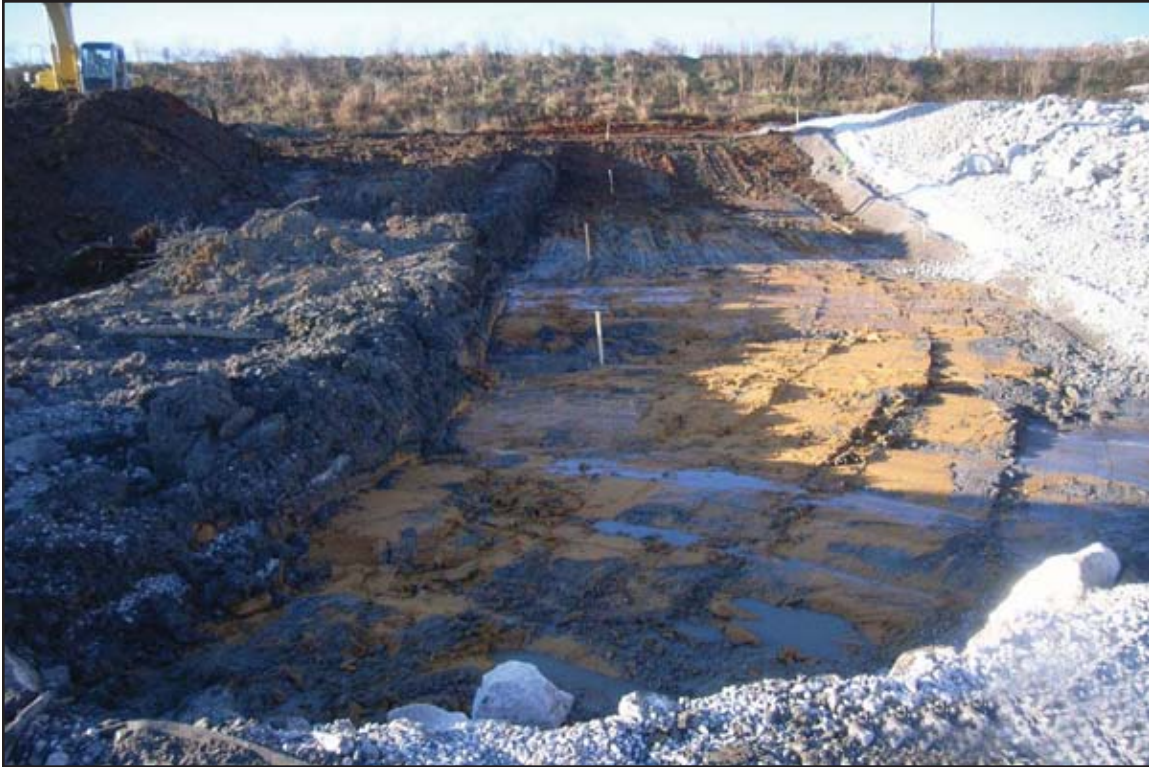
Excavating ash in “panels” from outboard slope of Dike C to expose dike material. June 5, 2010.

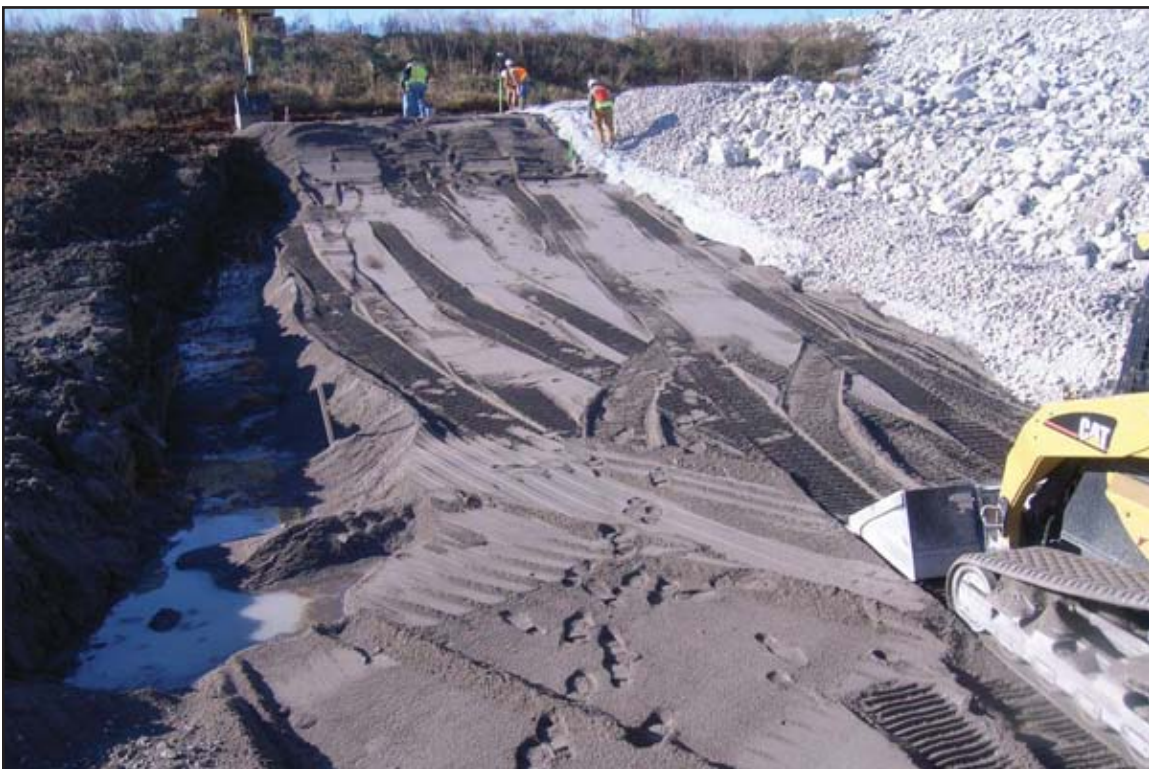
Placing layer of sand on top of dike material in panel. December 29, 2009.

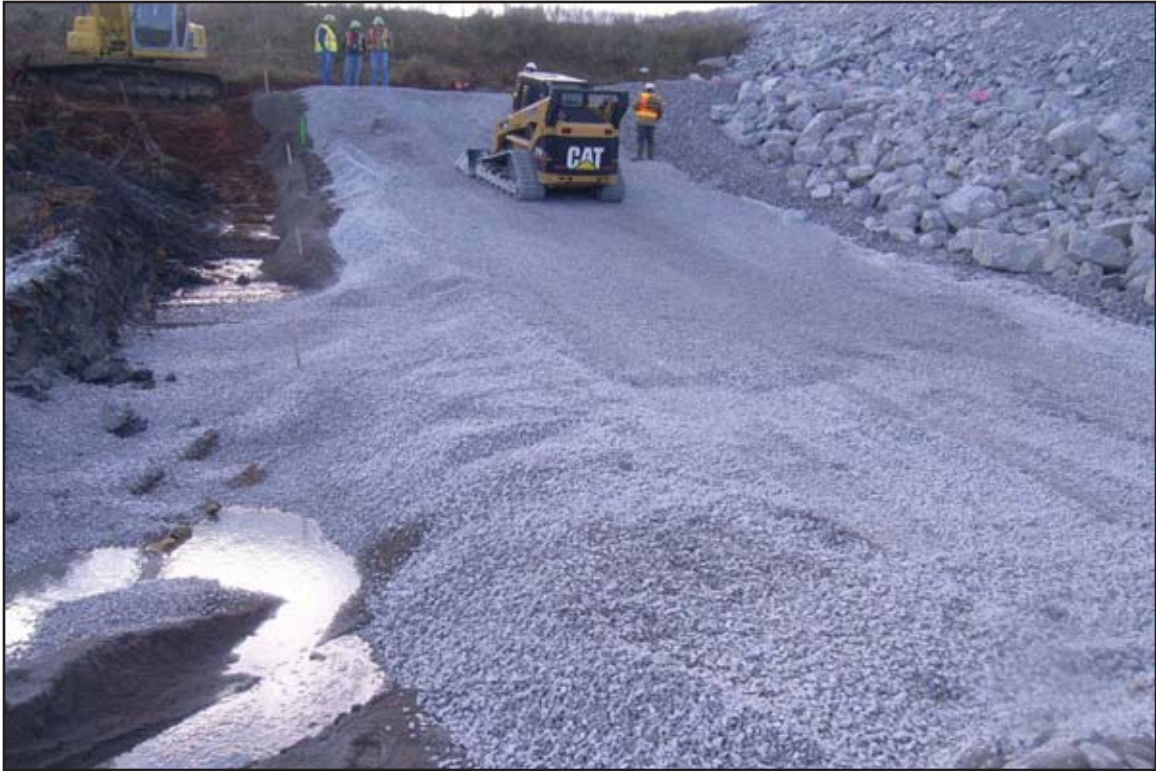
Placing layer of gravel on top of sand material in panel. December 27, 2009.

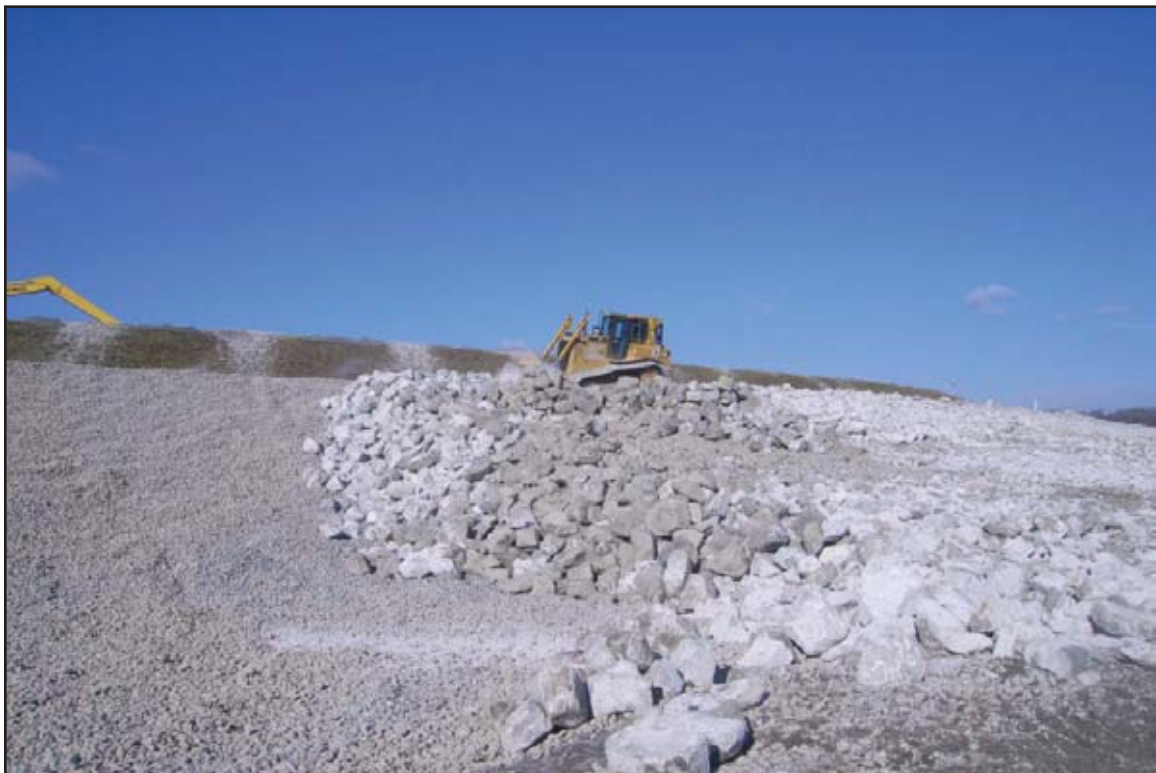
Placing riprap on top of gravel material. December 27, 2009.

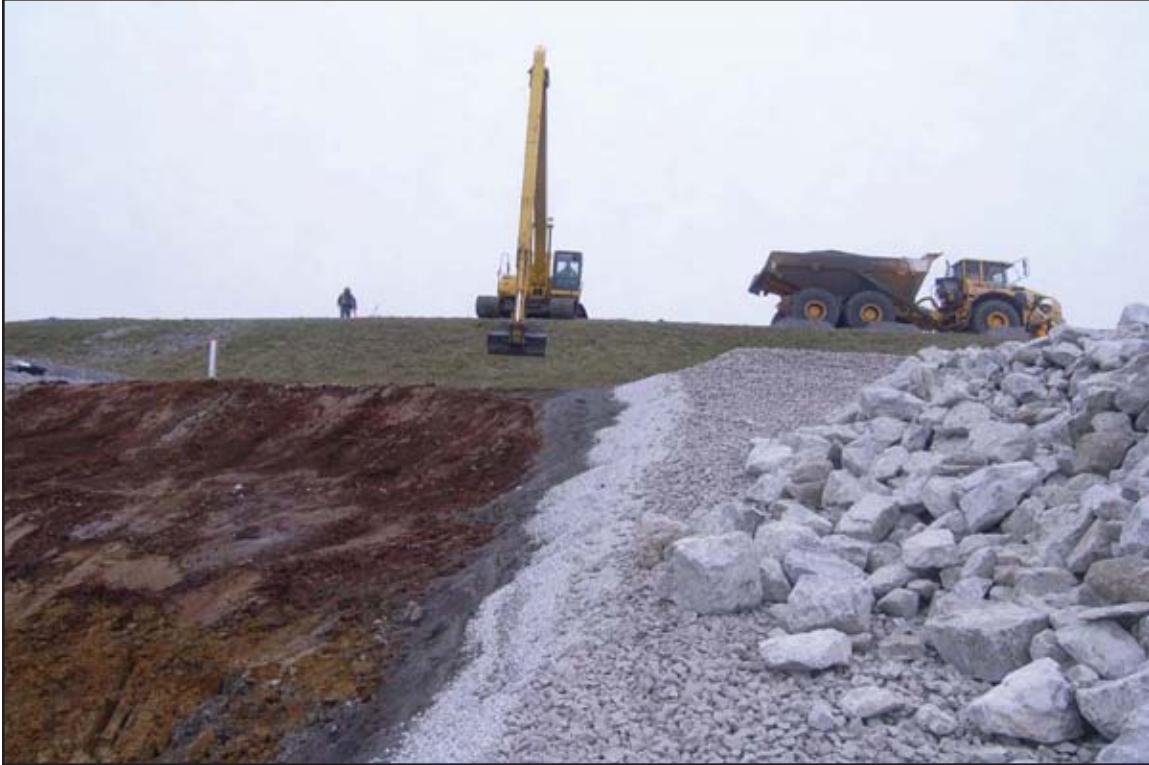
Excavation of subsequent panel next to a completed panel. February 12, 2010.

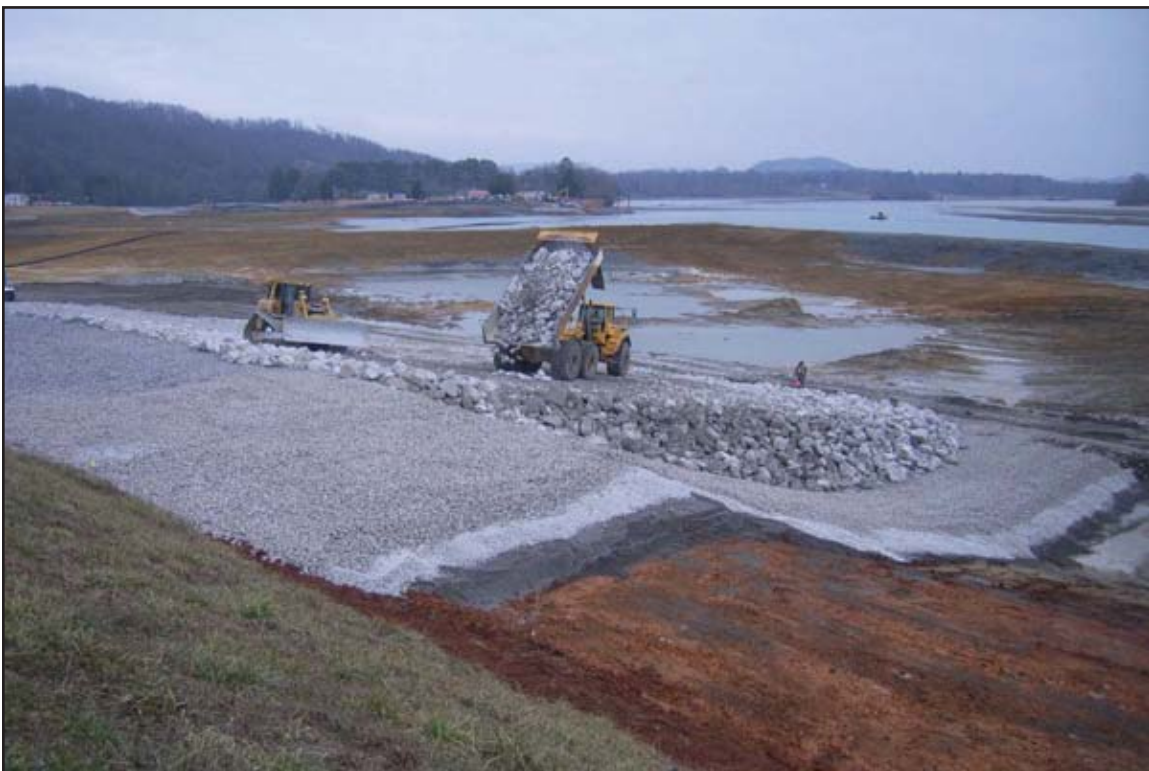
Progress of overall Dike C reinforcement work as viewed from top of Dike C.  
February 24, 2010.

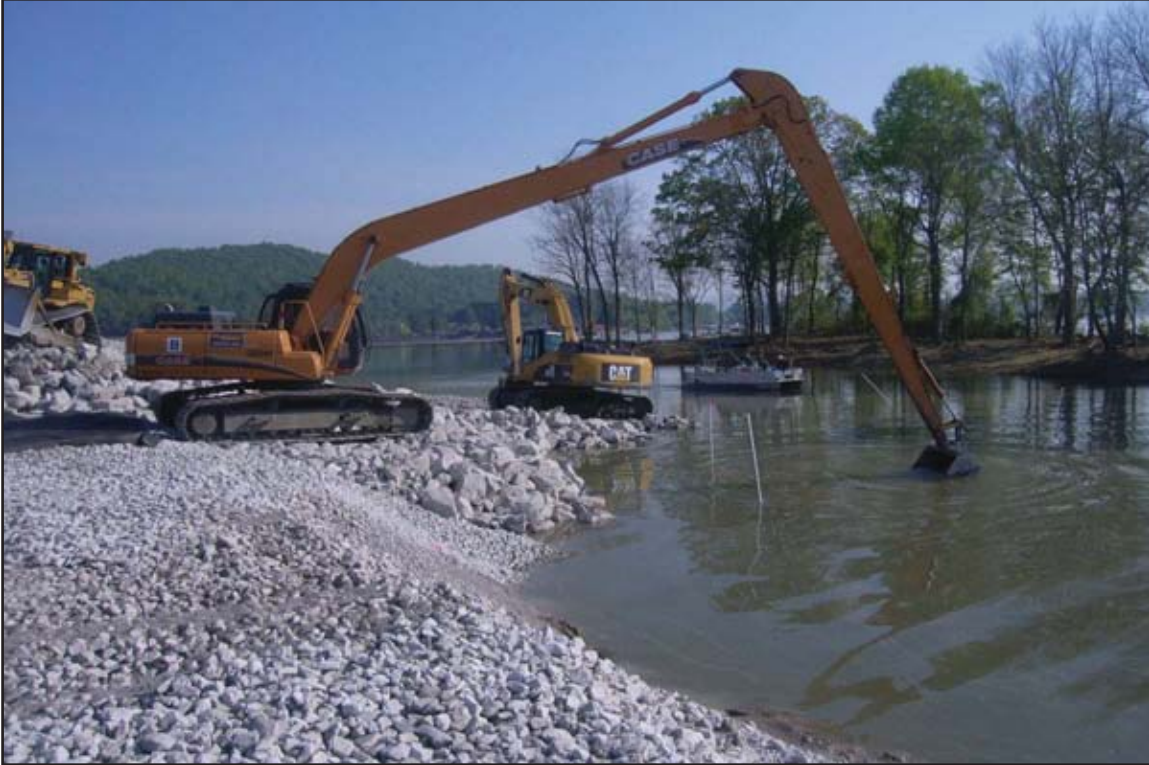
Below water excavation and sand, gravel, and riprap placement. April 23, 2010.

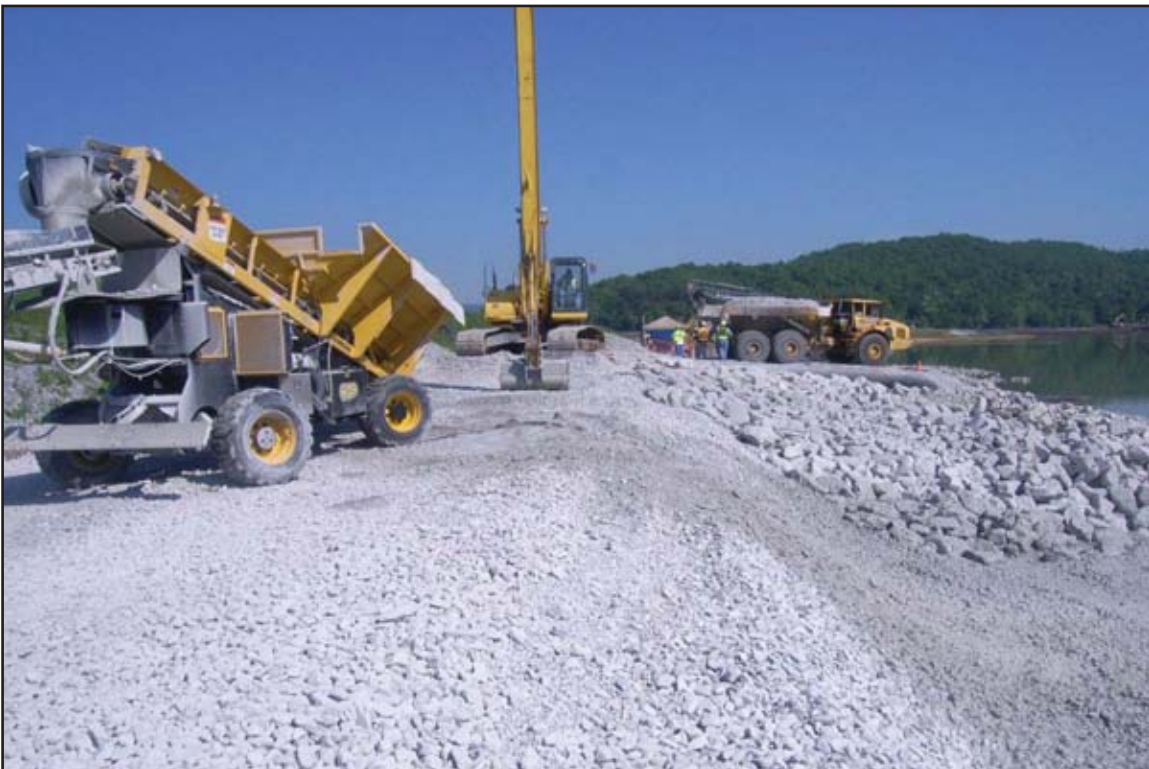
Equipment used in placing sand, gravel, and riprap during Dike C reinforcement. April 29, 2010.

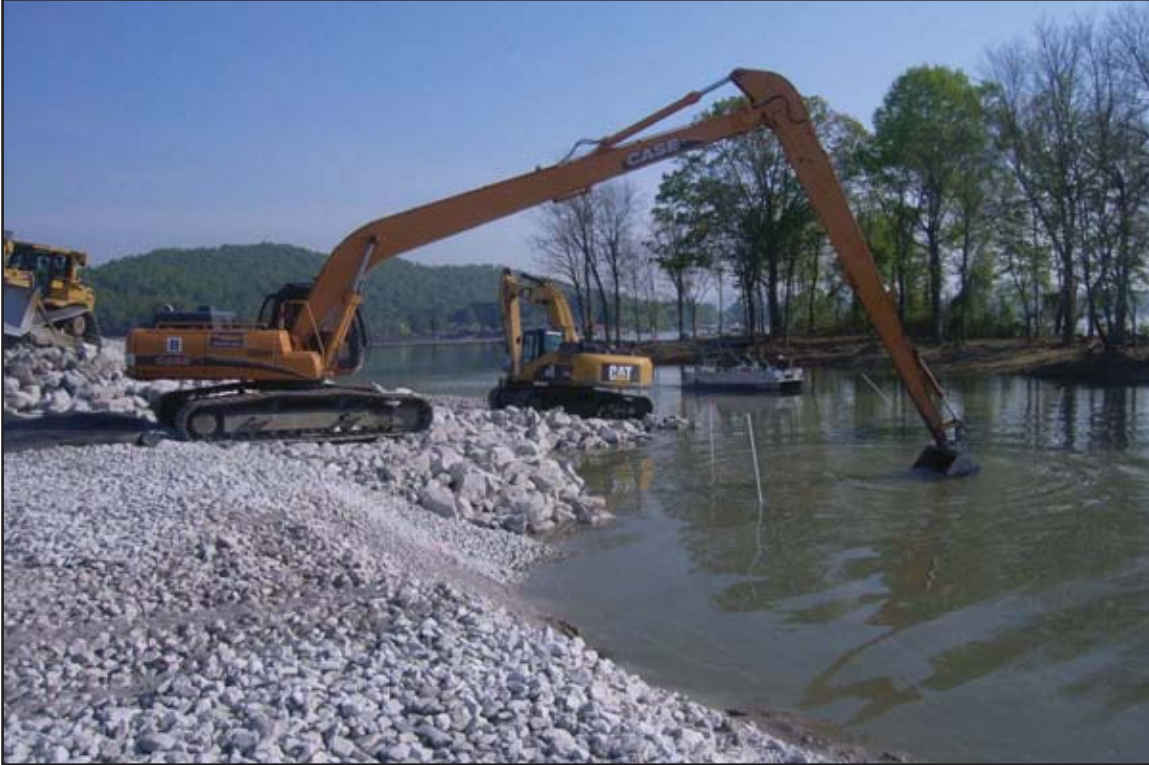
Below water excavation and sand, gravel, and riprap placement. April 23, 2010.

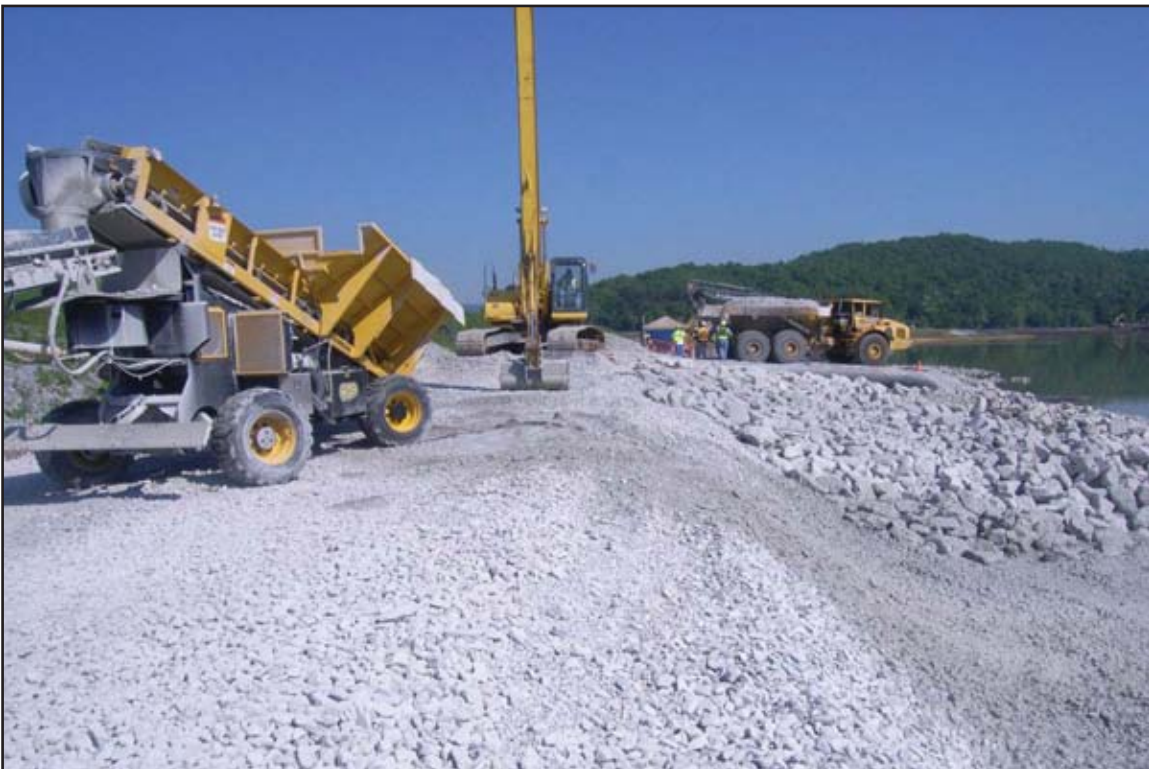
Equipment used in placing sand, gravel, and riprap during Dike C reinforcement. April 29, 2010.

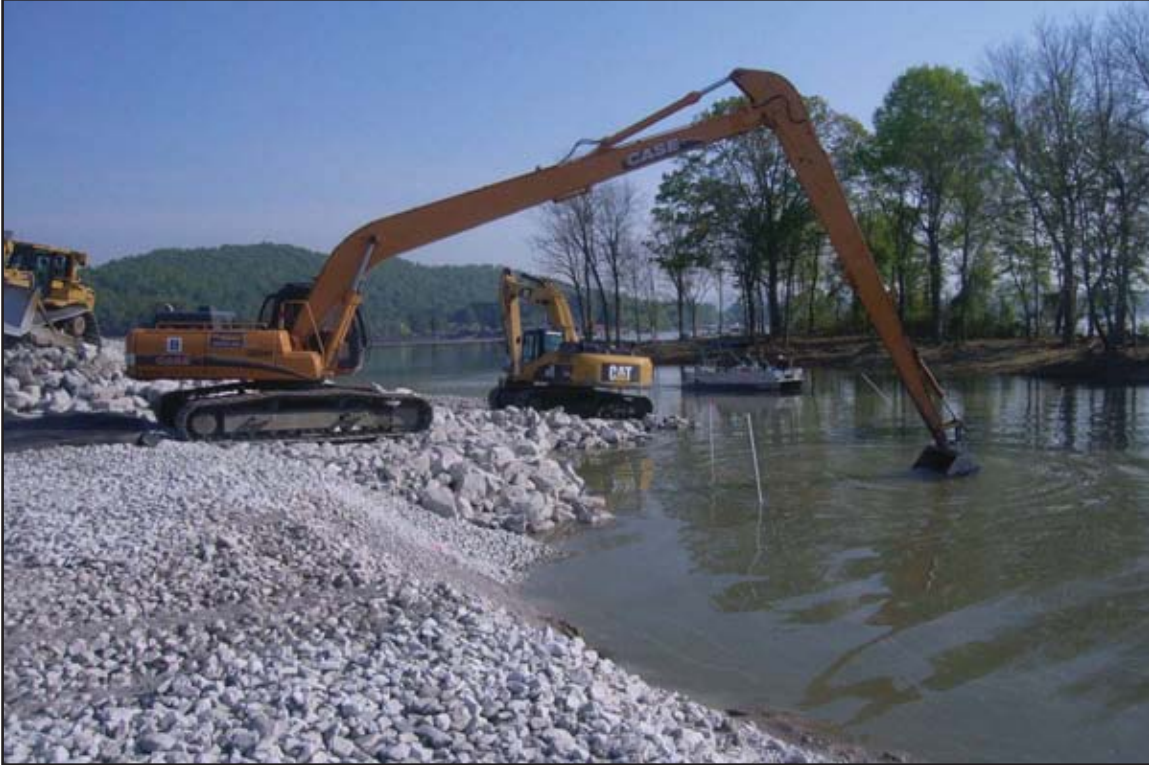
Below water excavation and sand, gravel, and riprap placement. April 23, 2010.

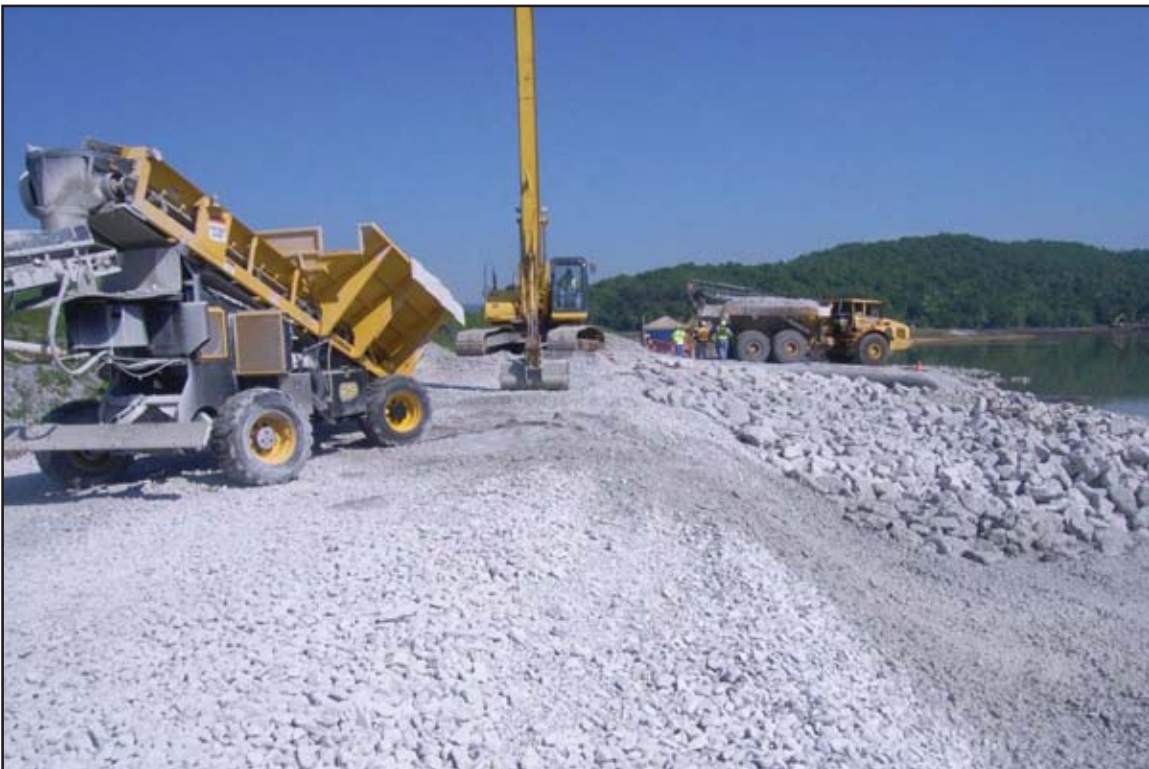
Equipment used in placing sand, gravel, and riprap during Dike C reinforcement. April 29, 2010.

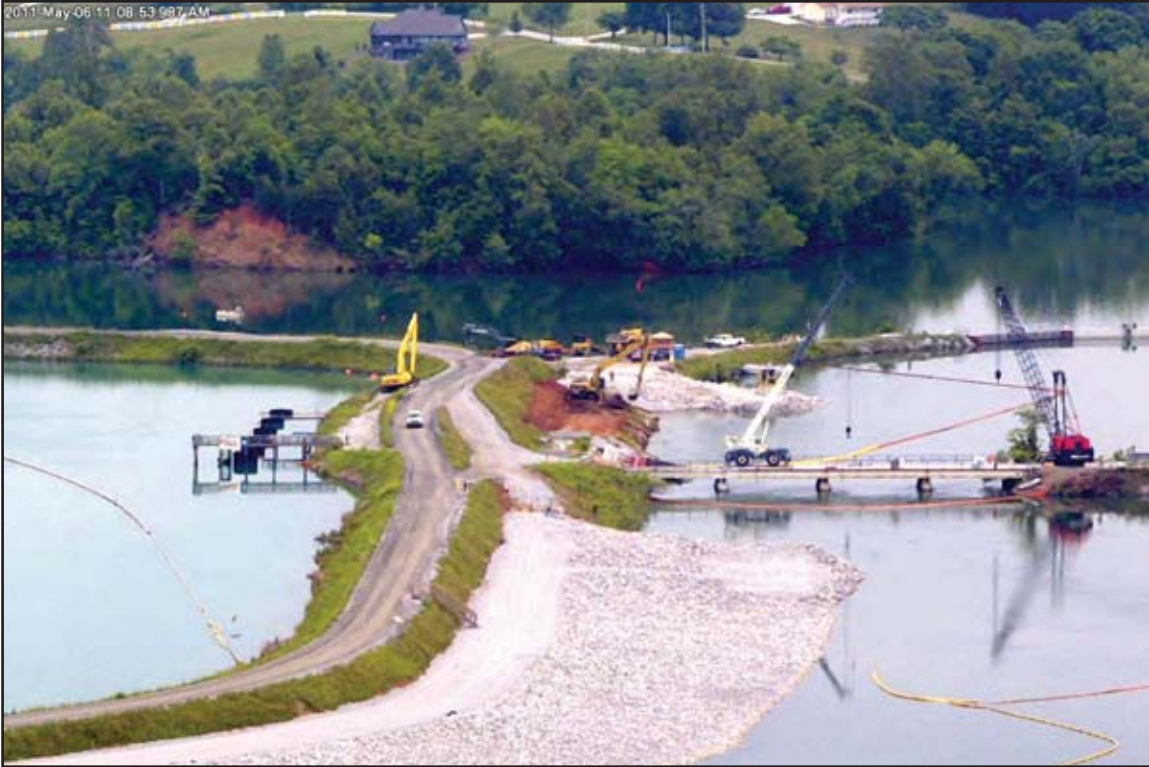
Bridge removal. May 6, 2011.

Bridge removal was implemented in accordance with the EPA OSC-approved *Intake Channel Bridge Removal Work Plan*, Document No. RAWP-087 (Ref. 5.1.4). Demolition of the bridge was contracted to DEMCO, Inc., a decommissioning and environmental management company. Award of the demolition contract was delayed while decisions were being made on how the existing bridge piers should be removed. It was ultimately decided that the pier closest to the causeway (Pier A) should be removed and the others left in place. Demolition began on May 6, 2011 and was completed on May 31, 2011.

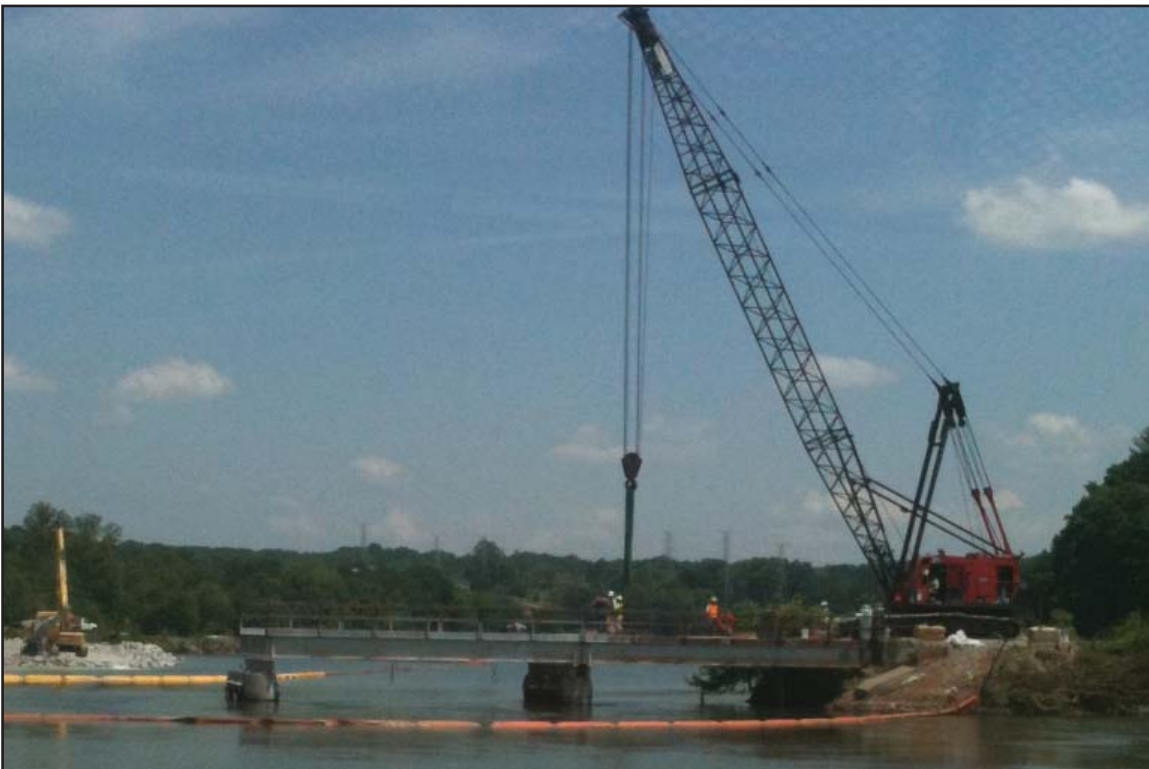
Bridge removal. May 2011.

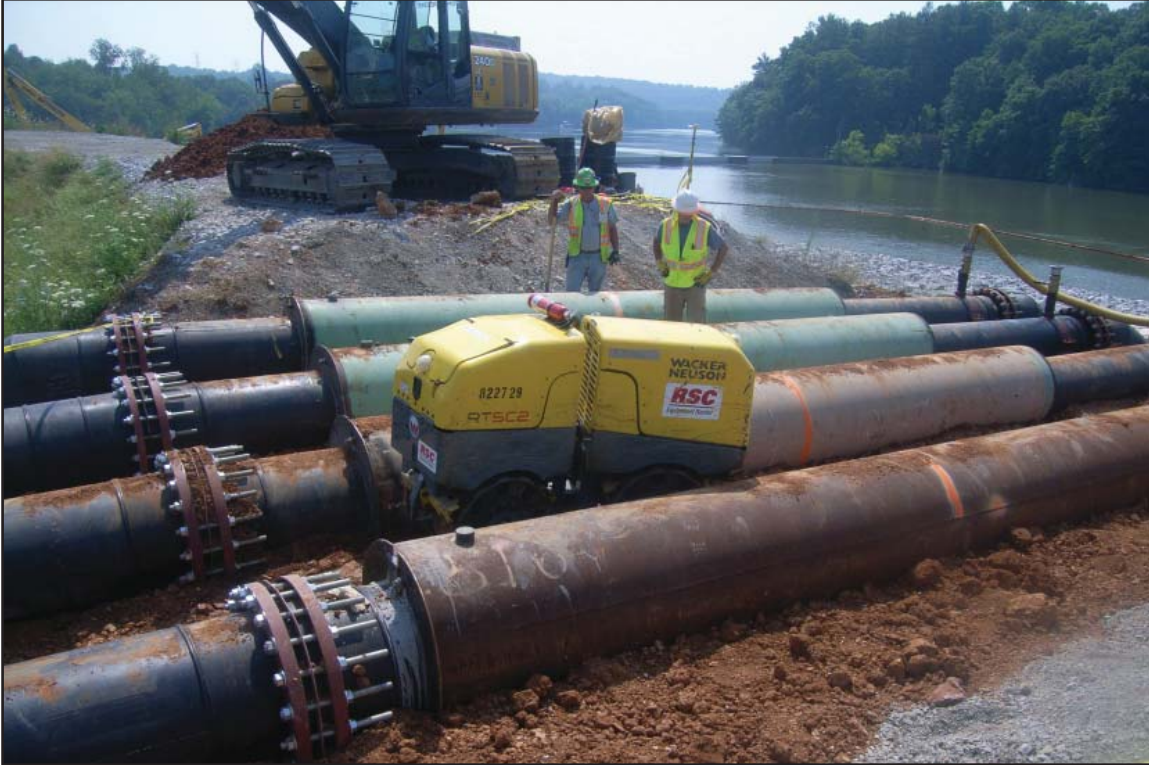
New siphon installation. June 7, 2011.

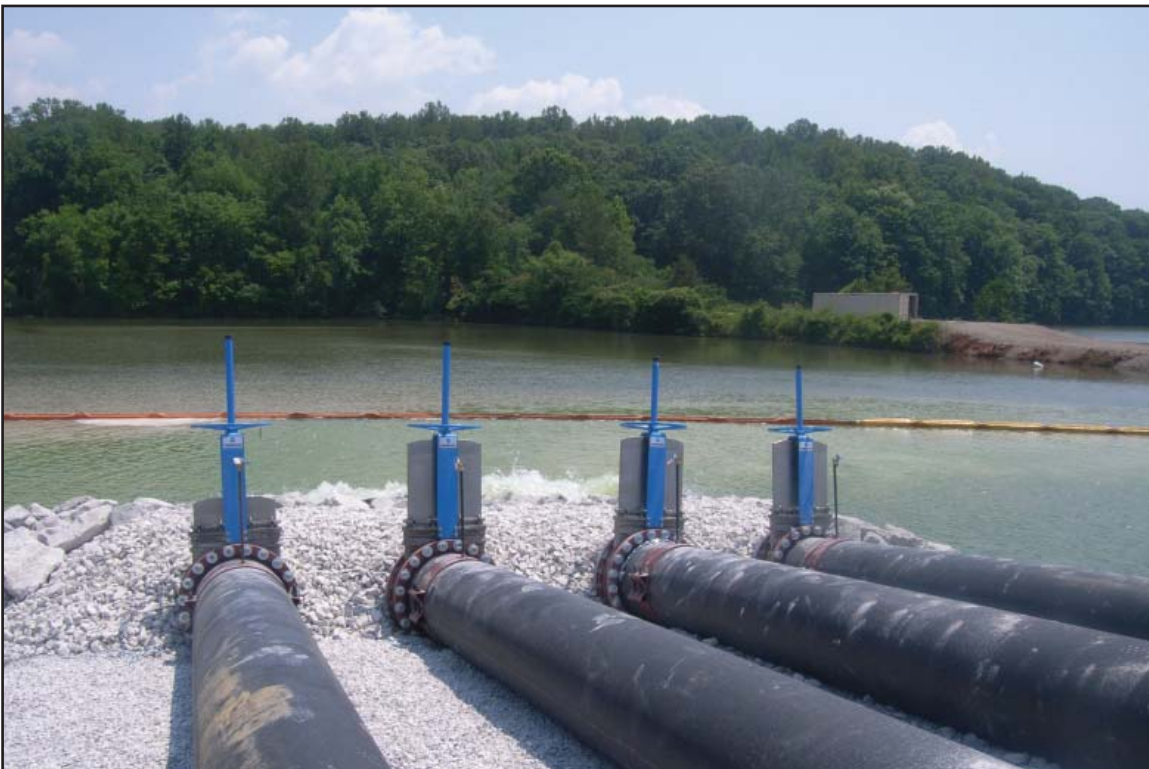
New siphon installation. June 7, 2011.

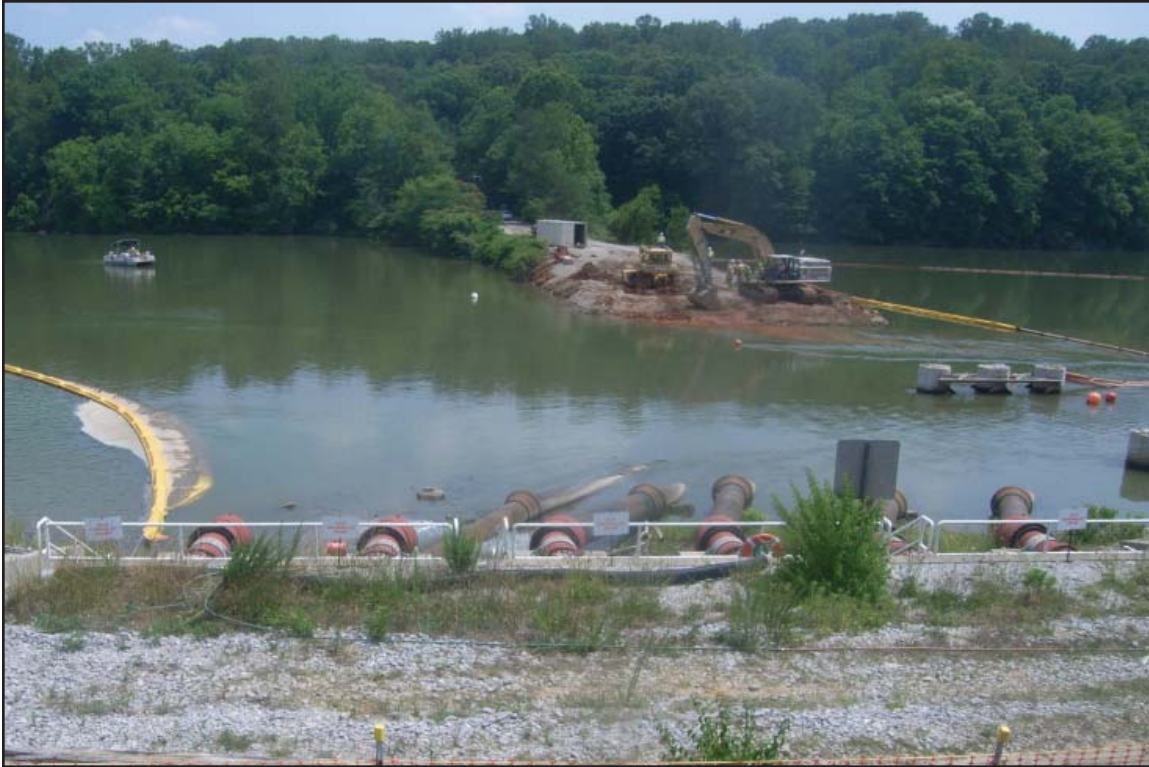
Causeway removal. June 10, 2011.

Removal of the causeway was implemented in accordance with the EPA OSC-approved *Intake Channel Causeway Removal Work Plan*, Document No. RAWP-094 (Ref. 5.1.6). Work on removing the causeway was begun on June 2, 2011. Appropriate sediment and turbidity control measures, including turbidity curtains, were installed prior to beginning excavation and maintained throughout the duration of the causeway removal to control sediment movement in the Intake Channel. Water quality was monitored for turbidity or color change. The clayey nature of the excavated material caused more discoloration of the water in the Intake Channel than was anticipated. However, turbidity measurements at the plant discharge showed no significant increase in turbidity levels. As a result, there were no delays encountered during causeway removal. Water quality monitoring is further discussed in Section 3.

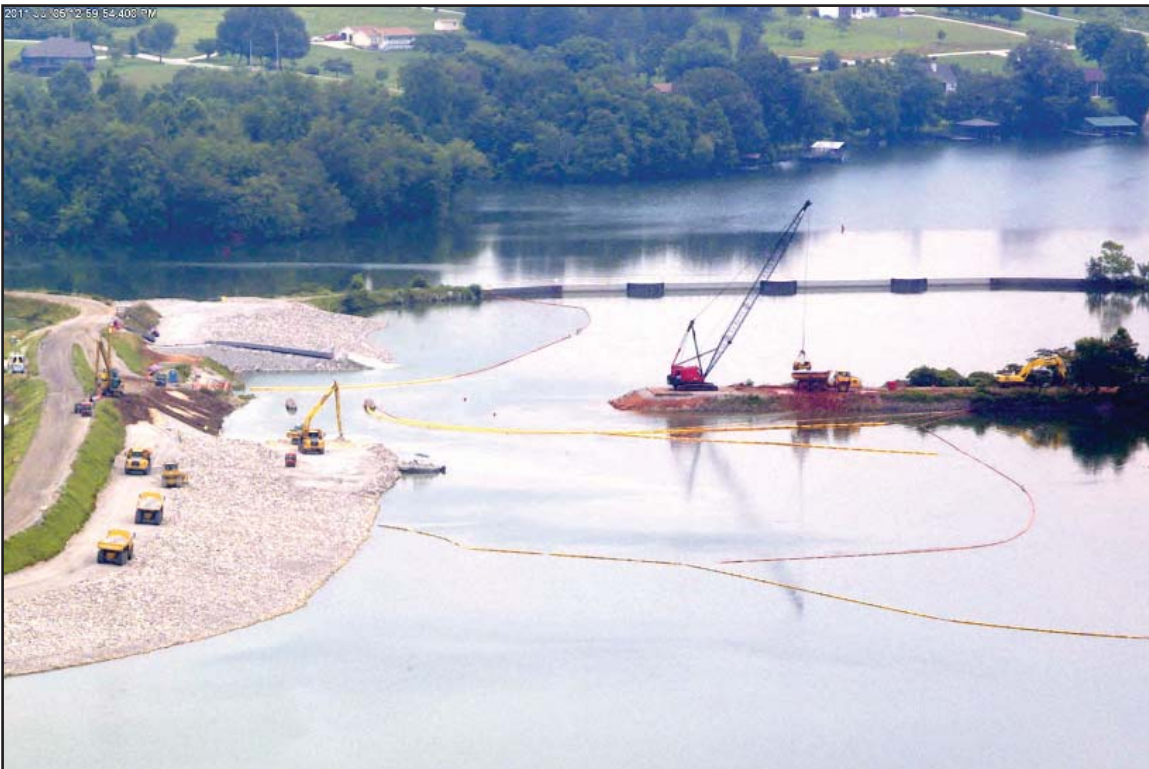
Causeway removal. July 5, 2011.

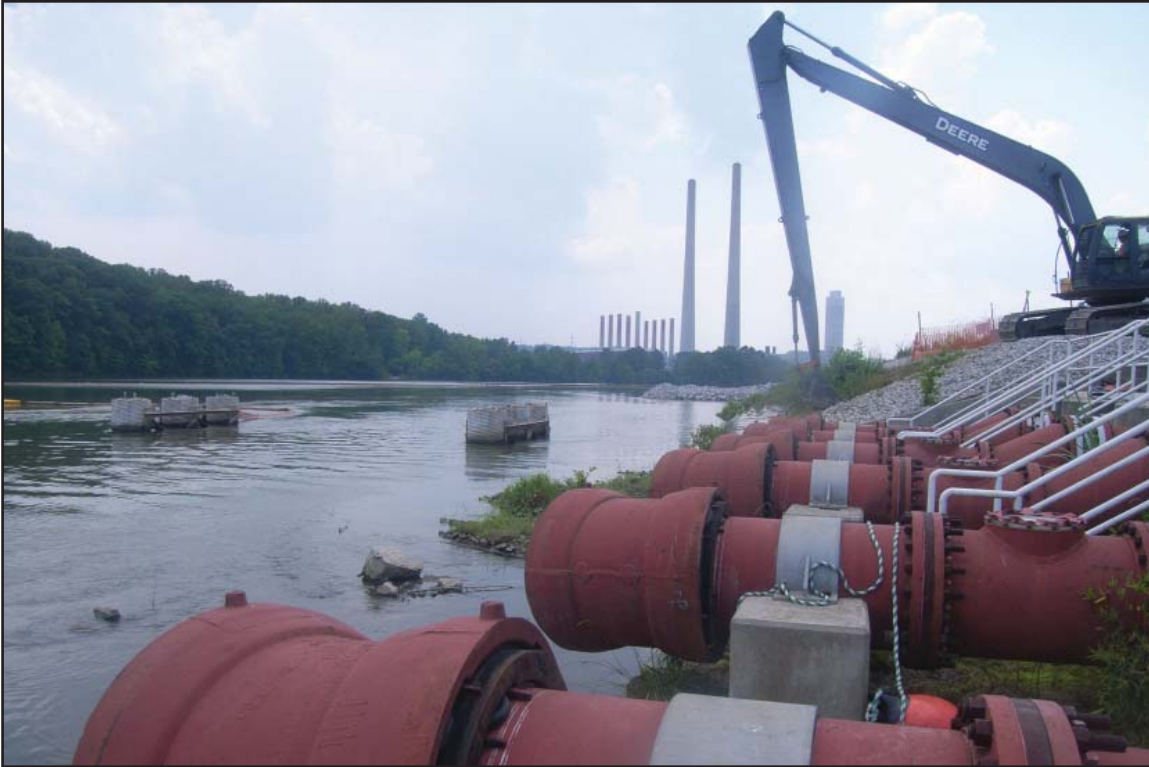
Old diffuser removal. June 11, 2011.

**Effectiveness of Siphon Installation and Diffuser Replacement.** Existing diffusers were removed to facilitate construction of the full buttress in the area of the diffusers. Removal of the diffusers improved effectiveness of the buttress construction by avoiding interruption to the plant effluent discharge from the Stilling Pond while the buttress materials were being placed.

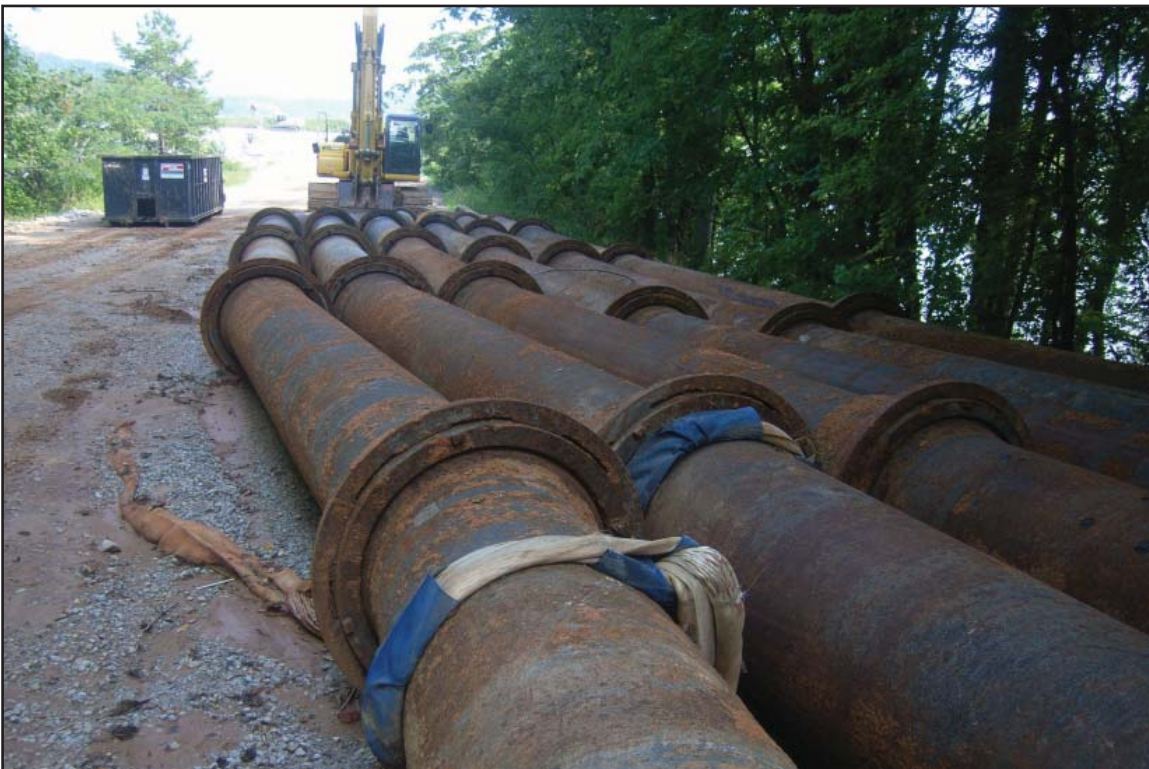
Old diffuser removal. July 19, 2011.

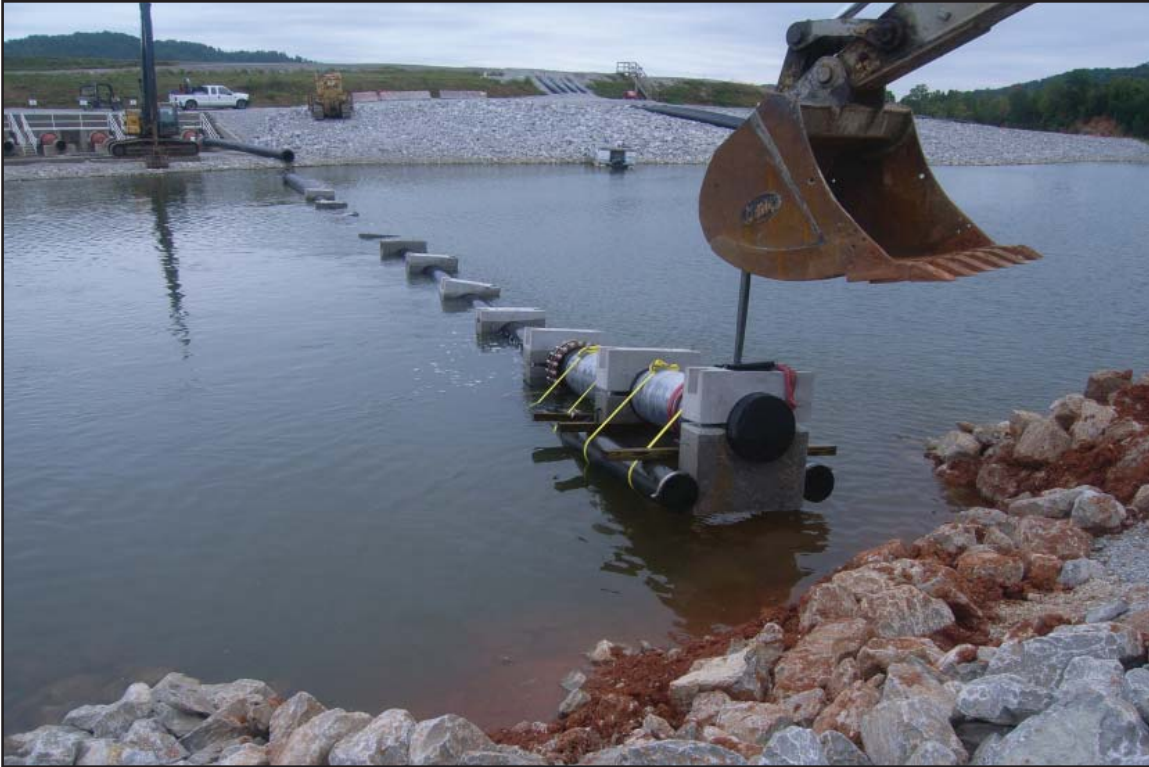
New diffuser installation. September 16, 2011.

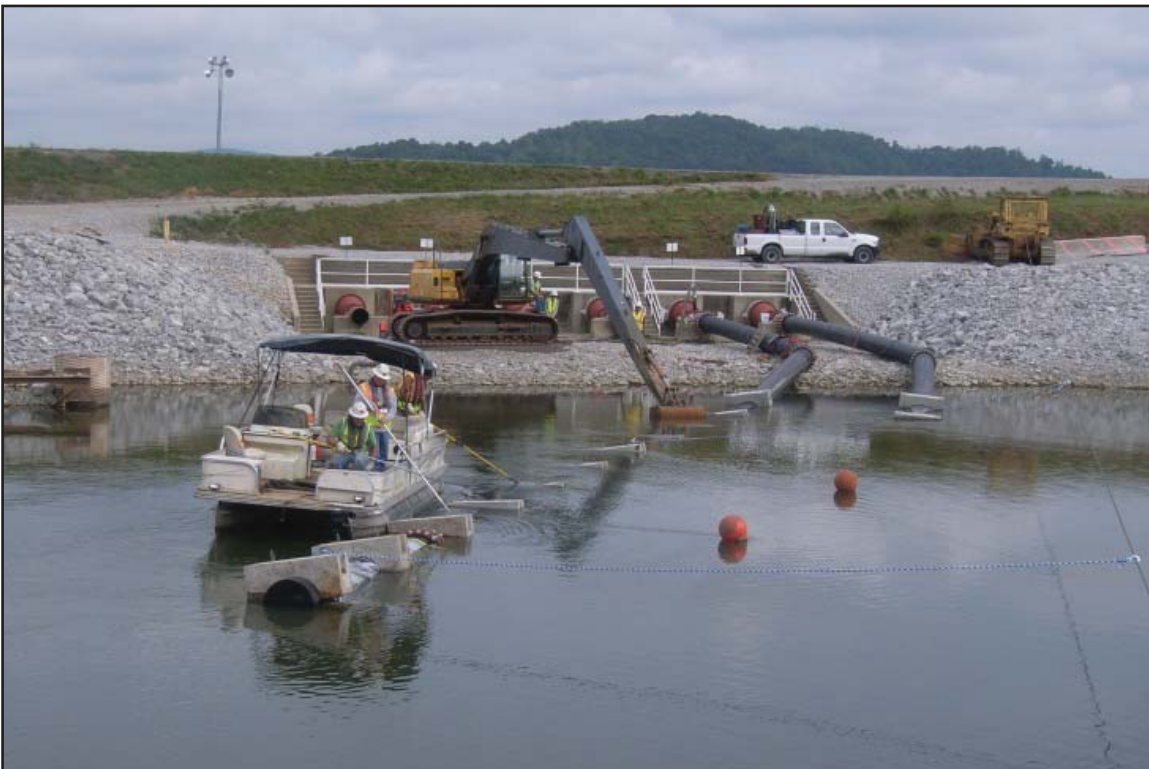
New diffuser installation. September 18, 2011.
