**INTERNAL RESISTANCE TO CORROSION
IN STEEL HOLLOW SECTIONS**

Notice 1059

**CIDECT
Final Report 10B-78/3**

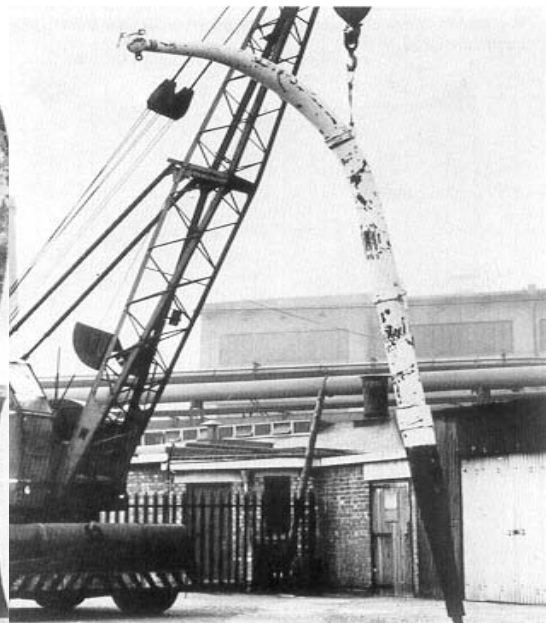
Figure 13: Complete S. S. Aquitania davit as delivered for inspection

These davits were then about 37 years old and had been exposed to a marine atmosphere for the greater part of their lives. As can be seen in the photo (Fig. 13) each davit is made of tube approximately 406 mm diameter and 52 mm thickness, cylindrical at the centre and conical at each end, where the diameter is reduced to about 170 mm. Both ends are sealed by welding, one with a steel ball to carry the lifeboat and the other by means of a circular plug in mild steel. The total length was about 9 meters. One of these davits was cut with the flame cutter so that the interior could be examined.

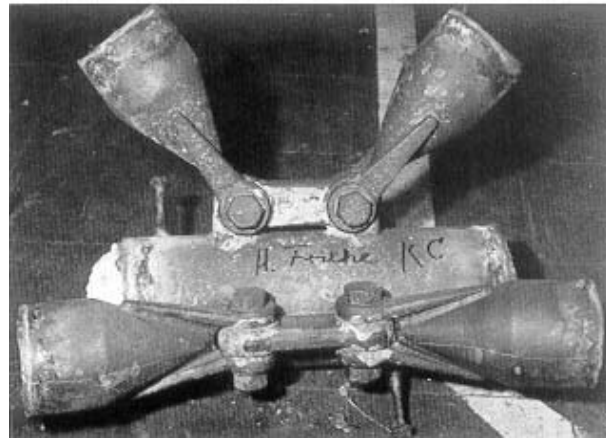
Figure 20: High voltage transmission tower. External view of the cut out joint sample.

Result of the examination: Figure 20 shows the part of the pylon which was supplied by Mannesmannrohren-Werke. This sample had been cut out of a joint situated some 12 m above the ground.

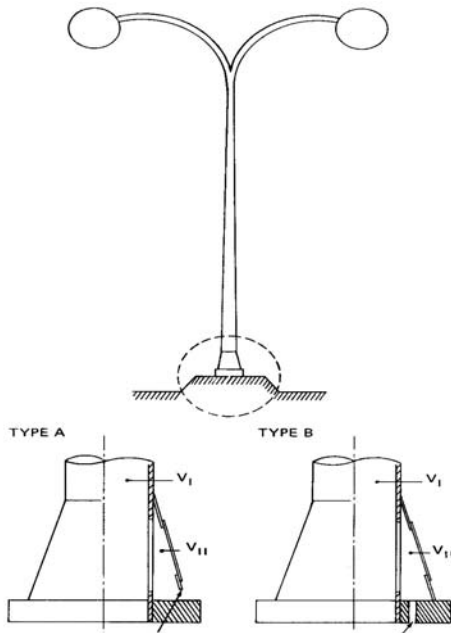
Structure: This document refers to the investigation carried out on the internal corrosion of lighting columns for public thoroughfares with a high level of traffic (Figure 26).

Figure 26 - Urban lamp-post: water drainage hole 10 mm radius for both types
 Type A: side hole Type B: base hole

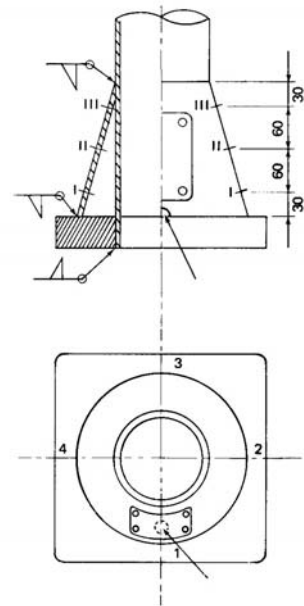
Figure 27 - Column Base

Measurements carried out: The internal corrosion was measured by means of an ultrasonic thickness tester. The measuring points (I, II and III) are shown on Figure 27. There was no internal paint.

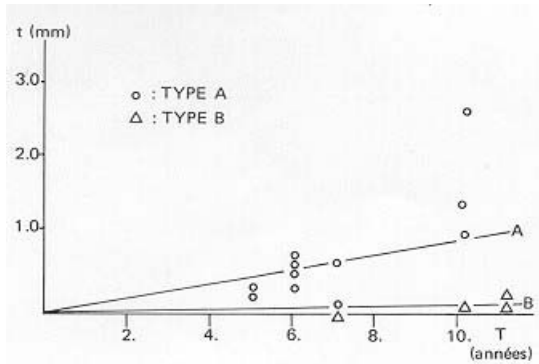
Result: The relation between t (thickness reduction due to internal corrosion) and T (years elapsed since installation) are shown on Figure 28 for two types of water drainage holes.

Figure 28: $-t/T$ ratio in relation to the type of drainage hole (years)

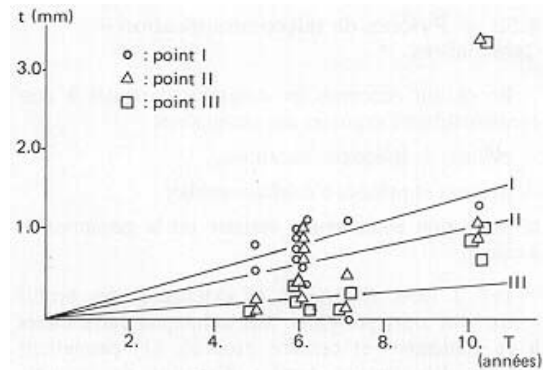
Figure 29: Type A column. t/T ratio in relation to the measuring points (years)

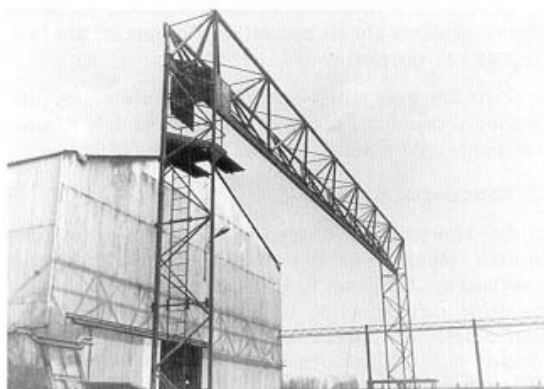
Figure 31: Valenciennes Works -General view of the loading portal before dismantling.

1) External loading gantry: This gantry (see Fig. 31) had been used for mechanical handling and for loading the structural components fabricated in an adjacent workshop. It had been erected in 1962, and had not been used since 1970, so it was due for dismantling. This is the reason why the highest number of members cut out came from this structure. The working and maintenance conditions for this gantry were those which are commonly encountered in metal workshops of the Valenciennes region, i.e. an industrial atmosphere and severe climatic conditions, being exposed to the weather.

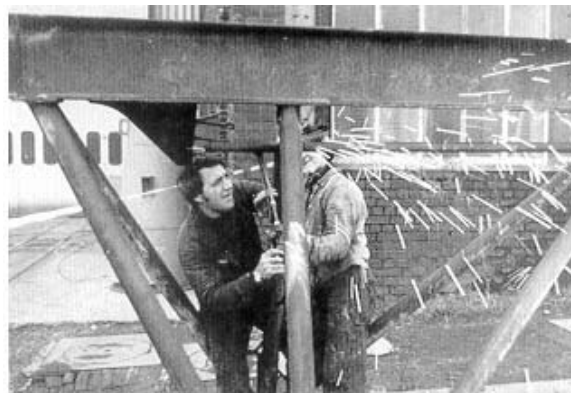
Figure 32 - Cutting out of a sample

Samples were cut out from the horizontal girder after it had been dismantled (see Fig. 32). Among these members 1 had 2 fixing holes for electric insulators which had been removed four years previously. The two holes, about 8 mm in diameter and some 50 mm apart, had never been plugged.

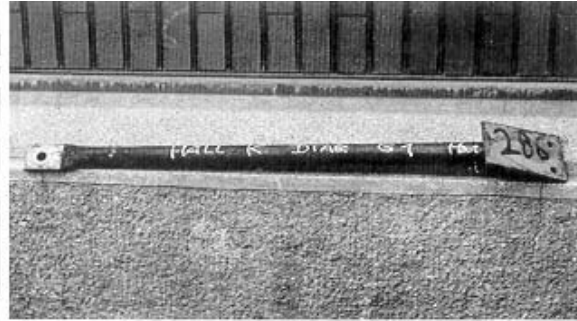
4) Factory shed - gable type wind girder: This building, constructed in 1958, had components which had been exposed to the industrial atmosphere since that date. One sample only was taken, namely a wind girder support (see Fig. 36). This strut was bolted at the top through a welded plate and at the bottom simply by flattening.

Figure 36: Diagonal member flattened at one end and welded to a plate at the other.

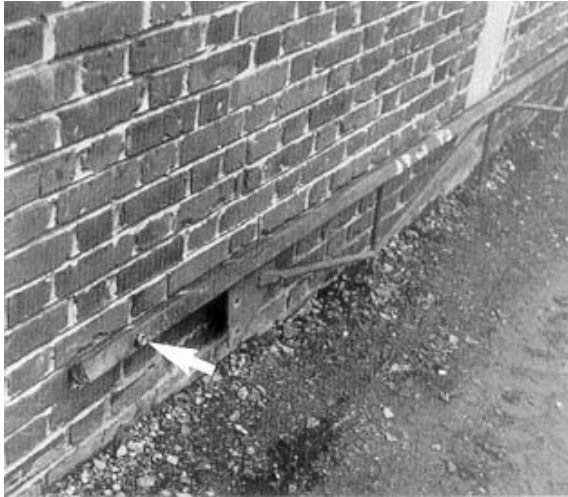
Figure 39: End of a lattice purlin with a bolt hole through the chord.

3) Storage hall - eastern extension: The lattice purlin included an upper chord member in square RHS sealed at both ends, but drilled through for bolting. The bolt had blocked the hole, apart from clearance, and it is interesting to note that some of the original mill-scale fell from the hole when the bolt was removed. (See Fig 39)

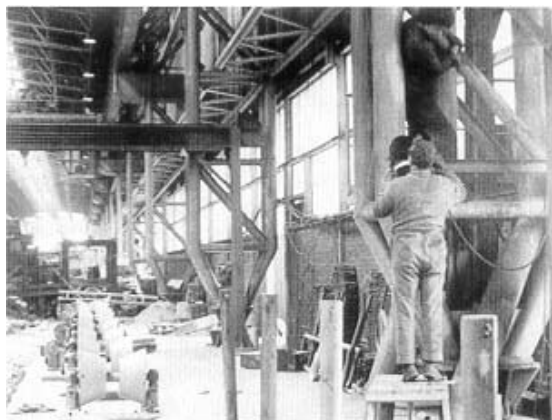
Column of Hall III: The hollow section marked "Column D-18-1" was cut from the horizontal bracing of a crane rail stanchion in No. 2. tube mill after more than twelve years in an industrial atmosphere. This stanchion numbered "D-18 row B" is shown on Figures 40 to 41. Figure 42 shows the same stanchion after 800 mm had been cut out from the bracing. The sample is shown in Figure 43. It is a seamless circular hollow section about 168 mm external diameter, sealed at both ends where it is welded to the

Figure 40: Hall III, Row B. Column D-18 and general view of hall.

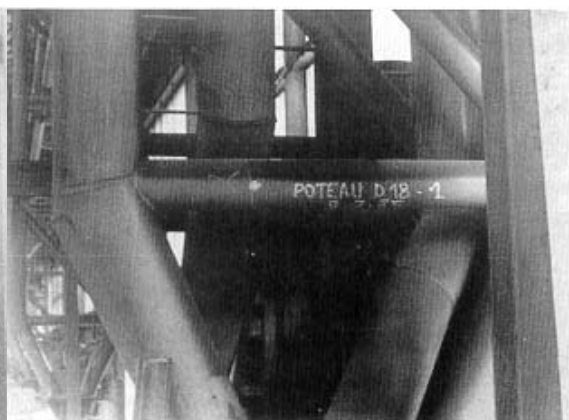
Figure 41: Distance piece 1 in column D-18

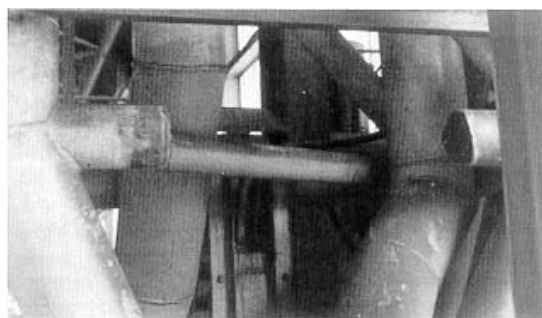
Figure 42: Column D-18 after part of the distance piece has been removed.

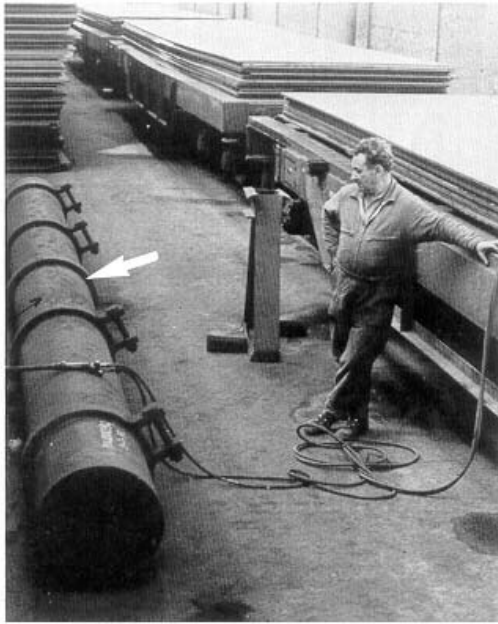
Lifting beam of Hall V: Lifting beam 2, which went into service some 10 years ago, has been stored in No. 5 tube fabrication shop for five years, (Fig. 44)

Figure 44: Hall no. 5, lifting beam 2
- General view.

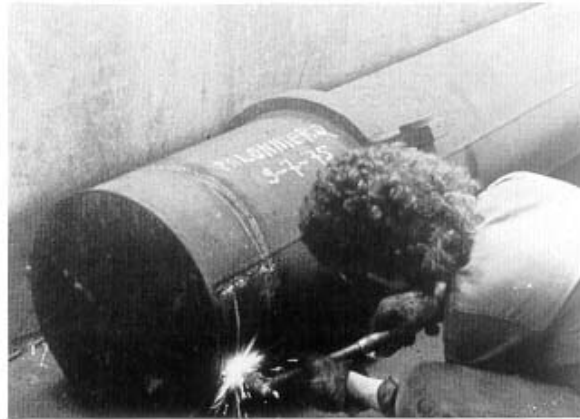
Figure 45: Lifting beam 2 – cutting out of sample

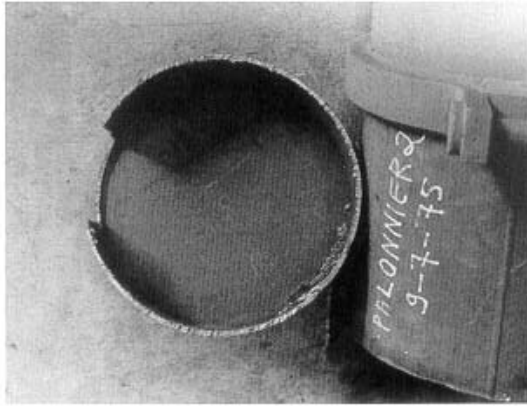
Figure 46: Lifting beam 2. View of the bottom plate at one of the ends.

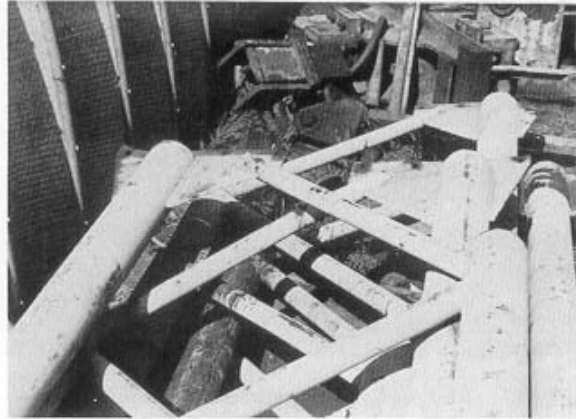
Wind girder 3: This was erected some thirteen years ago in the tube mill, was removed from its initial position five years ago, and has since been stored outside in the open air (Fig. 47) in an atmosphere both industrial and maritime (about 1 km from the North Sea). This girder consists of two tubular chords connected by diagonal bracings in hollow sections. The sample delivered to the Laboratory (Fig. 48) is a 600 mm length cut from the end of one of the chords.

Figure 47: Wind girder 3 in the store.

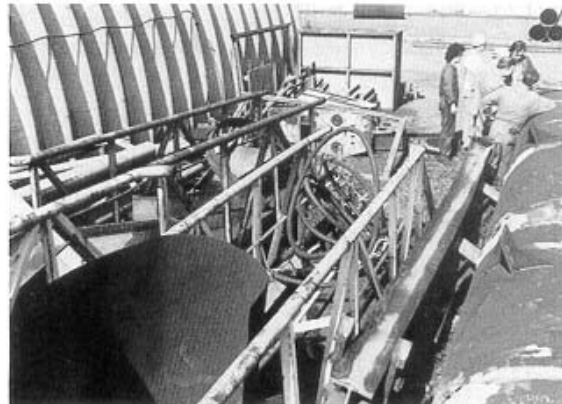
Figure 49: Gangway No. 4. as stored.

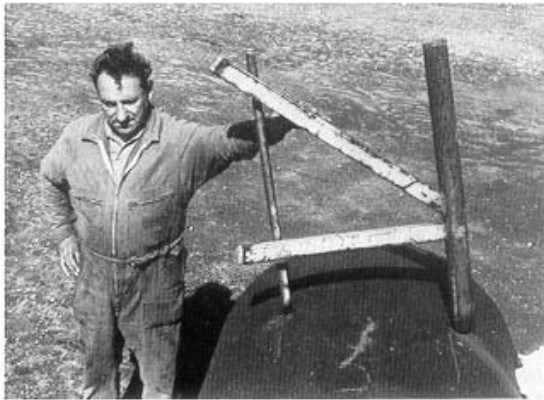
The sample delivered to the laboratory (Fig. 50) was about 850 mm long, cut from one end of one of the two gangway guardrails. It consisted of a longitudinal rail and secondary rail connected by two diagonal members in hollow section. The rail and secondary rail consisted of two seamless circular hollow sections of 70 mm and 76 mm approximate external diameter respectively, horizontal and open at the ends. The sample includes the node point of the two seamless 50 mm RHS diagonal members, which were sealed at their ends by being welded to the external face either of the rail or of another hollow section; one is laid in a vertical position and its external wall is welded to the external wall of the secondary rail, the other is in a sloping position.

The external face of the two circular hollow sections is covered by an anti-rust paint of a red colour, which has suffered considerably. This surface has been pitted by corrosion. The internal walls of these hollow sections, which were open at the ends, are relatively uniformly affected by corrosion (1).

Figure 50: Gangway 4 - Cut sample

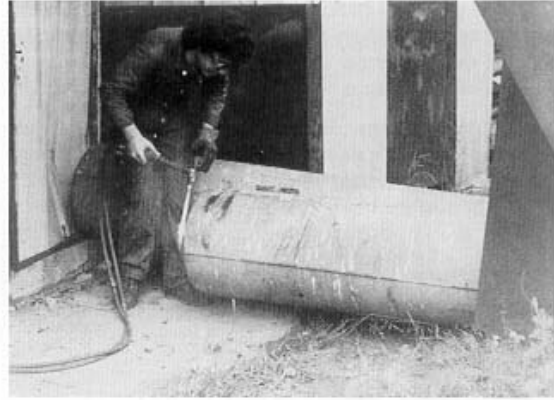
Figure 51: Hall I: single tube semi-portal.
Cutting out of the sample

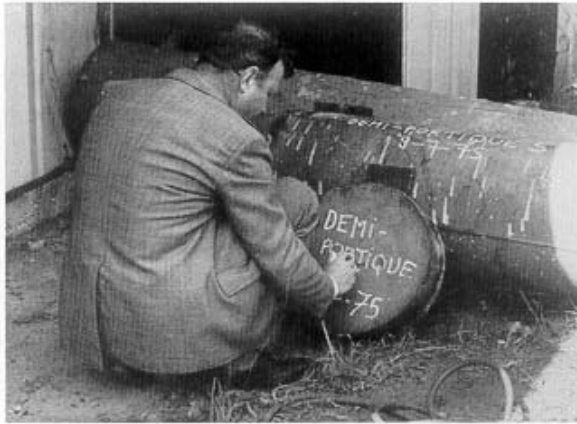
Figure 52: Single tube semi-portal. Cut sample

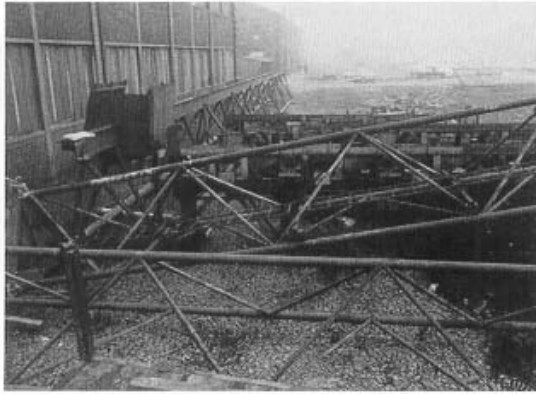
Figure 54: View of lattice column in storing area (first programme)

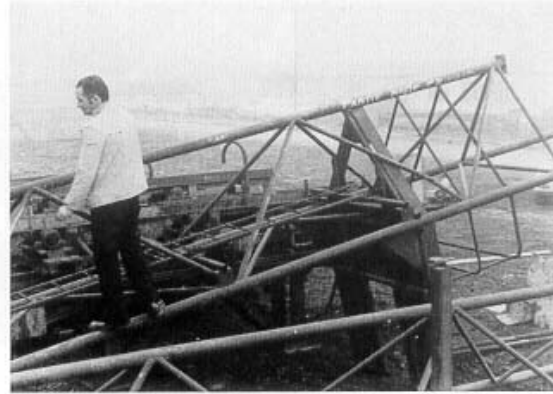
Figure 55: View of lattice column in storing area (first programme)

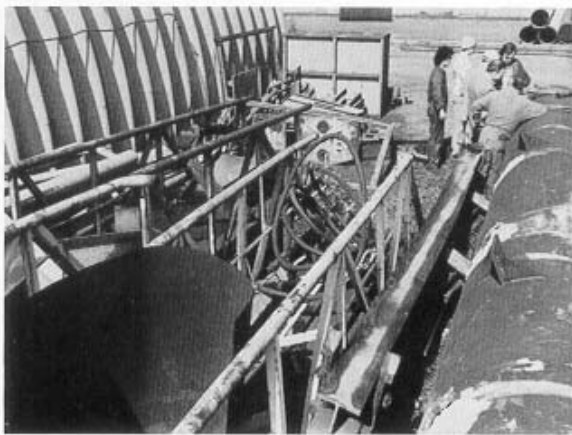
Figure 56: View of the samples in storing area (second programme)

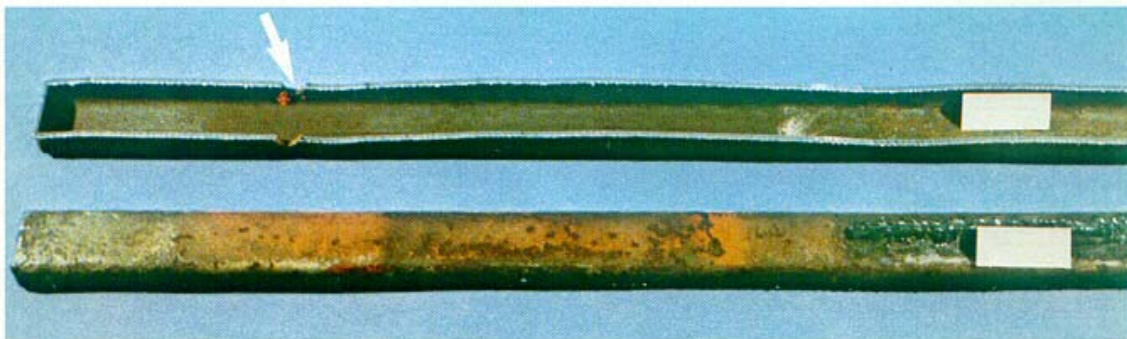
The original mill-scale was found to be virtually intact in the case of a hot-finished RHS whose ends had been sealed (Fig. 58) by being welded at one end and bolted at the other.

Figure 58: Tube with closed ends, one of which is bolted (First inspection programme)

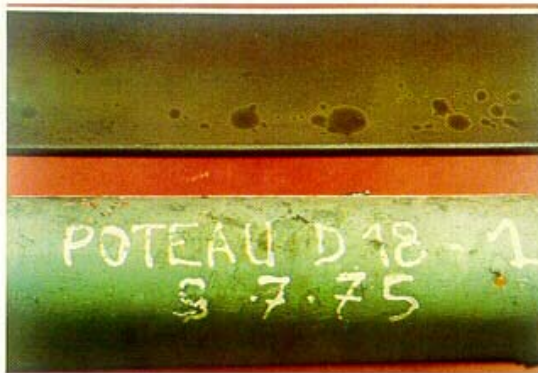
Figure 59: Tube with ends welded to the wall of another tube (Second inspection programme)

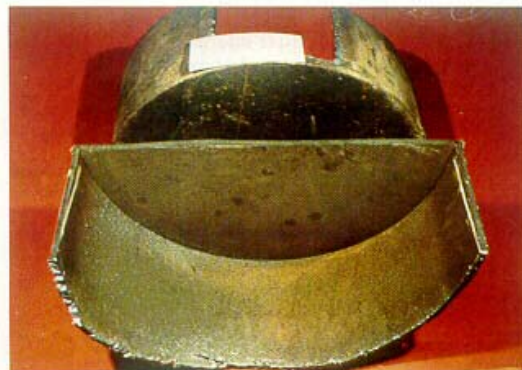
Figure 60: Tube with ends welded to a bottom plate (First inspection programme)

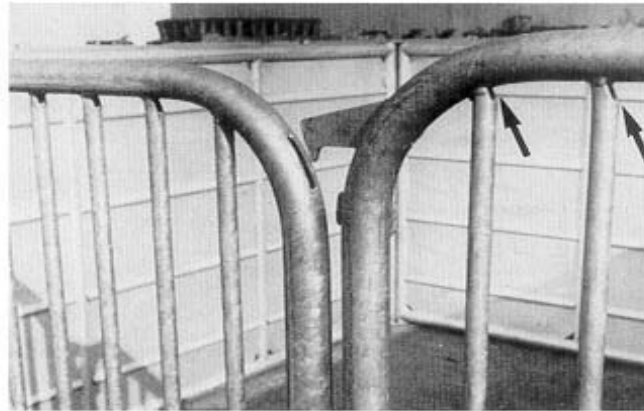
Figure 66: This partition fence in a cattle rearing installation has been galvanized after fabrication. Note the openings at the ends of the vertical infills (arrowed).

On the other hand, in the second case, it is necessary to provide openings which make it possible to carry out both the pickling and the rinsing operations and the final galvanizing (see Figure 66)
