AD COMPLIANCE

Aircraft Make *SGS* Model *1-26 F* Reg. No. *N33917* Serial No. *637*

PUBLICATION INDEX

SCHWEIZER SAILPLANES

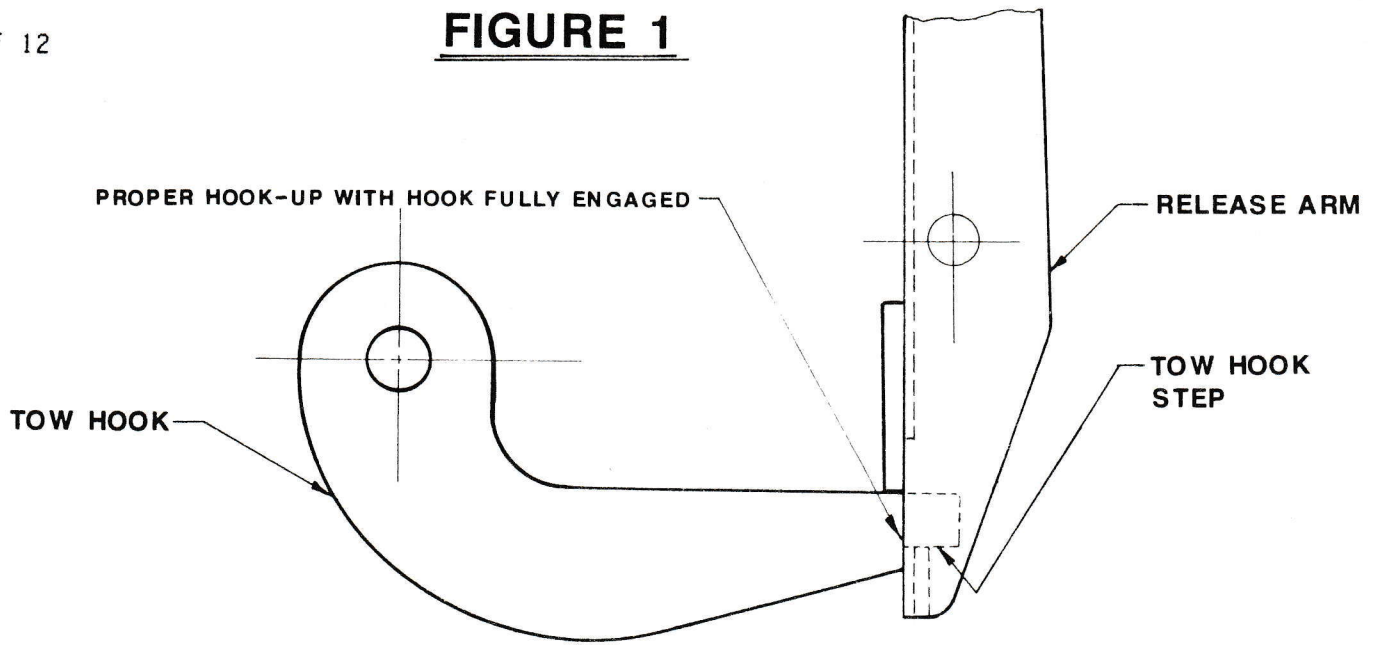
A. CORRECT HOOK-UP

- Proper engagement of the tow hook into the release arm is shown in Figure 1, View A and Figure 4. Excessive wear of the tow hook step could result in improper engagement. Figure 2 of this bulletin provides inspection data and wear limits for the tow hook. Tow hooks which do not meet the specified limits must either be reworked to obtain dimensions (as specified in Figure 2) or replaced.
- If tow hook is able to slide into the release arm, beyond the tow hook step, as shown by Figure 1, View C, the release arm must either be reworked with a slug as specified in Figure 3, or replaced.

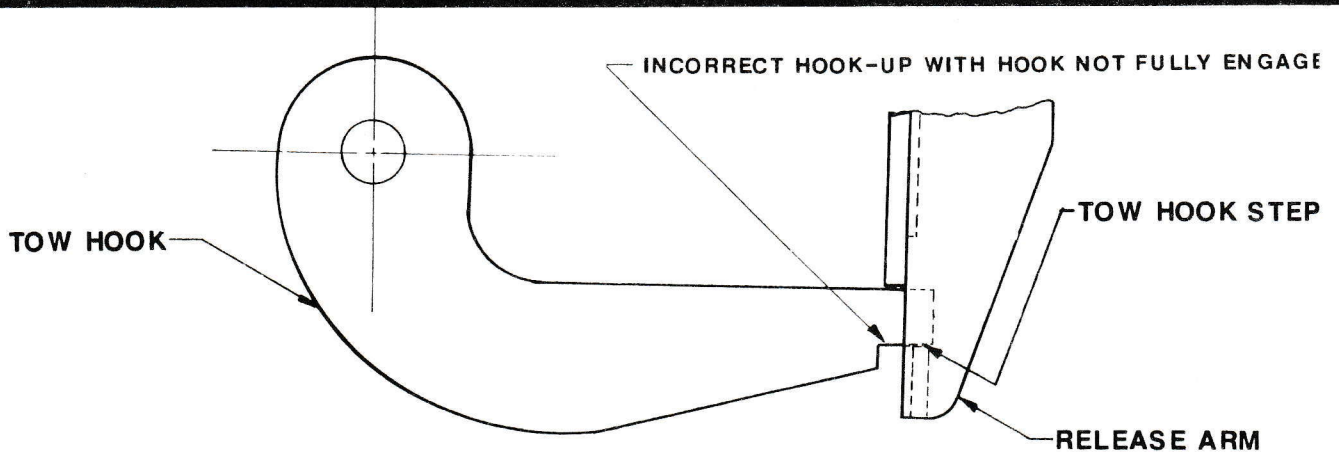
B. INCORRECT HOOK-UP

IF TOW HOOK CAN EXTEND THROUGH THE TOW RELEASE ARM AS SHOWN, RELEASE ARM AND POSSIBLY TOW HOOK MUST BE REPLACED.

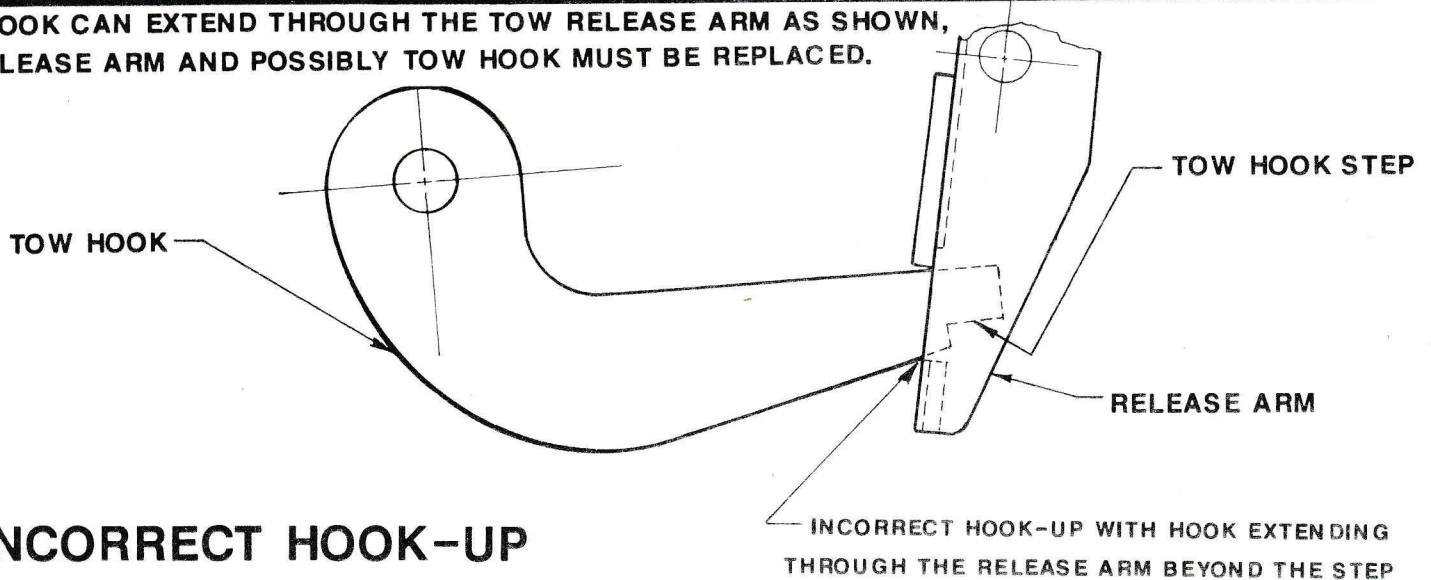
C. INCORRECT HOOK-UP

- g. If tow hook is able to travel too far inboard as shown in Figure 1, View C, disengage tow hook from release arm and measure the length of the release arm slot.
- h. If dimension is less than 0.66 inch, rework release arm by welding on 1B-217-19 slug at location shown in Figure 3. (Release arm may be replaced as an alternate to welding on slug.)
- i. If length of release arm slot is greater than 0.66 inch, replace release arm.
- j. Perform a thorough inspection of the tow hook installation in accordance with the 100 hour inspection requirements listed in Table 2 of this bulletin.
- k. Repair or replace unserviceable component(s), as required.
- l. Record compliance with Part I of this Service Bulletin in Aircraft Log Book.

IF TOW HOOK IS ABLE TO SLIDE THROUGH RELEASE ARM, BEYOND THE TOW HOOK STEP, THE RELEASE ARM MUST EITHER BE REWORKED IN ACCORDANCE WITH FIGURE 3, OR REPLACED.

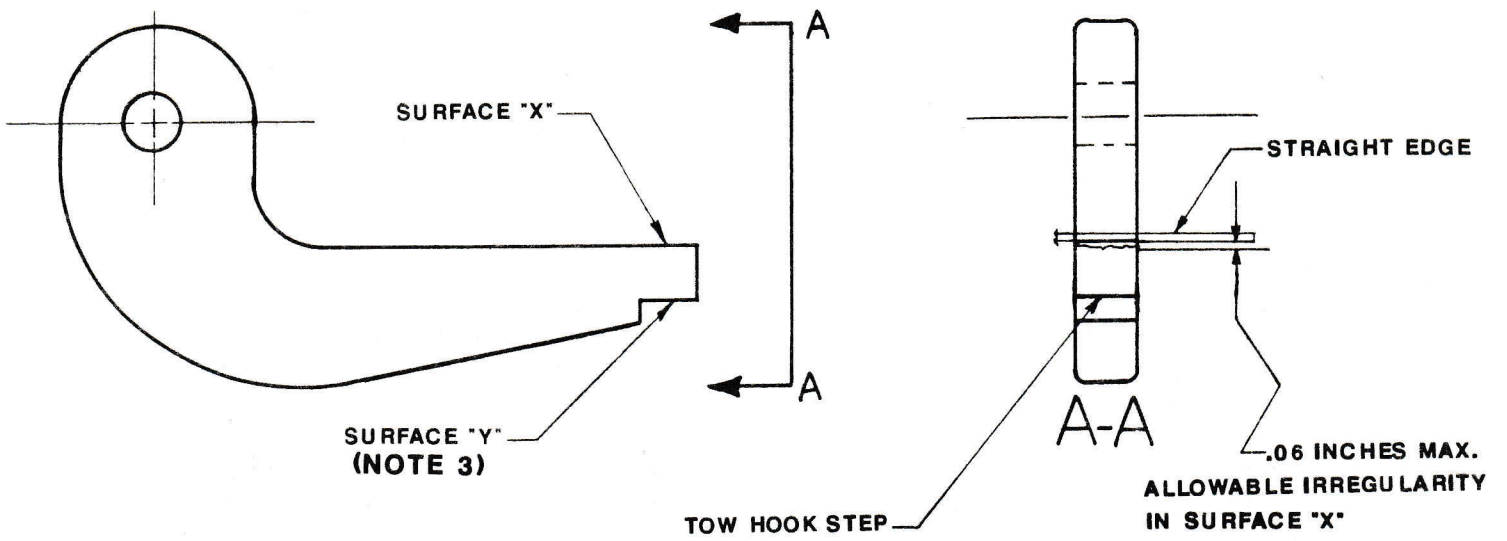
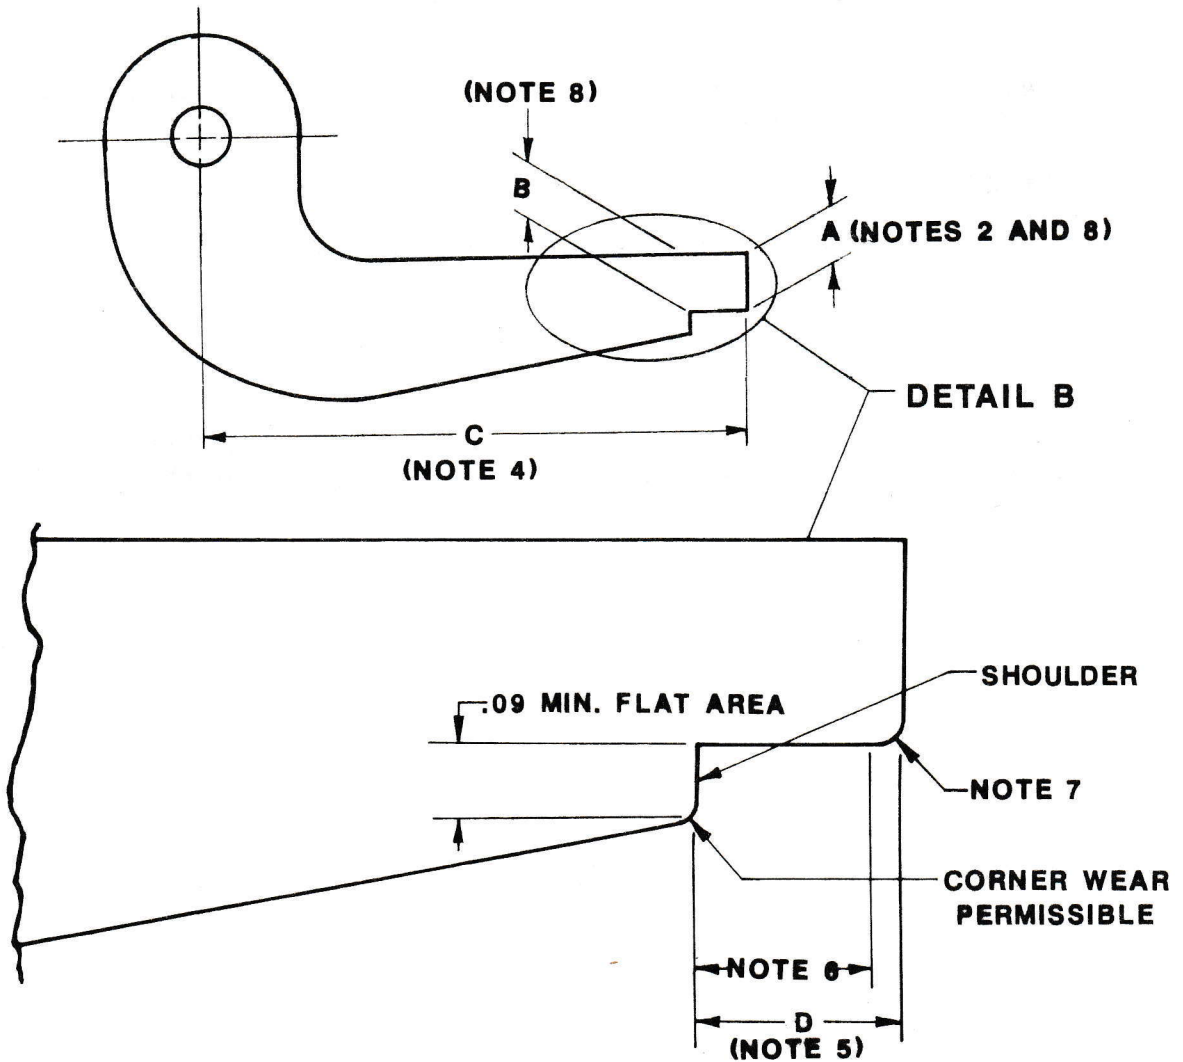
FIGURE 2. TOW HOOK INSPECTION AND REWORK (SHEET 1 OF 2)

1. IF WEAR OCCURS ON SURFACE "Y" IT MUST BE POLISHED FLAT WITHIN TOLERANCES PROVIDED IN FIGURE 2 (SHEET 1). IF THE HOOK CANNOT MEET THESE REQUIRED DIMENSIONS IT MUST BE REPLACED. UNDER NO CONDITIONS SHOULD SURFACE "X" BE POLISHED OR MACHINED TO CHANGE ITS ANGLE.

5. DIMENSION "D" SHALL BE .31 \pm .03 INCHES.
6. HOOK MUST REMAIN FLAT IN THIS AREA FOR A MIN. OF .21 INCHES FROM SHOULDER OF HOOK.
7. WEAR OUTSIDE OF THE .21 MIN. FLAT AREA IS PERMISSIBLE.

8. DIMENSION "B" MUST BE EQUAL TO DIMENSION "A", OR LESS THAN DIMENSION "A" BY NO MORE THAN .015 INCHES AND CANNOT BE GREATER THAN DIMENSION "A".

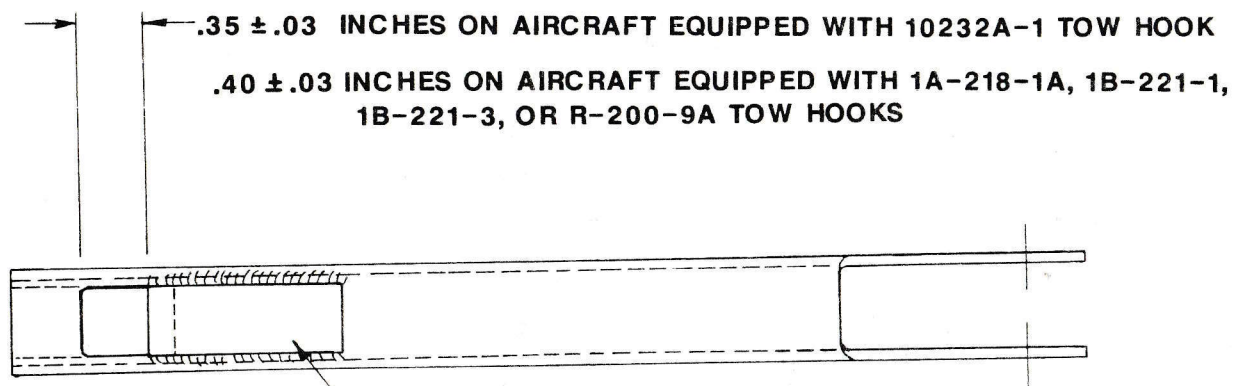
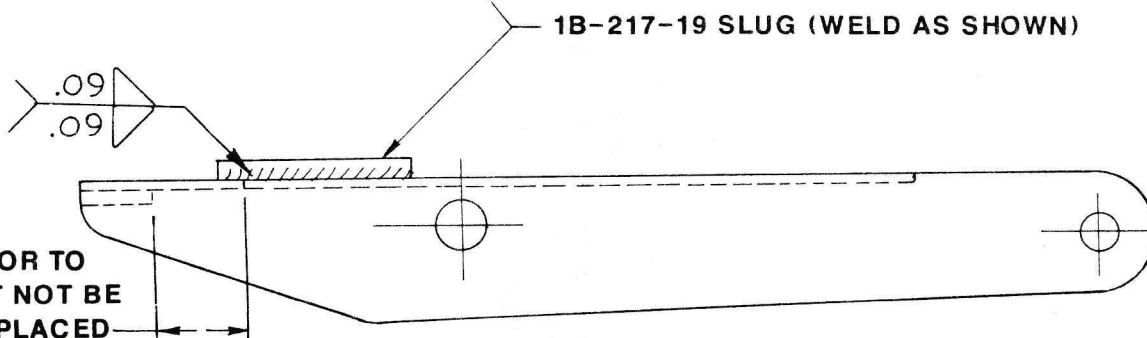
FIGURE 3
REWORK OF RELEASE ARM

IF THIS DIMENSION IS
.66 INCHES OR GREATER PRIOR TO
REWORK THE RELEASE MUST NOT BE
REWORKED AND MUST BE REPLACED

- C. All tow release arms must be reworked in accordance with Figure 3 or replaced with a new superseding Schweizer release arm as listed in Table 1. If the release arm wear exceeds the dimensions given in Figure 3, rework is NOT allowed and replacement is MANDATORY.
- D. Perform complete inspection in accordance with Item 4 of this bulletin.

NOTICE...ALL TOW RELEASE ARMS MUST BE REWORKED AS SHOWN
ABOVE OR REPLACED WITH THE PROPER SUPERSEDING
UNIT PER TABLE 1

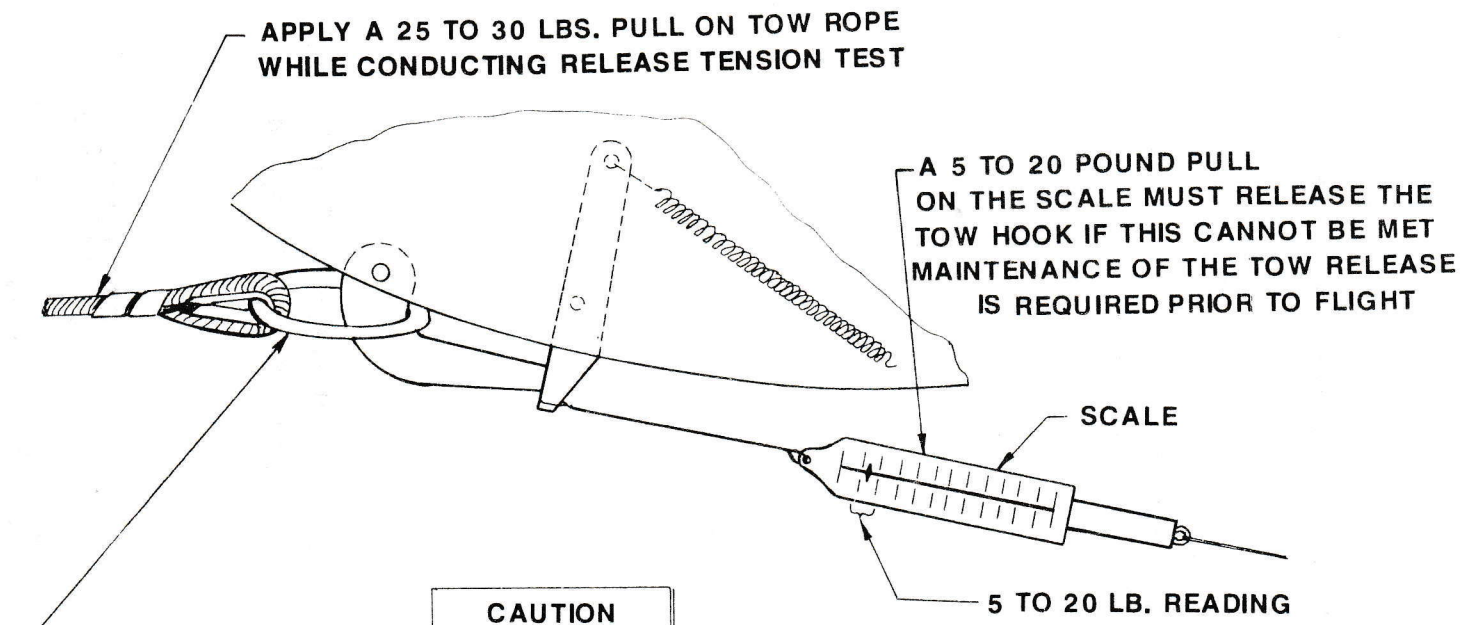
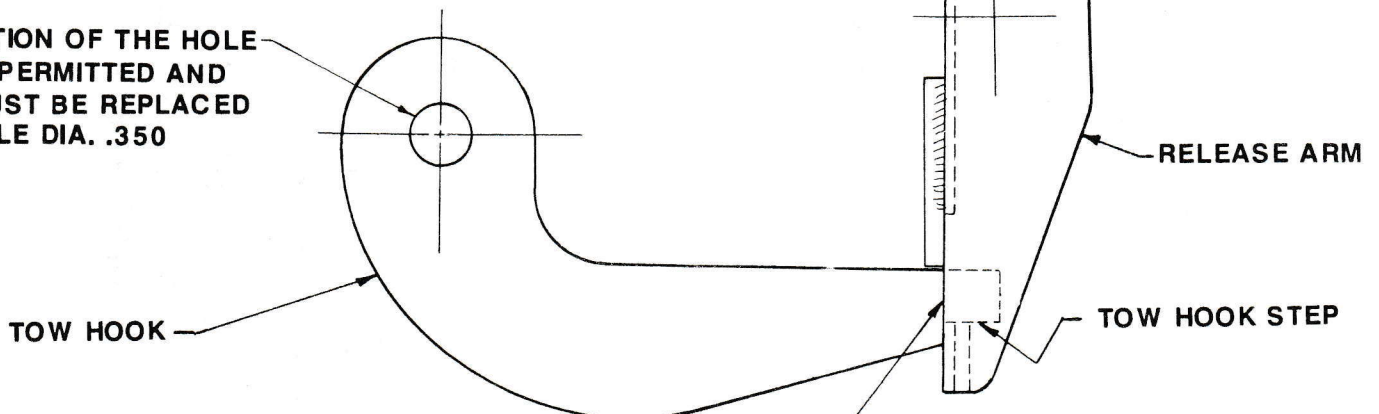
FIGURE 4

SCHWEIZER TOW RELEASES ARE DESIGNED TO OPERATE WITH A .31 INCH DIA. TOW RING. CHECK WITH SCHWEIZER AIRCRAFT ENGINEERING DEPARTMENT FOR WRITTEN APPROVAL PRIOR TO USING ANY ATTACHMENT DEVICE OTHER THAN THE SPECIFIED .31 INCH DIA. TOW RING.

ELONGATION OF THE HOLE IS NOT PERMITTED AND HOOK MUST BE REPLACED MAX. HOLE DIA. .350

ANY ROUGH EDGES MUST BE POLISHED SMOOTH AND BLENDED WITH EXISTING CONTOUR

CHECK TO INSURE THAT THE HOOK CANNOT PASS THROUGH THE RELEASE ARM BEYOND THE STEP ON THE HOOK
