SUPPORT COMMUNICATION - SERVICE ACTION ADVISORY

Document ID: c00775200

HP Color LaserJet 3000, 3600 and 3800 Printers - Cartridge Lock Replacement Procedure

HP Color LaserJet 3000, 3600, and 3800 Series Printers - Broken Cartridge Lock Emerging Issue

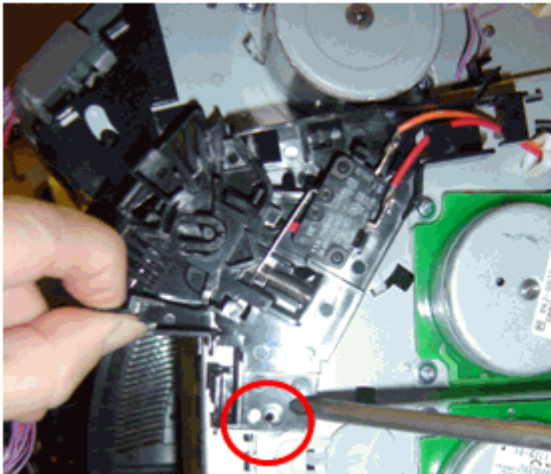
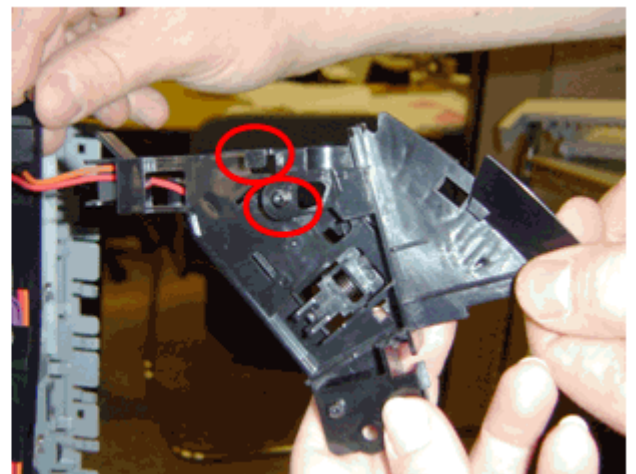
6. Remove the interlock switch assembly by removing the one screw attaching it to the chassis. Be aware of the clip at the top and the alignment knob when removing the assembly.

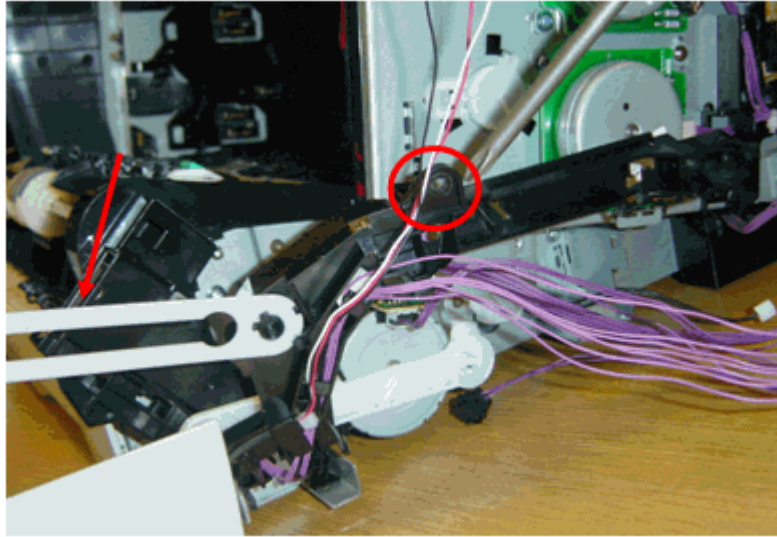
7. Remove the bottom cable harness. There is one screw at the top to remove. Hint: when you reinstall the guide, make sure that the rear locking tab is seated in the sheet-metal chassis. (See page 120 - 121 in the service manual). It may be necessary to disconnect the white door latch from the front door. (Notice the red arrow call-out).

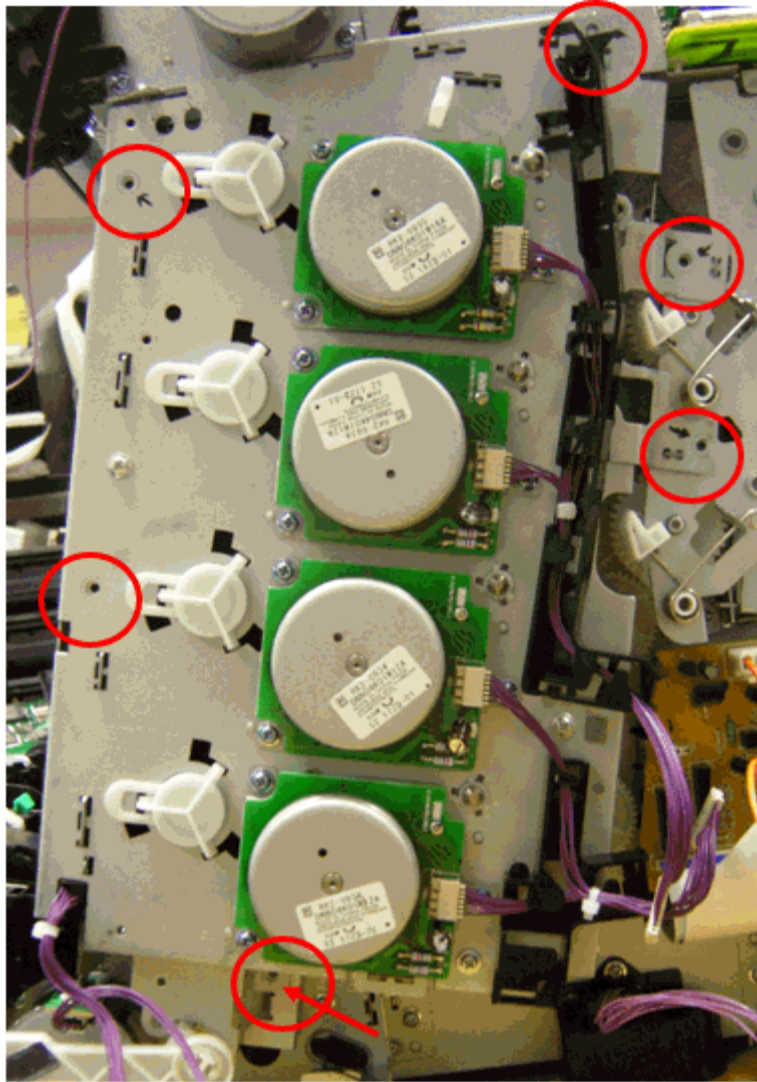
8. Remove the main drive assembly (MDA). There are six screws attaching the MDA to the chassis. Carefully note the locations of the screws to be removed.

CAUTION: Removing the incorrect screws could lead to opening up the MDA, requiring a unit replacement!

NOTE: Two gears may fall off, there are instructions in step 16 on how to align them during the re-installation process.

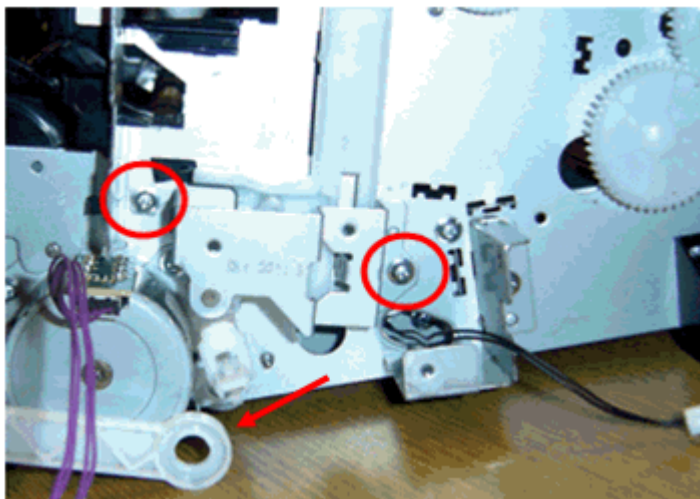
Remove the metal case by removing two screws. Remove the White Link Arm (see arrow in figure below)

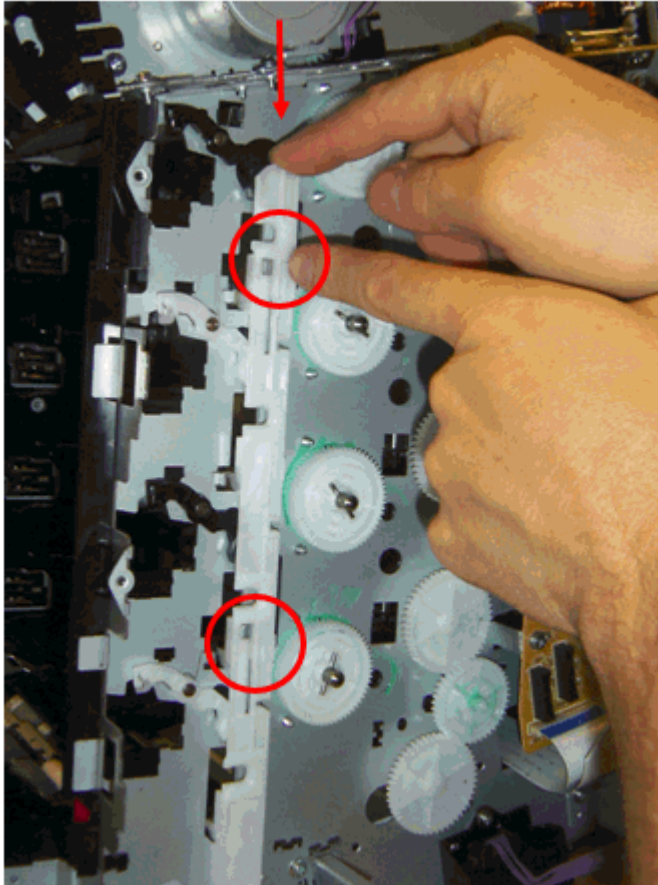
9. Remove the white slide lever by pushing down from the top to release it from the two tabs. Carefully remove the lever by pulling out, be aware that four springs are attached to this lever and the individual cartridge locks.

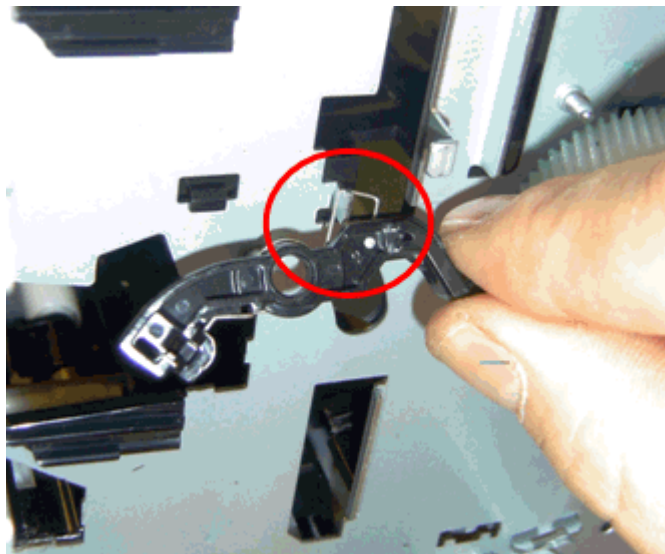
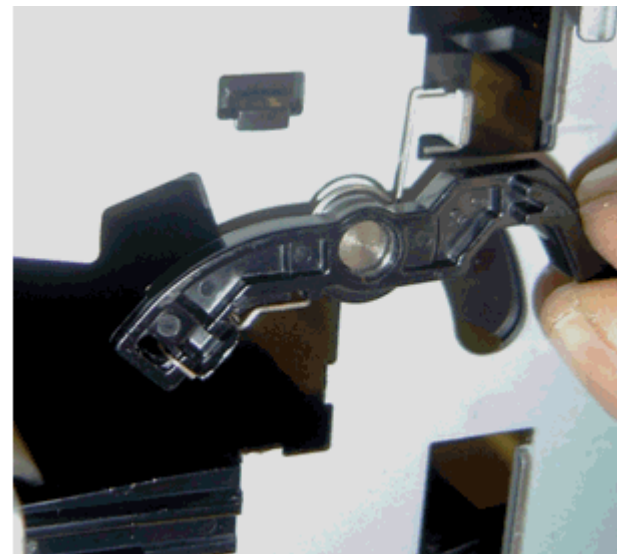
11. To attach the cartridge lock, hook the square part of the grounding spring to the metal chassis, then pull down and attach the lock on the metal shaft.

NOTE: Replace all four cartridge locks, even though the others may not be broken. If one lock experienced failure, the others are more prone for failure later.

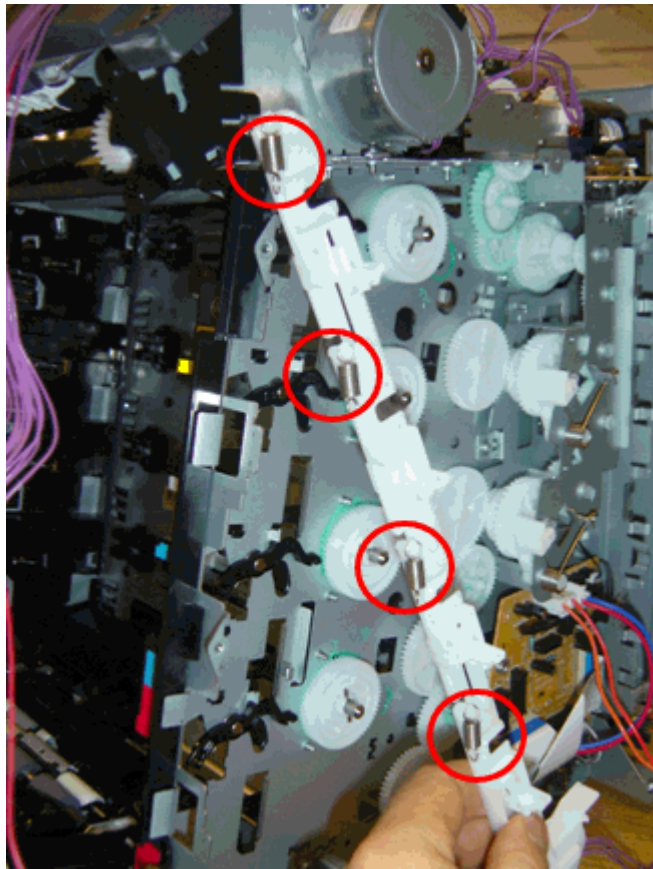
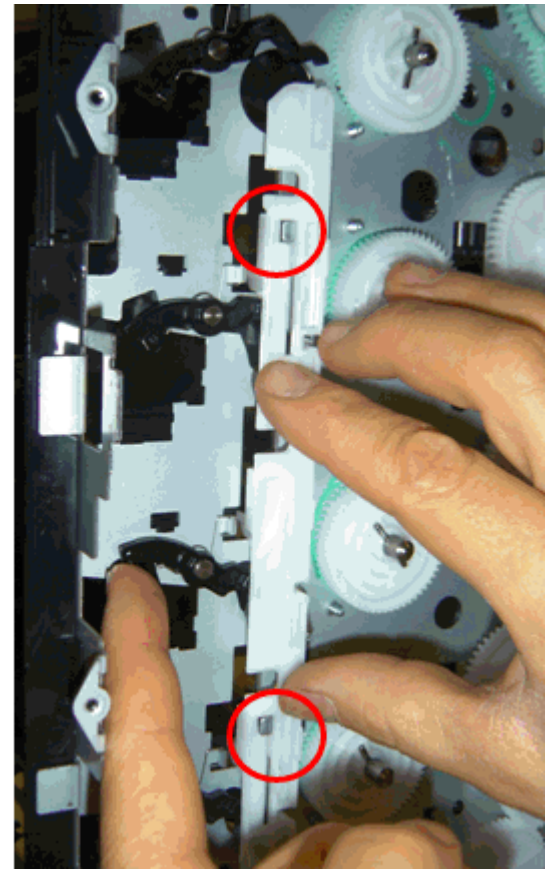
12. Attach one end the four springs to the white slide lever and install the lever back into the machine. (** Attach the other end of the spring in step 15.) Place the white slide lever so the two metal tabs are in place (circled below), then adjust all the black cartridge locks to be under the tabs on the white slide lever. Bend the top of the white slide lever out to put the top black cartridge lock in place. Slide the white slide lever up when all the black cartridge locks are in place.

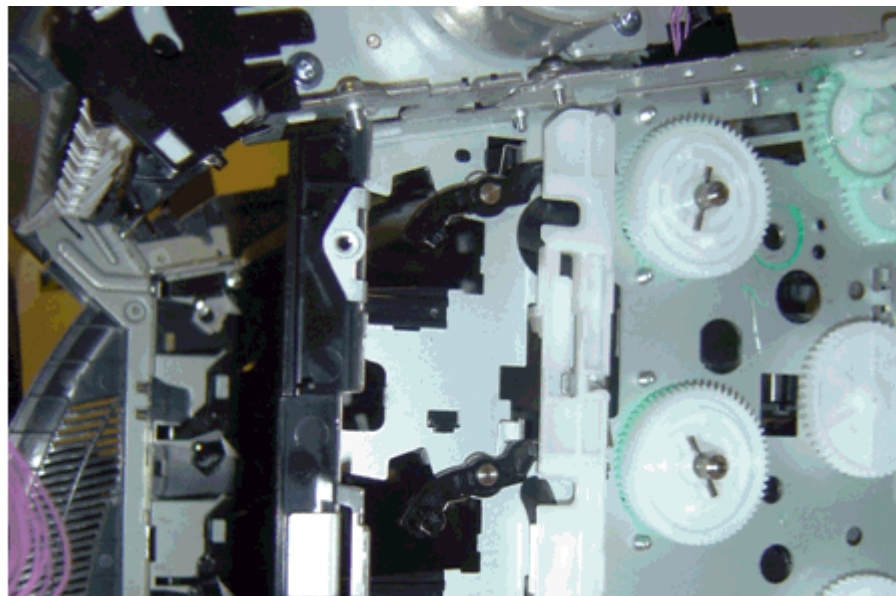
13. The slide lever and cartridge locks should look like the picture below when all is in place.

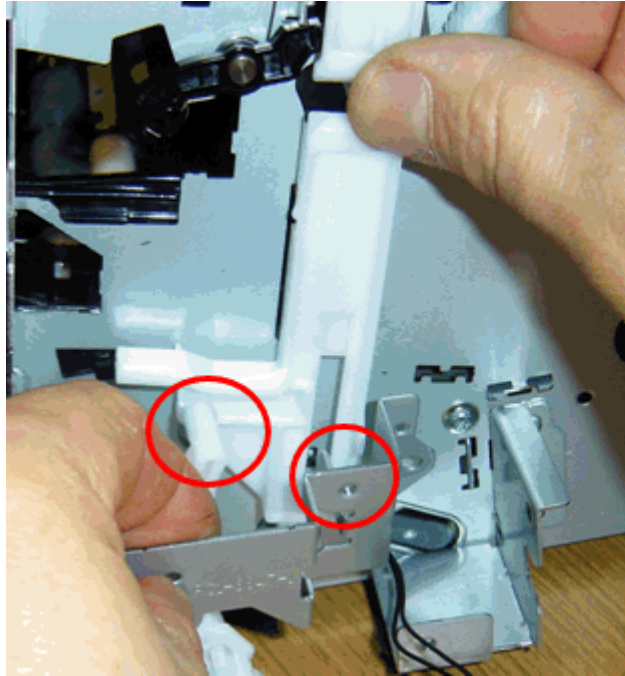
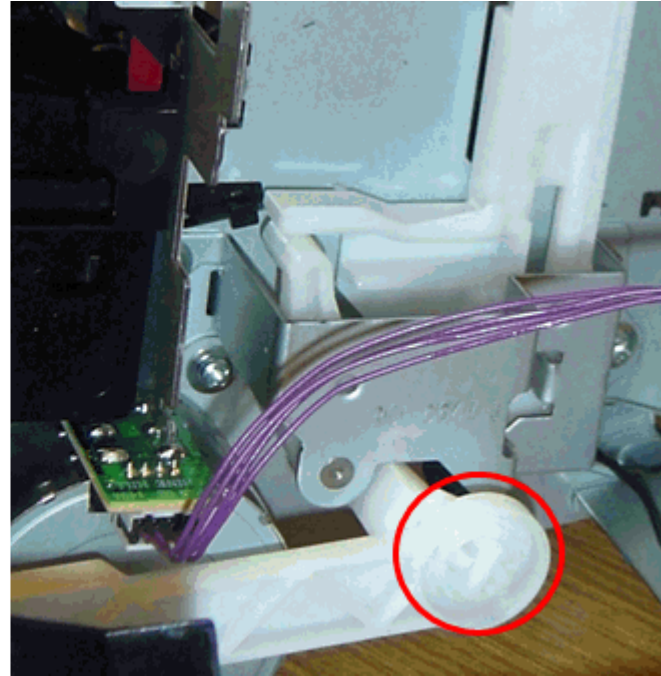
14. Lock the white slide lever in place by installing the metal case and white plastic piece. Make sure to insert the flange of the sheet metal in the slot on the sheet metal, and place the white shaft in the white slide lever. Reconnect the white arm to put tension on the white slide lever.

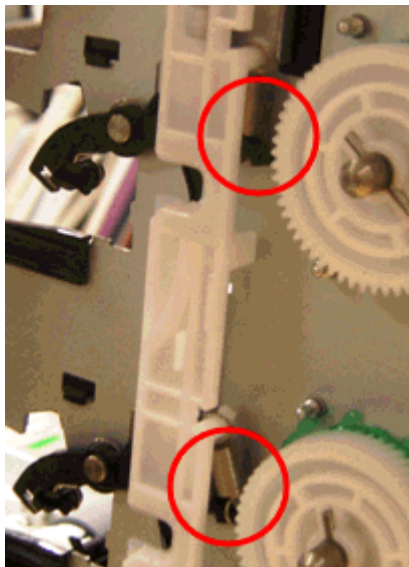
15. Connect the four springs on the white slide lever to each of the individual cartridge locks (start from the middle ones, it is easier that way). You will need needle-nosed pliers with pointed tips. The spring on the top is attached; the one on the bottom is not attached. Move the ETB guide to the up (vertical) position to help with removing and re-installing the Main Drive Assembly.

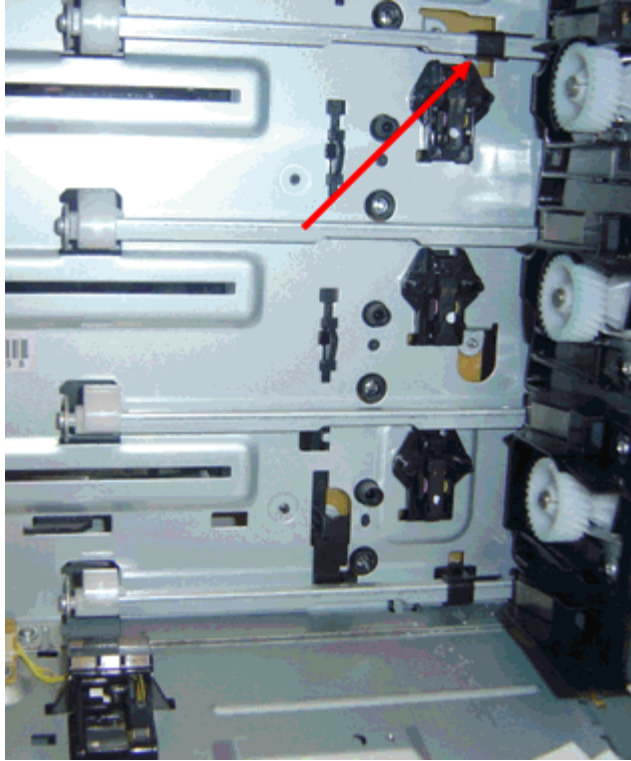
NOTE: If this procedure has been properly followed, in the back of the printer, you will see the 4 white cams that control the movement of developers (see figure below). On the top and bottom shafts, you can see a black plastic part that has a flag associated with it. The top flag is for the black cartridge, the bottom flag is for all the color cartridges. Also, note that the white cams are all at different degrees of rotation. This reduces the force required to drive the motors when turning the cams. Metal shafts should be oriented with the empty space downwards.

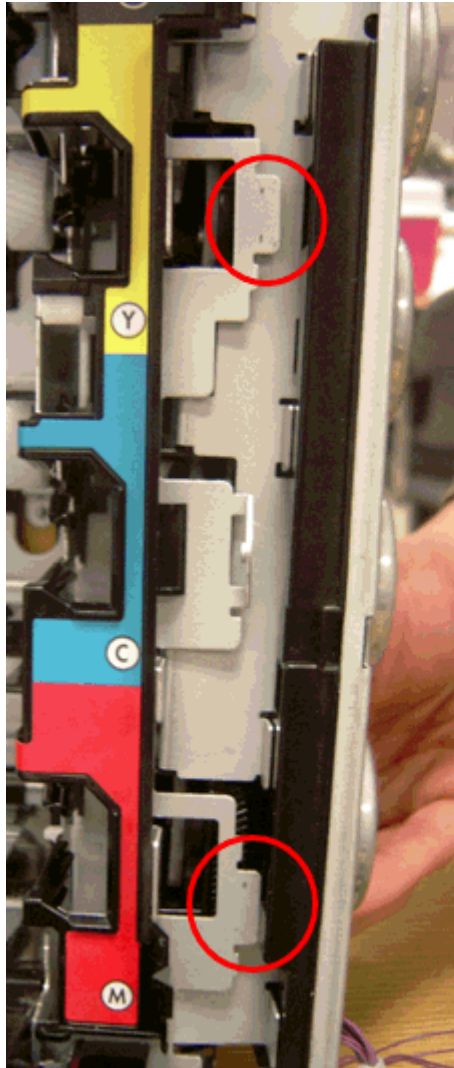
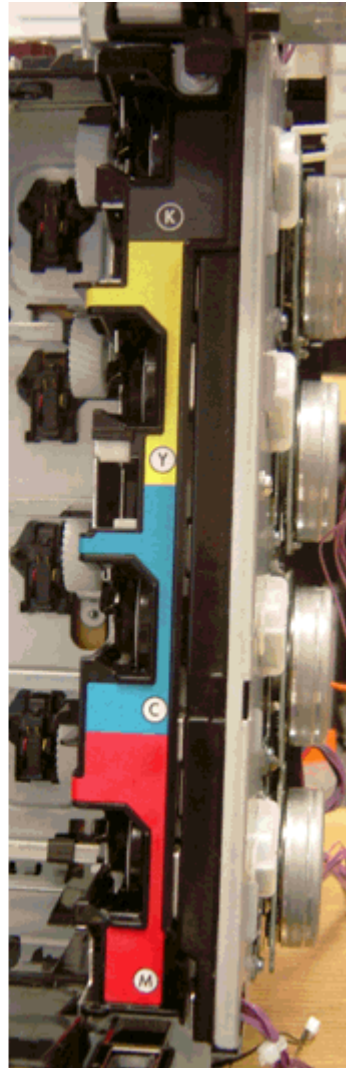
18. With the above in alignment, install the main drive assembly. Start at the left side, inserting the MDA into the metal slots and rotate it into position. Place a screw in the upper right corner of the MDA to help keep it in place if the MDA doesn't fit flush when first installing it. This gives access with both hands to "jiggle" it into place.

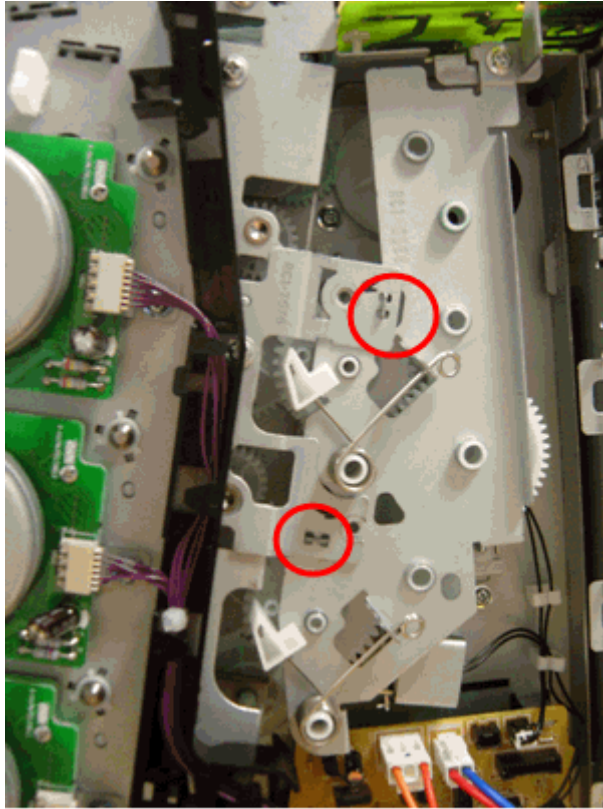
19. Make sure the clips are pushed in and the MDA is seated properly.

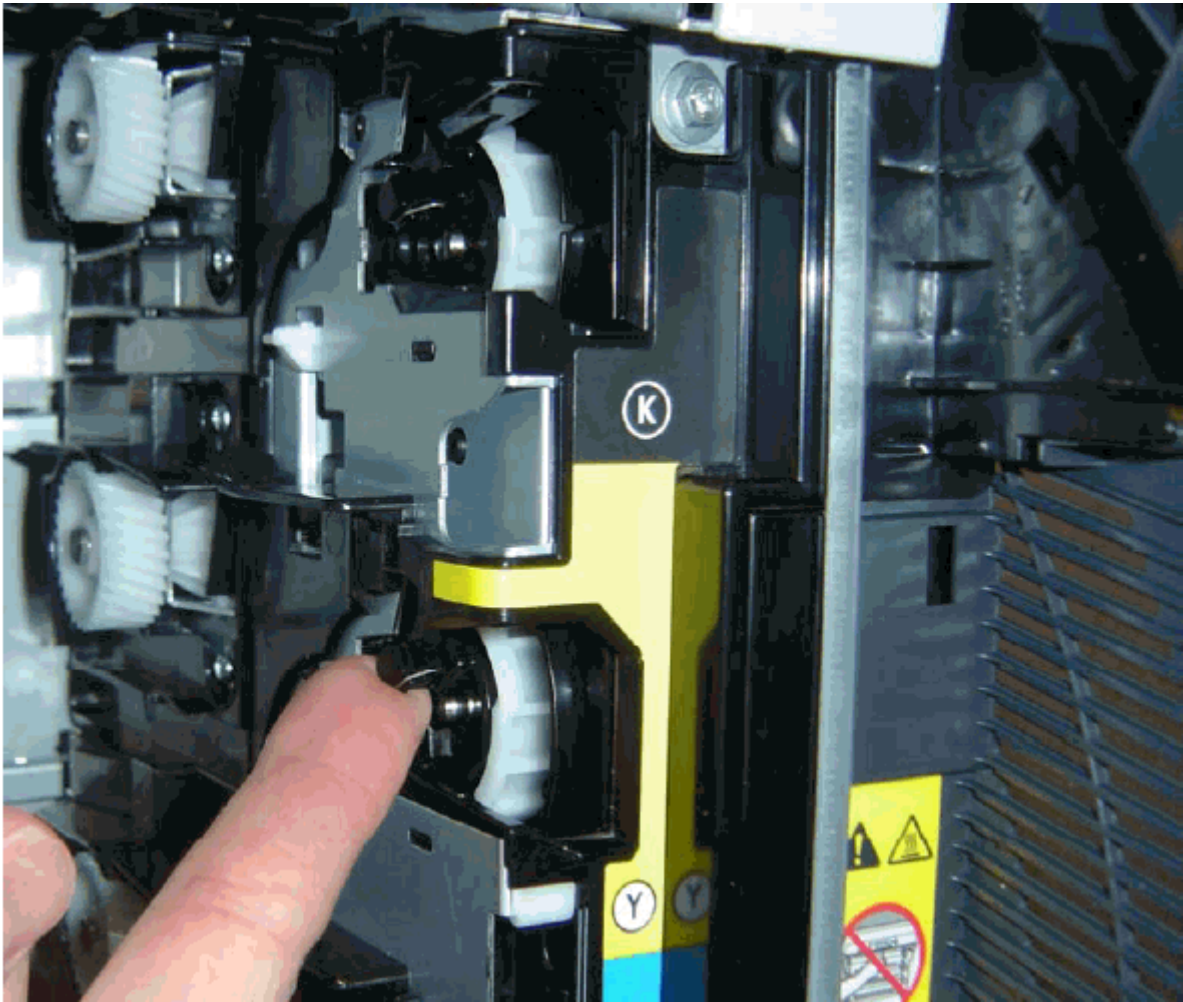
This is how it should look then when the cartridges are out, the ETB is removed, but the guides to the ETB are up instead of down, and the front cover is all the way open: (you can get to this mode by opening the door, remove the ETB, remove the cartridges, close the front door, and open it again. Note that you can NOT put in the cartridges as the guides to the ETB are in the "up" position. Pull the

guides down and the levers will go be in the correct position to insert cartridges. The white piece will be down and black locking levers will be up to allow easy insertion of the cartridge.

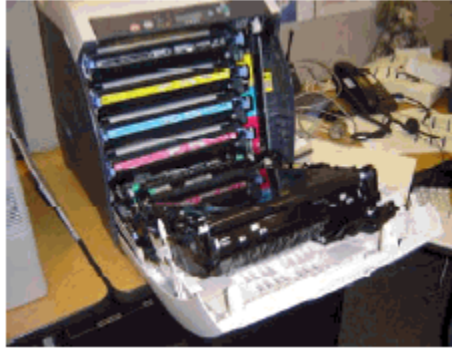
- Model number and serial number
- Which Cartridge lock is broken (Black, Yellow, Cyan or Magenta?)
- Advise how the fault manifest's itself (Control Panel message, noises, can't insert the cartridges, etc?)
- Describe the customer's use of the discovery tape:
 - Did the customer pull on the tape or just follow it to the toner cartridges?
 - If the customer did pull on the tape, did the front door open quickly for them?
 - Was the ETB attached to the front cover (see picture) when the door opened?

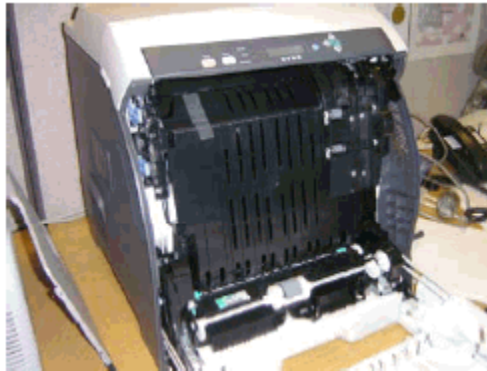
- Was the ETB in the 'up' position (see picture) when the door opened?
