**MINISTRY OF TRANSPORTATION  
AND INFRASTRUCTURE**

# **ISLAND RAIL CORRIDOR CONDITION ASSESSMENT**

**SUMMARY REPORT**

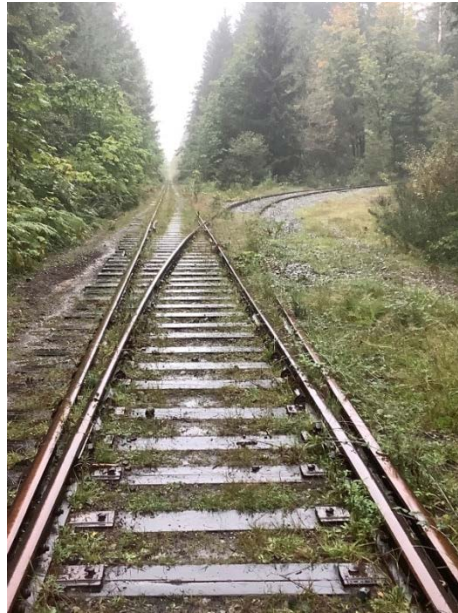
**Figure 19: Typical Turnout within Corridor**

The 2009, HMM report states that there is a mixture of 85lb and 115lb rail turnouts on the Island Rail Corridor. It also states the turnouts are in a good to fair condition noting that most turnouts are in need of varying levels tie replacement. In the recent 2019 site inspections, similar observations were noted. The condition of the ties within the turnout were considered to be fair to poor. There rail was also noted to have been worn, with 11mm of head loss as seen on some components of the turnout.

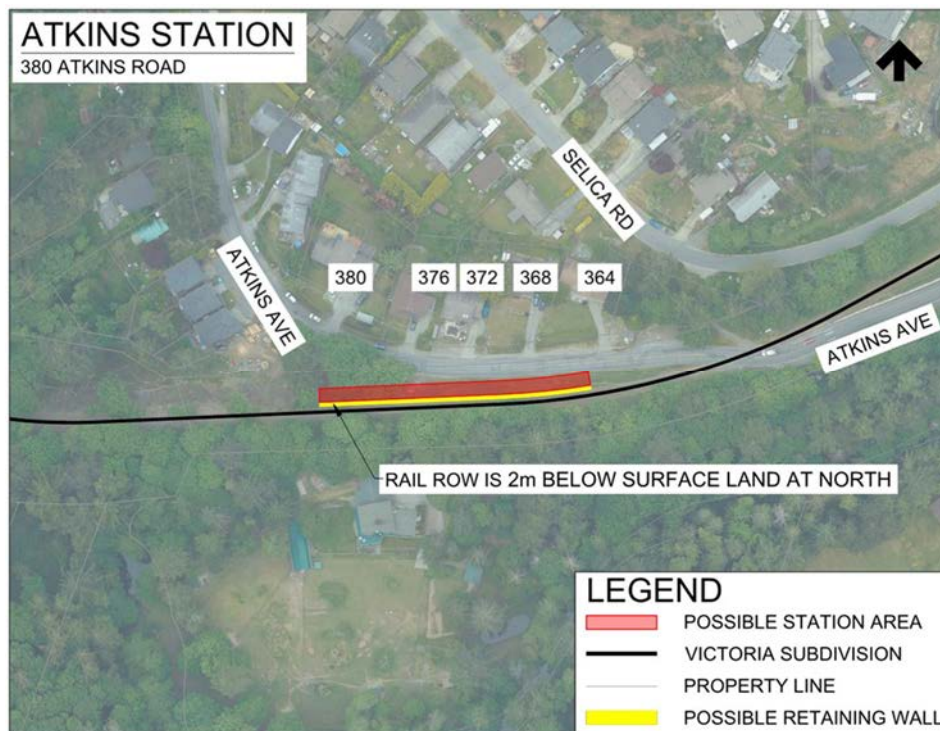
Figure 34: Atkins Station layout and context

Access to and around the station area is predominantly by car. There are no sidewalks in the immediate vicinity of the station and although there is a connecting link to the Galloping Goose Trail 280m to the east, there is otherwise no cycle infrastructure on Atkins Avenue; a relatively narrow, 2-lane road with a 30 km/hr posted speed.

There is currently no direct pedestrian or vehicle access to Goldstream Avenue, a major arterial and potential catchment area 300m to the south. The station site is served by BC Transit's 53 bus route, providing local service between the Langford and Colwood transit exchanges. The only road illumination is from vehicle headlamps and lighting from the homes on the north side of the road.

As with stations 1 and 3, the rail line at Atkins Station runs atop a steep wooded ridge sloping down to the south. The crossing and station area traverses a utility corridor, further limiting any dual-track or expanded station platform capacity. Visibility from the site of a potential platform is limited to less than 50m to the west due to a 90-degree bend in the road and less than 80m to the east due to vegetation and changes to the road's horizontal and vertical profile.
