Troubleshooting Guide

imagePRESS

C10000VP Series

January, 2019
Canon U.S.A., Inc.

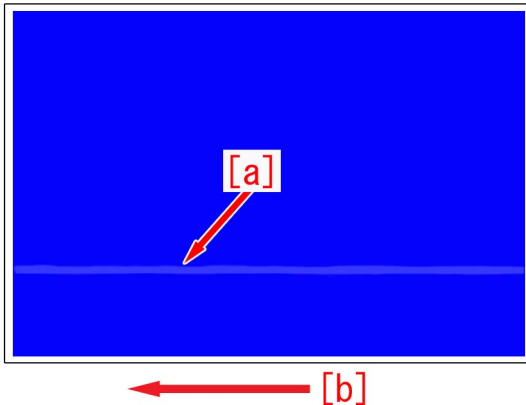
A faint white line [a] might appear on a second side image, if the machine is used a lot under the high temperature and high humidity environment.

The arrow [b] indicates the direction of feeding.

The symptom is easily found on a high density image such as halftone or solid image.

- 1) Open the Sub Station Front Right Cover to pull out the Primary Fixing Assembly.
 - 2) Clean the whole surface of the Connection Lower Guide Roller with lint-free paper moistened with alcohol rotating the roller by hand.
 - 3) Output the image having shown the symptom, and check that the symptom does not occur.
- If the symptom does not improve, then check other factors.

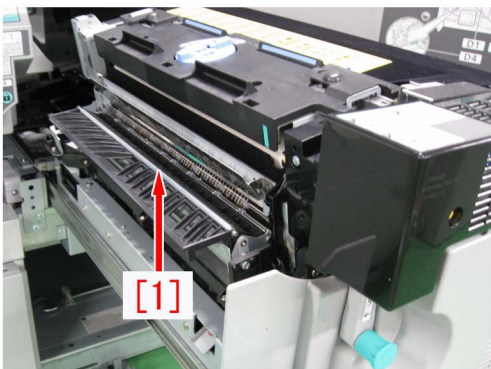
IF the paper having a lot of paper lint is used under high temperature and high humidity environment, the paper lint and wax component of toner combine and adhere to the Connection Lower Guide Roller [1] located at the outlet for the Primary Fixing Assembly.

When the paper lint and the wax component of toner which adhere to the roller are transferred to a paper, the above symptom occurs.

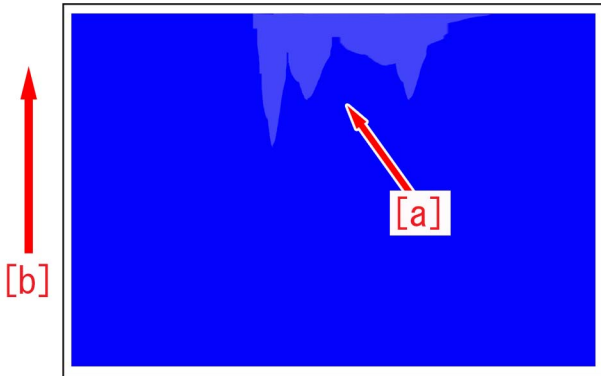
Uneven gloss (Rain drop mark) [a] may occur in the high-density area in usage of OHT. The arrow [b] indicates the direction of feeding.

Since the thickness and components of OHT vary depending on the kind, quantity of heat required for toner to fix on the film also varies.

The difference in glossiness made between the area where toner melts beyond necessity and the other image area causes the above-mentioned symptom.

- 1) Have the customer log in from System Management Mode in user mode.
- 2) Go to Select Settings/Registration > Paper Settings > Paper Type Management Settings, select an appropriate paper type from among the list, press "Duplicate" button and then "OK" button.

6) Press "-" button for gloss, Make sure the setting value [a] is set to "-1" and press "OK".

If the symptom improvement is inadequate, decrease the setting value of step 6) down to "-3" by "1" value while observing the symptom.

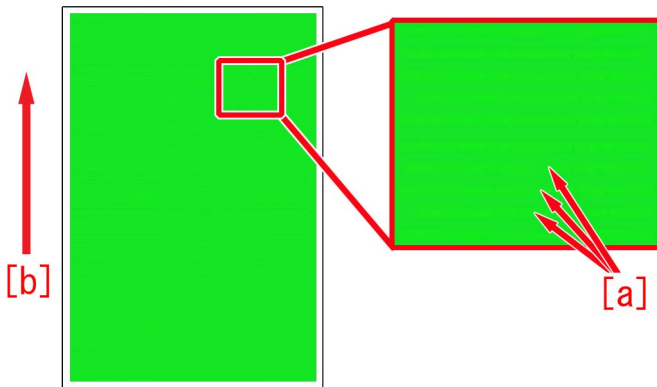
In a usage under a low humidity environment, horizontal white streaks [a] with 2mm intervals may occur on a high density green image

The arrow [b] indicates the direction of feeding.

Being affected by the influence of toner or ITB, the electric current may become uneven even if a constant primary transfer voltage is applied.

A low humidity environment is likely to have this symptom as the primary transfer voltage is large.

- 1) Have the customer log in from System Management Mode in user mode.
- 2) Go to Select Settings/Registration > Paper Settings > Paper Type Management Settings, select an appropriate paper type from among the list, press "Duplicate" button and then "OK" button.

7) Select black under primary transfer voltage, change the correction parameter [a] to "-5" by pressing "-" button and press "OK". The setting range is from "-10" to "+10 ". ("0" by default)
Change of the setting value changes the primary transfer voltage.

8) Output the image having shown the symptom, and check that the symptom does not occur.
If the symptom does not improve, then check other factors.

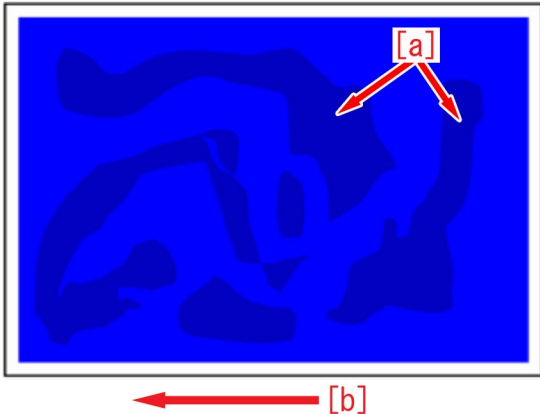
Uneven gloss [a] may occur on the entire high density image such as solid image. The arrow [b] indicates the direction of feeding.

The influence of an uneven temperature and uneven cooling of the member (guide etc.) on the delivery path after fixing may cause the time difference in solidifying the wax components included in the toner. When there is the time difference in solidifying the wax components, the difference in glossiness on the image surface tends to stand out, and the above-mentioned symptom occurs. This symptom is likely to be seen on the high density image with high quantity of toner and heavy paper/coated paper that is fixed at a high temperature.

- 1) Have the customer log in from System Management Mode in user mode.
- 2) Go to Select Settings/Registration > Paper Settings > Paper Type Management Settings, select an appropriate paper type from among the list, press "Duplicate" button and then "OK" button.

6) Press "-" button for gloss, Make sure the setting value [a] is set to "-1" and press "OK". The setting range is from "-4" to "+4" ("0" by default). Change of the setting value changes the fixing temperature.

If the symptom improvement is inadequate, decrease the setting value of step 6) down to "-3" by "1" value while observing the symptom.

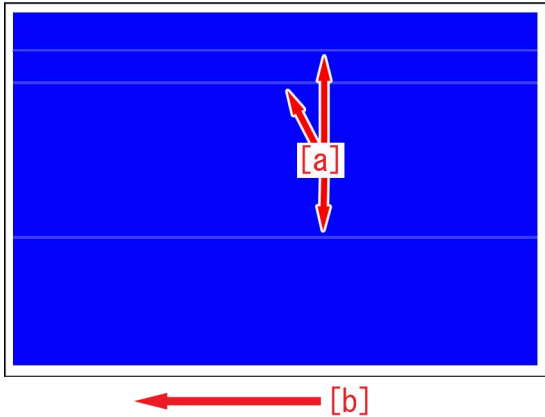
Glossy streaks [a] may appear on a high density portion.
The arrow [b] indicates the direction of feeding.
This symptom is more visible with heavy / coated paper.

The surface of the fixing roller may have minute scratches on it due to foreign particles such as paper lint.
The thermal conductance of the scratched portion of the fixing roller is lower than that of surrounding portions and the glossiness of image of the same portion is reduced.
The difference of the glossiness of the image generates the aforementioned symptom.

1) Select Settings/Registration > Adjustment/Maintenance > Maintenance > Refresh Fixing Roller[1], and press "Start" button[2].

2) Output the image having shown the symptom, and check that the symptom does not occur. If the symptom no longer occurs, the work is completed.

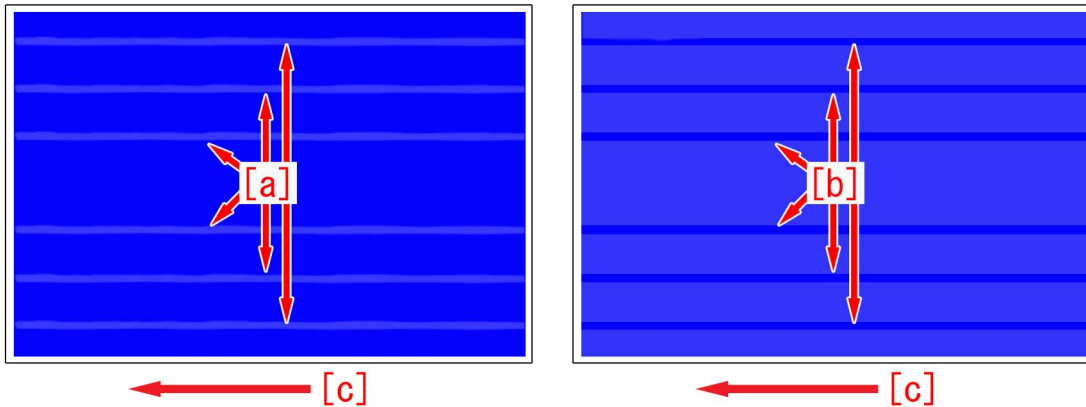
10 mm wide semi-glossy lines [a] and highly glossy lines [b] may occur at one of near 40, 80, and 120 mm from the center on the first side of duplex printing.

The arrow [c] indicates the direction of feeding.

1) Depending on the issue, choose and perform one of a) or b) below.

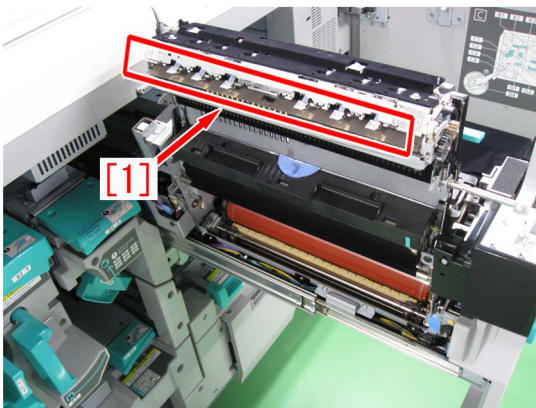
The secondary fixing assembly separates thin papers by engaging the fixing separation claw [1] to the pressure roller.

a. when the surface of the pressure roller is lightly scratched by the fixing separation claw, glossiness of the area where the fixing separation claw comes in contact with decreases and 10mm semi-glossy lines occur. The symptom tends to occur easily when the pressure roller is new.

b. The pressure roller in the secondary fixing assembly may be polluted in some cases due to paper and/or toner scattering inside the engine. The pollution is cleaned in the area where the fixing separation claw comes in contact with, so the glossiness is higher compared to the area where the claw does not come in contact with, causing the 10mm wide highly glossy lines to occur.

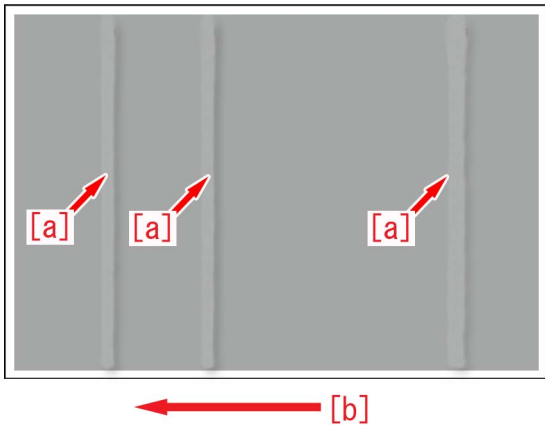
Horizontal lines [a] may appear randomly on a halftone image after leaving the machine for a long time. The symptom is especially visible in 250mm intervals attributable to a primary transfer roller. The arrow [b] indicates the direction of feeding.

The ITB that is curled from being unused for a long time cannot be fixed in a short time. If an ITB is left unused frequently, take one of the two following measures, a) or b), to prevent ITB from being curled.

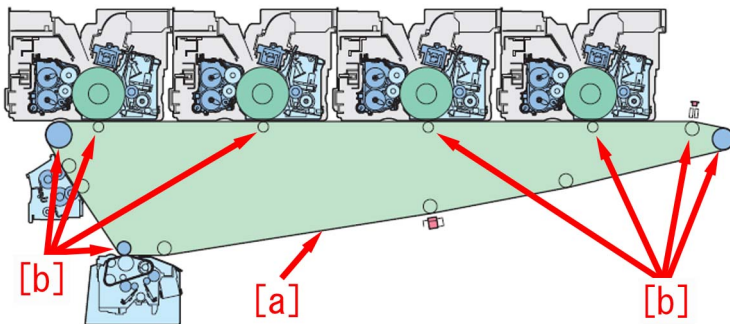
If a machine is left untouched for a long time, ITB[a] and 8 rollers[b] inside ITB are in contact each other for a long time, and this condition curls ITB.

The curled part makes tiny space between ITB and the secondary transfer outer roller, therefore discharge phenomenon may be generated.

If discharge phenomenon is generated, toner on ITB scatters, disarranges the image and this results in the above mentioned symptom.

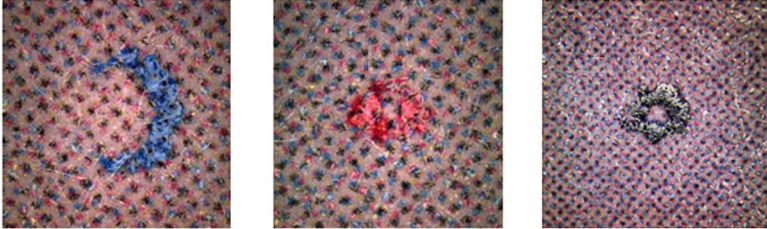
In the machines prior to the Countermeasure cut-in serial number in factory described below due to an inevitable mixing of foreign particles, a faulty image called a ring mark may be output on the print.

The metal powder mixed into the developing assembly attaches onto the surface of the developing sleeve and brings a leakage symptom to the drum. Toner attaches onto the leaked location and this leads to the aforementioned symptom.

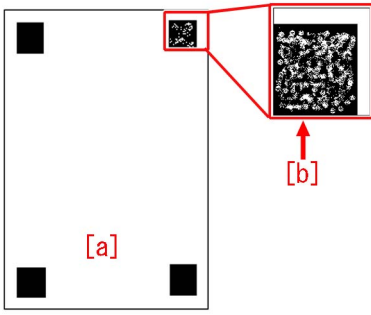
If the paper edge used for the test page is not at a right angle due to trimming failure or being folded or if transfer failure occurs on the test page image, it is regarded as faulty image at the time of reading the test page and the above-mentioned symptom occurs.

- 3) If there is transfer failure [b] on the test page [a] image, cancel the image position adjustment, execute auto adjust gradation and adjust the secondary transfer voltage, and then output the test page using the new paper to execute the image position adjustment again.

4) If the symptom does not improve, then check other factors.

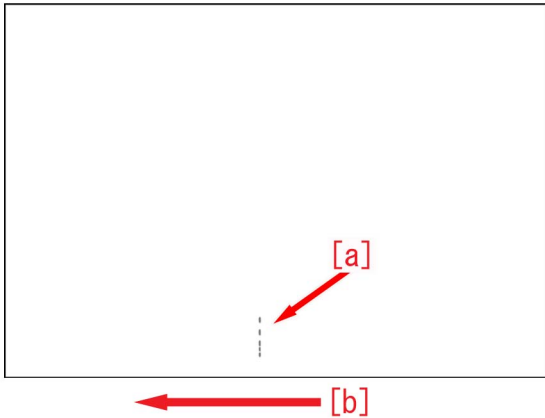
Marks may appear on the front side [a] of the back face of one-sided print or of the first page of two-sided print. The arrow [b] indicates the direction of feeding.

Paper dust or toner may attach onto the pressure belt of the primary fixing assembly from the influence of the paper or toner scattering inside the machine.

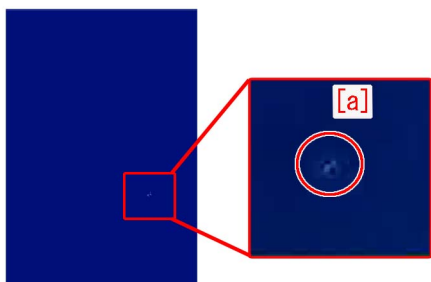
Strike mark [a] may appear on the image. The symptom is easily found on a high density image such as halftone or solid image.

When printing, the upper tandem guide and paper interfere with each other. As a result, toner peels from the paper and accumulates on the upper tandem guide. The above symptom may occur when a toner lump accumulated on the upper tandem guide peels and falls, and then is transferred by paper and finally attaches to the secondary fixing roller.

- 1) Follow the steps in Service Manual "Disassembly / Assembly > Fixing System > Replacing the Secondary Fixing Roller, Replacing the Secondary Fixing External Heat Belt, Replacing the Secondary Fixing Refresh Roller" and replace the Fixing Roller (FL1-1152-000), the External Heat Belt, (FE3-1881-000) and the Refresh Roller Assembly (FM3-2876-000) in the Secondary Fixing Assembly.
- 2) Check the upper tandem guide [a] and if toner is attached, follow the steps in Service Manual "Disassembly / Assembly > Fixing System > Cleaning the Tandem Guide" and wipe the toner with lint-free paper soaked in alcohol.

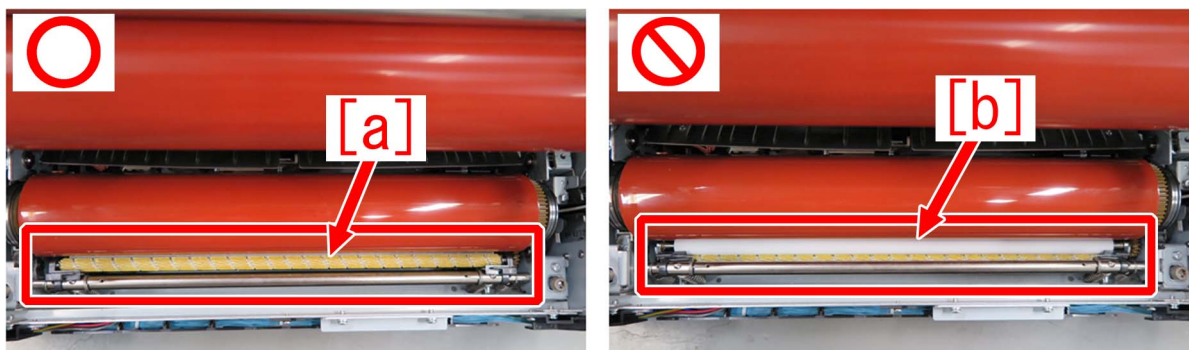
When the pressure refresh roller is replaced, the wrong order of its assembling leads poor rotation or too much contacting pressure of cleaning brush roller. Also the uneven abrasion of pressure refresh roller occurs and it causes fine scratches on the fixing roller causing the lines on an image.

When the pressure refresh roller is replaced, assemble the parts in proper order referring Service Manual. After the assembling, make sure that the cleaning brush roller is placed at proper position [a]. If the pressure refresh roller [b] can be seen, it has been assembled in a wrong way. Please assemble them again.

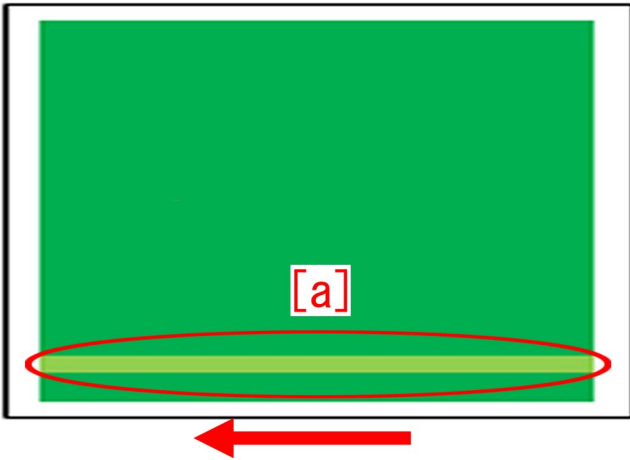
When a high-density image is output, non-glossy lines with a width of 7 mm wide [a] may occur. The arrow indicates the feeding direction of media.

Prepare new fixing belt (FL0-0358-000) to replace with reference to Service Manual.

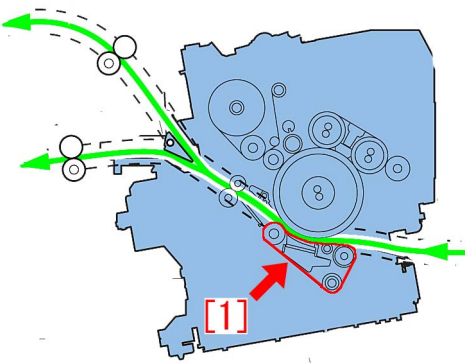
Wrinkles appear on the well-worn fixing belt [1] and it results in the symptom. The green arrows indicate the paper delivery paths.

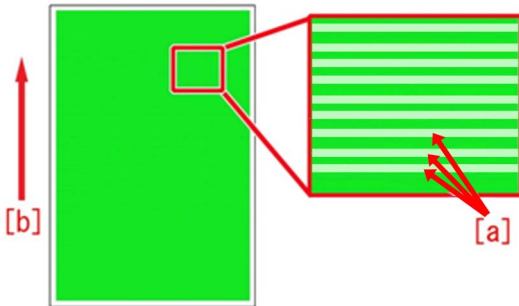
If used in the environment of the low humidity, white horizontal lines [a] may occur at intervals of 2mm on green high-density image. The arrow [b] shows the feed direction.

Even if the fixed amount of the primary transfer voltage is applied, uneven charge amount may occur caused by the toner or ITB. It gives a difference in the toner charging amount on the paper and the transferred toner is returned back to the drum (retransfer), which causes the above-mentioned symptom.

Especially, in the environment of the low humidity, the symptom is more likely to occur due to the high primary transfer voltage.

In order to lower the primary transfer voltage and avoid the above-mentioned symptom, implement the settings by following the steps below:

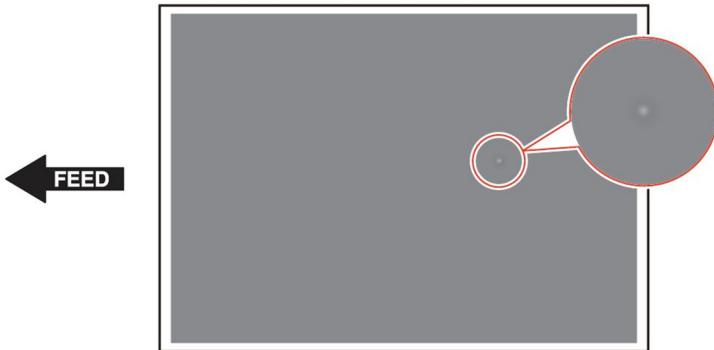
Soiling of spots at ITB intervals may occur.

Foreign matter is fixed on the ITB, causing soiling of spots at ITB intervals.

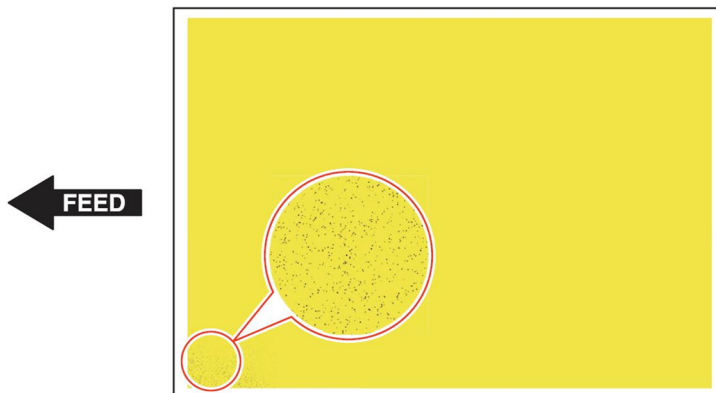
Soiling of many small black spots appears on the 1st side of 2-sided print.

When continuously feeding paper containing a high proportion of calcium carbonate (especially Mondi or UPM Fine, etc.), the PFA (material of belt surface) of the Pressure Belt Unit in the Primary Fixing Assembly is abraded when paper passes through the Primary Fixing Assembly and adhered to the back side of paper. This soiling is fed to the Secondary Fixing Assembly and transferred onto the Pressure Roller (which soils the Pressure Roller).

The soiling is not completely removed even if the forced Pressure Roller cleaning is performed. However, if it does not affect images, replacement is not necessary.

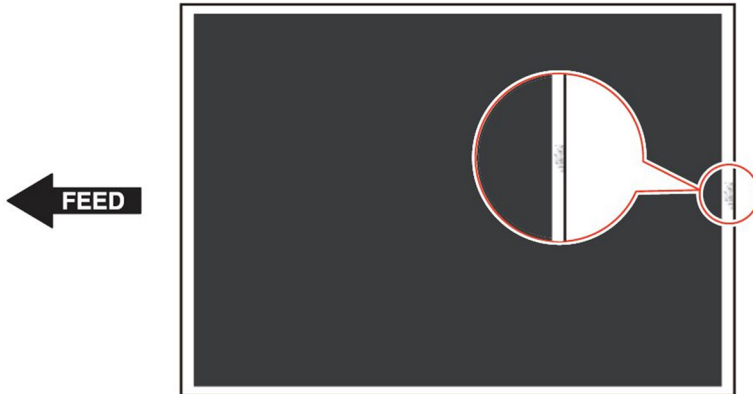
Soiled trailing edge on 2-sided print or soiled paper edge may occur.

Ejection of Bk toner increases at continuous output of low duty image or in the high temperature environment, causing the Post-secondary Transfer Guide to be excessively soiled by toner. When 2-sided printing is performed in this state, this Bk toner is attached for 20 mm around the center of the paper leading (trailing) edge or of the paper edge on the 1st and 2nd sides of 2-sided print.

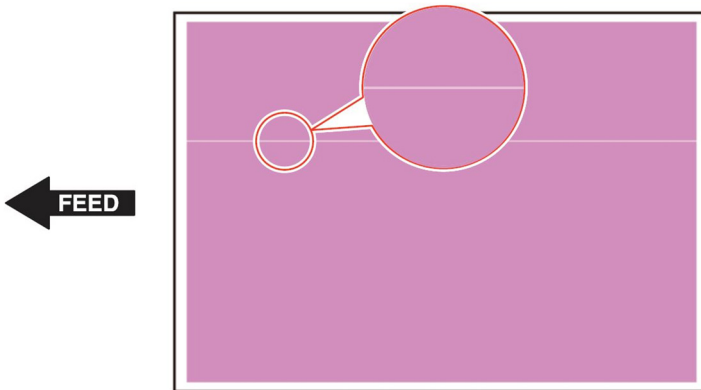
Vertical white line on solid image of each color may occur.

The above symptom occurs when a foreign matter gets stuck between the cylinder and the blade in the developing unit.

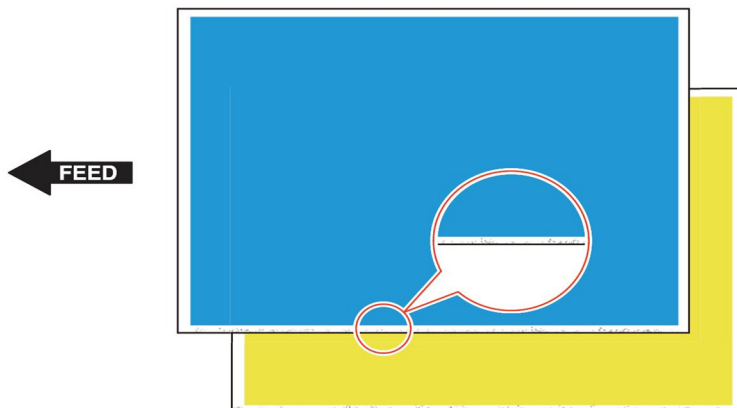
Bk soiling at the front edge on the back side may occur.

Toner always exists on the Secondary Transfer Outer Belt due to the scattering of ejected toner and waste toner; the toner is fixed onto the Secondary Transfer Outer Belt by the engagement pressure of Secondary Transfer Outer Belt against the ITB and the difference of peripheral speeds between the Secondary Transfer Outer Belt and the ITB. Toner may newly be attached onto the fixed toner, which has been accumulated as the life advances, causing toner to attach to the back side of the paper when it passes through the secondary transfer area.

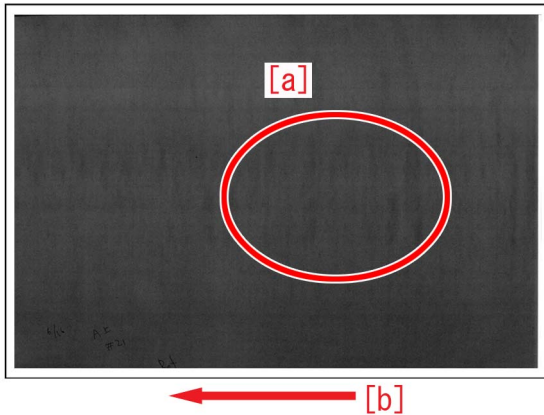
Uneven density [a] may appear on the second side of a black halftone image.
The arrow [b] indicates the direction of feeding.

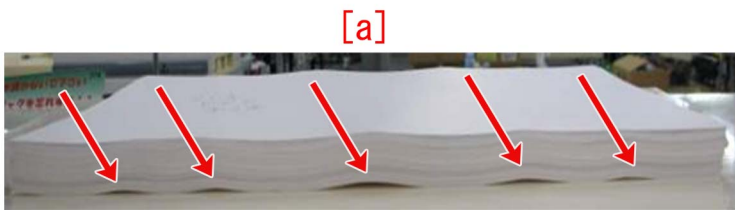
After the first side has passed through the fixing assembly, the paper may have wavy curls [a].
If printing in two-sided mode on the paper sheet with the wavy curls, it allows gaps between the ITB and the sheet during the secondary transfer, toner scatters in the gaps and results in the aforementioned symptom.

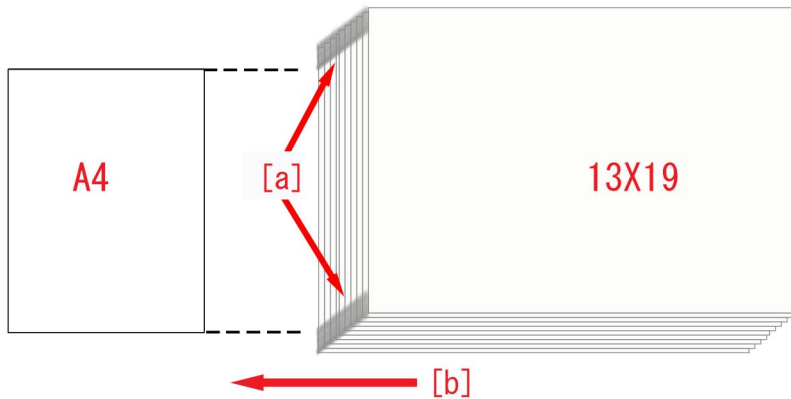
When feeding a wide media after reams of outputting of same size paper with high-density image, edge soiling [a] may occur on the edges of the media.

The arrow [b] indicates the direction of feeding.

Floating pre-fixing toner adheres to the fixing inlet guide when high-density images are fed.

[Note] The cleaning timing for the primary fixing inlet guide and the secondary fixing inlet guide is 5 hundred thousand-sheet feeding. However, when a lot of high-density image have been output, the cleaning for the primary fixing inlet guide and the secondary fixing inlet guide each time is recommended.

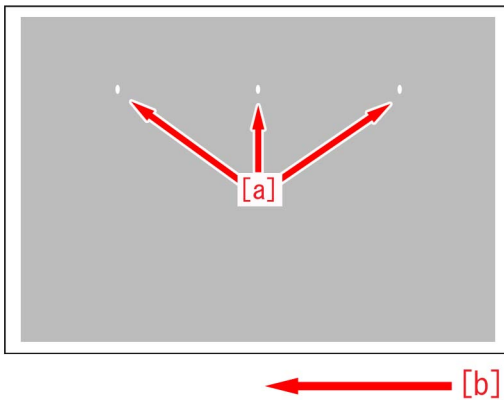
Repeating image failure [a] whose intervals are same pitch may occur.
The arrow [b] indicates the direction of feeding.

The image failure occurs when rollers have foreign matters or flaws.

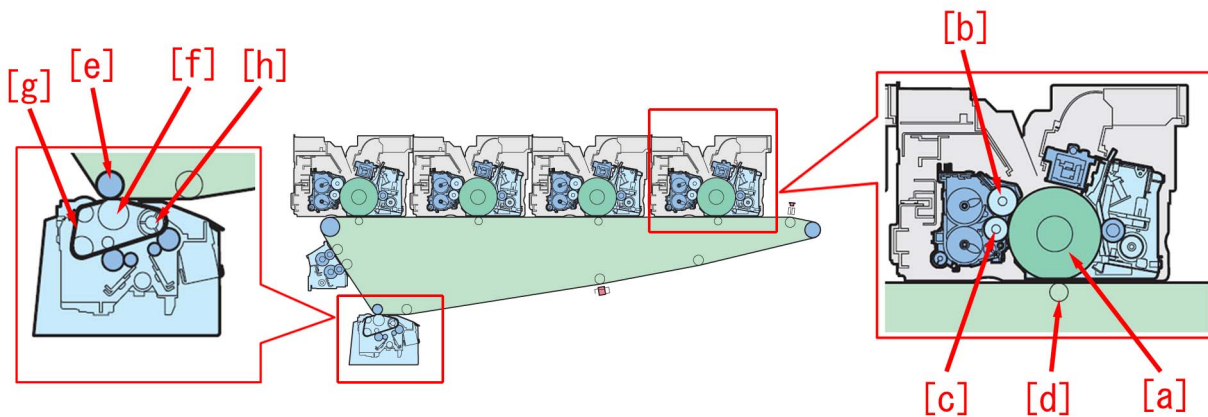
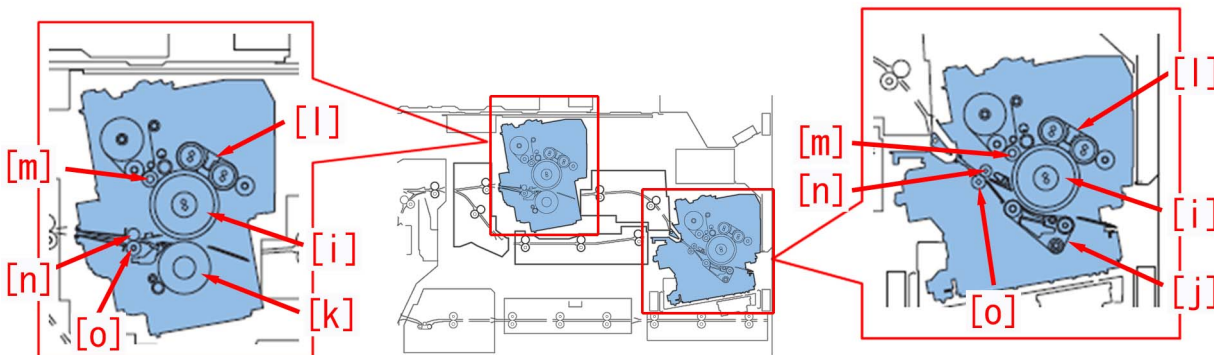
No	Interval(xx pitch)	Parts	Parts No
a	264mm	DRUM	DRUM
b	55mm	Developing Upper Cylinder	FM1-A304 (Developing Assembly)
c	45mm	Developing Lower Cylinder	FM1-A304 (Developing Assembly)
d	50mm	Primary Transfer Roller	FC8-6852
e	66mm	Secondary Transfer Inner Roller	FM1-A359 (2ND TRNSFR. INNER ROLLER ASS'Y)
f	75mm	Secondary Transfer Outer Roller	FE4-6066
g	198mm	Secondary Transfer Outer Belt	FE3-1953
h	69mm	Secondary Transfer Outer Belt Drive Roller	FM1-M250 (BELT DRIVE ROLLER ASSEMBLY)
i	252mm	Fixing Roller	FL1-1151 (Primary Fixing)
			FL1-1152 (Secondary Fixing)
j	220mm	Pressure Belt (Primary Fixing Assembly)	FL0-0358
k	190mm	Pressure Roller (Secondary Fixing Assembly)	FL0-0515
l	189mm	External Heat Belt(Primary/ Secondary Fixing Assembly)	FE3-1881
m	63mm	Collection roller (Primary/ Secondary Fixing Assembly)	FM1-D338
n	50mm	Fixing Inner Delivery Lower Roller (Primary/ Secondary Fixing Assembly)	FC5-9775
o	45mm	Fixing Inner Delivery Upper Roller	FC7-4644 (Primary Fixing)

- a) When the interval is 264 mm pitch, check Drum [a].
- b) When the interval is 55 mm pitch, check Developing Upper Cylinder [b] of the DEVELOPING ASSEMBLY (FM1-A304).

- c) When the interval is 45 mm pitch, check Developing Lower Cylinder [c] of the DEVELOPING ASSEMBLY (FM1-A304).
[Note] If the failure occurs in all the colors, check Fixing Inner Delivery Upper Roller [o].

- d) When the interval is 50 mm pitch, check Primary Transfer Roller [f] (FC8-6852).
[Note] If the failure occurs in all the colors, check Fixing Inner Delivery Lower Roller [n].

- e) When the interval is 66 mm pitch, check Secondary Transfer Inner Roller [e] of the 2ND TRNSFR. INNER ROLLER ASS'Y (FM1-A359).
- f) When the interval is 75 mm pitch, check Secondary Transfer Outer Roller [f] (FE4-6066).

- g) When the interval is 198 mm pitch, check Secondary Transfer Outer Belt [g] (FE3-1953).
- h) When the interval is 69mm pitch, check Secondary Transfer Outer Belt Drive Roller [h] of the BELT DRIVE ROLLER ASSEMBLY (FM1-M250).

- i) When the interval is 252mm pitch, check Fixing Roller [i] (FL1-1151) of the Primary Fixing Assembly or Secondary Fixing Assembly.
- j) When the interval is 220 mm pitch, check Pressure Belt [j] (FL0-0358) of the Primary Fixing Assembly.

- k) When the interval is 190 mm pitch, check Pressure Roller [k] (FL0-0515) of the Secondary Fixing Assembly.
- l) When the interval is 189mm, check External Heat Belt [l] (FE3-1881) of the Primary Fixing Assembly or Secondary Fixing Assembly.

- l) When the interval is 189mm, check External Heat Belt [l] (FE3-1881) of the Primary Fixing Assembly or Secondary Fixing Assembly.
- n) When the interval is 50mm, check Fixing Inner Delivery Lower Roller [n] (FC5-9775) of the Primary Fixing Assembly or Secondary Fixing Assembly.
[Note] If the failure occurs only for any color of Y/M/C/B, check Primary Transfer Roller[d].

- o) When the interval is 45mm, check Fixing Inner Delivery Upper Roller [o] (FC7-4644/ FM1-K630) of the Primary Fixing Assembly or Secondary Fixing Assembly.
[Note] If the failure occurs only for any color of Y/M/C/B, check Developing Lower Cylinder[c] of the Developing Assembly.

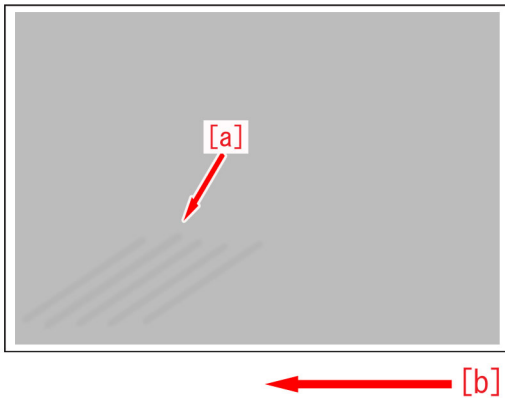
When outputting a halftone image in duplex mode, uneven density [a] might appear on the second face of paper. The arrow [b] indicates the feed direction.

When outputting in duplex mode, the paper may wait at the duplex path assembly prior to the printing on the second face of the paper.

If the paper waits in the duplex feeding path assembly, the moisture would partially evaporate from the surface of paper and the distribution of moisture on the paper surface becomes uneven.

When distribution of moisture is uneven, the transfer performance of the paper surface would change, and this results in the aforementioned symptom.

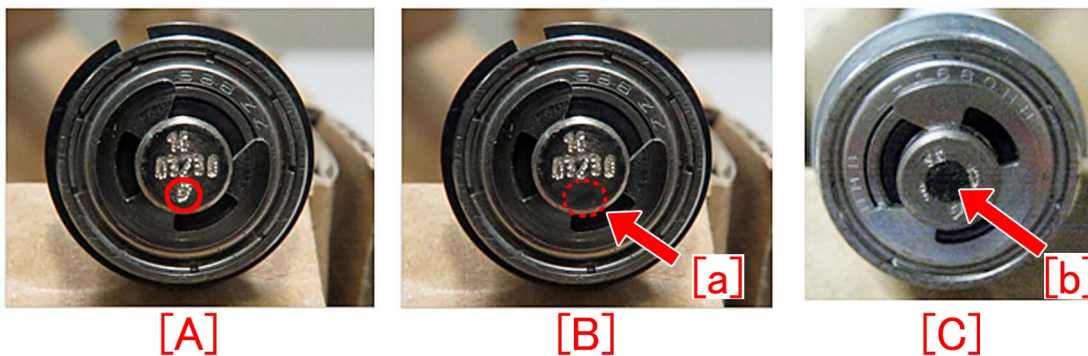
Photo [A] shows the old-type refresh roller shaft, photo [B] and [C] show the new type.

When the aforementioned symptom has occurred, prepare and replace with the new type refresh roller (FM1-T299-000) referring to the service manual.

Change the engraving [a] on the roller shaft or mark [b] the center of the roller shaft with a black permanent marker.

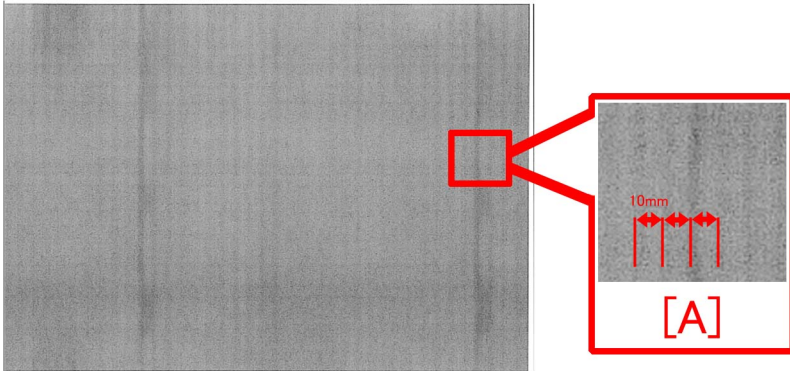
Uneven density [A] at regular intervals of 10mm may appear during printing.

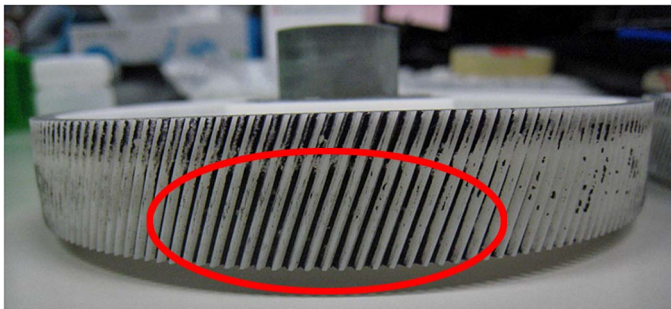
If a large amount of paper dust attaches onto the 192T gear connected to the drum drive assembly, this reduces the precision of meshing between the gears and leads to the above mentioned symptom.

Replace the 192T gear (FL3-0561-010) following the procedure below.

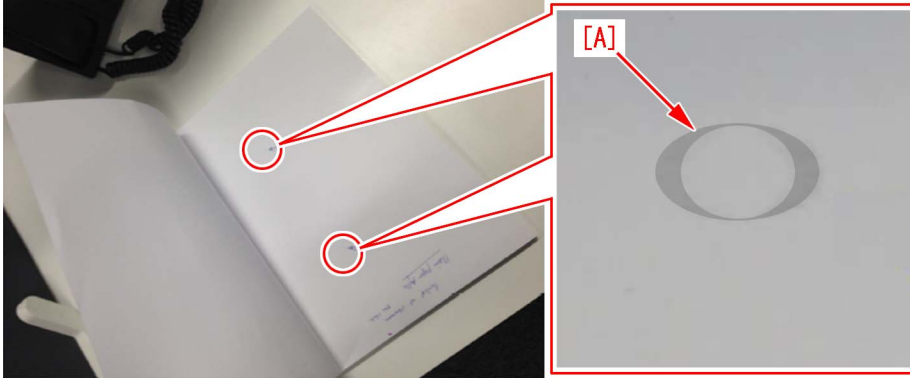
The marks caused by friction [A] may appear on the first and last pages of glued stacked of sheets during printing.

[Reference] This symptom remarkably occurs on glossy paper such as coated paper.

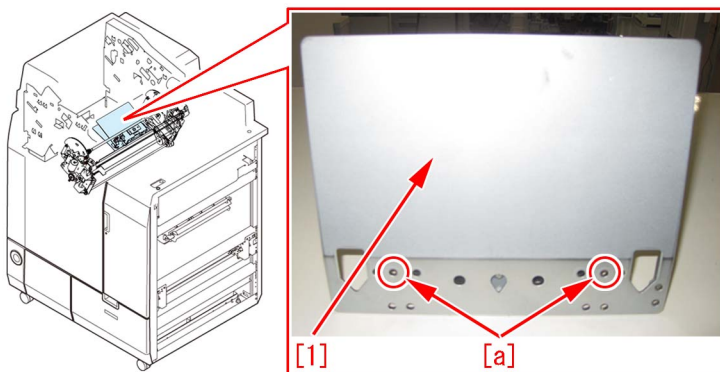
The stack of sheets loaded on the height tray assembly is fed by sub gripper assembly and then transferred to the main gripper assembly. The marks caused by friction are put on the first and last pages of glued stacked of sheets due to the edges of round holes [a] of mini gripper [1] being located at the upper and lower sides of main gripper assembly when transferring.

If the above-mentioned symptom occurs, prepare the sheet kit (4Y8-3138-000) to affix the sheet on the mini gripper being located on the upper and lower sides of main gripper assembly.

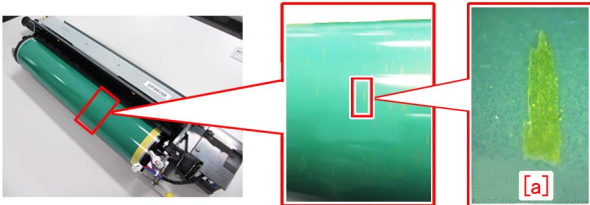
Due to fusing toners on drum surface, white band/white spots may occur. In addition, such fusing toners may damage cleaner blade, and scratches on blade or chipped blade may cause streaks on images.

When the aforementioned symptom is seen, prepare the following parts to conduct cleaning and parts replacement.

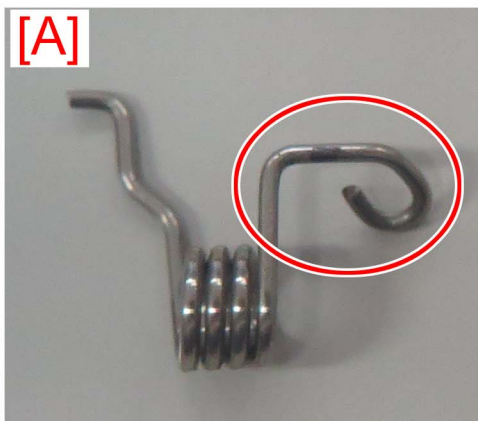
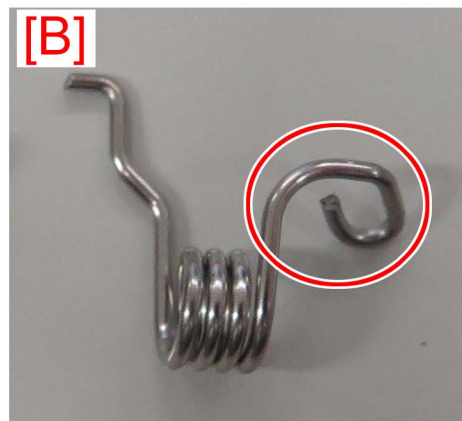
The torsion spring, which is used for the primary fixing assembly [1] and the secondary fixing assembly [2], to pressurize the collection roller may be damaged [a]. If the torsion spring is damaged, the pressure runs short and cleaning performance reduces, resulting in the above-mentioned symptom.

[Reference] Photo [A] shows the old-type torsion spring and Photo [B] shows the new-type.

When the above-mentioned symptom occurs, prepare and replace the following parts. Replace the torsion spring both on the front and rear sides at the same time even if only either of them is damaged.

- New-type torsion spring (front side) : FU2-0419-010
- New-type torsion spring (rear side) : FU2-0420-010
- Washer : XD1-1104-122 (2 pieces)
- Hanarl UD-321 : FY9-6037-000
- New E-ring (2 pieces)

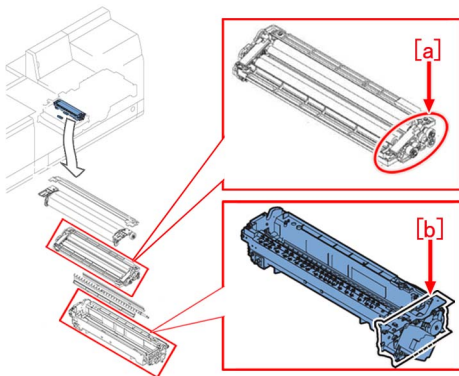
In the secondary transfer assembly, the gears used at [a] in the belt cleaner assembly and at [b] in the transfer cleaner drive unit are worn out, it may cause drive failure, leading to the aforementioned symptom.

When the aforementioned symptom has occurred, prepare a set of 2ND TRNSFR. CLEANER GEAR SET (FM1-U402-000), which is set up as a service part for exclusive use, and replace all with the set at the same time.

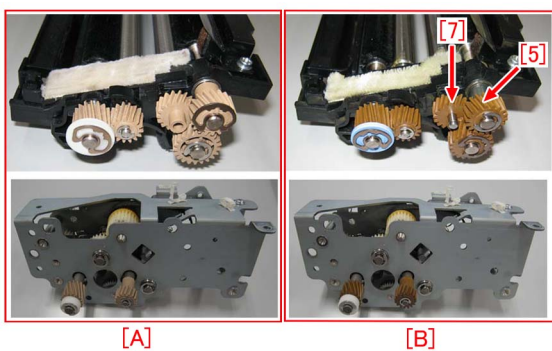
In order to increase strength, the materials of gears and positioning rollers are changed. [A] is the old type and [B] is the new type parts. In addition, as for [5] and [7], not only the materials but also the shape is changed at the same time.

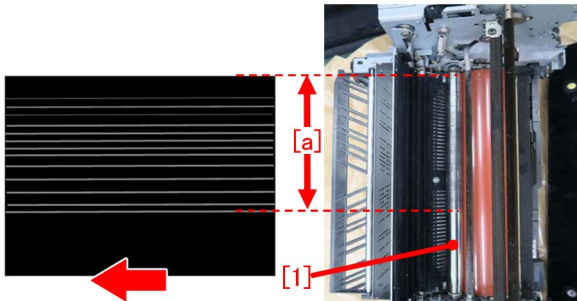
Streaks and stains on image in feeding direction may occur. When checking the collection roller upon the issue occurrence, the location of the soiled areas [a] is found to match between the streaks and stains on the image and the collection roller [1]. The arrow indicates the paper feeding direction.

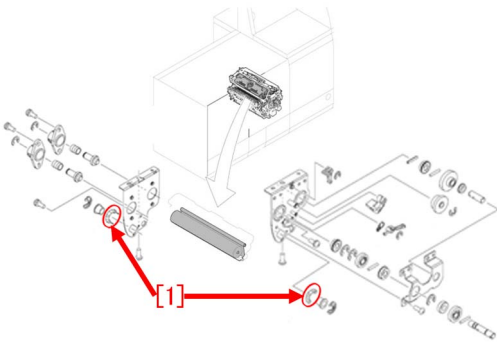
As the life of the tension spring [1] of the web roller in the fixing web unit advances, the tension spring may break. When the web roller is pressed against the collection roller with less force due to the tension spring breakage, cleaning capability decreases. As a result, the collection roller is soiled gradually and it results in the above symptom.

When the above symptom occurs, prepare the new tension spring (FU2-1836-000) and replace it by following the steps below. For every web roller, there are 2 tension springs located, one each in the front [A] and the back [B]. Even when only one of them breaks, be sure to replace both at once.

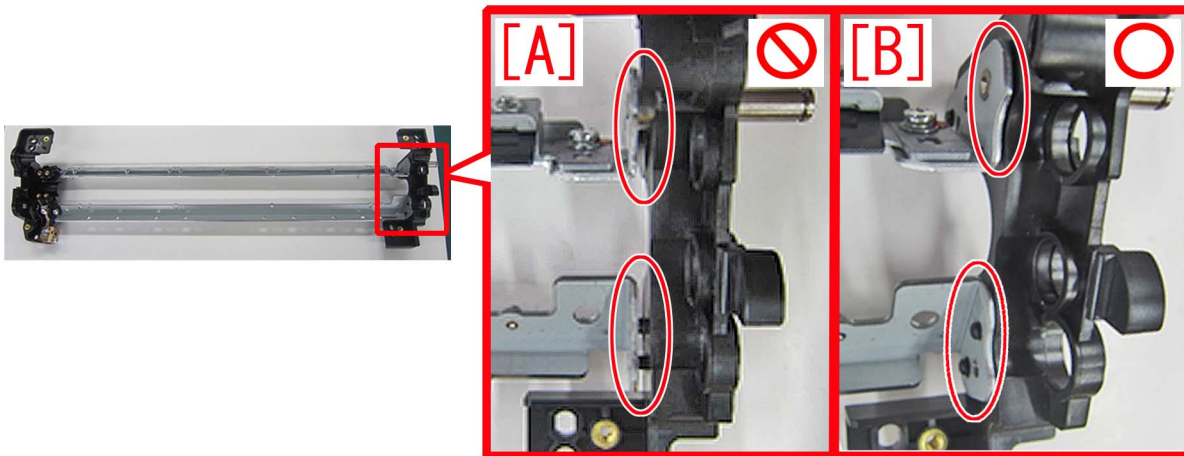
[Note] Make sure there is no gap between the upper/lower blade supports and the cleaner front side plate. Photo [A] is showing that the cleaner front side plate is not inserted correctly, thus the shaft is seen and the bosses are not fitted. Photo [B] is the correctly installed status without gap.

10) Install the newly assigned service part, cleaner front side plate (FL0-5502-000) [1] by inserting in the direction shown in arrow slowly.

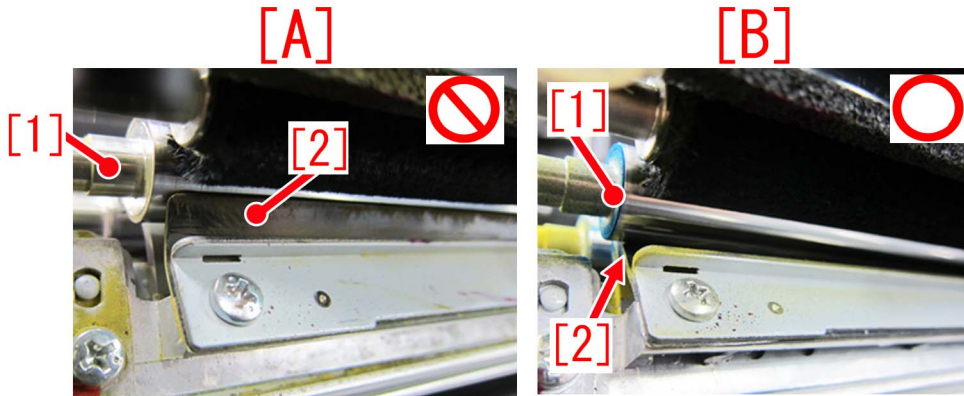
- After the installation of bias roller/bias roller 2 [1] in step 7), check and confirm that the scraper sheet [2] is not turned up. [A] is showing turned up state of a scraper sheet [2], and [B] is a correct state of a bias roller, with the scraper sheet properly set.

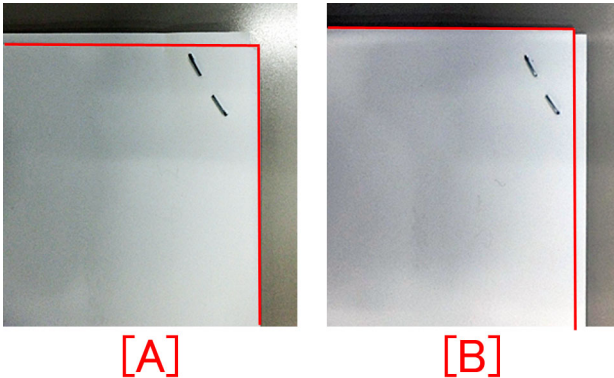
Misalignment of the last sheet occurs on the outer side of the set as shown in the photo [A] or on the inner side of the set as shown in the photo [B].

[Reference] The specification of staple misalignment is within 2 mm

The following are the three factors, which may cause staple misalignment. In addition, only the last sheet may be stapled with being misaligned, since there is no paper to be delivered after the last sheet, thus no lead-in operation and alignment operation for next feeding paper be performed.

The paper may not be pulled back to the trailing edge push-on plate in some cases due to insufficient feeding force caused by the height of paddle and feed power. As a result, staple misalignment may occur.

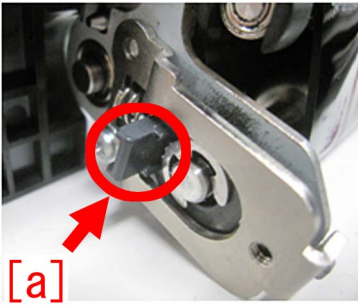
The figure A shows a state where the finger is put against the whole face of the releasing claw. The figure B shows a state where the finger is put against only a part of the face of the releasing claw. The arrows in the figures indicate the direction to push the releasing claw.

To push the releasing claw [a] of the secondary transfer outer roller holder (front) shaft support, be sure to put a finger against the whole face of the releasing claw [a].

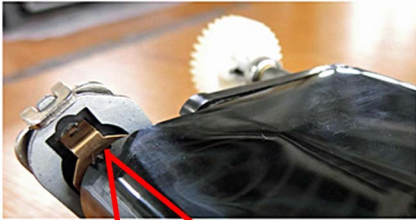
Secondary transfer outer belt may be torn from the edge. [A]

Prepare the new type 2nd transfer belt assembly (FM1-A345-020). Refer to Service Manual and replace the assembly.

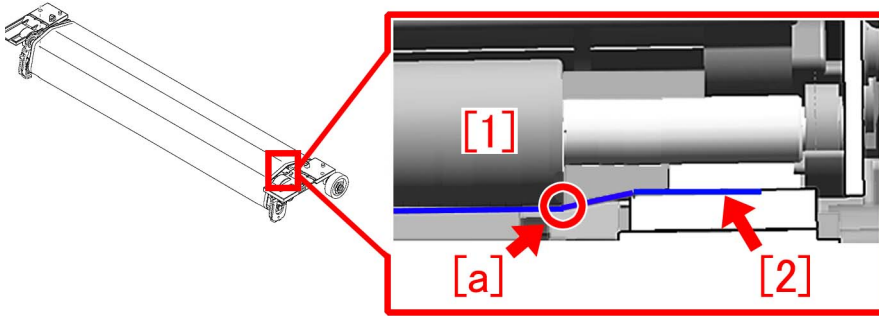
At the first time of the production start, the machine was transported with the secondary transfer outer belt [2] set. Therefore, the back-up roller [1] of the secondary transfer outer belt assembly repeatedly vibrated upward and downward and the force was focused on the bent portion [a] of the secondary transfer outer belt [2] where it came in contact with the back-up roller [1], resulting in the above symptom.

[Reference] The product manufactured on December 18, 2015 and later has been shipped without the secondary transfer outer belt set and packed in a different package.

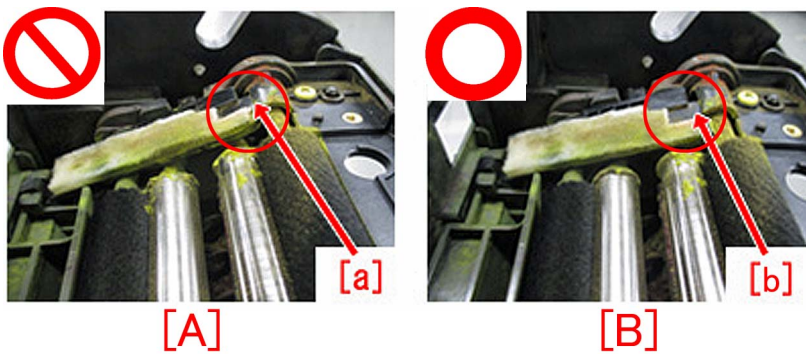
If the side seal of the belt cleaner assembly is attached with unfixed edge, the base area (mold) of the side seal touches the secondary transfer outer belt and that applies a load. It may result in the secondary transfer outer belt breakage.

Photo [A] shows the state that the side seal (rear) is attached with unfixed edge [a], and photo [B] shows the state that the side seal is correctly attached [b].

Prepare new type side seal (front/rear) and the belt cleaner lower cover set as a new service part. Refer to Service Manual and replace them.

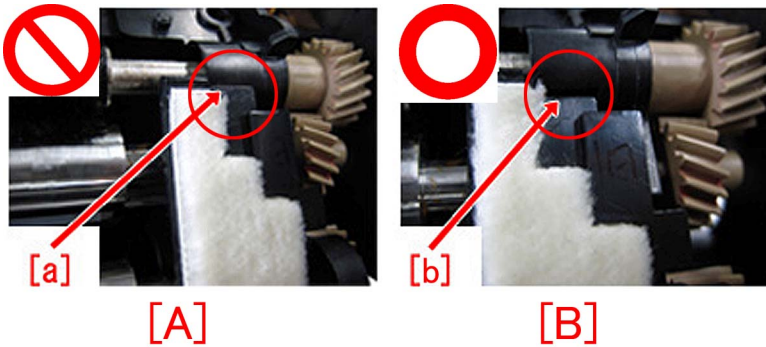
Photo [A] indicates the state that the side seal (front) is attached with unfixed edge [a], photo [B] indicates the state that the side seal is correctly attached [b].

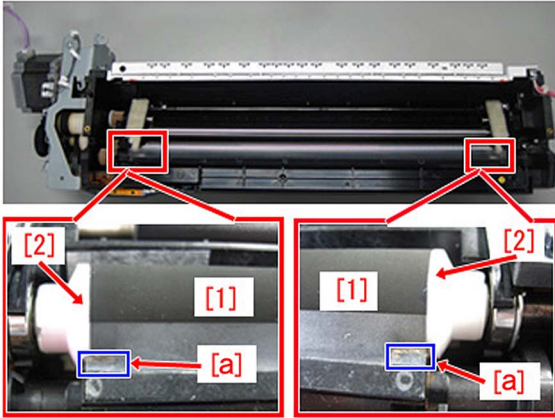
The belt edge seal in the belt cleaner lower cover presses the secondary transfer outer belt assembly against the belt drive roller [1] and rollers [2] together at [a] positions. The size of outside diameters of belt drive roller and rollers are different, and the difference of diameter causes peripheral speed difference. It applies the load to the pressed secondary transfer outer belt and that may cause the breakage.

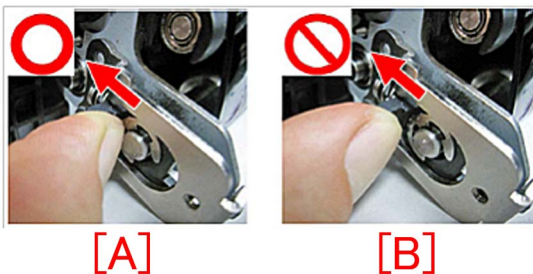
When pressing the claw of the tension roller during some work and if the claw is pressed with finger on its edge, a force larger than expected is applied to the curved area of the claw, resulting in the above symptom.

The figure [A] shows a correct state where the finger is put against the whole face of the claw.

The figure [B] shows an incorrect state where the finger is put against only a part of the edge of the claw.

Same as a) above, replace with the new type 2nd transfer belt assembly (FM1-A345-020), or prepare the following new type service parts and replace the old ones by following the steps below.

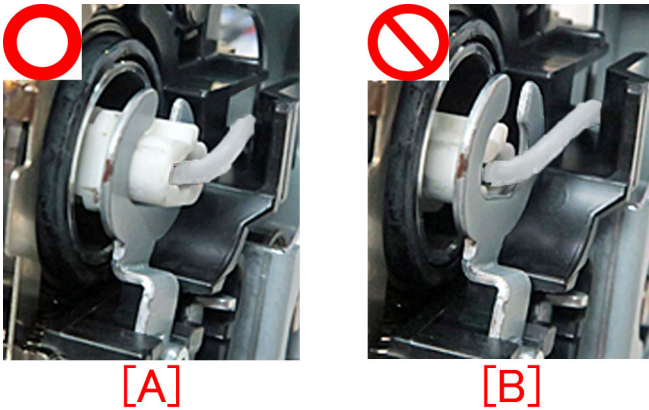
One side of the halogen heater of fixing assembly is secured with the sheet metal and the other side has a leaf spring structure. If the halogen heater is pushed from the fixing sheet metal side, the insulator on the end comes off from the securing section, and the cables of the halogen heater may come in contact with the sheet metal etc. Photo [A] shows the insulator that is properly secured and Photo [B] shows the insulator that is coming off.

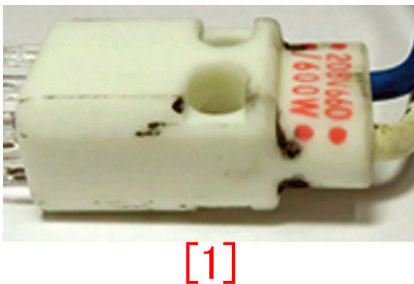
If the operation continues with the insulator detached, the cables may be damaged, resulting in short-circuit. Therefore, check that the insulator [1] of the halogen heater is secured in the correct position when visiting the user, replacing the halogen heater or when attaching/detaching the unit having the halogen heater.

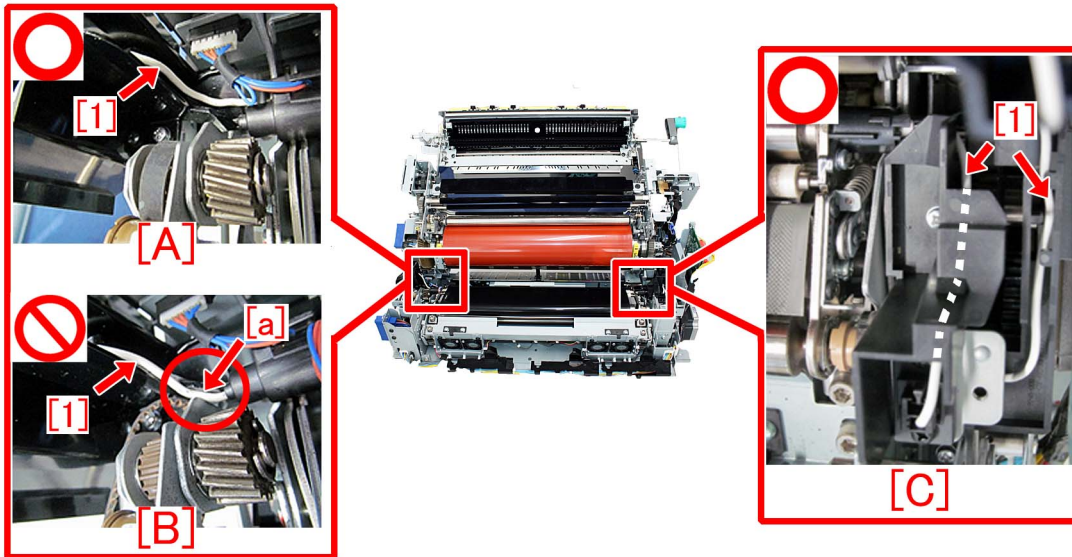
The photo [B] shows a state where the halogen heater cable [1] on the rear side is pinched [a] between the guide and the separation drive mount. In this case, fix the wiring correctly.

The photo [C] shows a state where the halogen heater cable on the front side is properly arranged along the guide. The white dashed line indicates the correct route that the halogen heater cable inside of a guide plate is wired.

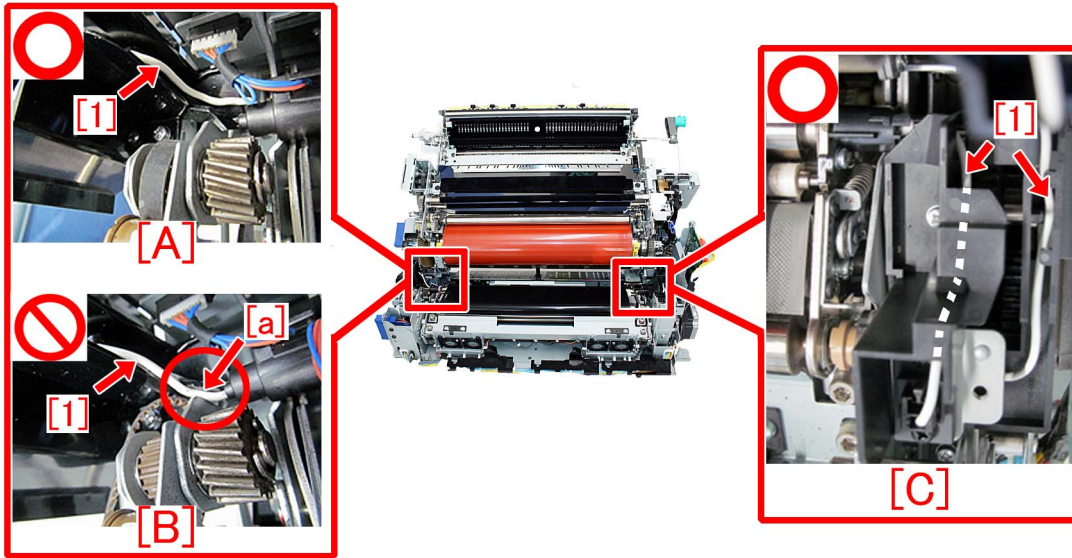
The photo [A] shows a state where the halogen heater cable [1] on the rear side is adequately arranged along the guide. The photo [B] shows a state where the halogen heater cable [1] on the rear side is pinched [a] between the guide and the separation drive mount. In this case, fix the wiring correctly. The photo [C] shows a state where the halogen heater cable on the front side is properly arranged along the guide. The white dashed line indicates the correct route that the halogen heater cable inside of a guide plate is wired.
