Troubleshooting Guide

imagePRESS

C10000VP Series

January, 2019
Canon U.S.A., Inc.

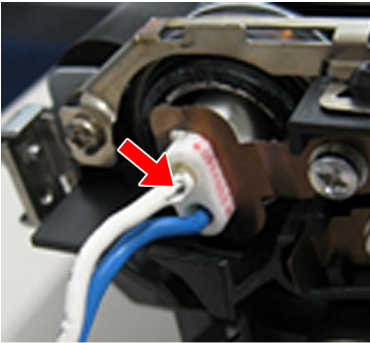
If the insulator of the halogen heater end of the working machine is detached, check whether the halogen heater cables are damaged. If they are damaged to the state where the conductor is visible as shown in the photo below, replace the halogen heater by referring to Service Manual.

If the insulator of the halogen heater end is detached, secure the insulator in the correct position.

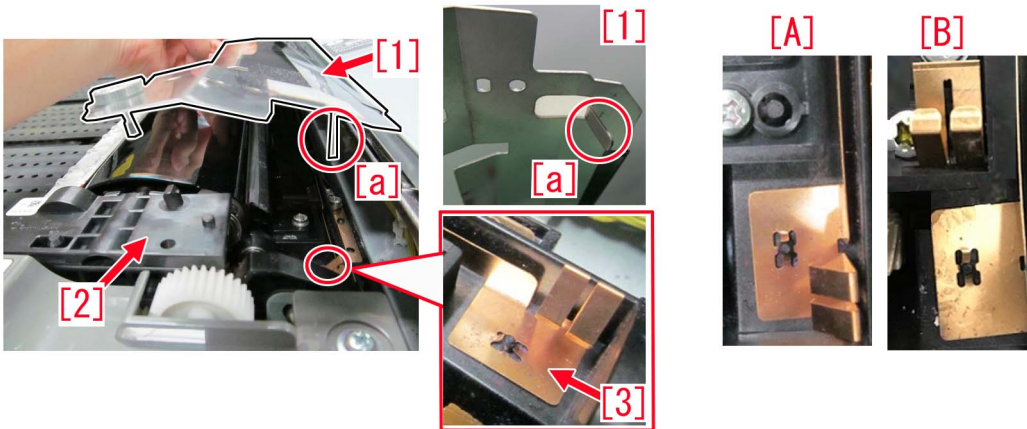
When installing a lower entrance guide [1] to the secondary transfer outer roller holder (front) [2], it could damage a varistor plate [3].

[A] is the normal state and [B] is showing the damaged varistor plate which was broken from the base.

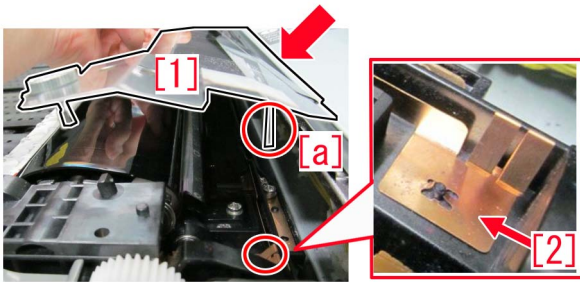
When installing a lower entrance guide [1] from the direction shown in arrow below, the bent part [a] of the lower entrance guide could hit the varistor plate [2], causing the above symptom.

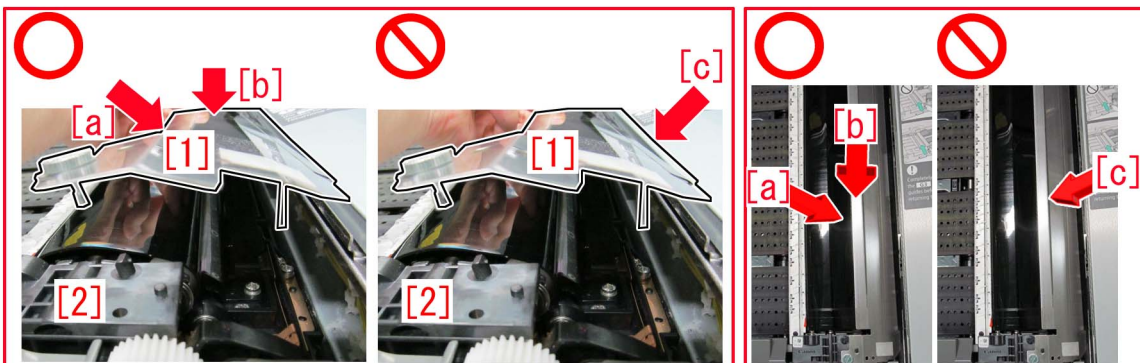
[a] or [b] is the correct direction, while [c] is the wrong direction to be installed.

1) When installing a lower entrance guide [1] to the secondary transfer outer roller holder (front) [2], be careful with the direction to be installed.

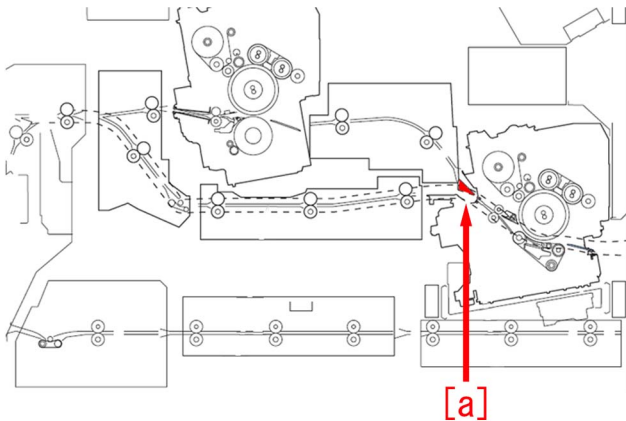
As the paper that has been left in a high temperature/humidity environment contains a plenty of moisture in it, the more the paper curls, the more its elasticity gets reduced and it would have a folded corner as a result.

If a sheet of paper that is curled upward has a folded corner at the flapper [a] that switches the single fixing path and the tandem fixing path, the above mentioned symptom may occur.

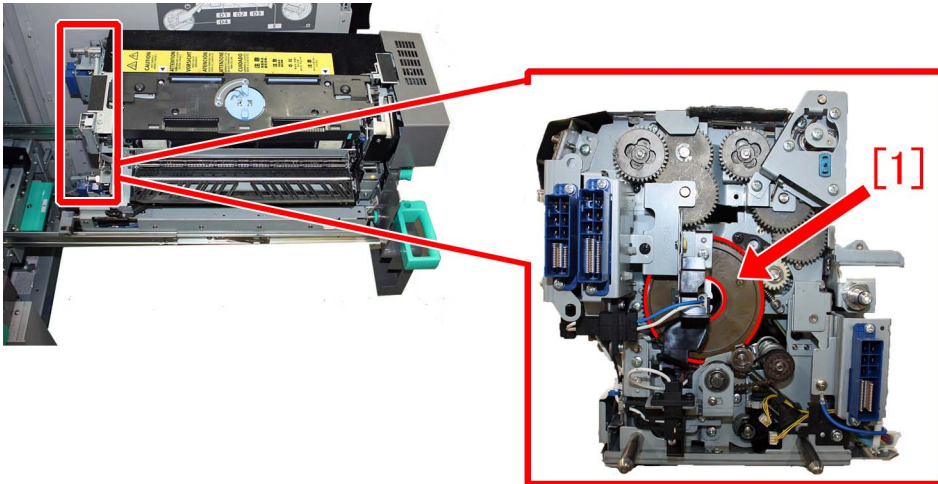
The 86T gear [1] on the rear side of fixing assembly has not enough strength due to short heat treating time when the gear is created. Therefore missing teeth occurs and that results in the foregoing symptom.

When the above-mentioned symptom occurs, prepare new type 86T which is strengthened gear (FU6-0336- 020) [2] and then replace the gear referring "Replacing the primary fixing roller, bearings, and insulating bushes" or "Replacing the secondary fixing roller, bearings, and insulating bushes" for the service manual.

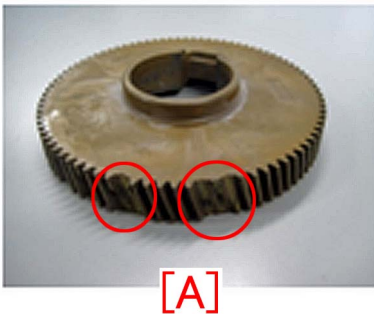
[Reference] Photo [A] shows the 86T with missing tooth.

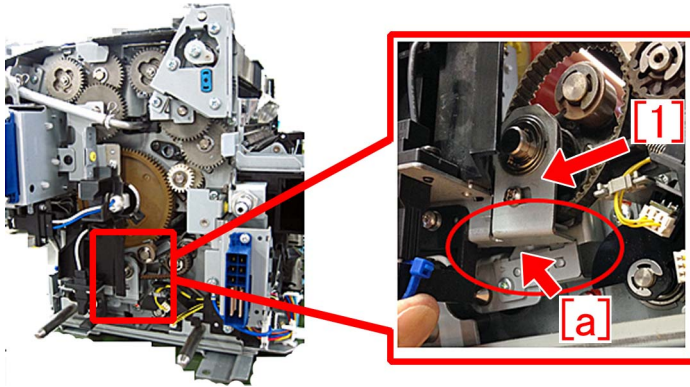
If debris from the teeth of the gear gets into meshing of the gear, a load is applied to and damages [a] the hemming of the separation drive mount 2 [1], and this may result in the above mentioned symptom.

Also, the separation drive mount 1 may break.

When the separation drive mount 2 is broken, prepare the model-specific separation drive mount 2[1] and an e-ring (XD2-1100-642).

When the separation drive mount 1 is broken, prepare the model-specific separation drive mount 1[2] and an e-ring (XD2-1100-642).

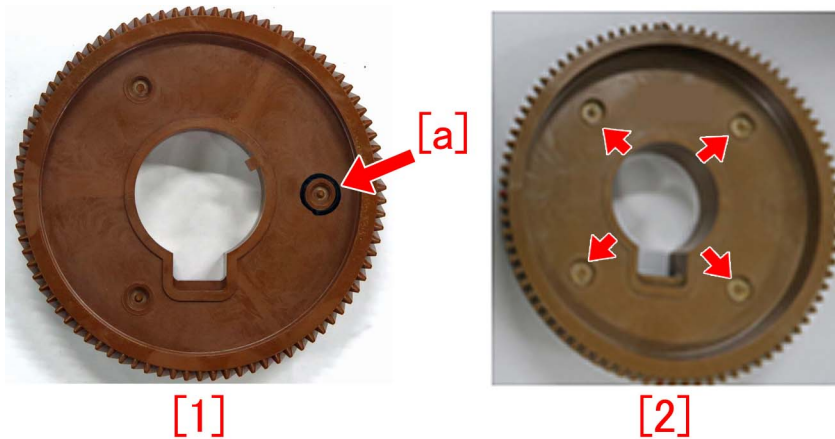
[Reference] The old type 86T gear (FU6-0336-010)[1] has a permanent pen marking [a] in the hollow of the surface. On the new type 86T gear (FU6-0336-020)[2], there are 4 hollows on the surface and there is no permanent pen marking.

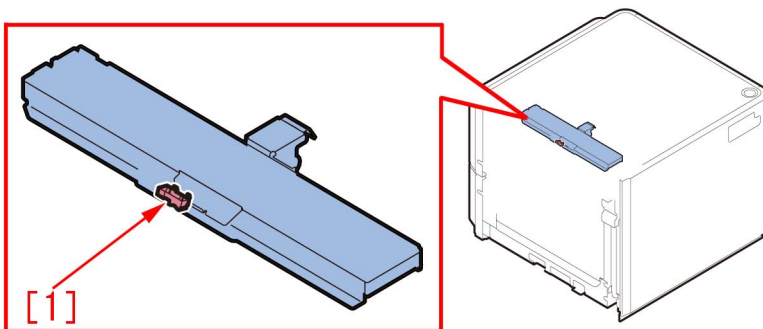
The deck pull-out sensor [1] of the pickup unit may incorrectly detect the reflected light of the adjacent deck pull-out roller feeder guide as paper, resulting in the above-mentioned symptom.

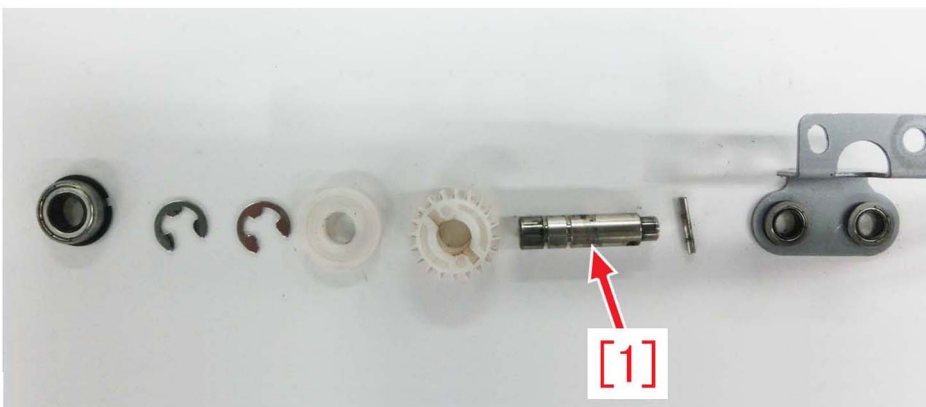
The decurler drive shaft, the decurler drive shaft 1 or the swing shaft 1 being shaved in the delivery guide assembly causes the symptom. After some endurance time, the grease applied to the circumference of the shaft is depleted and the shaft is shaved, resulting in the above-mentioned symptom.

a-6) Disassemble the decurler drive swing plate 2 removed in the step a-5), into the E-ring, the gear, the parallel pin, the ball bearing and the decurler drive shaft [1], and replace it with the new-type decurler drive shaft (FC6-2447-010) [1] and the new ball bearing (XG9-0520-000).

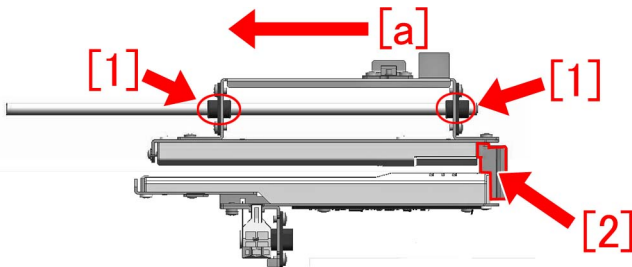
When the sliding load from the sliding part [1] inside the side registration sensor assembly is great, the side registration sensor assembly drive motor steps out and the position of the support [2] is displaced towards the front side of the product [a]. In the said condition, the paper contacts the support [2], would be skewed in delivery and may result in the aforementioned symptom.

When the above mentioned symptom frequents, prepare and replace with the new type side registration sensor assembly for each product referring to the service manual.

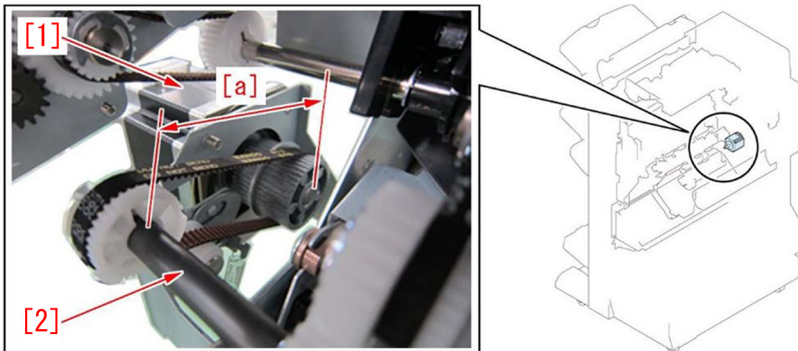
When the belt roller [2] of the process upper guide tilts to the processing feed motor (M26) [1] side, the distance between the shafts [a] becomes smaller and makes it easier for the timing belt to get loose. When the timing belt gets loose, a meshing failure occurs between the timing belt and the gears, resulting in the above symptom.

When the above symptom occurs, remove the paper delivery drive assembly (L) by following the procedure below. Then align the connecting holes of the upper dispose guide and the front plate/rear plate, and reattach the operation feed motor (M26) so that the distance between shafts of the belt roller in the upper dispose guide and the operation feed motor (M26) is appropriate. The following procedure starts from after the finisher being removed from the engine.

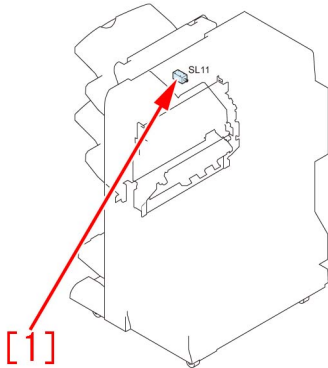
When pull in current value of the solenoid was insufficient and the installed position of estrangement solenoid unit (SL11) [1] was inappropriate, nip pressure of the postcard feeding rollers may be insufficient. This may lead to the above mentioned phenomenon.

b) Prepare and replace with a new type of estrangement solenoid unit (FM1-A170-010), following the procedure below. Note that the following procedure starts from where the finisher was removed from main body of a copying machine.

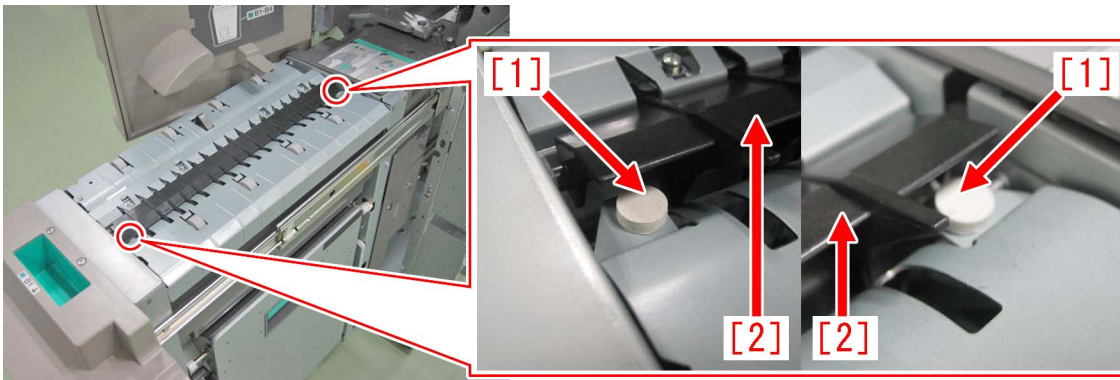
As the spacer [1] gets softened and its surface gets sticky, the folding/straight flapper [2] sticks to it, causing the above symptom to occur.

Follow the steps below and check if the spacer [1] is stuck to the folding/straight flapper [2]. If it is stuck, prepare the 2 new type spacers (FL1-6535-000) and replace with them.

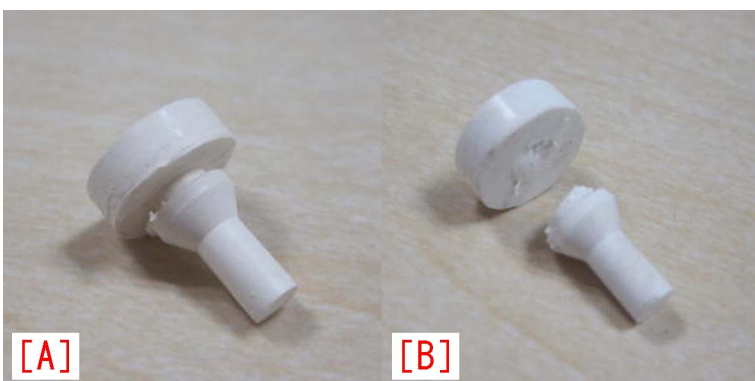
[Note] When removing the spacers, be sure not to break it as when the spacer breaks and falls inside the machine, jam and error may occur.

The photo below shows the normal spacer [A] and the broken spacer [B].

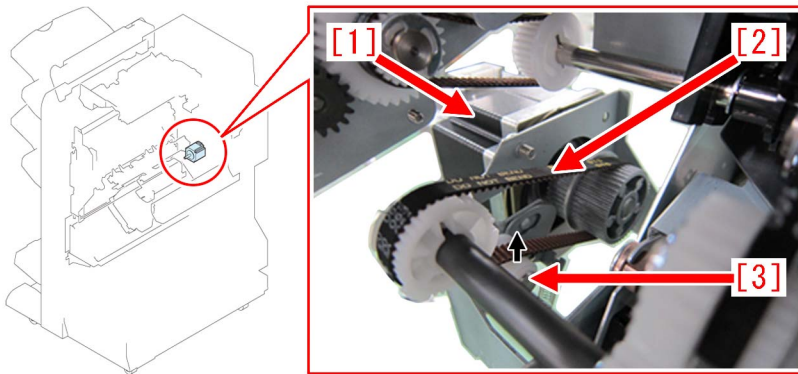
The timing belt [2] in the operation feed motor (M26) [1] is designed to keep its tension and prevent from being loose by having the tensioner [3] pressed in the direction of the arrow. This tensioning method is "unfixed type". However, the pressing power of the tensioner [3] in the unfixed type is insufficient in some cases and when the operation feed motor (M26) [1] drives rapidly a meshing failure occurs on the timing belt because of power, resulting in the above symptom.

When the above symptom occurs, prepare and replace the paper delivery drive set (L) (4Y8-3156-000).

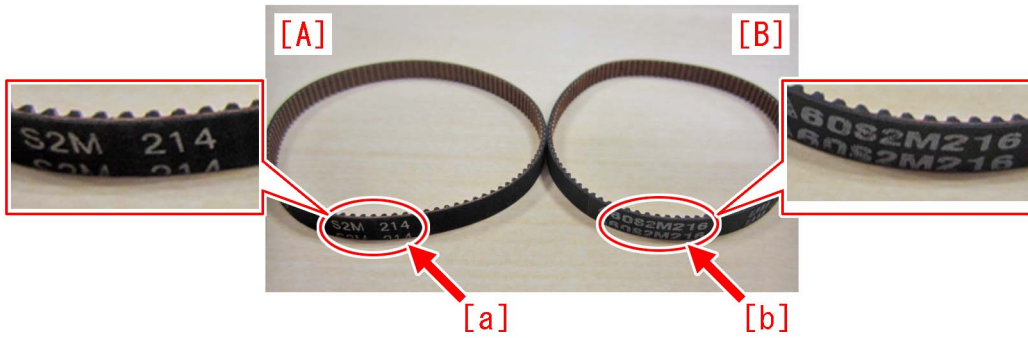
[Note] When replacing to the paper delivery drive assembly (L), be sure to also replace the timing belt [B] at the same time that is included in the set. 110F jam occurs when using the old type timing belt [A] as the number of teeth of the new type is different from the old type originally attached to the engine.

In the photo below, [A] is the old type and [B] is the new type.

The old type [A] has "S2M 214" [a] printed on it. The new type [B] has "60S2M216" [b] printed on it.

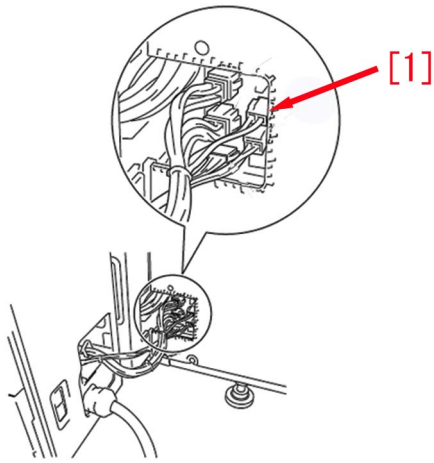
i) For the case that bit7 to bit9 of [PWR- GP6] show "1". (All 24V errors of Sub Station are detected.)

i-1) Check if there is a disconnected connector or a cutoff harness between UN402/J4766(J6300) to panel mount of Sub Station / J7859 [1].

- i-2) Check if there is a disconnected connector or a cutoff harness between UN311/J4013 to UN402/J6303.
- i-3) Check if there is a disconnected connector for UN402/J6301 and J6302.
- i-4) Replace the UN402 (Fixing Relay PCB).

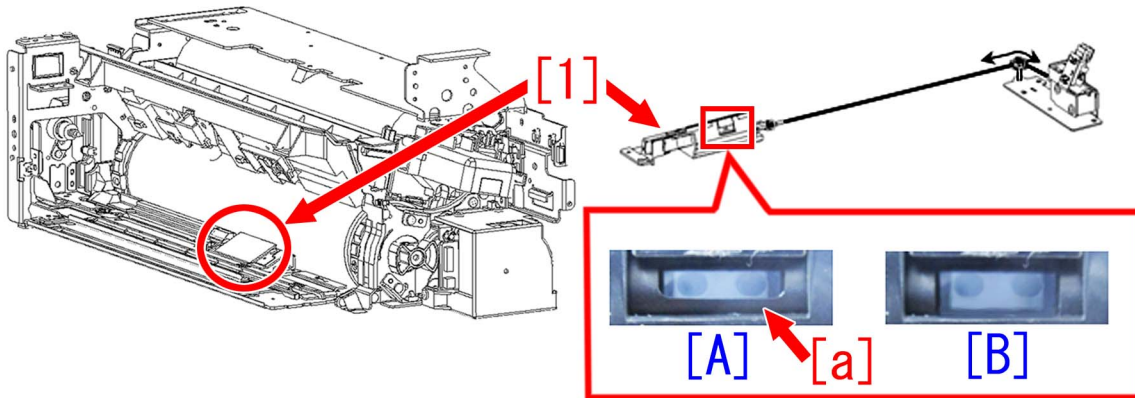
a). Incorrect position of the shutter solenoid

When the shutter solenoid is attached in the process, the shutter [1] of patch sensor should have been attached in the state of fully opened [B]. However it has not been attached with proper adjustment. Photo [A] shows the state that the shutter [a] is not opened fully and Photo [B] shows the proper state.

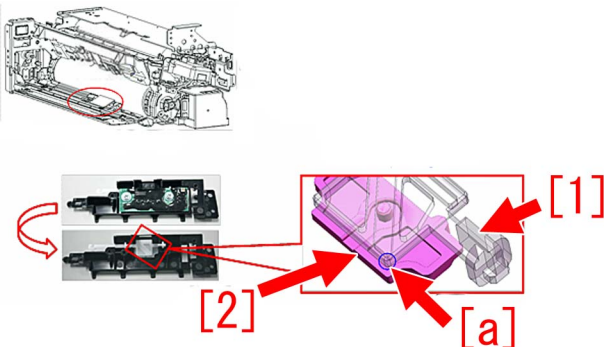
b). Error of the shutter slide lever

The slide lever and the shutter cover [2] interfere with each other [a], and the shutter may not be able to be opened or closed.

*b) Replace the patch sensing sensor unit with the new type that includes countermeasure shutter slide lever.

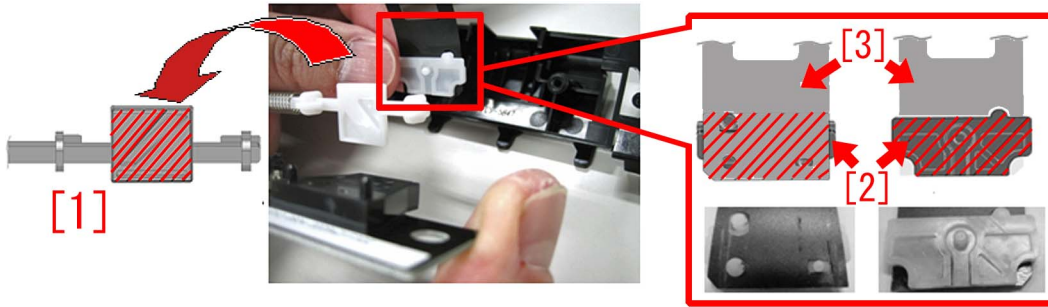
If Jam or error occurs during printing, the developing bias suddenly stops the output. At this time, the carrier absorbed to the drum surface floats and may enter inside the drum patch sensor. In particular, the machine in which jams and errors frequently occur during printing, the carrier enters more possibly, and the operational error may rarely occur.

Therefore, a measure is taken so that the shutter moves smoothly by applying Hanarl to the hatched areas of the slide lever [1], the shutter slider [2] and the shutter [3], even if the carrier enters inside the drum patch sensor.

*c) Replace the patch sensing sensor unit with the new type to which Hanarl is applied.

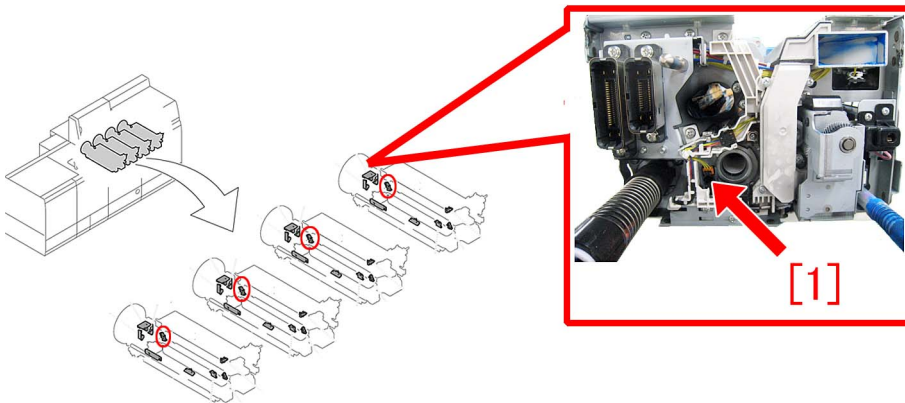
After some endurance time, the detection surface of the patch sensor shutter solenoid sensor [1] gets dirty, and this may cause false detection.

[Reference] There is 1 patch sensor shutter solenoid sensor per process unit of each color. (Y : , M : PS402, C : PS403, Bk : PS404)

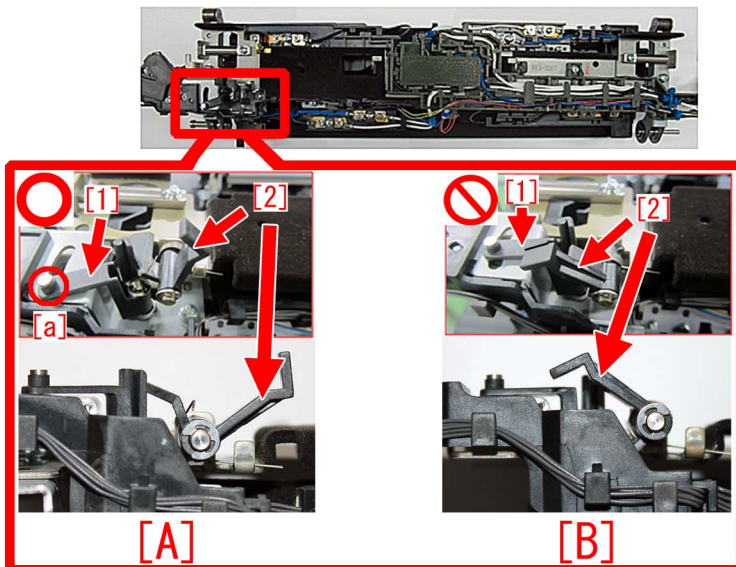
Check to see if the sensor flag [1] is at the retractable position [a] and also if the sensor retractable arm [2] is at the appropriate position.

Figure A shows a proper state and B, an inappropriate position where the sensor retractable arm [2] comes underneath and hinders the sensor flag [1] from returning to the retractable position.

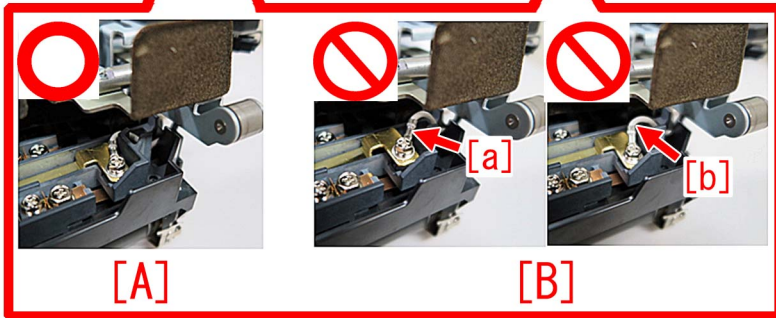
Check to see if the heater cable does not come on top of the rib of the cable guide at 2 locations.

Fig. [B] shows an inappropriate wiring where the terminal [a] and the heater cable [b] come on top of the rib.

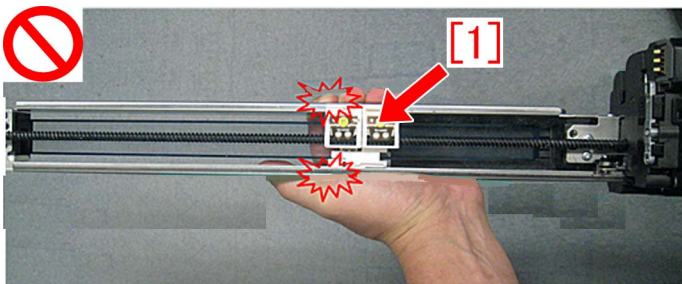
When holding the primary corona assembly with hands, hold it by the handle. (black molded part) When holding the center of the shield plate as shown in the photo, the shield plate deforms. Using the unit in this state causes a load to the slider [1] around the center section when the slider [1] moves causing it to stop. As a result, E060-0x01 may occur.

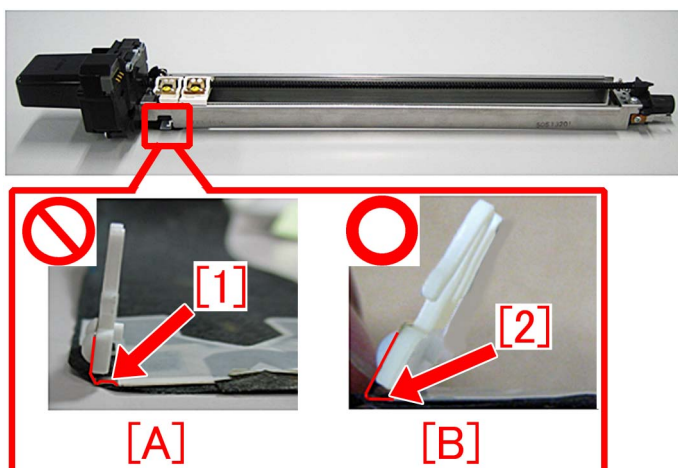
When placing the primary corona assembly on a working table, the leaf spring [1] of the shutter may deform as shown in the photo [A] if placing the unit with the etching grid plate facing down. The photo [B] is the leaf spring [2] in a normal state. When the leaf spring deforms, E060-0x01 may occur because it gets stuck to the etching grid plate when the shutter moves.

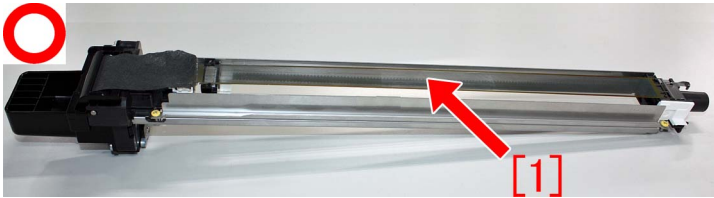
[Reference] When placing the unit with the etching grid plate [1] facing down, foreign material may attach to the etching grid plate. When placing the primary corona assembly on a working table, be sure to place it with the etching grid plate facing up.

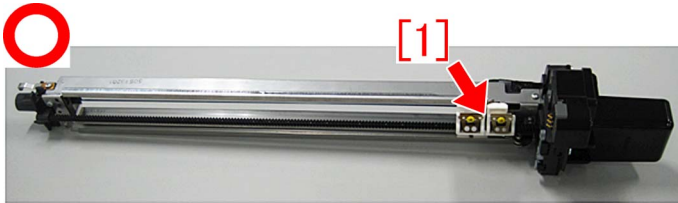
When loosening the yellow screws in the slider, place the primary corona assembly sideways as in the photo [A] and loosen the screws. The leaf spring of the shutter may deform when placing the unit as in the photo [B] and loosening the screws.

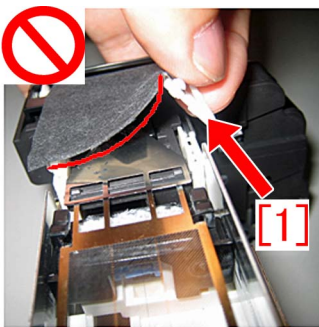
When removing the shutter hook [1] one by one as shown in the photo [A] to remove the shutter, the leaf spring on back of the shutter sheet may deform when opening the shutter hook wide while the other shutter hook is intact. In addition, when installing the shutter, holding the shutter hook [1] with one hand as in the photo [B] trying to install the both ends at once may cause a deformation of the leaf spring on back of the shutter sheet.

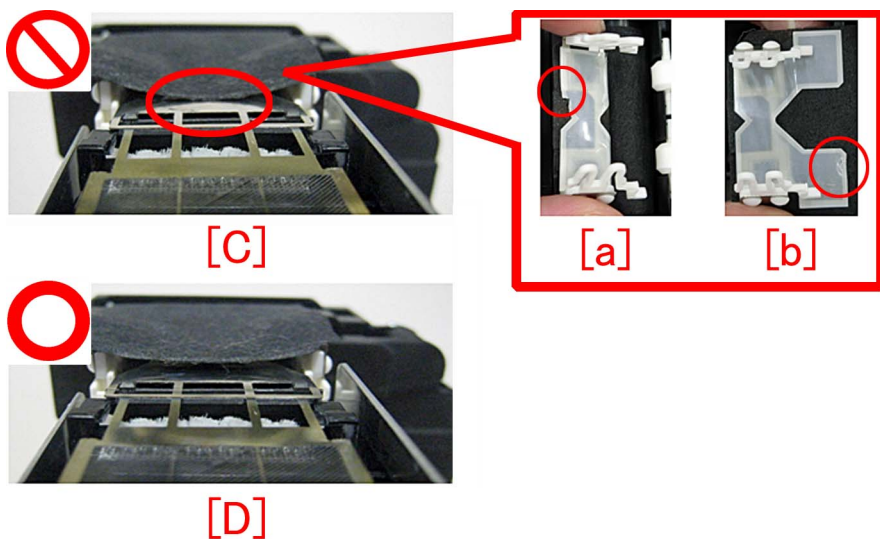
When the leaf spring is deformed severely as shown in the photo [C], the leaf spring of the shutter and the etching grid plate interfere causing the shutter sheet or the shutter to get stuck to the etching grid plate and get torn [a] or damaged [b]. If the torn section gets stuck, E060-0x01 may occur. The photo [D] is a normal state without the deformed leaf spring of the shutter.

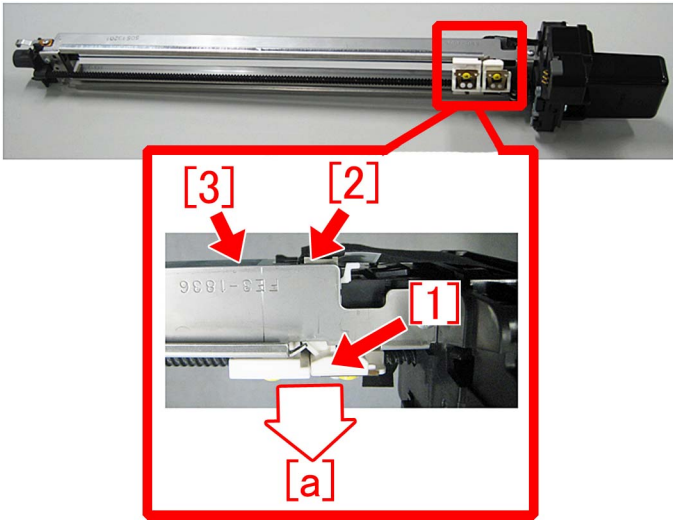
When opening and closing the shutter manually by holding and sliding the slider [1] by hand, the shutter and the leaf spring [2] gets stuck to the etching grid plate [3] if the slider [1] is pulled strongly in the direction of the arrow [a] and it may damage the shutter sheet or the shutter. When opening and closing the shutter manually, be sure not to pull the slider too strongly in the direction of the arrow [a].

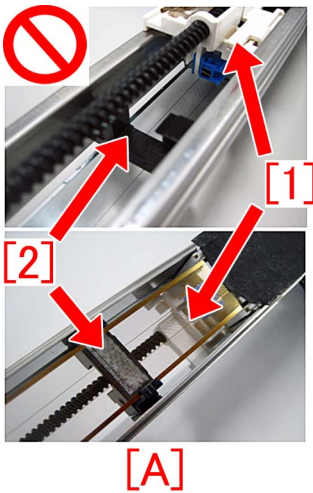
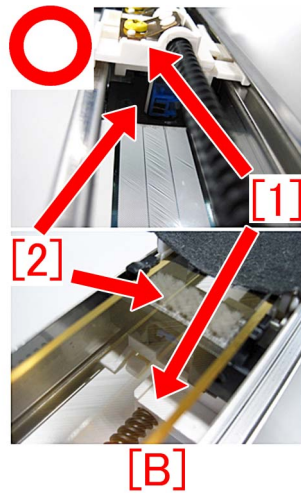
When opening and closing the shutter manually by holding and sliding the slider [1] by hand, the grid cleaning unit [2] may come off the shutter slider if a force is applied in the direction of the arrow [a]. The photo [B] shows the unit in a normal state. When moving the slider, be sure not to apply a force in the direction of the arrow [a].

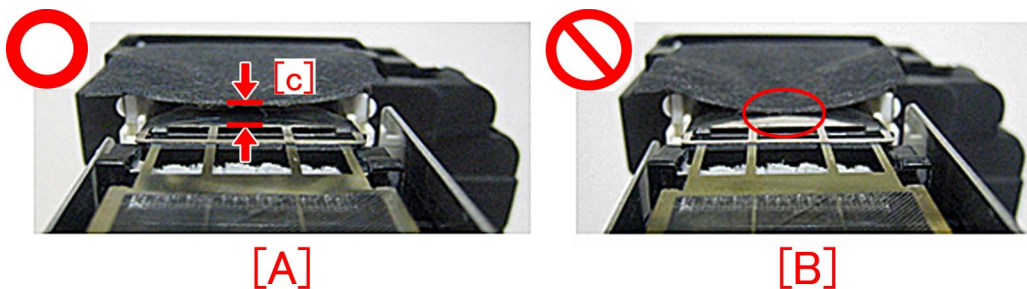
In the field service, as a step of cleaning the primary charger, the leaf spring may be deformed from opening/closing the shutter by holding the leaf spring or replacing the grid plate. From either of the operations the sheet [1] of the leaf spring catches the grid plate [2] and this condition leads to an E060-0x01. If the protective sheet is torn [a] and the fragment [b] mixes into the cylinder of the developing assembly, it results in a white line image.

The photo [A] shows a normal state where the distance [c] between the grid and the leaf spring is maintained properly. Meanwhile the photo [B] shows a state where the leaf spring is deformed and the leaf spring has come in contact with the grid.

When the aforementioned symptom has occurred, prepare and replace with the new type shutter unit (FM1-A485-010) following the below procedure:

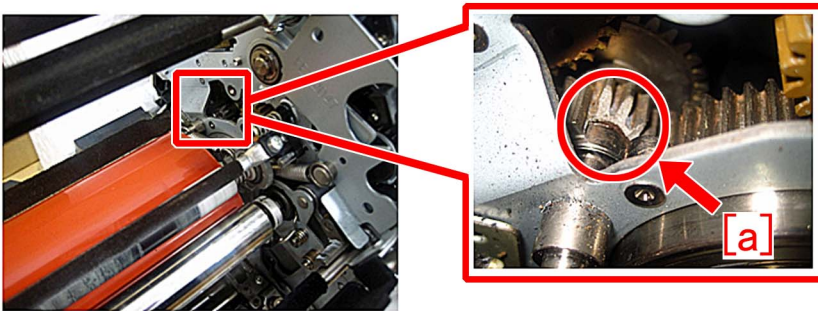
16T/31T gear in the fixing assembly may break [a] due to load applied when press fit a bearing into the gear and some endurance time. When broken pieces go into the fixing pressure belt assembly, one of the above symptoms occurs.

When the above symptom occurs, prepare the following service part and follow the steps below.

- imagePRESS C10000 Series : Idler gear unit (FM1-T019-000)
- imagePRESS C6000/C6000VP/C7000VP/C7000VPE/C6010/C6010VP/C7010VP/C6011/C6011VP/C7011VP : Idler gear unit (FM1-T026-000)

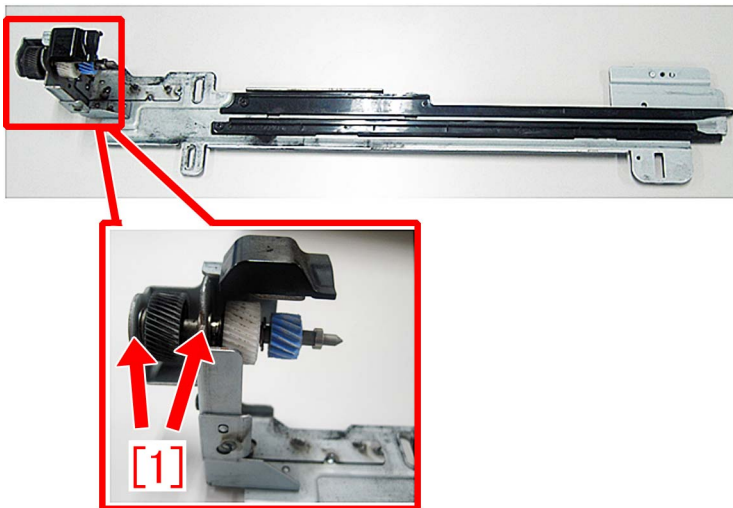
When the product has a job with great number of continuous prints and large printing volume, the exhaustion of grease for two ball bearings [1] in the developing drive rail assembly damages the bearings and that results in the above-mentioned symptom.

When the above-mentioned symptom occurs, prepare two new type ball bearings (XG9-0787-000) and four E-rings (XD2-1100-502) to replace them following the steps below.

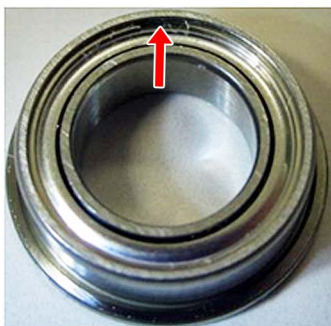
Photo [A] indicates new type ball bearing having one slit and photo [B] indicates a conventional ball bearing having seven slits.

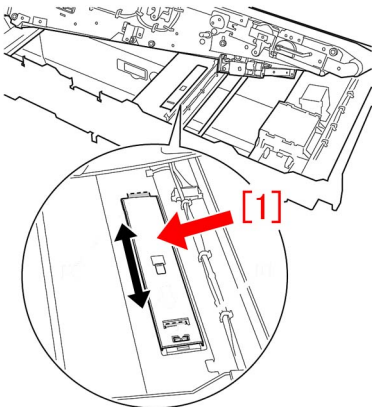
As the life of the ITB unit advances, the sliding part of the leading edge registration patch sensor shutter[1] becomes overloaded, resulting in the above symptom.

When the above symptom occurs frequently, prepare HANARL (FY9-6037) and the E-ring (XD2-1100-502) and follow the steps below.

When working on imagePRESS C6000/ C6000VP/ C7000VP/ C10000 Series, prepare 1 piece of the new type shutter stay (FC9-6076-000)[1], whose shape was changed to decrease the sliding load.

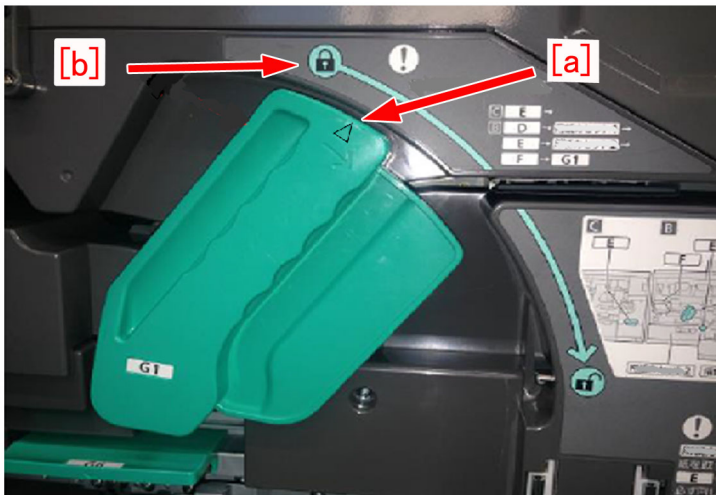
If the arrow [a] of the lever is located on the right side of the key mark [b] after jam removal etc. by pulling out the registration feed assembly from the main station and putting it in, the registration feed assembly is not completely locked.

If closing the front cover with the registration feed assembly incompletely locked, the initial rotation operation starts, which causes unsuccessful completion of engagement/disengagement operation of the secondary transfer roller, resulting in the above-mentioned symptom.

Check the position of the lever of the registration feed assembly. If it is locked incompletely, turn the lever until the arrow of the lever comes onto the left side of the key mark and lock it completely.

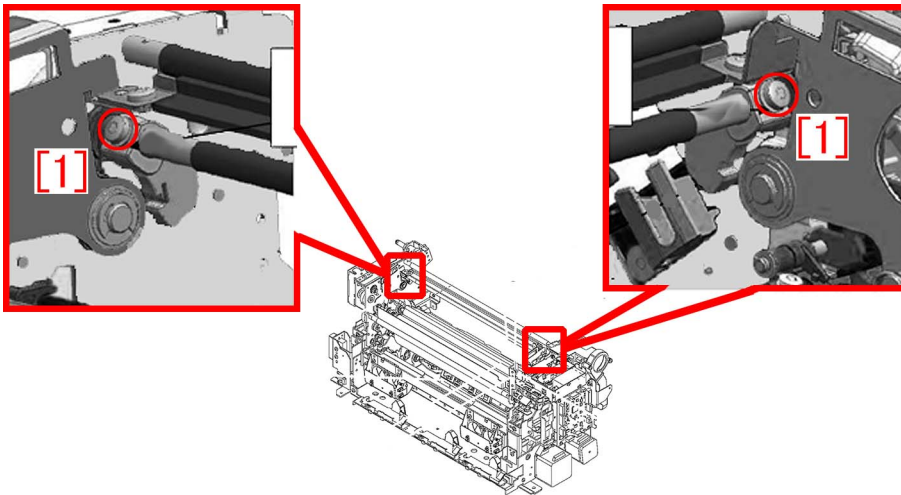
If the W sems screw that secures the engagement/disengagement cam to the shaft is loosened, in the main engines before the countermeasure in factory(S/N listed below), a large force might be applied to 20T/42T gear (FL3-7951-000) and 40T gear (FU7-0828-010), which may lead to gear teeth damage.

If the W sems screw [1] that secures the engagement/disengagement cam to the shaft is found loosened by the inspection, tighten up the W sems screw [1]. Or replace it with the w/washer screw (XA9-0961-000) [2] which has a locking member.

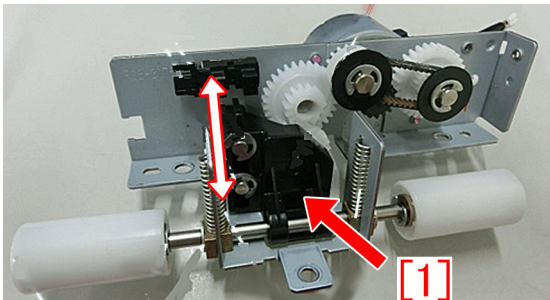
While the feed roller shaft is moving up and down to detect home position, if the estrangement rack [1] that holds the feed roller shaft inclines, the load from sliding increases and the feed roller shaft becomes unable to go back to home position, and this brings the aforementioned symptom.

When the above-mentioned symptom occurs, perform the work either A) Replacing the upper feeder assembly with the new type or B) Applying the grease to the feed assembly.

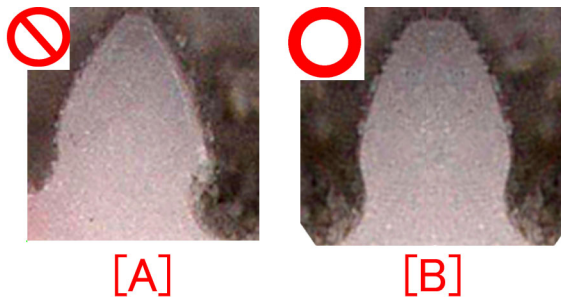
The picture [A] shows a shaved gear tooth in a triangle shape. The picture [B], a gear tooth in the normal shape.

If chipped/shaved teeth are observed, shift the phase of the gear position by rotating by 180 degrees at angle.

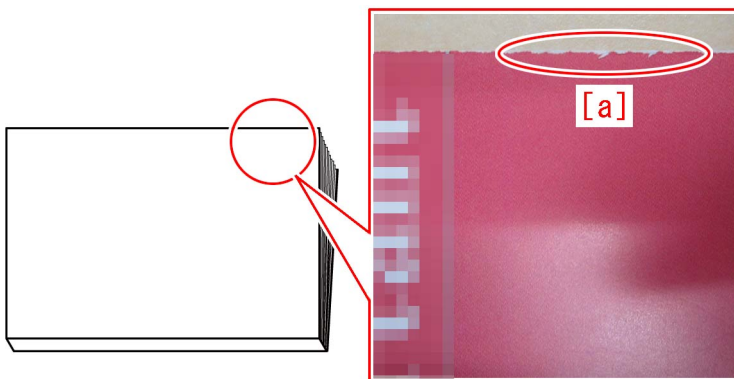
Trimming performance of the trimming blade goes down and trimming failure [a] occurs.

Replace the trimming blade and the heater (Glue vat unit) in accordance with the designated work interval described in Service Manual.

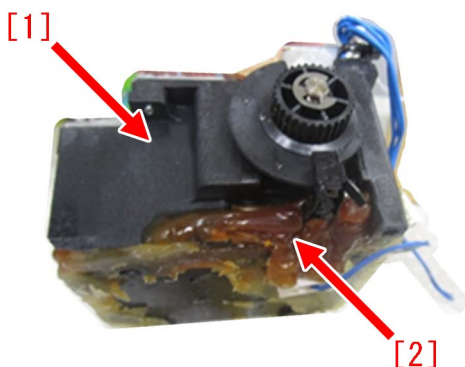
When glue [2] overflows from the glue vat [1] and hardens on surrounding parts of the glue vat, the glue vat [1] may become unable to be detached. Also, errors (E5B0-8007/E5B2-8001/E5B7-0001/E5B7-0002/E5B8-8001) may be triggered.

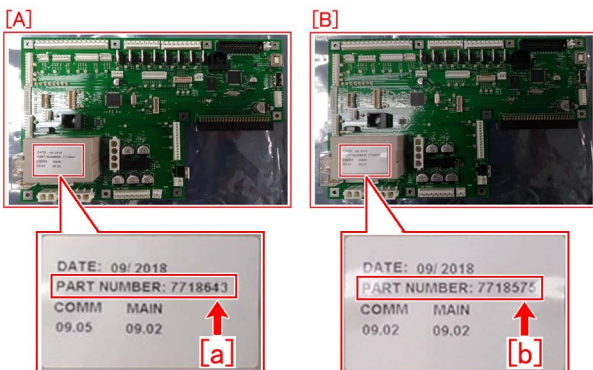
For some reason, when power drop or power OFF is caused during the version upgrade process of Multi Function Professional Puncher-A1, some part of the firmware fails to be written in, causing the above symptom.

The new/old type of MAIN CONTROLLER PCB ASS'Y could be identified by the PART NUMBER [a] [b] printed on a label on a PCB.

- New type [A]: 7718643[a]
- Old type [B]: 7718575[b]

When the above mentioned failure is observed, replace with the new type MAIN CONTROLLER PCB ASS'Y(FC3-7449-000)[A], which has its Bootloader firmware modified.

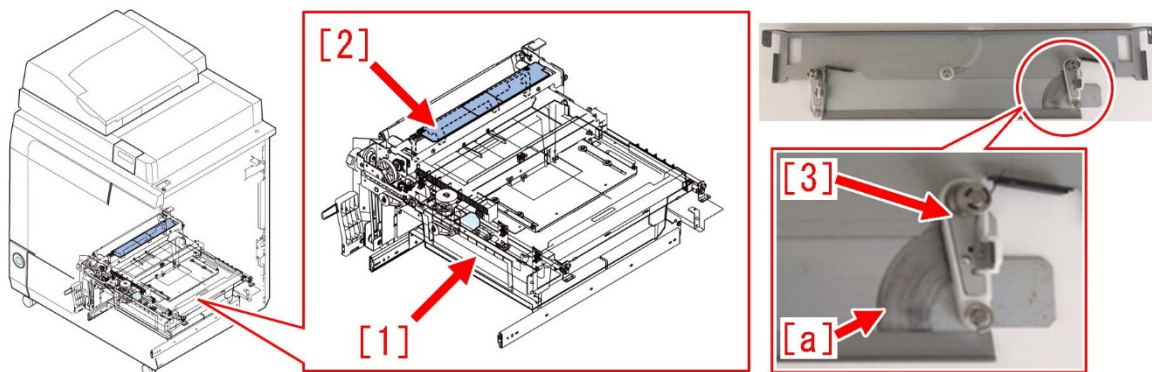
As the life of the dust buffer [2] in dust collecting area [1] advances, the surface [a] that comes in contact with the arm [3] gets shaved. This causes sliding failure of the dust buffer, resulting in the above symptom.

When the above symptom occurs, prepare some lint-free paper and alcohol, and clean the dust buffer in the following procedure. [Note] When bringing down the trimming assembly, be sure to do so with two people.

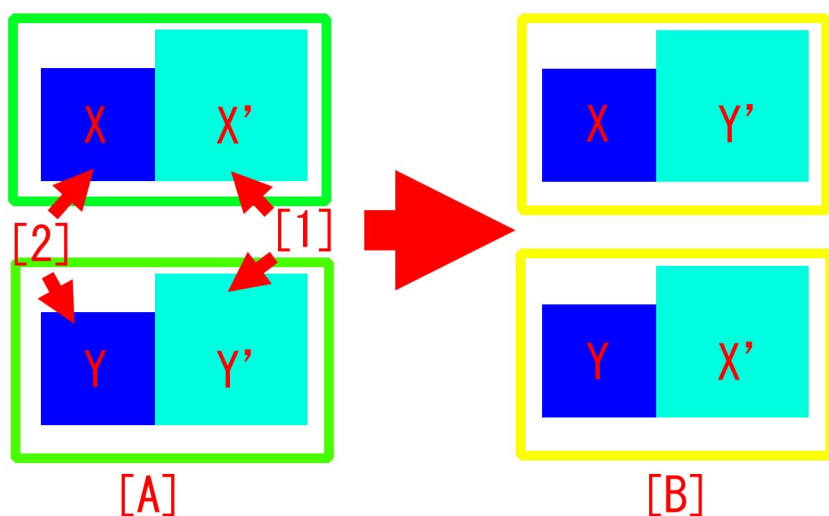
The color sensor detection sensitivity is adjusted on the combination of the main station [1] and the sub-station [2] at the factory. The calculated adjustment value is put down to the service label and the label is affixed to the sub-station [2]. At the same time, the adjustment value is entered to DCON of the main station [1], and both of them are shipped in sets [A].

Hence if a main station and a sub-station is installed in field in a combination that is different from that at the time of shipment from the factory [B], the adjustment value of the color sensor detection sensitivity that was entered to the main station [1] may not be suitable for the auto gradation adjustment processing, and the aforementioned symptom may occur.

Perform the work following the installation procedure.

1) In the step "Supplying the Starter" of the installation procedure in the service manual, put down the value of the following 12 items in the service label which is put on the sub-station. Service label is located near [a].

2) In the step of "Auto Gradation Adjustment (Full Adjust)" of the installation procedure in the service manual, go to Service Mode (Level2) > COPIER > ADJUST > P-PASCAL and enter the service label value that was put down in the step 1).

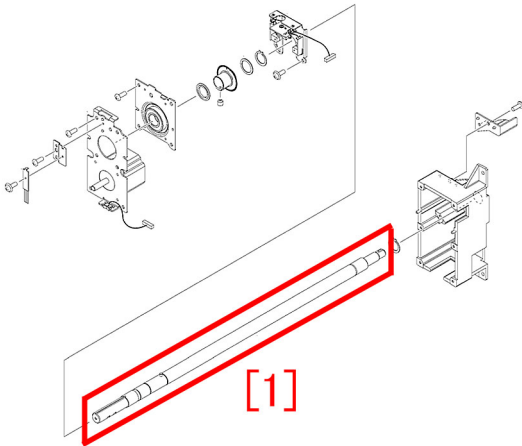
[Reference] When E012-0x40/0x80 occurs, and the symptom reoccurs even after replacing the drum drive driver PCB, the drum shaft encoder sensor A, the drum shaft encoder sensor B and the drum HP sensor, and the chips of transmission shaft inside the drum drive assembly [1]scatter, such symptom may be improved by replacing the transmission shaft.

The transmission shaft (FC6-0118-000) [1] inside the drum drive assembly is newly set up as a service part. When replacing it, follow the steps below.

Prepare the required number of transmission shafts (FC6-0118-000), newly set up as a service parts, and C rings (XD2-3100-202), and follow the steps below for replacement.

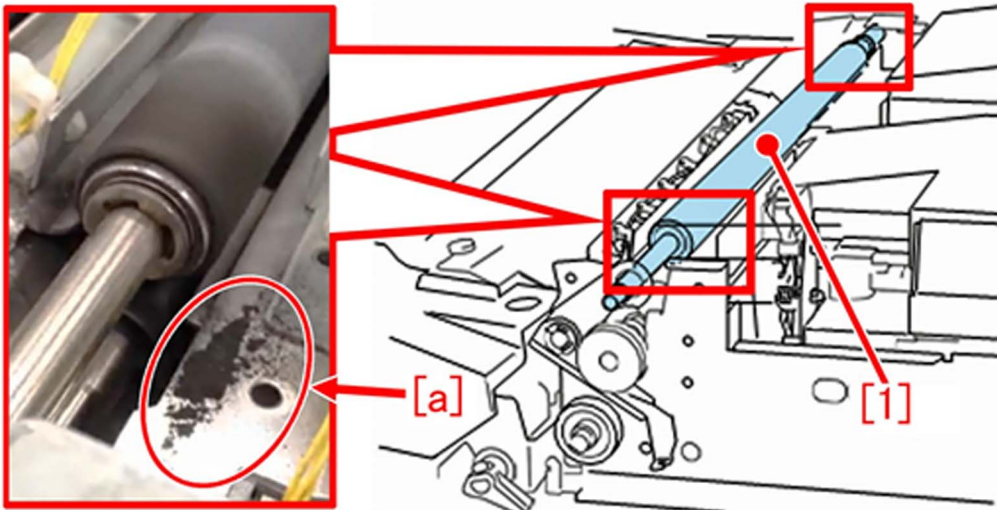
Shavings [a] of the shaft may be attached around the both ends of the upper registration roller [1] in the machine earlier than the following countermeasure cut-in serial numbers in factory.

After some endurance time has elapsed, the outer periphery of the bearing of upper registration roller and the inner periphery of the roller scuff and shave each other, and this leads to the above mentioned symptom.

When the aforementioned symptom has occurred, prepare and replace with the new type upper registration roller (FM1-F405-010) referring to the "Replacement Manual for Durability Enhancement Parts". When to replace, first wipe off the shavings before performing the work.

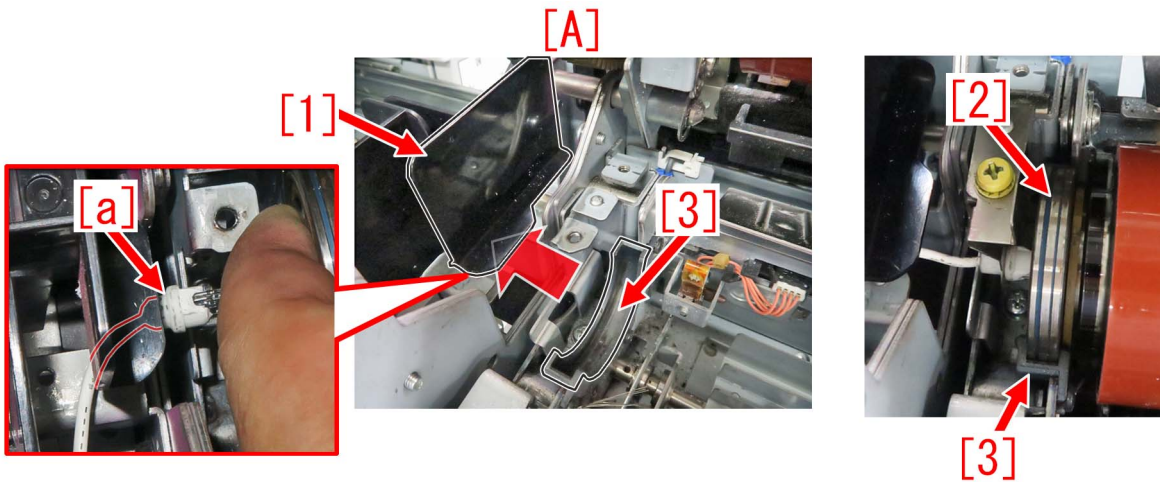
When the pressure roller heater is incorrectly set in the secondary fixing assembly, the AC cable of the pressure roller heater may be damaged and the following symptoms may occur.

[Note] If the bearing is set in place with the insulator [a] of the pressure roller heater positioned over the cable guide [1], the heater may break from the weight of the pressure roller being applied to it.

3) Be sure to have the insulator [a] of the pressure roller heater on the rear side [A] pass below the cable guide [1] of the secondary fixing assembly of the machine. After confirming that the insulator [a] of the pressure roller heater is not positioned over the cable guide [1], set the bearing [2] in the bearing holder [3].

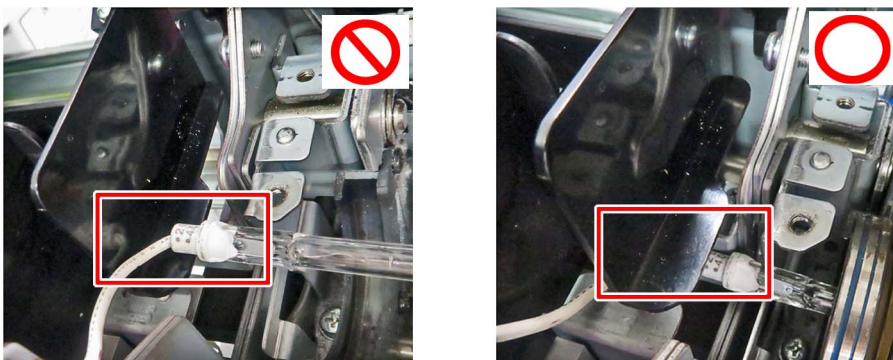
[Reference] The left photo is the image of the insulator of the pressure roller heater on the rear side positioned over the cable guide. The pressure roller is being removed for easier viewing. The right photo shows the correct state.

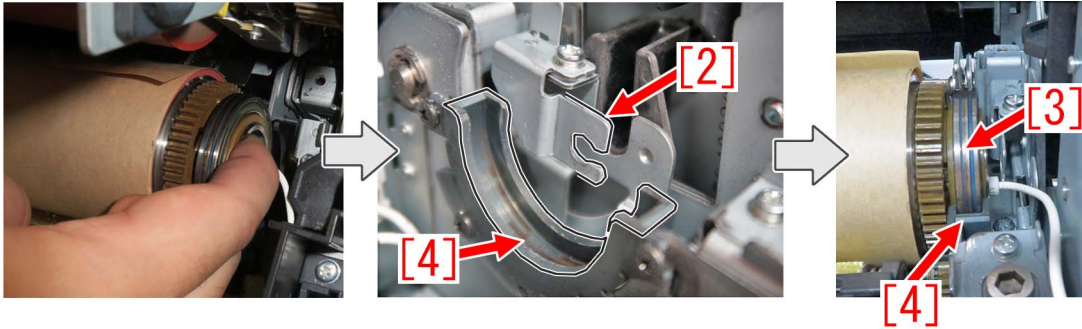
[Reference] The left photo is the image of the insulator of the pressure roller heater on the front side positioned over the heater retainer (Front) [1]. The pressure roller is being removed for easier viewing. The right photo shows the correct state.

4) While keeping the insulator of the front end of the pressure roller heater inside the pressure roller [B], set the bearing [3] in the bearing holder [4] without going over the heater retainer (Front) [2] of the secondary fixing assembly of the machine.

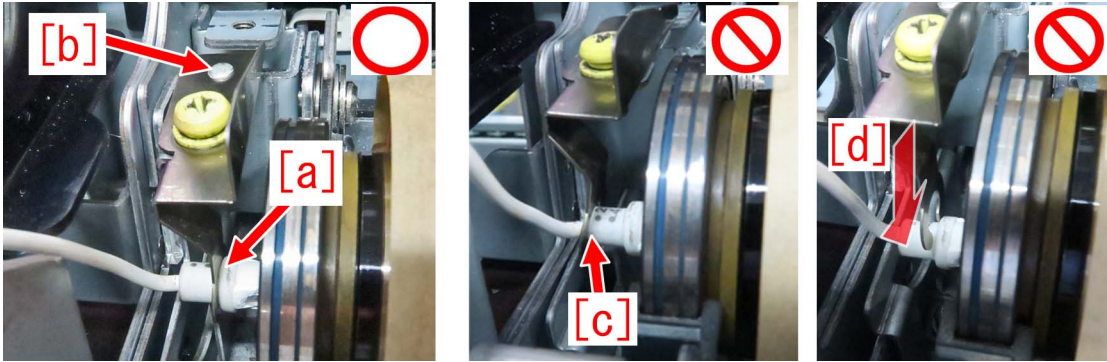
[Reference] In the photo [c] below, the edge of the insulator is hitting the mounting component. In the photo [d], the insulator is not set in the mounting component. The insulator is not in the correct state in both cases.

Rear side: The insulator of the pressure roller heater is inserted into the notch of the heater mounting spring up to its stepped section [a].

The heater mounting spring is engaged with the positioning emboss [b]. (It should not be on the emboss.)

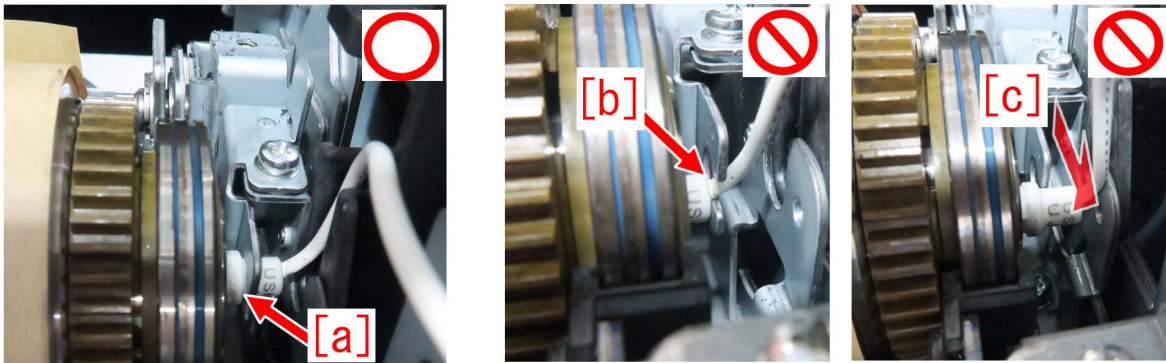
[Reference] In the photo [b] below, the edge of the insulator is hitting the notch of the heater retainer (front). In the photo [c], the insulator is not set in the notch of the heater retainer (front). The insulator is not in the correct state in both cases.

Front side: The insulator of the pressure roller heater is inserted into the notch of the heater retainer (front) up to its stepped section [a].
