Troubleshooting Guide

imagePRESS

C10000VP Series

January, 2019
Canon U.S.A., Inc.

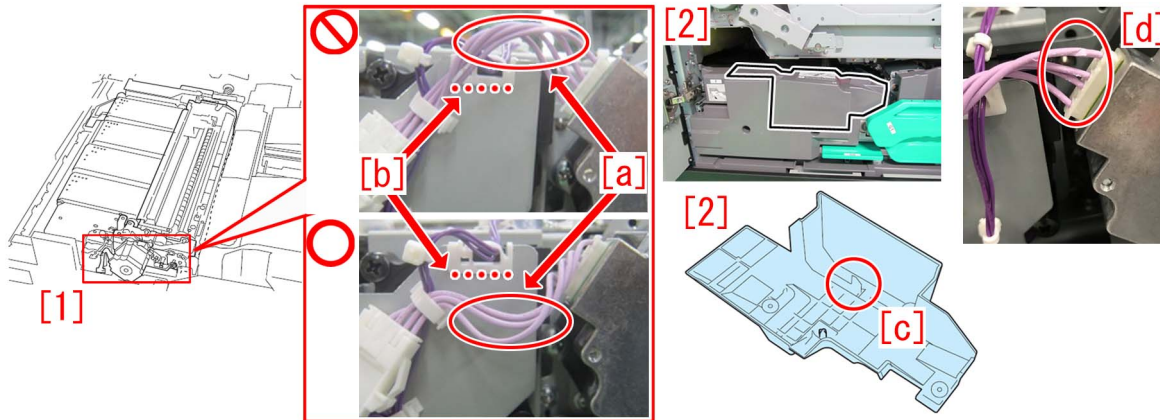
When installing the inner cover 2 [2] with the cables [a] of the secondary transfer drive unit [1] located higher than the edge of the edge saddle [b], the protrusion [c] on the back side of the inner cover 2 hits the cables and the coating of the cables may be damaged [d].

When working with the secondary transfer drive unit or removing the inner cover 2, check the cables for any dents, damages and scratches.

If any dents, damages and scratches are found on the harness, prepare the new motor connecting cable (FM1-T808) and follow the steps below.
