PRODUCT CAMPAIGN BULLETIN

NUMBERS: TKA-20R
 TKB-20R
 TKC-20R

DATE: 01/06/20

SUBJECT: Takata Front Passenger Airbag Module / Inflator “Like for Like” Recall

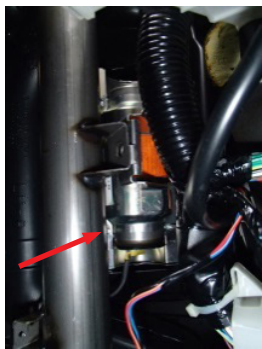
Model Years	Carline	Part Number	Type	Procedure / How to Identify	ZF TRW End Collar Color	ZF-TRW: OK - Do NOT replace the Inflator or Module Assembly. Process Claim for INSPECTION ONLY.	TAKATA: NG - Replace the Inflator or Module Assembly per the table.
2004-05MY	IMPENZA WRX	98279FE070 98279FE07A	Inflator	<ol style="list-style-type: none"> For these models, there is no need to remove any parts. Check the inflator collar from the bottom backside of the instrument panel (IP) on the passenger side. <ul style="list-style-type: none"> If the color of the collar is Pink, it is a ZF TRW inflator. If no collar is found, it is a Takata inflator. 	Pink

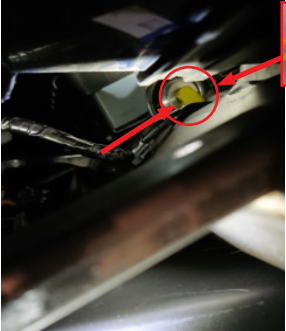
<p>Harness connector is a combination of Black and Yellow.</p>

<p>Harness connector is Solid Yellow.</p>

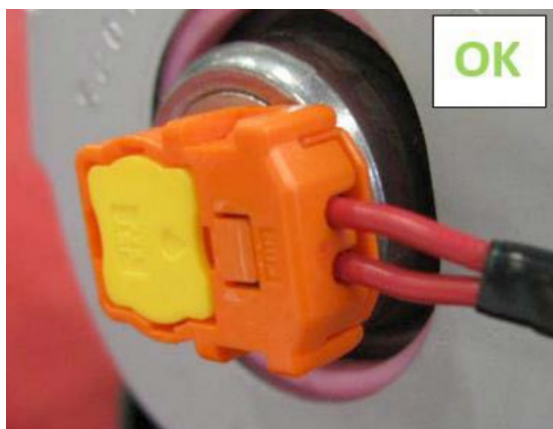
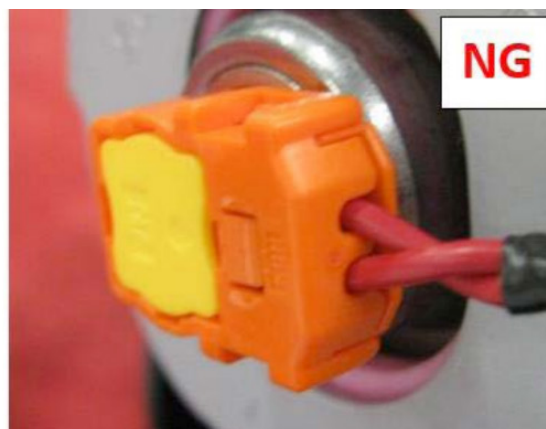
BEFORE connecting the harness to the inflator, make sure the harness is not twisted as shown below.

STEP 16- The new inflator wiring harness has 2 “sides” with 2-pin connectors on both ends. The side with the black harness tube goes with the black inflator connector and the other side (yellow harness tube) will connect to the orange connector. The end of the inflator aligned with the new Stopper Plate (A) will have a black harness connector while the connector on the opposite end of the inflator will be orange. This makes it impossible to install the harness backwards as the tangs (shown in Step 17) are also in different positions.

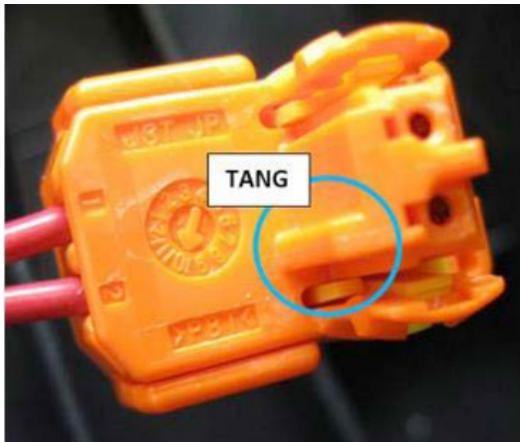
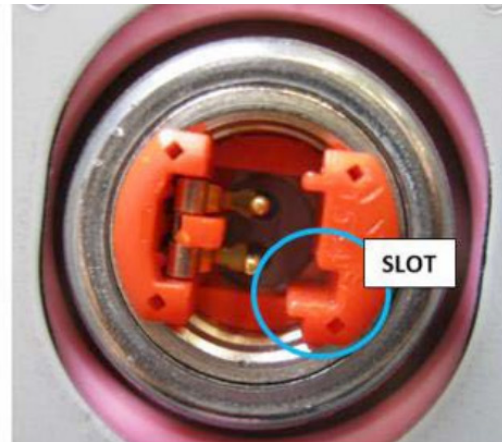
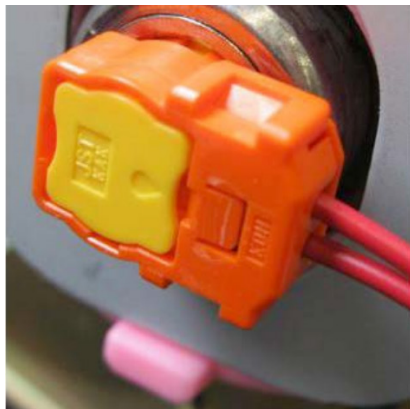
IMPORTANT: NEVER PEEL BOTH THE WHITE DUST COVERS OFF AT THE SAME TIME!

STEP 17- Peel off **one** white dust cover and **CAREFULLY** align the tang of the new harness connector with the receiving slot in the inflator connector. This assures proper routing of the harness in relation to the airbag assembly mounting bracket.

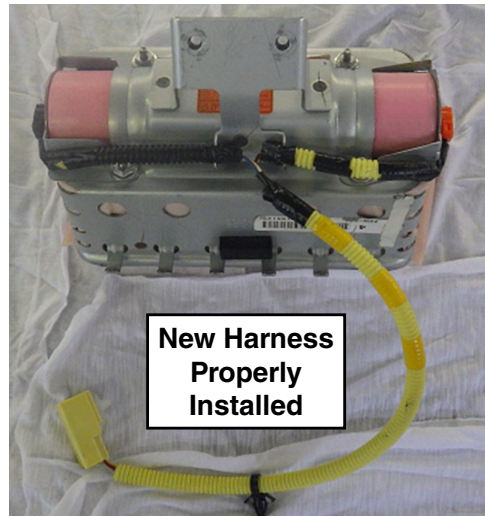
VERY IMPORTANT: After connecting the new harness to the inflator, **both sides MUST be routed as shown** in the “New Harness Properly Installed” photo below.

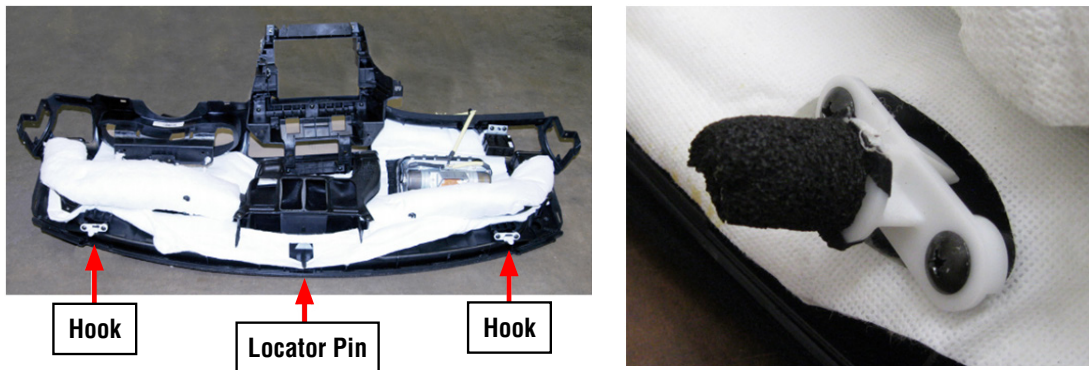
TIP: To eliminate a possible source of a rattling sound from the dash, wrap the 2 hooks and locator pin with non-woven material, p.n. SOA963W110 (or an equivalent self-adhesive foam) as shown below.

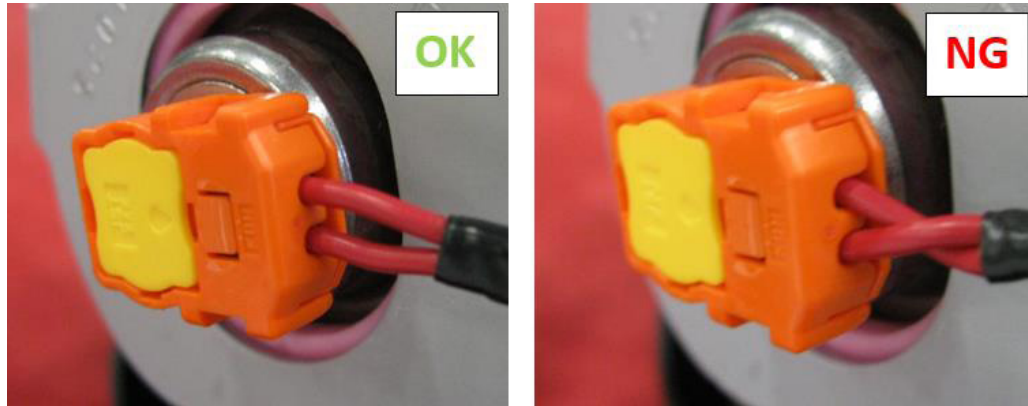
STEP 13- Reinstall the wiring harness retaining clip into its position on the mounting bracket.
IMPORTANT: Confirm the harness is not twisted at the inflator connector as shown below.
