PRODUCT CAMPAIGN BULLETIN

APPLICABILITY: 2003-2004 Baja
 2003-2008 Legacy and Outback
 2004-2005 Impreza, WRX, STI

SUBJECT: Takata Front Passenger Air Bag Inflator Replacement

NUMBER: WQR-53R
DATE: June 2, 2015
REVISED: April 12, 2016
NHTSA ID: 15V-323

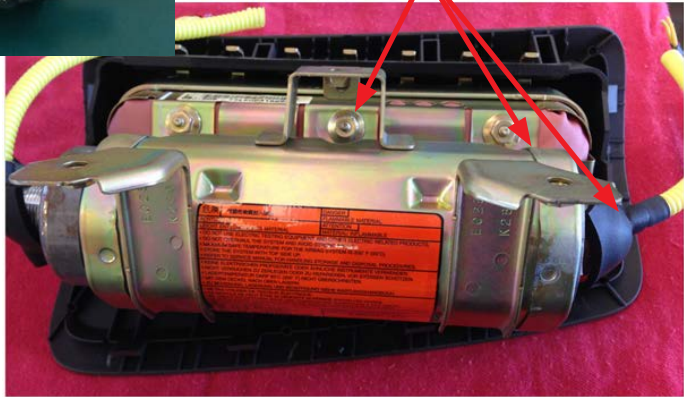
The shape, holes, and copper-colored stud indicate this not a Genuine Subaru inflator.

No visible stopper plates, a 6-nut configuration and rubber harness boots are other examples to indicate this is not a Genuine Subaru airbag module.

- Document the presence of the aftermarket or counterfeit device on the repair order and with photos. Report this information immediately on a Quality Monitoring Report (QMR).
- Once the QMR has been submitted, contact the Subaru Claims Helpline to discuss the details. They will advise you on how to proceed with treatment of the open campaign.

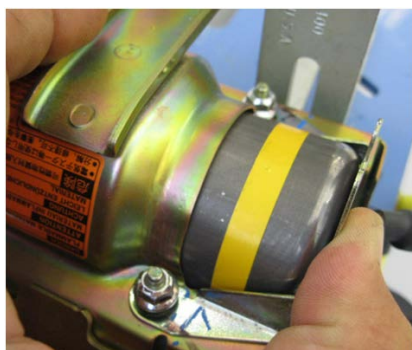
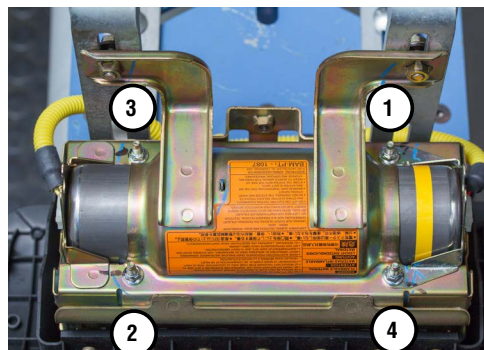
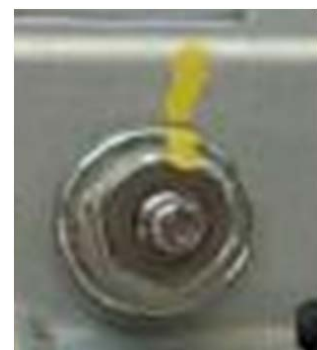
Inflator properly seated against mounting bracket (NO GAP)

STEP 10- As shown below, install but **do not fully tighten** 2 of the NEW self-locking nuts while holding the stopper plate tight against the inflator. Remove the nuts still installed on the mounting bracket and replace them with 2 NEW self-locking nuts. Once all 4 NEW nuts are in place, **torque to 31 - 38 inch pounds in the sequence shown below**. Use a marker to mark the nuts after torquing to indicate they have been fully tightened.

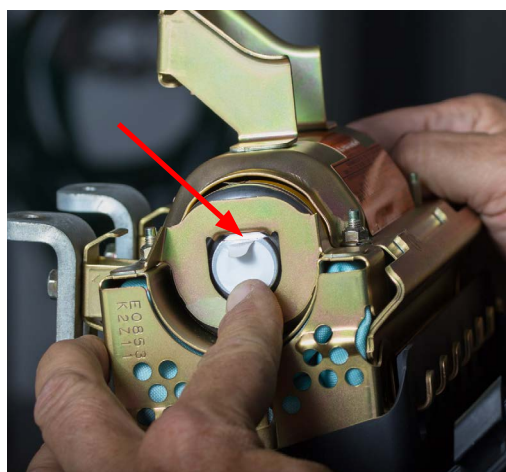
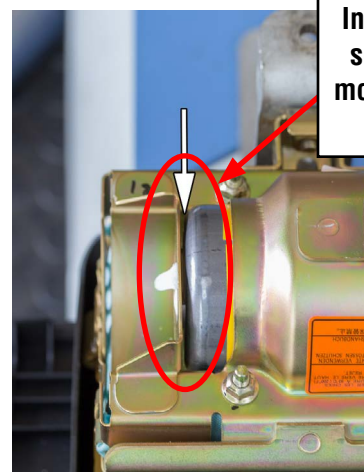
Inflator properly seated against mounting bracket (NO GAP)

STEP 9- Install the new inflator into the mounting bracket with the harness connector end going in first toward the mounting bracket. Make sure the “D-shaped” portion of the inflator harness connector boss aligns with the “D-shaped” portion of the hole in the end of the mounting bracket as shown below. When properly installed, the end of the inflator will be seated tight against the mounting bracket. Do not peel the white harness connection dust cover at this time.

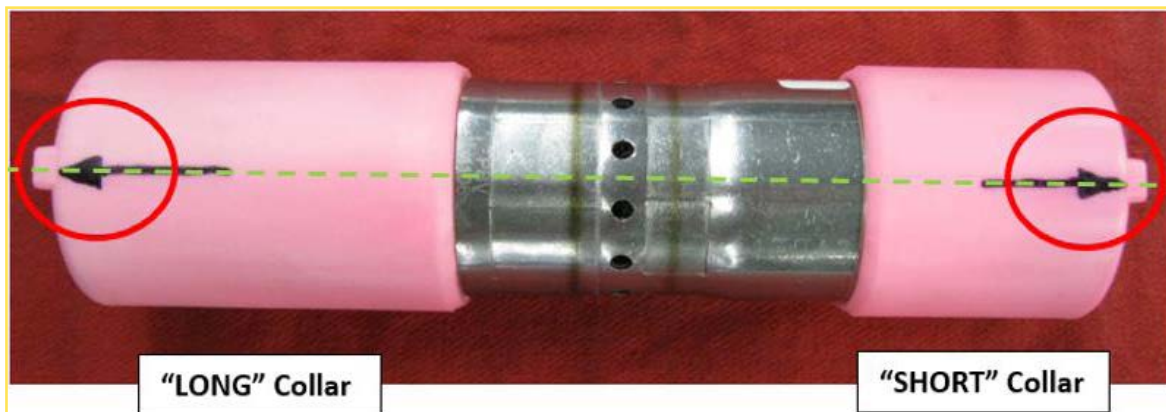
NOTE: The **Type 2** inflator is installed in the opposite direction of the original. This change puts the connector on the other end. The new harness has been extended approximately 2” to compensate.

STEP 9- Inspect the new **Type 2** inflator to confirm the locating protrusions on each of the pink collar portions are aligned as shown below. The “short” collar can be rotated as needed to align it with the protrusion on the “long” collar if necessary.
