David J. Johnson
 Director
 Service Engineering Operations
 Ford Customer Service Division

May 21, 2021

SUBJECT: Safety Recall 19S54 – Supplement #2
 Certain 2006-2010 Model Year Fusion/Milan/MKZ/Zephyr Vehicles Equipped with Anti-Lock Brake Systems
 DOT 3 Brake Fluid and Anti-Lock Brake System Function

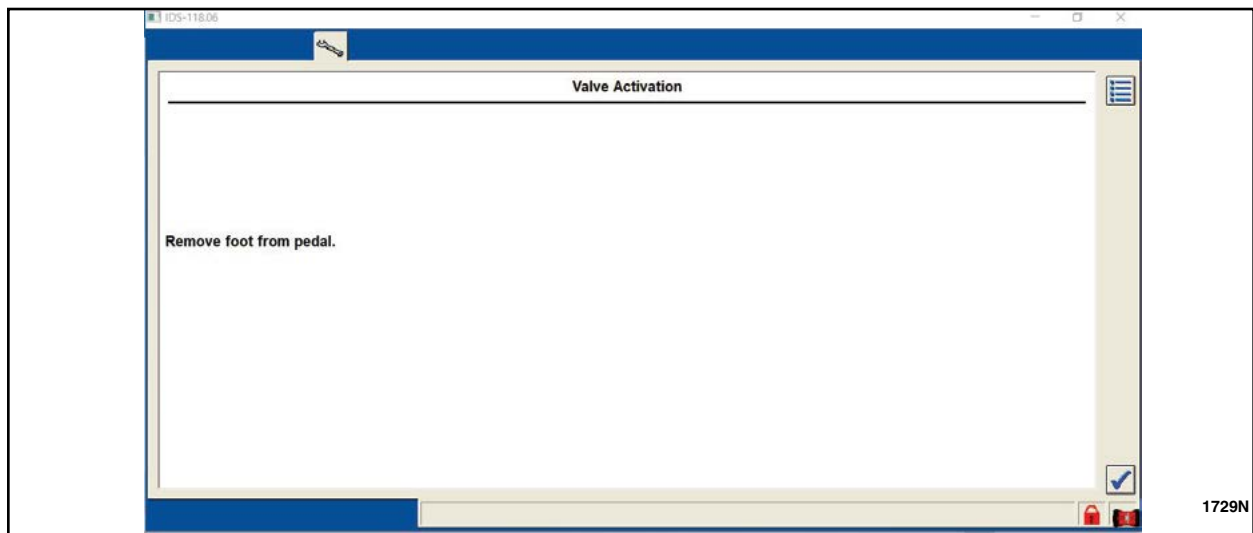
FIGURE 6

NOTE: Brake pedal must be depressed when prompted to complete the IDS routine, **if brake pedal is not depressed** you will receive a message prompting you to do so. See Figure 6.

NOTE: If brake pedal is depressed properly, Figure 6 **will not** apply.
