Device **TC29x**
Marking/Step **ES-BC, BC**
Package **see Data Sheet**

This Errata Sheet describes the deviations from the current user documentation.

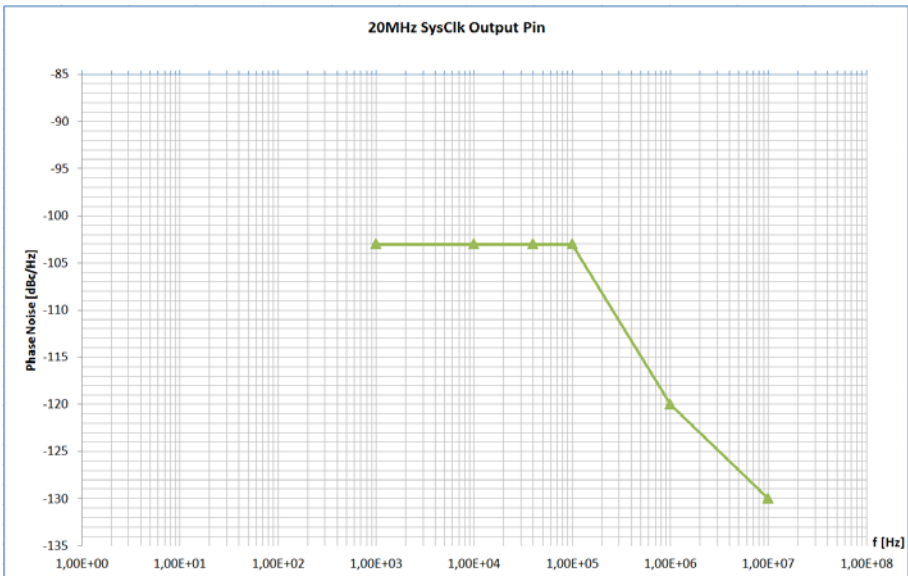
Figure 5 Phase Noise Density on SysClk Output Pin

The diagram below shows the phase noise density on the SysClk pin when no application pattern but only the HSSL/HSCT subsystem is running:

When designing the PLL for an HSSL/HSCT ASIC, the values for I_{PN} and J_{ABS20} above and ultimately $BER_{20} = 10^{-12}$ can be achieved with the following recommendations:
