## Technics SLP8

# AUDIO FAULTS

# DVD

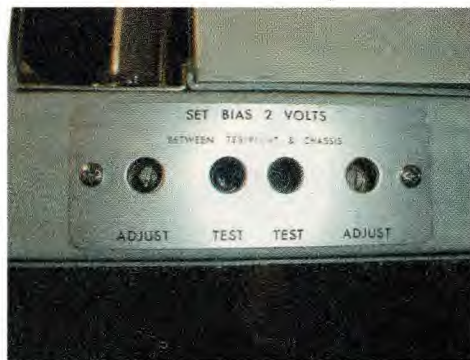
This particular model has a facility for setting the bias for the output valves, see Photo 3. All you have to do is to connect an accurate meter (a DVM is best for this job) between a test point and chassis, then adjust the accompanying potentiometer for a reading of exactly  $2V$ . This procedure has to be carried out for all four valves, with the amplifier fully warmed up. The grid-bias reservoir capacitors, dated 1966, were obviously the originals, so I replaced them with new long-life ones – good for another forty years perhaps!

Photo 3: The grid bias adjustment test points/potentiometers.

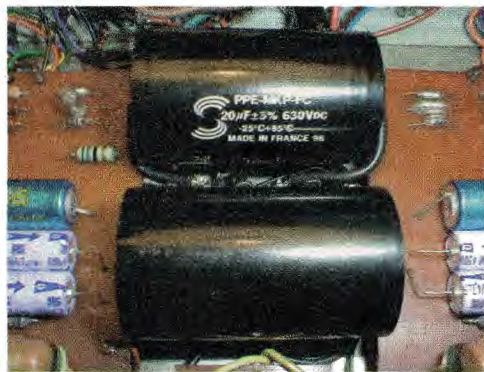
The smoothing capacitors in this amplifier had been replaced with the largest polyester-film capacitors I've ever seen,  $20\mu F$  at  $630V$ ! See Photo 4.

Photo 4: The replacement polyester-film HT smoothing electrolytics.

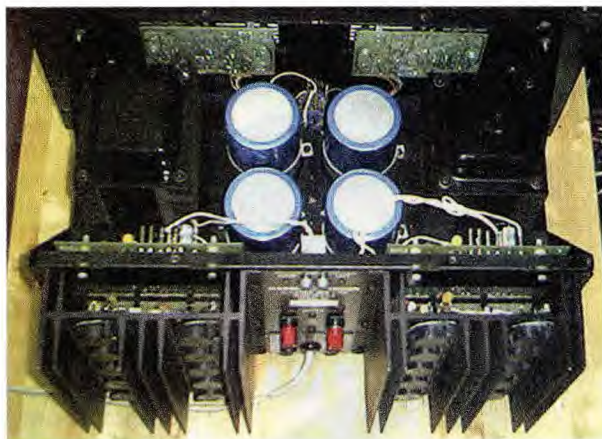
*The Harman Kardon Citation 16 amplifier.*

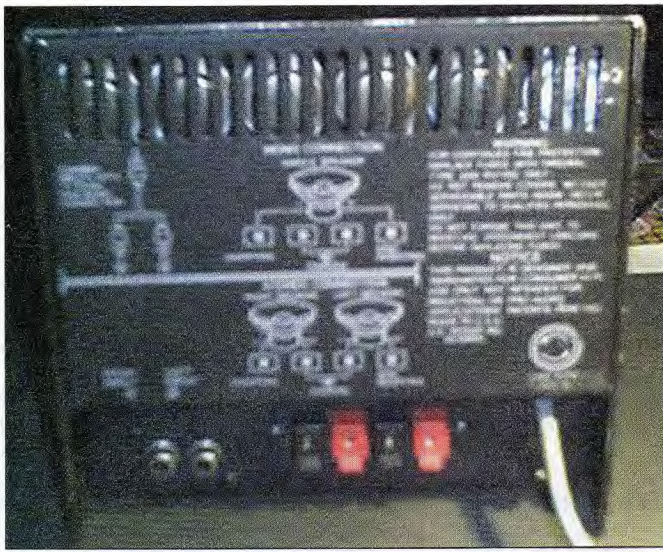
**Left – The Carver Cube’s rear panel.**

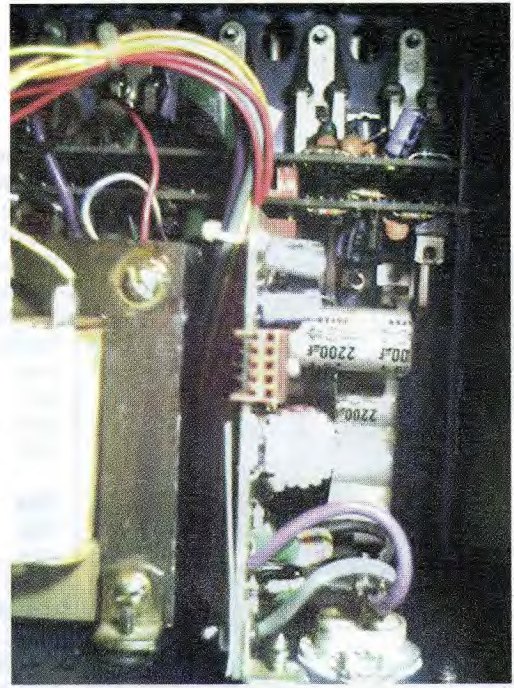
**Right – Internal view of the Carver Cube.**

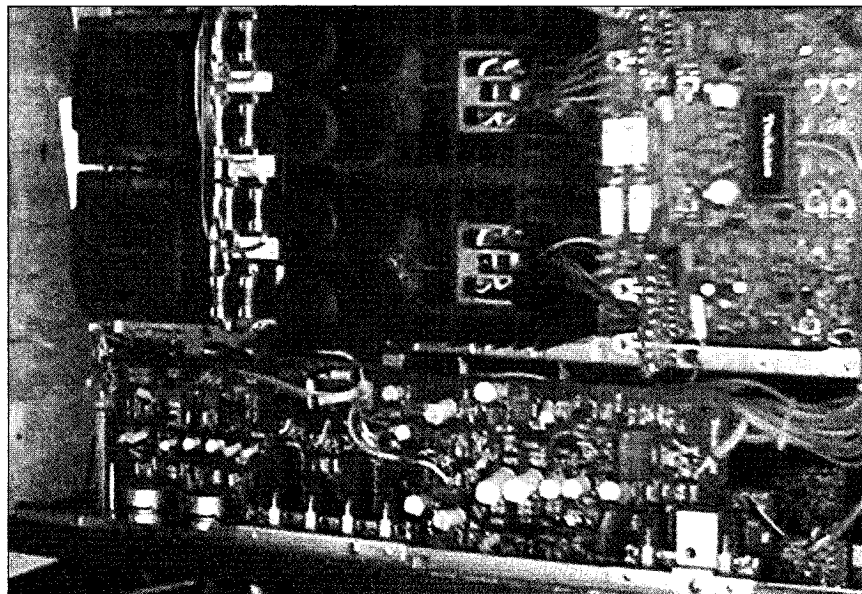
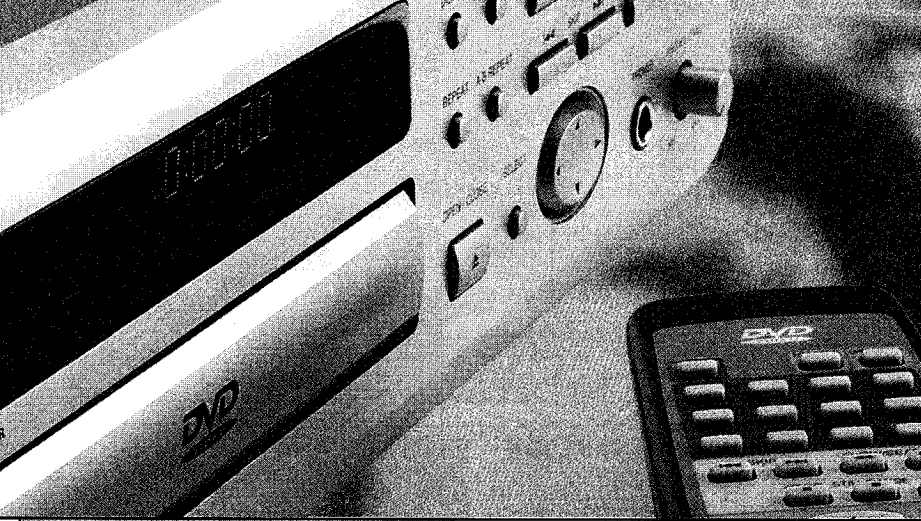
**Inside the Technics SU8080 amplifier.**

A common complaint is no sound from any input. Check that the preamplifier-main amplifier links are present! There's a bunch of fuses under a plate to the right of the transformers (see photo).

These may be missed if you don't know they are there. **P.R.**

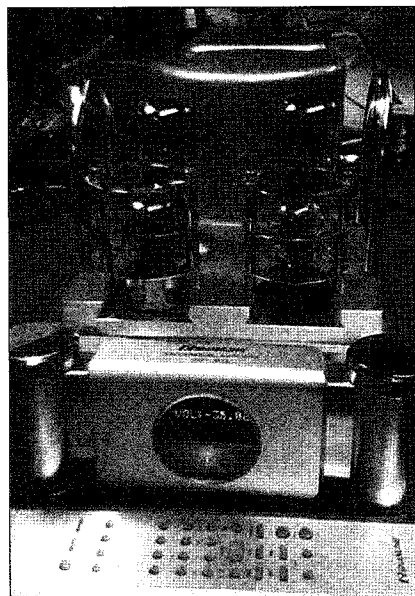
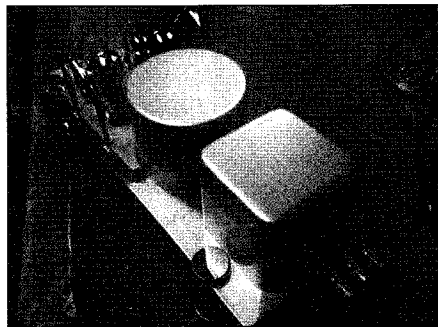
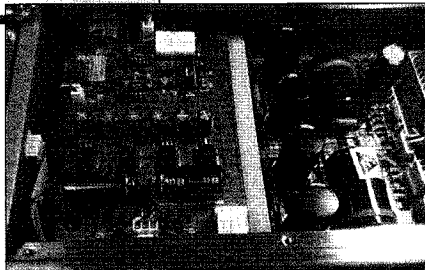
## Shanling SP-80

This beautifully presented, and very well made, monoblock amplifier – see photos - originates in China. It is a very high-end item, and carries a price tag that not so long ago, you would have expected to see on a decent second-hand car !

The described fault was " Whistles ". When powered, as the valves warmed up, it produced what can only be described as an air raid siren 'all clear' sound. I also noticed that the VFD was producing no display. It should produce a welcome message, followed by a dB display for the volume. If you have a pair of the amps for stereo use, they are coupled together by a thin data cable. One amp is then set to "master" and the other to "slave" by rear panel miniature switches. The master receives infra red data via a sensor co-located with the VFD, and passes this to its own processor, and the remote processor in the
