**SUBJECT: NEW VEHICLE DEMONSTRATION / DELIVERY HOLD -  
Safety Recall 21S22**

Certain 2016 - 2019 Model Year Explorer Vehicles equipped with Painted Roof Rail  
Covers  
Roof Rail Cover Detachment

## CERTAIN 2016-2019 MODEL YEAR EXPLORER VEHICLES — ROOF RACK REPAIR

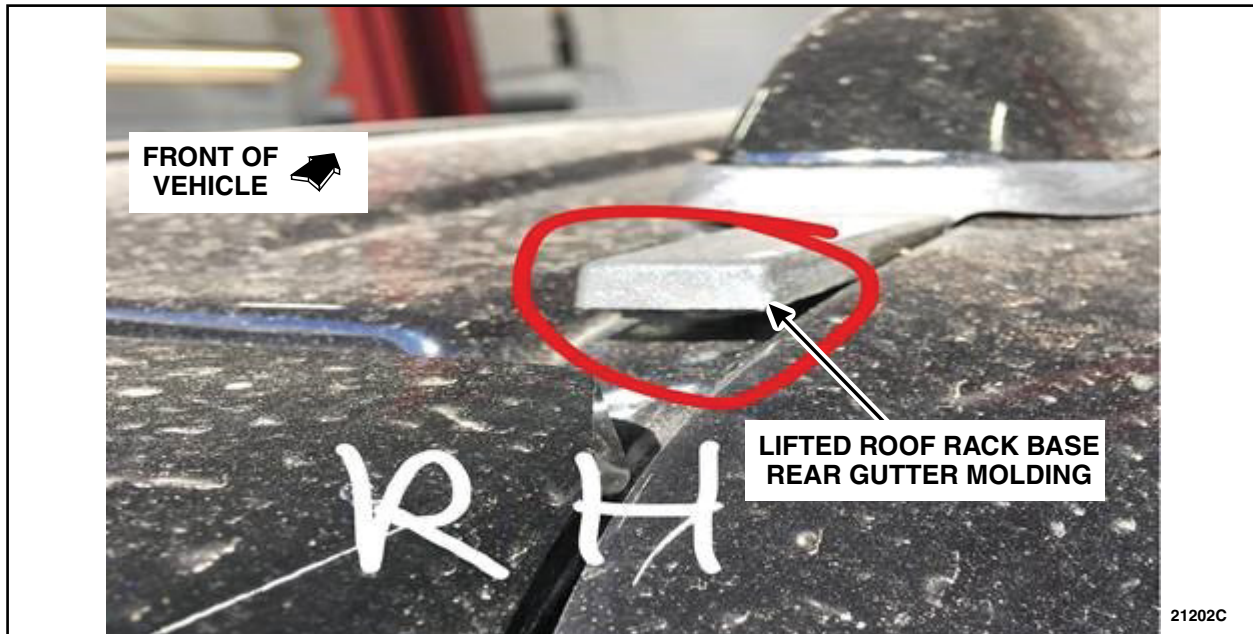
FIGURE 3

A loose or lifted roof rail cover in the front or rear does not indicate the need for parts to be replaced, the root cause needs to be identified in the inspection procedure. See Figures 1, 2 and 3.

**NOTE:** The roof rail base front end caps do not need to be replaced if the roof rail passes inspection. Only replace the roof rail base front end caps if damage has occurred during transfer of parts.

**NOTE:** The roof rail base rear gutter molding does not need to be replaced if the roof rail passes inspection. Only replace the roof rail base rear gutter molding if damage has occurred during transfer of parts.

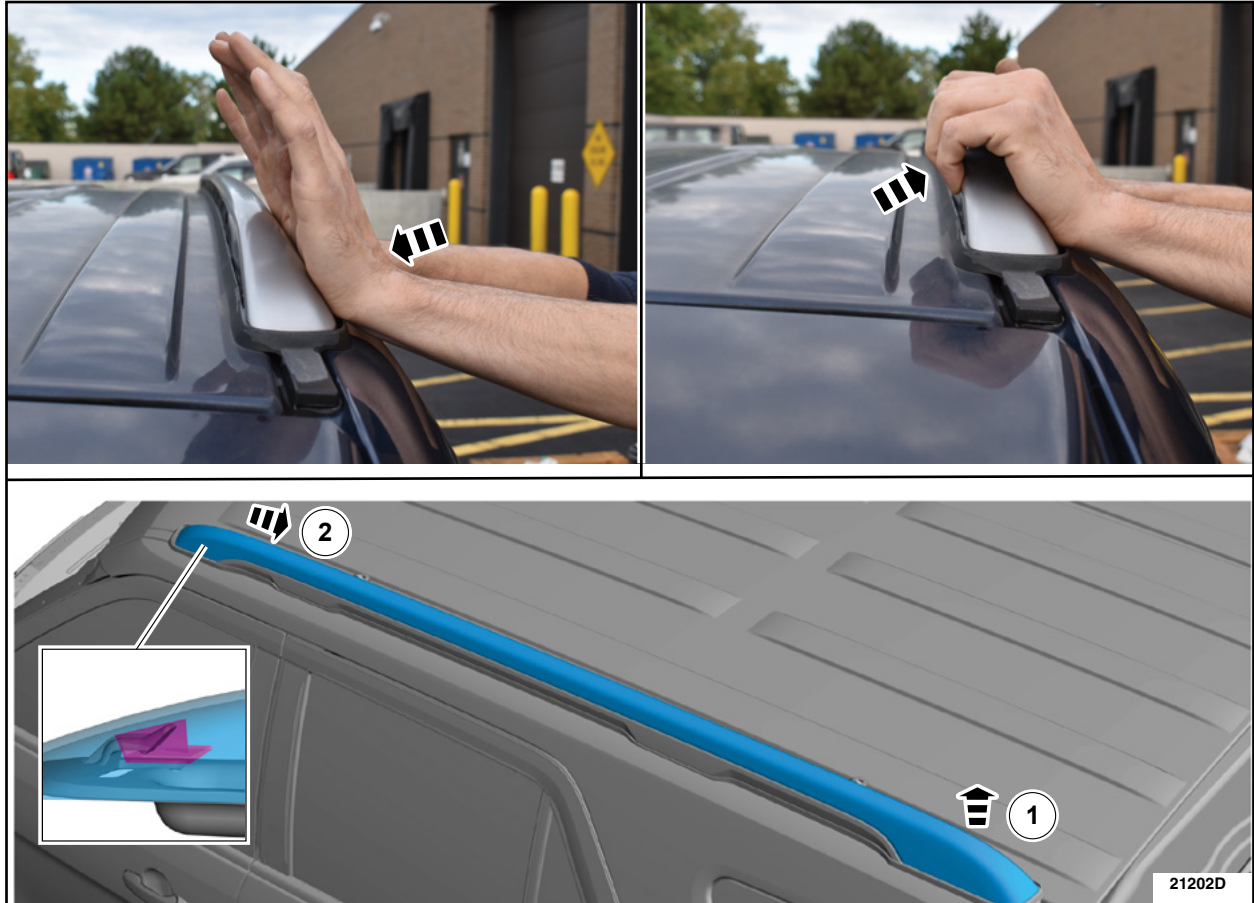
FIGURE 5

a. Remove the affected roof rail cover(s). See Figure 5.

2. Reinstall the roof rail cover by reversing the removal procedure. See Figure 5 on Page 5.

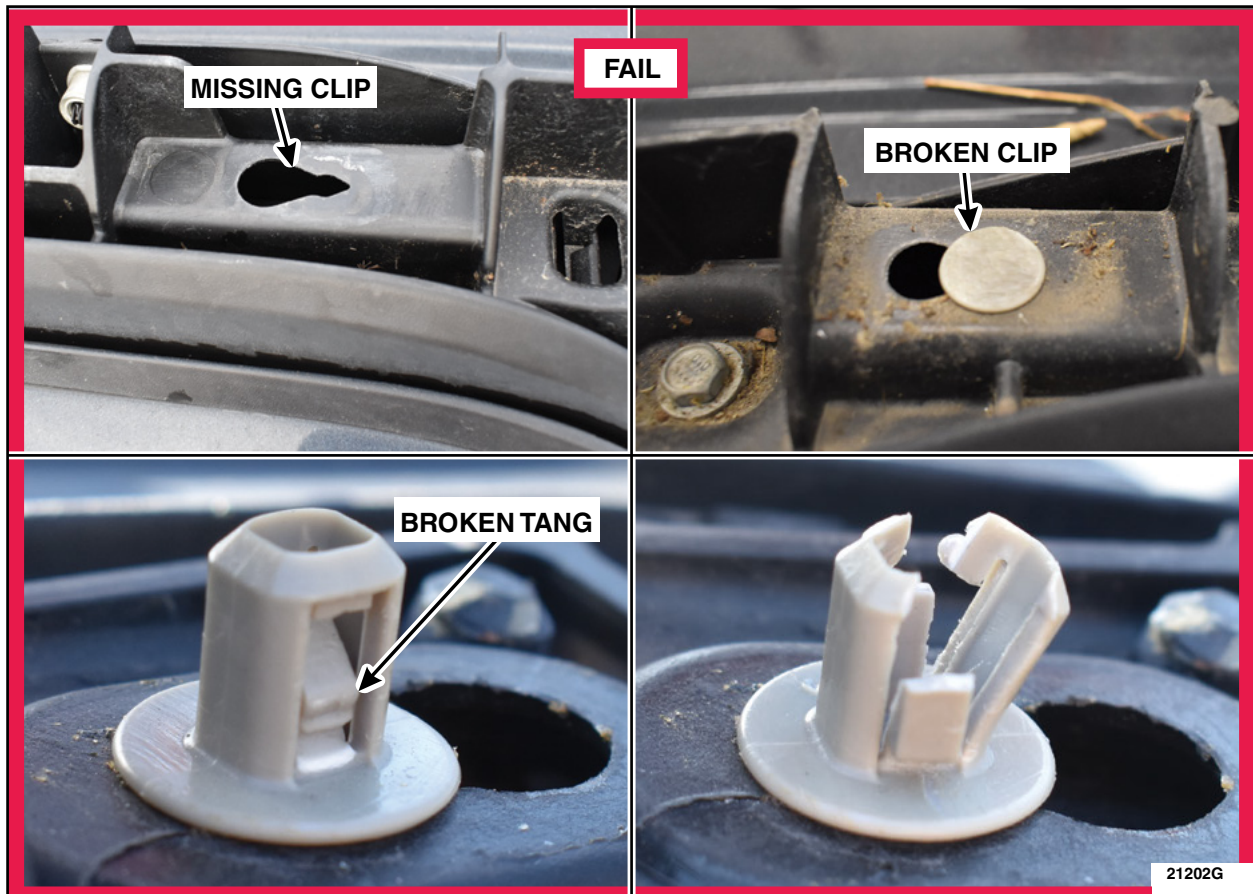
FIGURE 8

c. Inspect the retaining clips (7 per side) on the affected side without removing them from the roof rail base. See Figures 7, 8 and 9.

- Missing.
- All or partial of the top missing from the clip base.
- Broken retaining tang.
- Covered in epoxy from a previous repair.

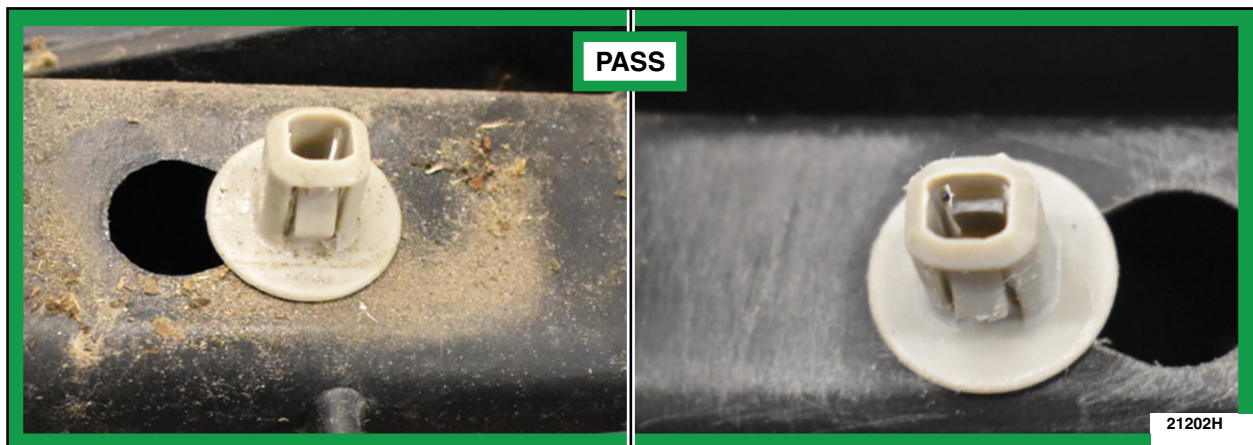
FIGURE 9

d. Inspect the retaining towers (7 each side) on the interior or underside of the affected roof rail cover(s). See Figure 9.

i. Broken tangs do not require replacement.

2. Broken retaining towers must be clearly identified with a bright highlighter or similar.

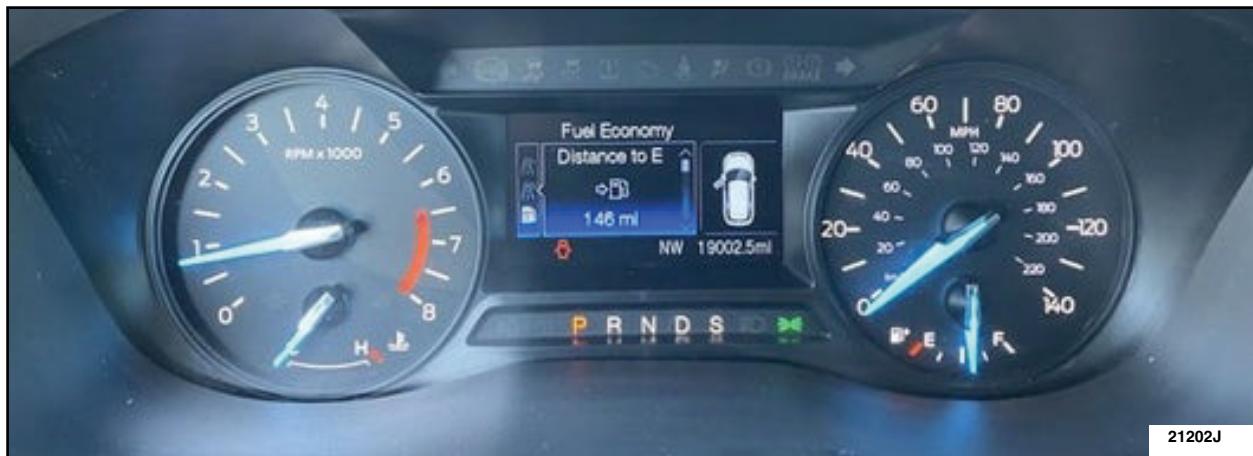
**FIGURE 10**

ii. Take photo showing vehicle mileage. See Figure 10.

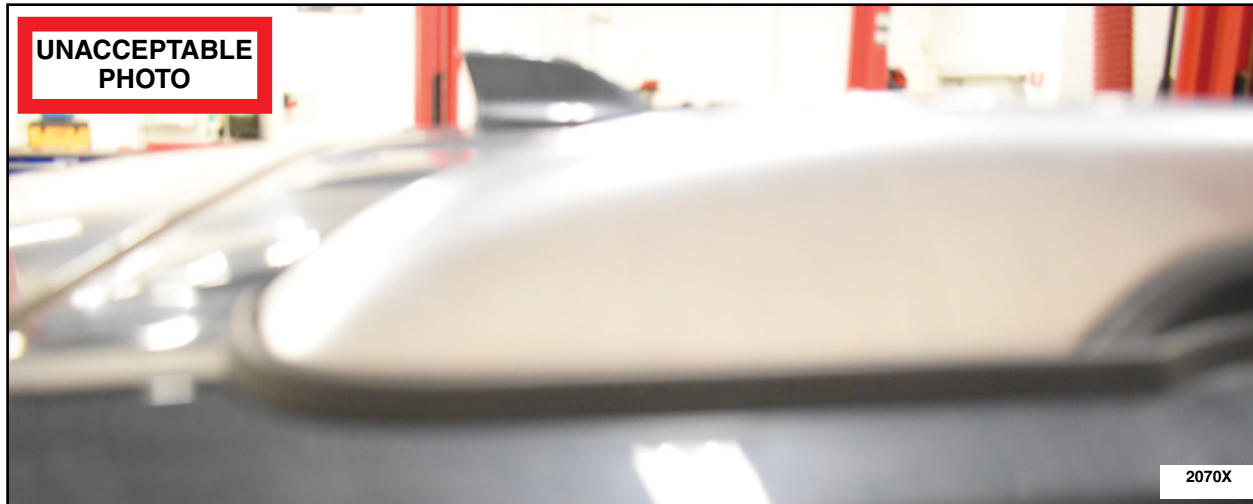
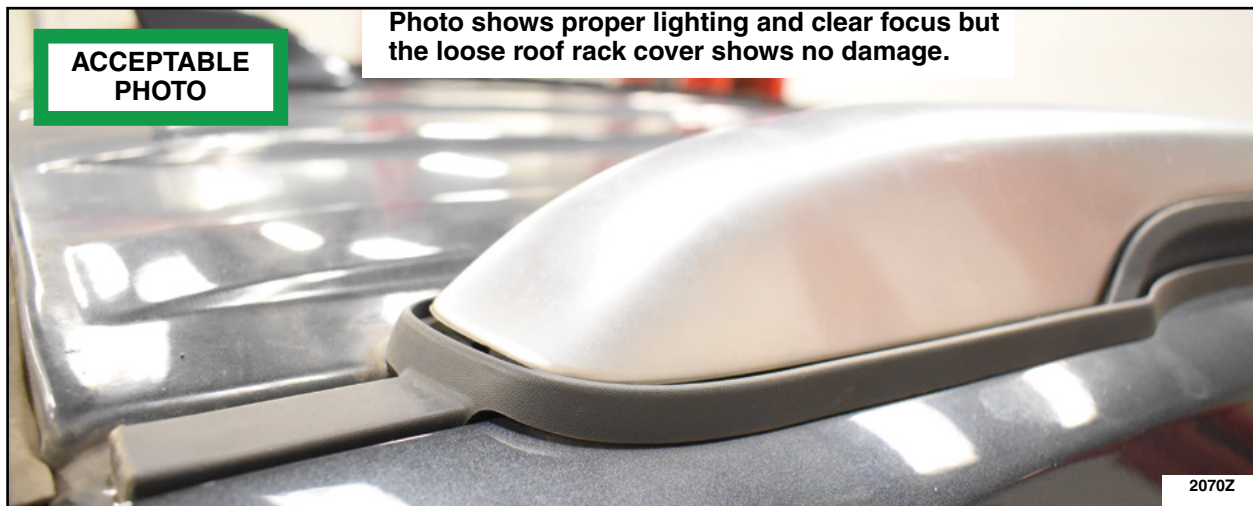
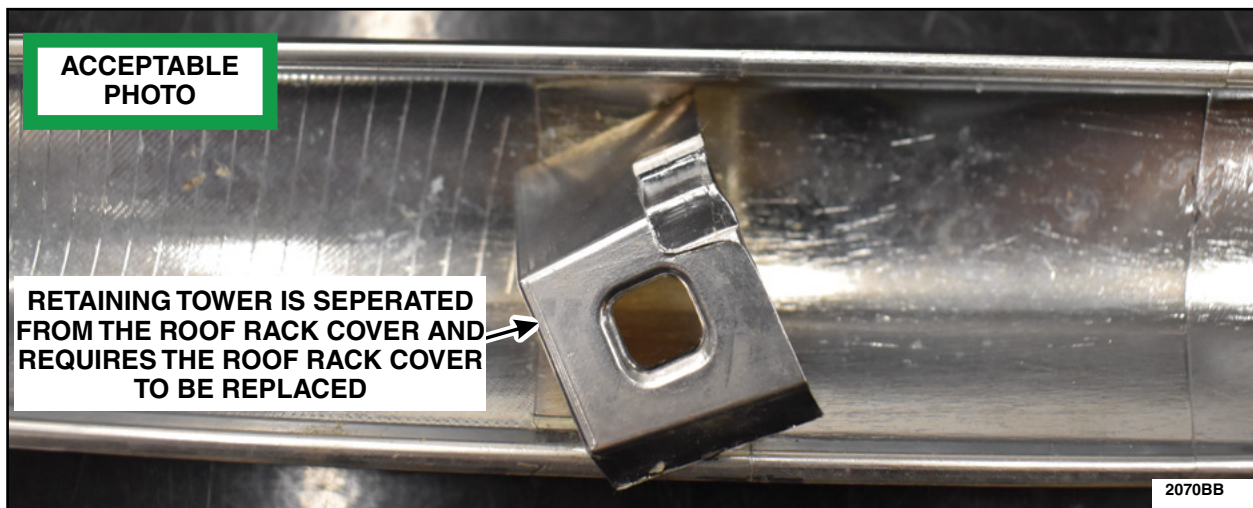
1. Digital images are now required to be attached to each roof rail cover part order. Before submitting VIN-specific part order to SSSC, review new digital image submission requirements on page 2 of Attachment II in the Dealer Bulletin. See Figures 22 through 25 for examples.
