Device TC39x
Marking/Step (E)ES-BD, BD
Package see Data Sheet

10219AERRA

This Errata Sheet describes the deviations from the current user documentation.

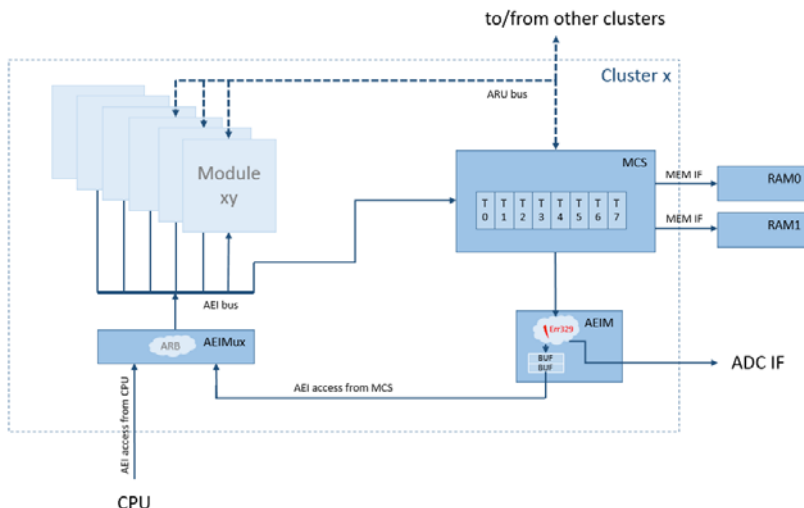
Figure 5 Cluster-internal AEI network

Problem GTM_AI.329 is related to a potential incorrect handling of MCS access requests to the AEI bus at the AEIM entry stage in case that one AEIM buffer is already filled. If in such a case a new access request from MCS enters the AEIM logic during a very specific time window (related to progress on the AEI bus), the AEIM logic might signalize incorrect parameters back to MCS that could result in incorrect data, the loss of data or a repetitive execution of MCS accesses to AEI.

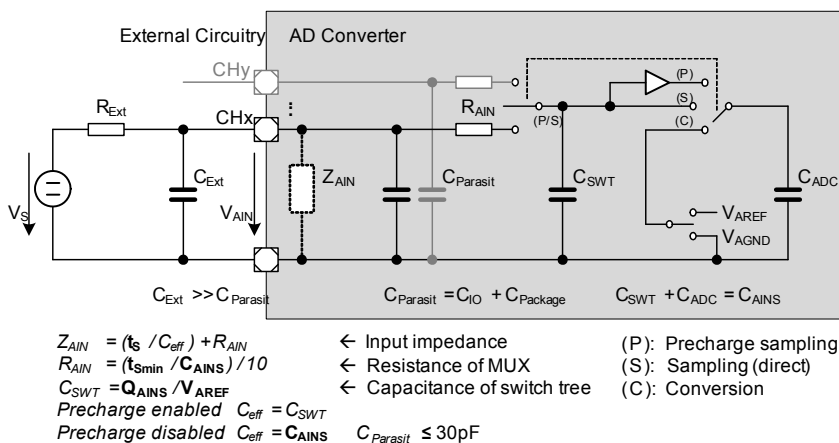
Figure 9 Equivalent Circuitry for Analog Inputs
EDSADC TC.P002 Parameters Input Current, Gain Error - Additional information

Figure “Equivalent Circuitry for Analog Inputs” will be modified in future revisions of the Data Sheet, including the term $C_{\text{Parasit}} \leq 30$ pF, as shown in the following figure:

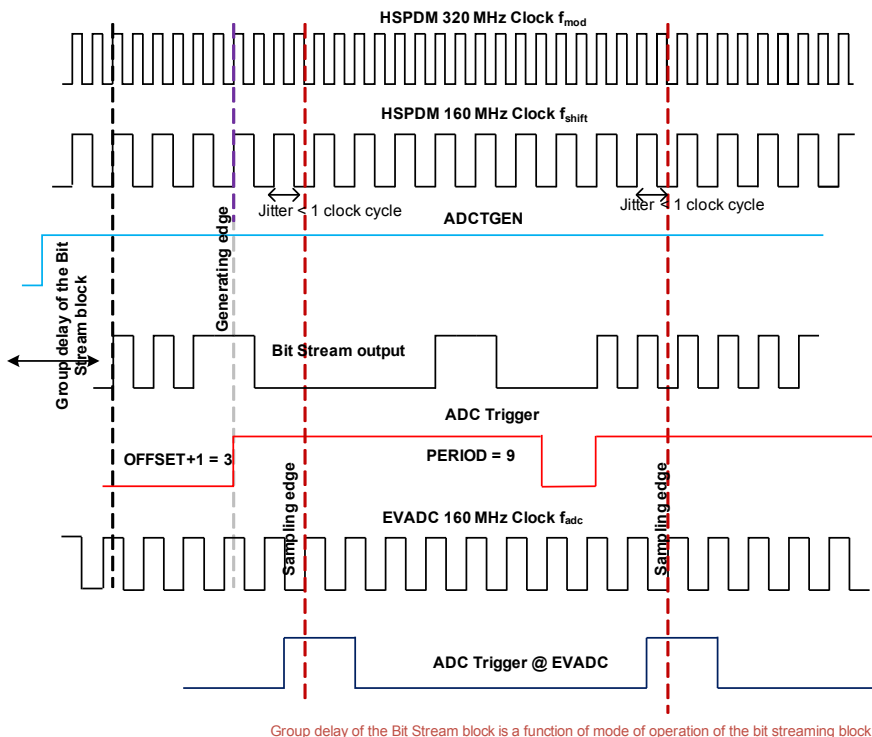
Figure 12 ADC Trigger Concept

HSPDM_TC.H004 ADC Trigger Concept - Figure update

Figure “ADC Trigger Concept” in the current version of the HSPDM chapter of the TC3xx User’s Manual shall be replaced with the following updated figure:
