Device **TC26x**
Marking/Step **ES-BC, BC**
Package **see Data Sheet**

10212AERRA

This Errata Sheet describes the deviations from the current user documentation.

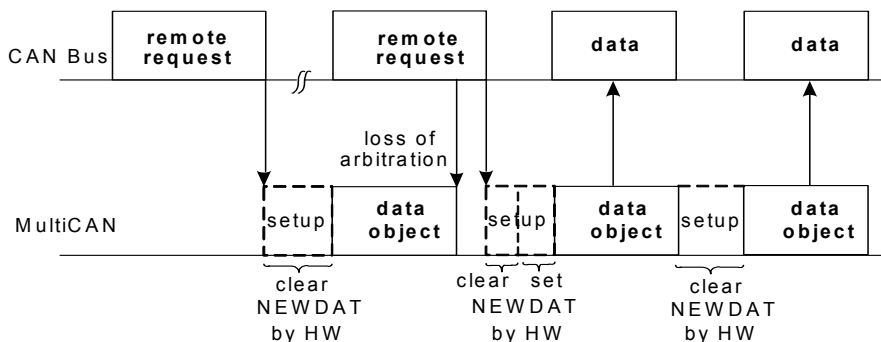
When the appropriate message object (data frame) triggered by the first remote frame wins the arbitration, it will be sent out and NEWDAT is not reset. This leads to an additional data frame, that will be sent by this message object (clearing NEWDAT).

There will, however, not be more data frames than there are corresponding remote requests.

Figure 11 Loss of Arbitration
MultiCAN_TC.H007 Oscillating CAN Bus may Disable the CAN Interface

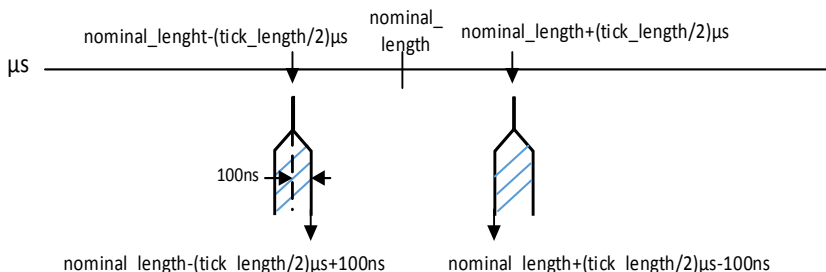
The length of a nibble in the SENT protocol determines the value of this nibble. For each value this length can vary, but it has to be at least inside a given range. This range is given by the SENT standard.

- The lower border is $\text{nominal_value} - (\text{tick_length}/2) \mu\text{s} + 100 \text{ ns}$
- The upper border is $\text{nominal_value} + (\text{tick_length}/2) \mu\text{s} - 100 \text{ ns}$.

Figure 15 SENT Standard Tolerance
