Device	XMC4700/XMC4800
Marking/Step	ES-AA, AA
Package	PG-LQFP-100/144, PG-LFBGA-196

Document ID is **056/18**.

This “Errata Sheet” describes product deviations with respect to the user documentation listed below.

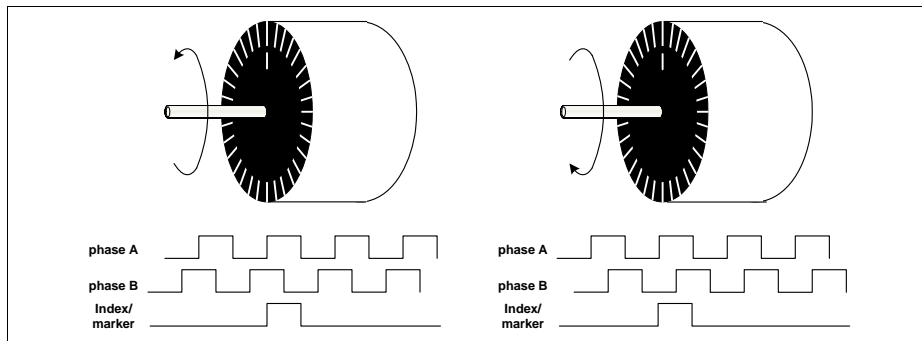
Figure 10 Rotary Encoder outputs - Phase A, Phase B and Index

POSIF_AI.001 Input Index signal from Rotary Encoder is not decoded when the length is 1/4 of the tick period

Each POSIF module can be used as an input interface for a Rotary Encoder. It is possible to configure the POSIF module to decode 3 different signals: Phase A, Phase B (these two signals are 90° out of phase) and Index. The index signal is normally understood as the marker for the zero position of the motor Figure 1.
