# PHILCO TV

## SCHEMATIC DIAGRAMS

MODEL 48-700 THRU 53T2750

# 1947-1953

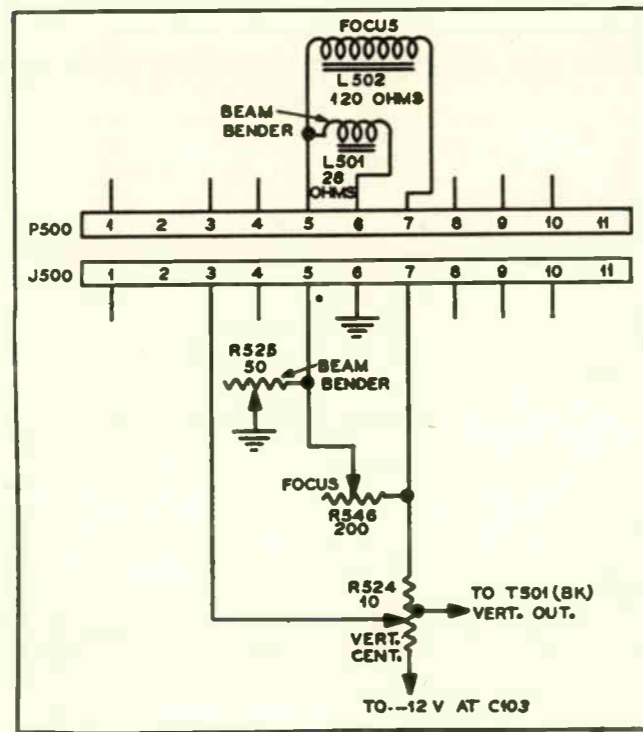
Figure 13. Focus and Beam-Bender Changes

1	R443 changed to 100,000 ohms.	17. 27	Run 1	66-4108540	66-5103340	To increase a-v-c stability.
2	R415 changed to 470,000 ohms.	17. 27	Run 1	66-4473340	66-5473340	To increase a-v-c stability.
3	R203 changed to 100,000 ohms.	18. 27	Run 1	66-4108540	66-3473340	To improve a-i-f performance.
4	R207 changed to 100,000 ohms.	18. 27	Run 1	66-4108540	66-3273340	To improve a-i-f performance.
5	L502 changed.	19. 27	Run 1	76-2622-2	76-2622	To improve focus. See figure 13.
6	R546 changed.	19. 27	Run 1	33-5547-2	33-5546-5	To improve focus. See figure 13.
7	L502 changed.	19. 27	Run 1	76-2622-1	76-2622	To improve focus. See figure 13.
8	R525 changed	19. 27	Run 1	33-5546-4	33-5546-2	To improve focus. See figure 13.
9	R545 removed.	19. 27	Run 1		66-3105340	To improve focus. See figure 13.

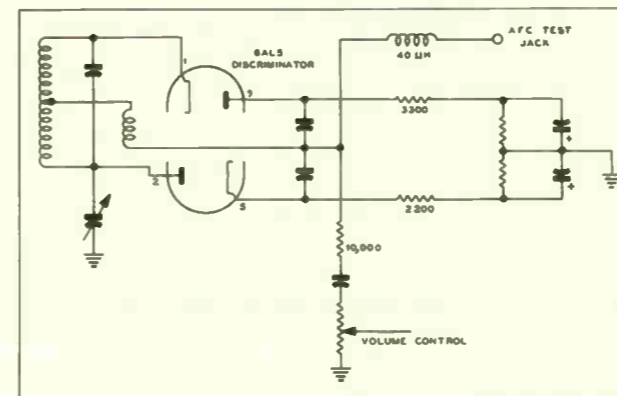
Figure 14. Revised Discriminator Schematic

Beat patterns may appear in the picture when operating on Channel 7; less frequently on Channels 4 and 11. This condition may be corrected by adding compensating and filter resistors to the FM discriminator circuit, as shown in the revised schematic, figure 14, and the layout drawing, figure 15.

It is recommended that the following changes be made when the chassis are serviced, or when Channels 4, 7, or 11 are adjusted for reception.

2. Install a wiring panel, Part No. 12W45661, at the location indicated by TB4 in figure 15. Note how the terminals are numbered, and make sure that the number 3 terminal is used as the mounting foot.
3. Connect the 27,000-ohm resistor R215 between terminals 2 and 4 of TB4, as shown in figure 15.
4. Connect the 27,000-ohm resistor R216 between terminals 1 and 4 of TB4.
5. Connect a bare wire jumper between terminals 3 and 4 of TB4.
6. Connect the 10-mf. condenser C218 between terminals 2 and 4 of TB4 (positive lead to terminal 2).
7. Connect the 10-mf. condenser C219 between terminals 1 and 4 of TB4 (positive lead to terminal 4).
8. Connect a 40-microhenry choke, Part No. 32-4143-1, between terminals 1 and 3 of TB3. (If terminal 3 is already in use, connect to any nearby vacant terminal.)

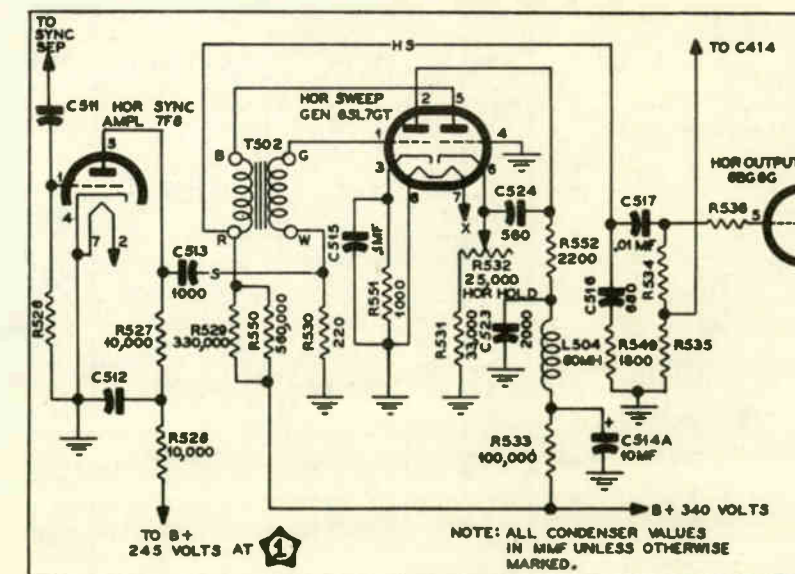
Figure 12. Horizontal-Sweep Changes

ITEM NO.	DESCRIPTION OF CHANGE	FIGURES OF PR-1103 AFFECTED	CHANGE EFFECTIVE	NEW OR ADDED PART NO.	OLD OR REMOVED PART NO.	REASON
28	R550, 560,000 ohms, added as in figure 12.	19. 26. 27	Run 6 and 7	66-4563340*		To improve horizontal-sync stability.
29	R551, 1000 ohms, added as in figure 12.	19. 26. 27	Run 6 and 7	66-2103340*		To improve horizontal-sync stability.
30	R552, 2200 ohms, added as in figure 12.	19. 26. 27	Run 6 and 7	66-2223340*		To improve horizontal-sync stability.
31	C514A rewired as in figure 12.	19. 26. 27	Run 6 and 7	No change		To improve horizontal-sync stability.
32	C515 changed to .1 mf. and rewired as in figure 12.	19. 26. 27	Run 6 and 7	61-0113*	60-10825401*	To improve horizontal-sync stability.
33	C516 changed to 680 mmf. and rewired as in figure 12.	19. 26. 27	Run 6 and 7	60-10685401*	60-10825401*	To improve horizontal-sync stability.
34	C517 rewired as in figure 12.	19. 26. 27	Run 6 and 7	No change		To improve horizontal-sync stability.

35	C523, 2000 mmf., added as in figure 12.	19. 26. 27	Run 6 and 7	60-20205304*		To improve horizontal-sync stability.
36	C524, 560 mmf., added as in figure 12.	19. 26. 27	Run 6 and 7	60-10565314*		To improve horizontal-sync stability.
37	L504, 60 mh., added as in figure 12.	19. 26. 27	Run 6 and 7	32-4256		To improve horizontal-sync stability.
38	Wiring panel, four-point added on bottom of chassis, parallel to sides of chassis, between vertical output (6K6GT) socket and C506.	19. 26. 27	Run 6 and 7	12W45661		To improve horizontal-sync stability.
39	R505 changed to 47,000 ohms.	19. 26. 27	Run 6 and 7	66-3473340*	66-4473340*	To improve horizontal-sync stability.

ITEM NO.	DESCRIPTION OF CHANGE	FIGURES OF PR-1103 AFFECTED	CHANGE EFFECTIVE	NEW OR ADDED PART NO.	OLD OR REMOVED PART NO.	REASON
26	L504, 60 mh., added as in figure 12.	19, 26, 27	Run 7	32-4256		To improve horizontal-sync stability.
27	Wiring panel, four-point, added on bottom of chassis parallel to sides of chassis, between vertical-output (6K6GT) socket and C506.	19, 26, 27	Run 7	12W45661		To improve horizontal-sync stability.
28	R505 changed to 47,000 ohms.	19, 26, 27	Run 7	66-3473340*	66-4473340*	To improve horizontal-sync stability.
29	R529 changed to 150,000 ohms.	19, 26, 27	Run 8	66-4154340	66-4333340	To remove vertical black line.
30	R550 removed. See Note.	19, 26, 27	Run 8		66-4563340	To remove vertical black line.
31	R535 changed to 180,000 ohms.	19, 26, 27	Run 8	66-4183340	66-2683340	To remove vertical black line.
32	R435 changed to 18,000 ohms.	19, 26, 27	Run 8	66-3183340	66-3823340	To remove vertical black line.

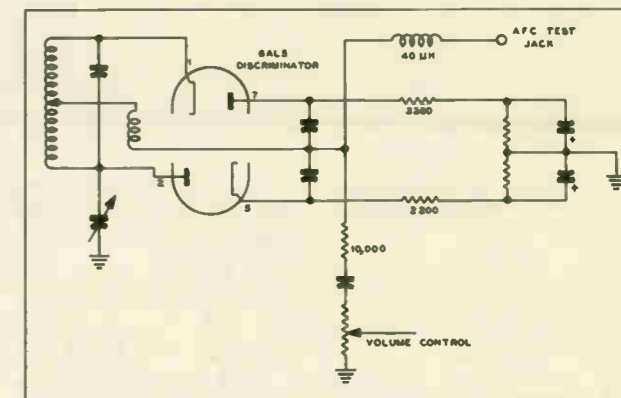
Figure 13. Revised Discriminator Schematic

circuit, as shown in the revised schematic, figure 13, and the layout drawing, figure 14.

It is recommended that the following changes be made when the chassis are serviced, or when Channels 4, 7, or 11 are adjusted for reception.

- Remove the following parts carefully, as they are to be reinstalled.
  - C218, connected between pin 5 of the discriminator tube (6AL5) and ground.
  - C219, connected between pin 7 of the discriminator and ground.
  - R215, connected between pin 5 of the discriminator and ground.
  - R216, connected between pin 7 of the discriminator and terminal 3 of terminal board TB6.
  - Length of wire, connected between terminal 1 of terminal board TB3 and socket J200.

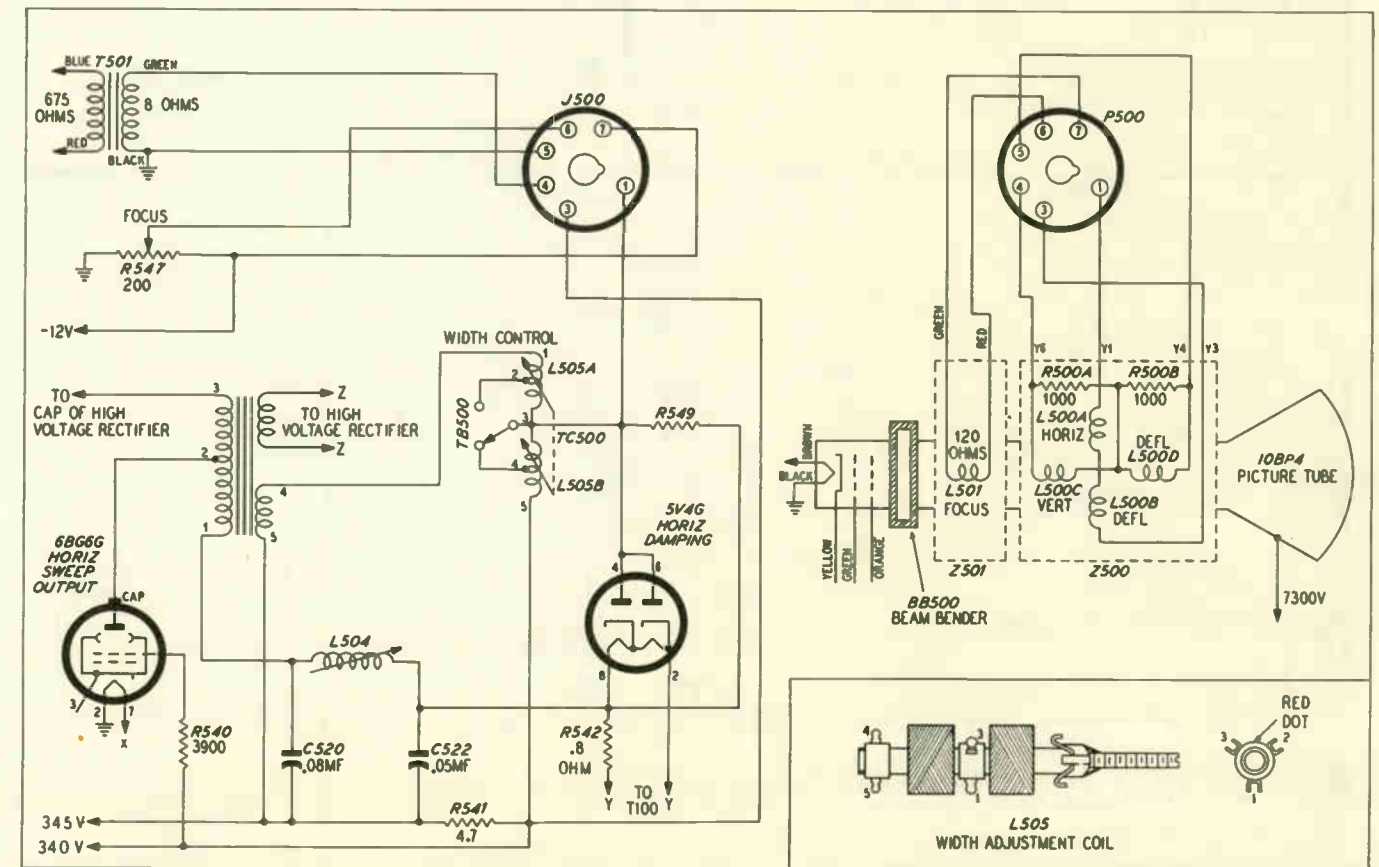
Figure 4. Changes in Output Circuit

1. C509, condenser, coupling, .25 mf., Part No. 61-0125\*, was changed to .1 mf., Part No. 61-0113\*.
2. The connection of the vertical deflection yoke, P9 and P3, were changed to 4 and 5, respectively.
3. R549, resistor, linearity-control limiting, 6200 ohms, was changed to 33,000 ohms, Part No. 66-3333340\*.
4. R545 and R546, horizontal linearity controls No. 2 and No. 3 were removed. The circuit was rewired as shown in figure 4.
5. R548, beam-bender control, was removed.
6. Z502, beam-bender-coil assembly (including L502A and L502B) was removed.
7. A permanent-magnet type of beam bender (BB500), Part No. 76-3913, was added.
8. J500, receptacle, chassis (deflection-yoke-cable connector) 11 pins, Part No. 27-6229, was changed to 8 pins, Part No. 27-6174-4.
9. P500, deflection-yoke-plug connector and cable, 11 pins, Part No. 41-3764-1, was changed to 8 pins, Part No. 41-3860.

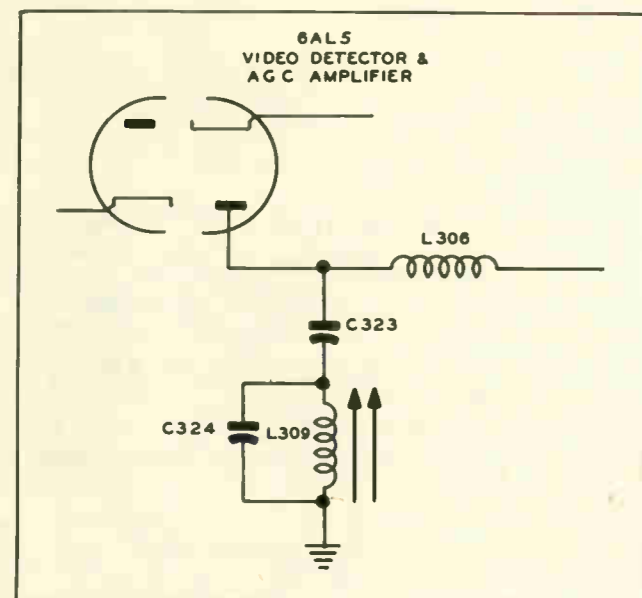
Figure 24. Addition of Accompanying-Sound Trap

3. An additional accompanying-sound trap, Part No. 32-4218, was added, to reduce the possibility of sound interference in the picture. The ground lead of condenser C323 was disconnected from ground and connected to the new sound trap (L309 and C324). This trap is effectively in series with the detector input, and is tuned to the accompanying-sound frequency, 22.1 mc.

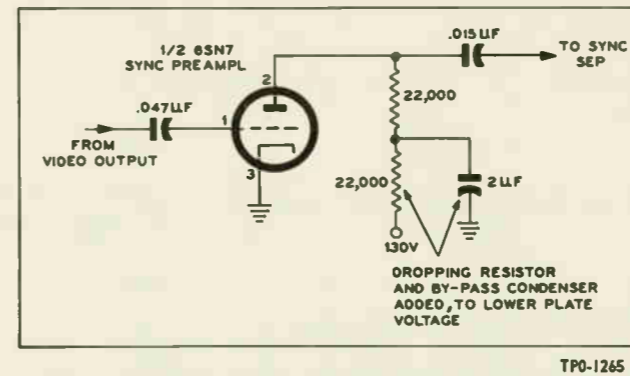
Figure 8. Modification of Sync Preamplifier

Another simple modification, which is accomplished by decreasing the plate voltage on the sync preamplifier stage, will improve sync performance in extremely noisy areas. The reduction in plate voltage causes negative-peak clipping on signals of lower amplitude. Since the composite video signals are negative at the grid of this stage, the change permits noise clipping closer to the sync tips on weak signals. The plate voltage is reduced by inserting an adequately dropping resistor on the B+ side of the plate load resistor. This circuit is shown in figure 8. The value of the resistor can be determined experimentally by observing the clipping action on a scope connected to the preamplifier output. A plate-voltage reduction of 15 to 20 volts is usually sufficient to give better operation under noise conditions.

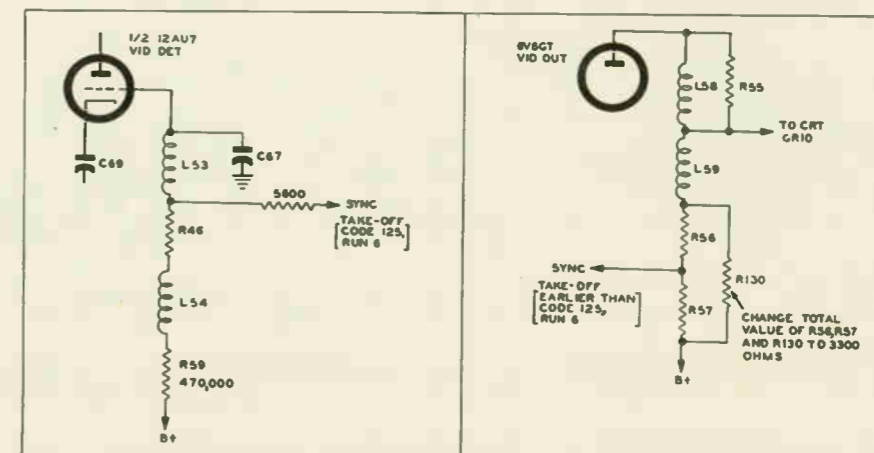
Figure 10. Sync Take-off Change

changes, the sync take-off point is moved to the video detector, good sync performance is obtained (see figure 10). However, moving the sync take-off to the video detector may deteriorate sync performance under noisy conditions in two ways. First, the level of signal fed to the sync preamplifier is lower; this reduces the clipping effect obtained there. Second, any clipping effect previously obtained in the video amplifiers is also lost.

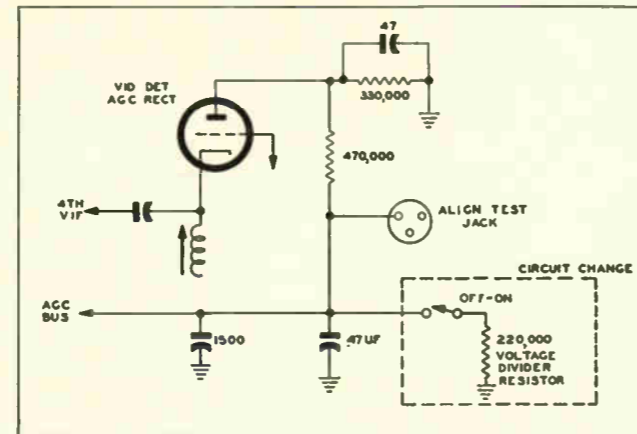
Figure 11. Addition of A-G-C Voltage Divider

In fringe areas, the greater portion of the a-g-c voltage is developed by noise; consequently, loss of gain during bursts of noise often results in loss of sync. The effect of noise on the gain of the receiver may be re-

duced by lowering the a-g-c voltage applied to the video-i-f amplifiers. This is done by connecting a 220,000-ohm resistor between the a-g-c bus and ground. See figure 11. This resistor and the a-g-c filter resistor constitute a voltage divider. A single-pole, single-throw switch should be connected, as shown, to switch the voltage divider in and out of the circuit. When more a-g-c action is required, for strong signals, the switch should be placed in the open, or normal, position.

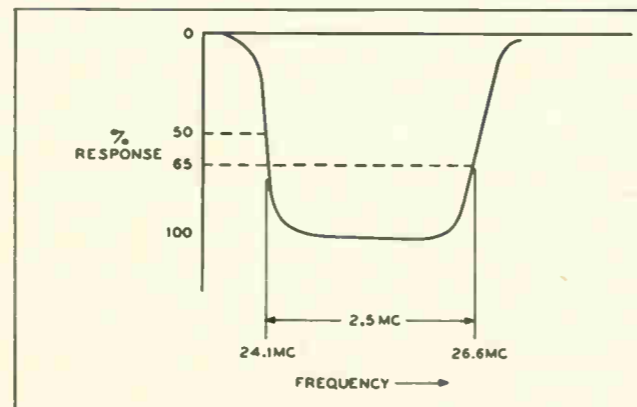
Figure 12. Video-I-F Response of I-F System, After Realignment for Fringe-Area Reception

The i-f alignment of receivers that are used in extreme fringe areas is most important. In the very weak signal areas, where little or no a-g-c voltage is developed, and only a small signal appears at the video detector, the v-i-f alignment should be checked and corrected with no a-g-c voltage applied to the grids, and the adjustment should be made for an output reading of approximately .5 volt, peak to peak, measured at the video detector. Under these conditions, the v-i-f carrier at 26.6 mc. should be placed at approximately 65% of maximum, and the response curve should maintain the same bandpass and amplitude, even when the sweep-input level is further reduced and the curve disappears into the "grass." Any tendency for the i-f system to be regenerative will be indicated by a "peaking" of the curve as the sweep output is gradually reduced. If the proper alignment techniques are used (proper bonding, jigs, etc.), the peaking can be eliminated by careful re-adjustment of the i-f slugs. It is not desirable to reduce the i-f bandwidth to less than 2.5 mc., or to place the v-i-f carrier higher than 65%, since this practice usually results in a very smeary picture, with an accompanying, and more objectionable, type of smeary snow. The bandwidth, as measured from the 65% v-i-f carrier to the 50% point of the low-frequency side of the i-f curve, is an approximate figure, and, on some i-f systems, the exact curve will be extremely difficult to obtain. However, the position of the v-i-f carrier at 26.6 mc. is extremely important, and should be placed accurately on the curve. The desired response curve for fringe areas is shown in figure 12.

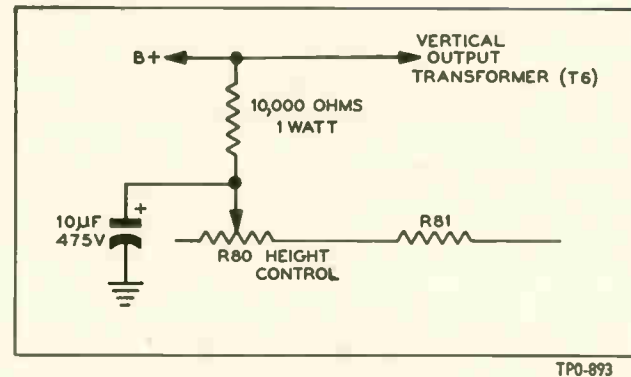
Figure 7. Addition of Filter Network, Model 50-T1400 Series, Runs 1 and 2

### MODEL 50-T1400 SERIES, RUNS 1 AND 2 — REDUCTION OF VERTICAL JITTER

Vertical jitter in the picture due to line voltage fluctuations in the above models may be greatly reduced or eliminated, in the special cases where necessary, by adding an extra filter network to the B supply feeding the vertical oscillator and discharge tube. This network consists of a 10,000-ohm resistor and a 10- $\mu$ f. condenser. The circuit is shown in figure 7,

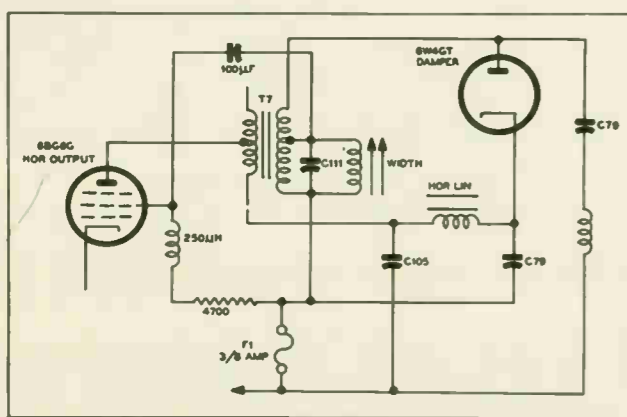
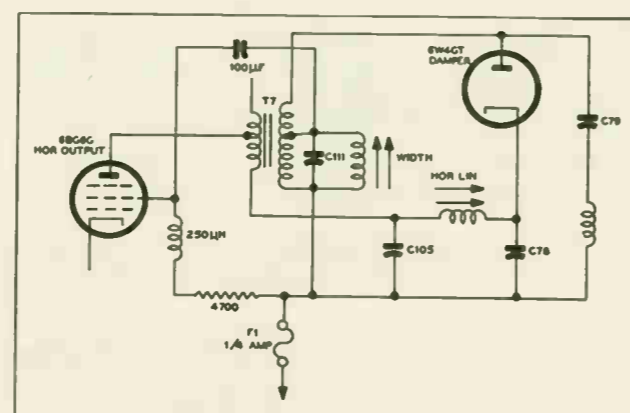
RUN NO.	DESCRIPTION OF CHANGE	REMOVED PART NO.	ADDED PART NO.	REASON FOR CHANGE
2	2.2- $\mu$ f. condenser added between ground and junction of C6 and R128.		30-1221-4	To center tuning of first video-i-f transformer.
2Z and 3	Arm of HEIGHT control disconnected and rewired to junction of R89 and R96.			To improve vertical linearity.
1F	F1 removed from position shown in service manual and rewired as shown in figure 3. This run does not include the changes made in runs 2, 2Z, or 3.			To provide increased protection.

RUN NO.	DESCRIPTION OF CHANGE	REMOVED PART NO.	ADDED PART NO.	REASON FOR CHANGE
2F	F1 removed from position shown in service manual, and rewired as shown in figure 3. This run includes the changes made in run 2, but does not include the change made in runs 2Z and 3.			To provide increased protection.
3F	F1 removed from position shown in service manual, and rewired as shown in figure 3. This run includes the changes made in runs 2, 2Z, and 3.			To provide increased protection.
4	F1 rewired as shown in figure 4. Value changed from $\frac{3}{4}$ ampere to $\frac{1}{4}$ ampere.	45-2656-10	45-2856-8	To reduce a-c current through fuse.
5	330-ohm resistor added in series with lead between ungrounded (negative end) of C42 and junction of R20 and pin 2.		66-1338340	To reduce harmonic beat.
5	Lead from junction of R19 and pin 3 of J3 disconnected from junction of C40 and C41. C41 removed. C40 connected across R20.	62-215001011		To reduce harmonic beat.

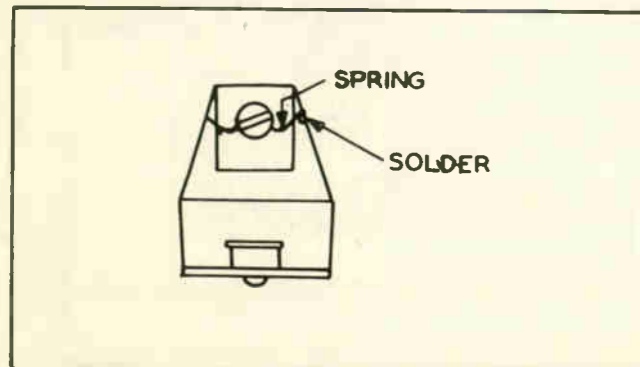
Figure 6. Oscillator Coil for 8-Position Tuner, Showing Spring Installed Over Tuning Core

The oscillator tuning cores of all models using the 8-position turret tuner may be secured by the use of a spring, Philco Part No. 56-7270.

Slip this spring over the tuning core and solder one side to the coil form. See figure 6.

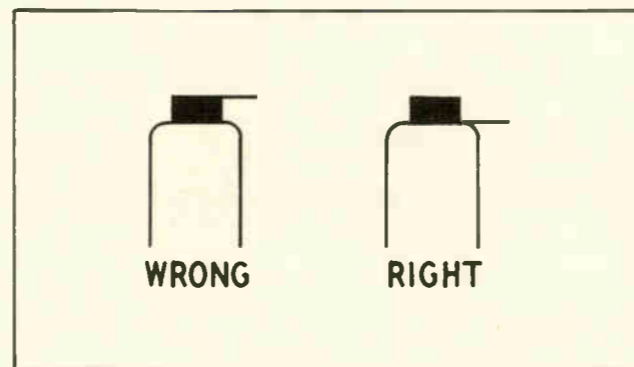
Figure 4. Placement of 1B3GT Anode Cap

### MODELS 50-T1104, CODE 123, 50-T1400, 50-T1401, 50-T1402, 50-T1403, 50-T1404, 50-T1406, 50-T1430, AND 50-T1432— PLACEMENT OF 1B3GT ANODE CAP

It is possible to place the anode cap on the 1B3GT tube, in the above Receivers, so that it is too close to the top of the high-voltage cage. When placing the anode cap on the tube, make sure that it is placed as illustrated below.

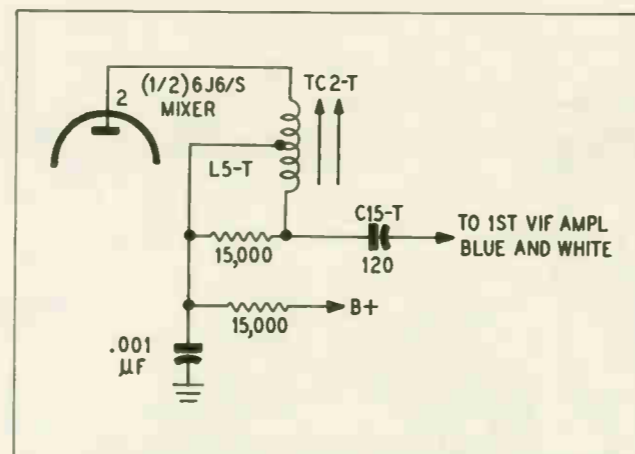
Figure 3. Changes in Mixer Plate Circuit for Models Using 12-Position Turret Tuner

To reduce the effect of the mixer plate tank on the mixer grid tuning, the mixer plate tank coil was changed to a tapped type, and the circuit was changed. Part No. 45-1695, given in the turret tuner manual (PR-1803), is for this tapped coil. The part number of the untapped coil used in some early tuners is 45-1711. The new circuit is shown in Figure 3.

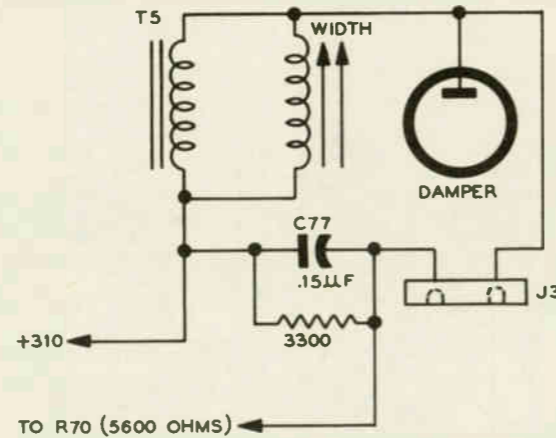
Figure 1. Change in Horizontal-Output Circuit, Models 50-T1403, 50-T1404, and 50-T1406, All Code 125

1. Resistor R118 was changed to 390,000 ohms, Part No. 66-4394240\*.
2. Condenser C83 was changed to .001  $\mu\text{f.}$ , Part No. 45-3505-52.
3. The blocking condenser (C71) in the horizontal-output circuit was rewired as shown in figure 1.

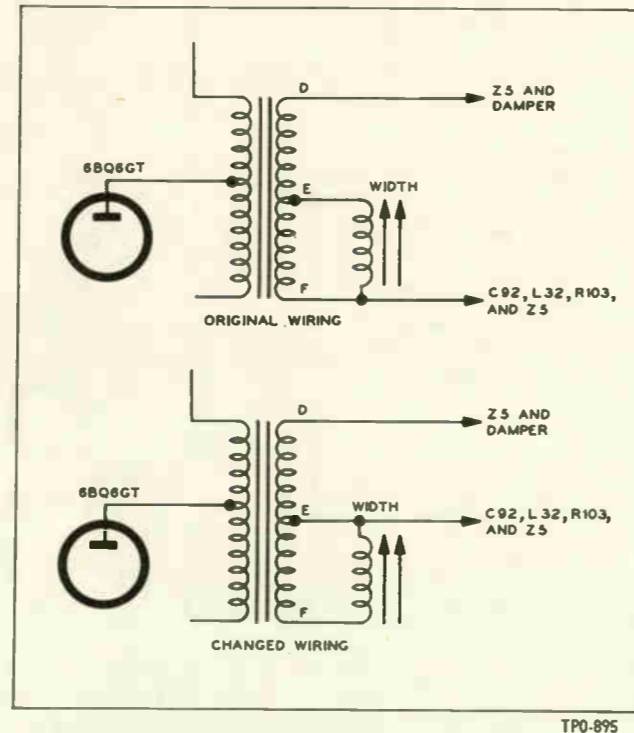
Figure 5. Wiring Changes in Horizontal-Output-Transformer Secondary, Models 50-T1600, 50-T1632, and 50-T1633

- The filament pins of the 6BF5 tube are 3 and 4, instead of 1 and 4.
- R73 was changed to 5600 ohms, Part No. 66-2568340.

- C87 was changed to 820  $\mu\text{f}$ ., Part No. 60-10825401.
- The width coil was rewired as shown in figure 5.

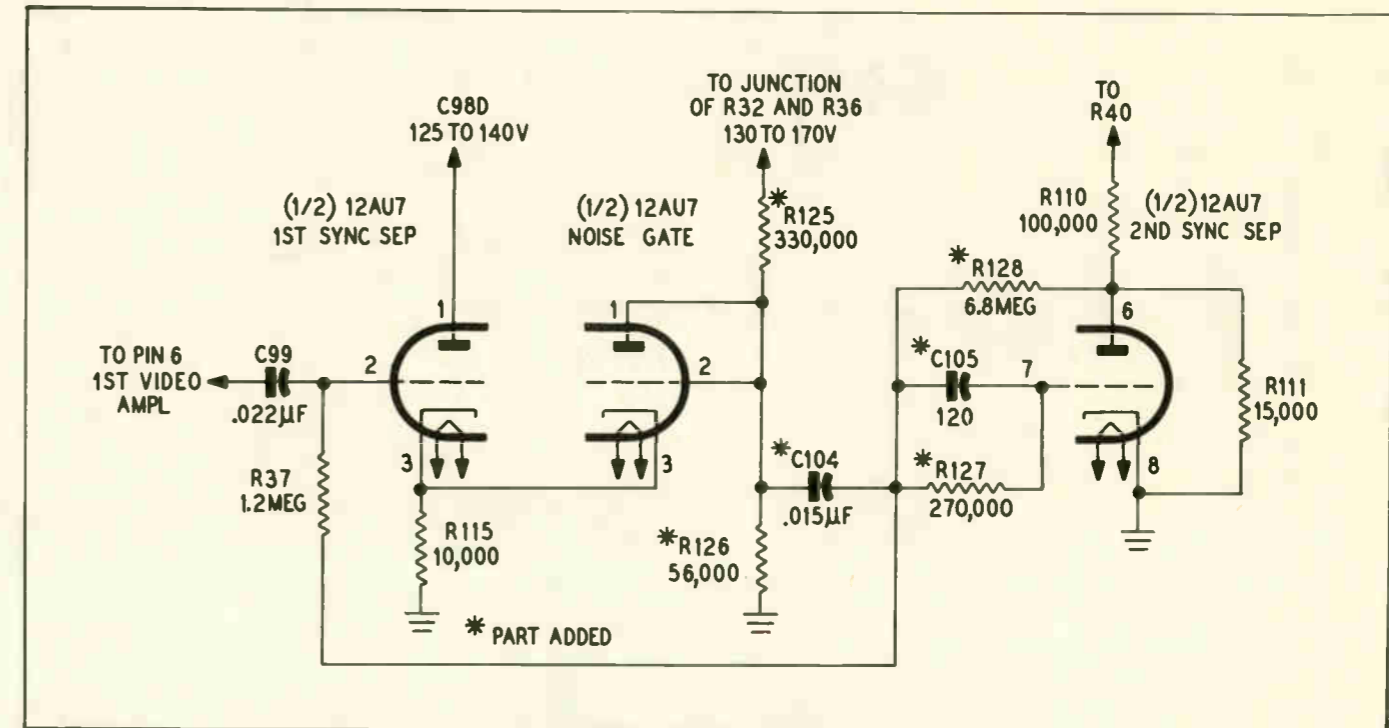
Figure 1. Changes in Sync Separator Circuit, Run 4 of Deflection Chassis, Models 50-T1600, 50-T1632, and 50-T1633

4 (Deflection)	Vertical and horizontal sync separator changed, as shown in figure 1.	66-5128340* (R109) 66-2688340* (R116) 45-3505-62* (C97) 60-10335407* (C96) 62-110009001* (C100)	45-3505-59* (C104) 60-10125237* (C105) 66-4338340* (R125) 66-3568340* (R126) 66-4278340* (R127) 66-5688340* (R128)	To improve sync performance in weak-signal areas.
4 (Deflection)	R53, 10,000-ohm resistor, 4-watt, changed to 5-watt.	66-3104340*	66-3105340*	To prevent overload with high line voltage.
4 (R-f, i-f)	39-ohm resistor in series with 22.1-mc. trap (L6), changed to 15 ohms (added in Run 2).	66-0398350*	66-0158350*	To change 22.1-mc. trap attenuation.
4 (R-f, i-f)	100- $\mu\mu\text{f}$ . condenser added, from pin 5 of Z3 to ground.		62-110009001*	To improve AM rejection of FM detector.
4 (R-f, i-f)	56- $\mu\mu\text{f}$ . condenser added, from pin 2 of video output tube (6AQ5) to ground.		62-056409001*	To reduce lead radiation.

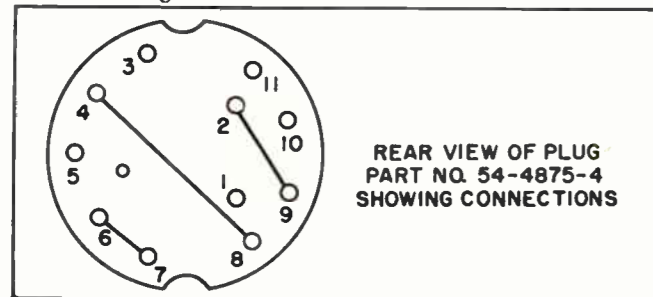
Figure 2.

Receivers incorporating either the 84 R-F, or 94 R-F chassis, may be operated independently of the radio section by using a shorting plug in place of the radio section power-connecting plug (PL102). This service aid may be fabricated from a male plug, Part No. 54-4875-4, by wiring between the pins as shown in figure 2.

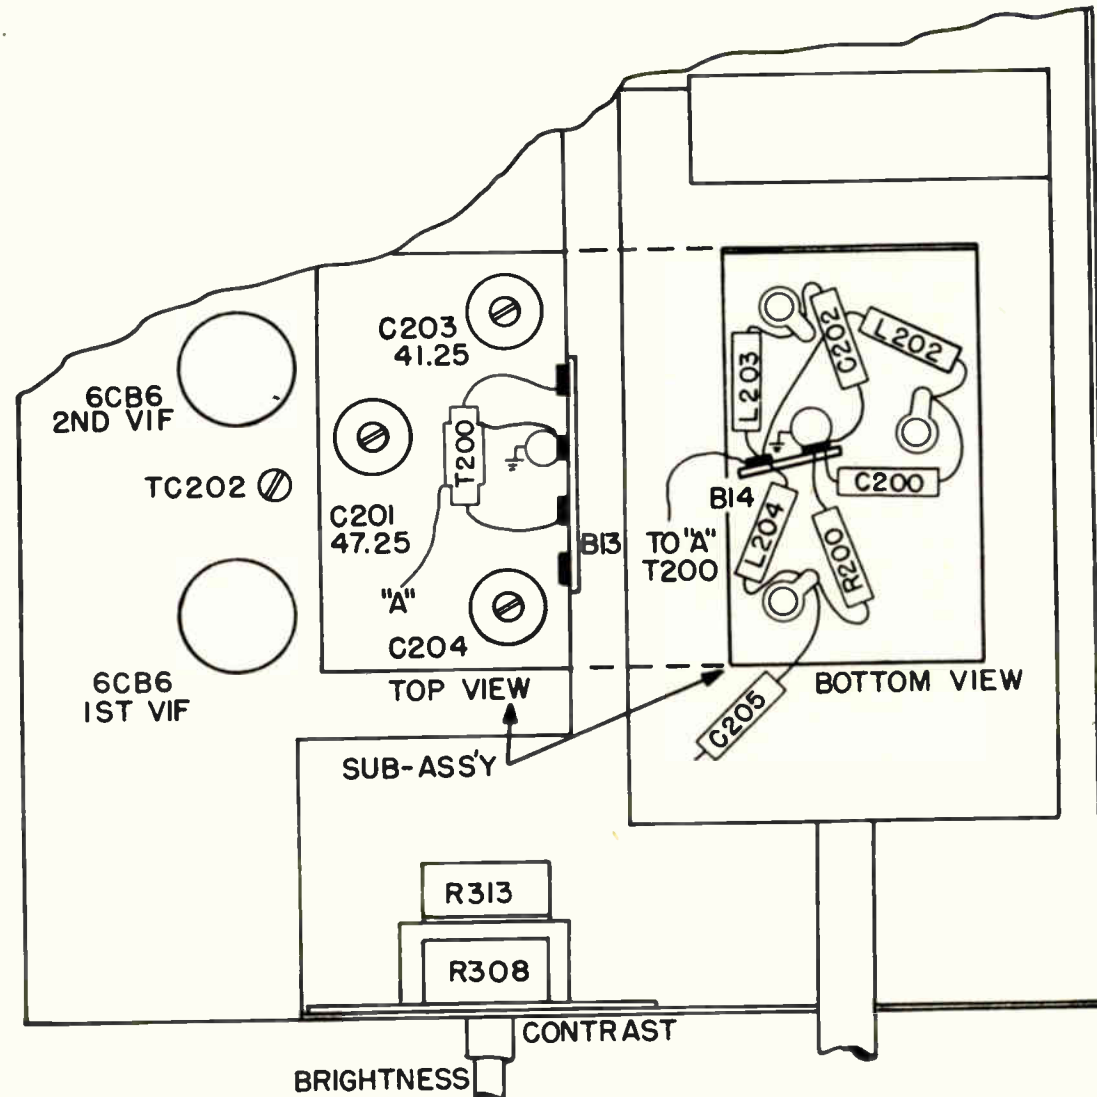
Figure 1.

To reduce i-f interference.	The 47.25-mc. and 41.25-mc. traps, 1st v-i-f trimmer, and associated parts were removed from the chassis and remounted in a shielded subassembly on top of the chassis. Figure 1 shows new location of trimmers and parts that were removed.
