Troubleshooting Guide

imagePRESS 1135/1125/1110 Series

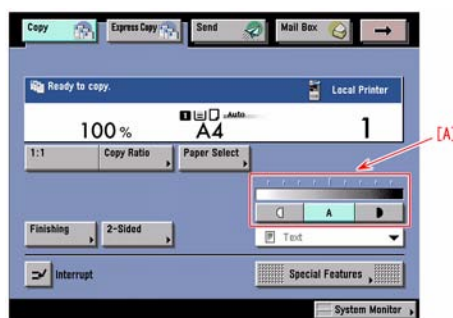
In the field, changing image density with exposure adjustment scale [A] affected only the first sheet and from the second sheet, the density returned to the default. When the same symptom occurs, perform the following field remedy.

Press Service Mode > COPIER > Display > VERSION and check the version; if it is earlier than Ver. 23.04, upgrade the software to Ver.23.04 or later.

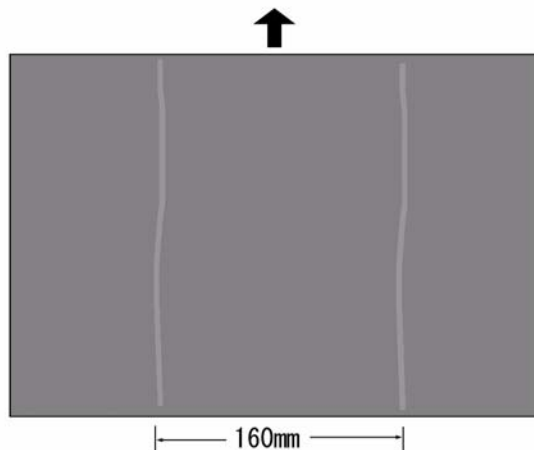
When printing on transparency paper, unevenness image appears on 2 places where the driven rollers rotate (with the distance approx. 160 mm) in the sub scanning direction of the half tone image.

Because paper dust sticks in the driven roller.

On the below step 1 to 3, clean the driven roller [2], [5], [9] and the surrounding feed guide plate with lint-free paper moistened with alcohol

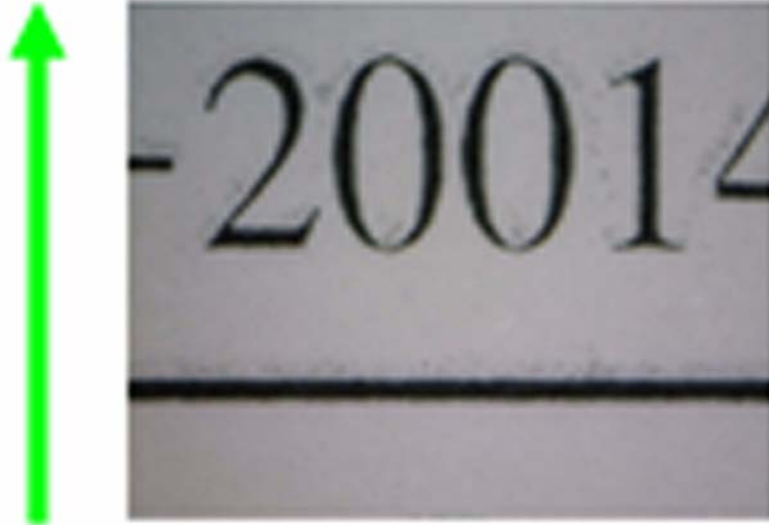
F-1-4

Toner spatters forward in the image traveling direction.

The issue occurs when toner with changed charging characteristics in the developing assembly increases. This charging characteristics depends on the durability of toner, and the temperature and humidity.

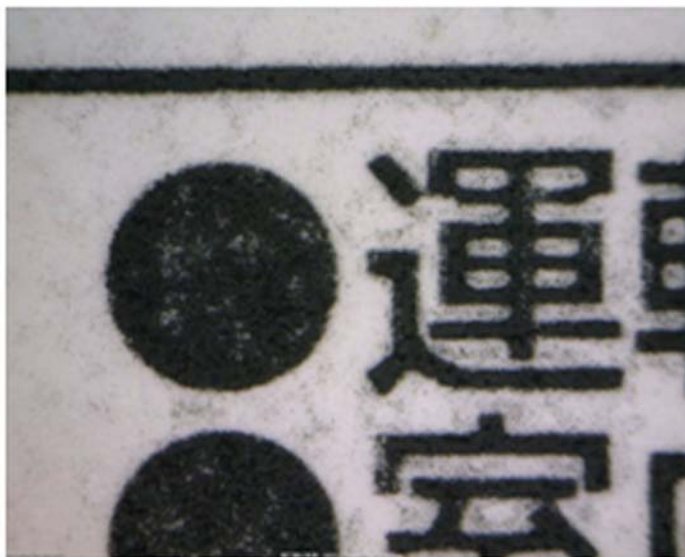
F-1-5

Toner mainly spatters every direction and creates whisker-like pattern on solid color area.

The issue is considered to be caused by insufficient current in the secondary transfer.

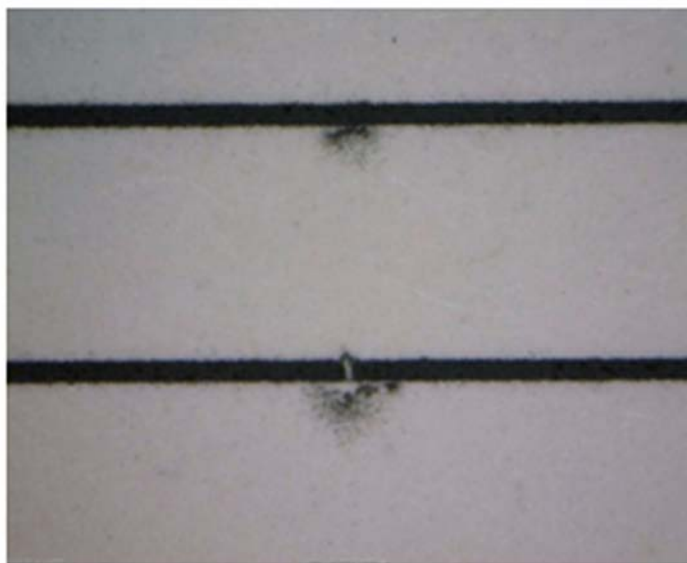
F-1-6

(Part of line is suddenly missing)

There are several causes (primary/secondary transfer, fixing). The following is the classification method;

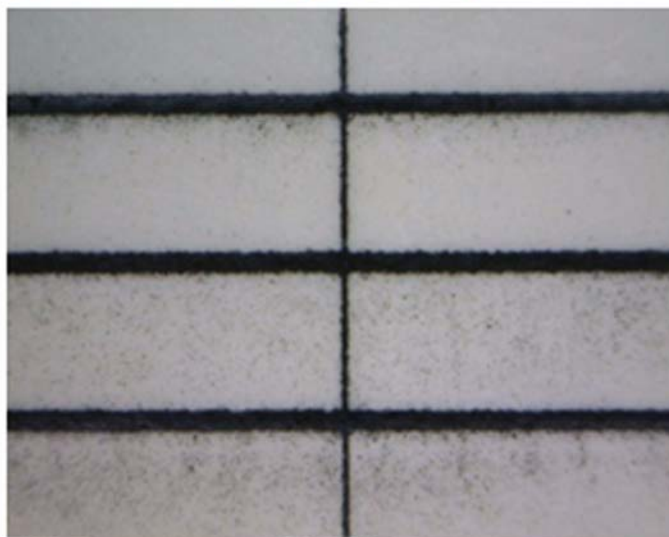
F-1-7

Toner spatters backward like fog in whole.

The primary and secondary transfer may be involved. The issue attributed to the secondary transfer has the following characteristics; it is likely to occur with a media with a large basis weight, or the state of the leading/trailing edge tends to deteriorate because of the influence of the paper posture of coming into the secondary transfer assembly.

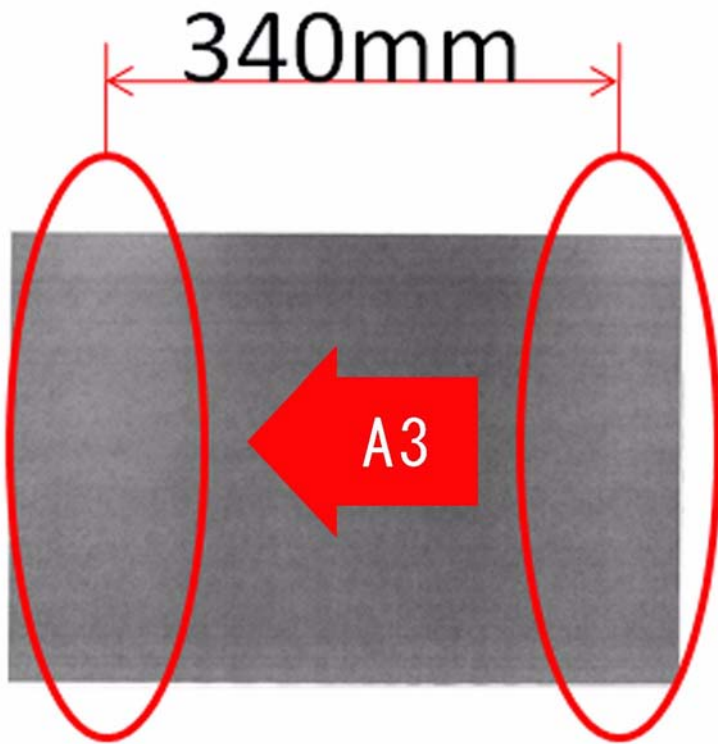
Uneven density of images at 340 mm intervals due to poor accuracy of the rear drum flange.

- A sample of gray (halftone) images printed on an A3 paper by feeding the paper in the direction of the arrow.

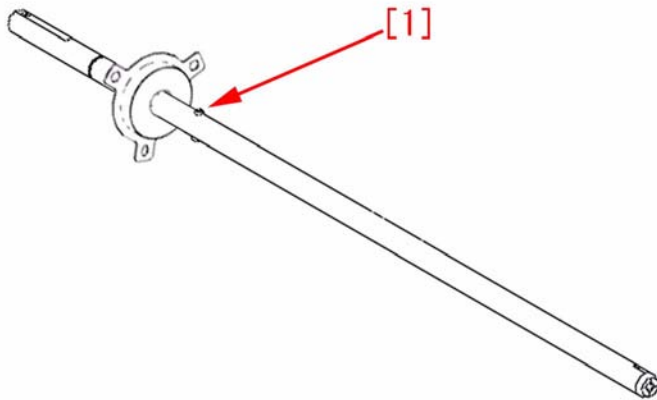
The rear drum flange engages with the dowel pin [1] of the drum shaft assembly has poor accuracy, which decenters the drum against the rotational center.

A mechanism was changed so as to drive the drum at the front side rather than the conventional mechanism of making the dowel pin on the drum shaft drive the drum. This change required a change of the drum shaft, cam flag and cam flag screw. It also newly required a compression spring. Activation of the drum shaft can be transmitted to the drum by fixing cut-offs in the drum shaft and the drum flange with cam flags.

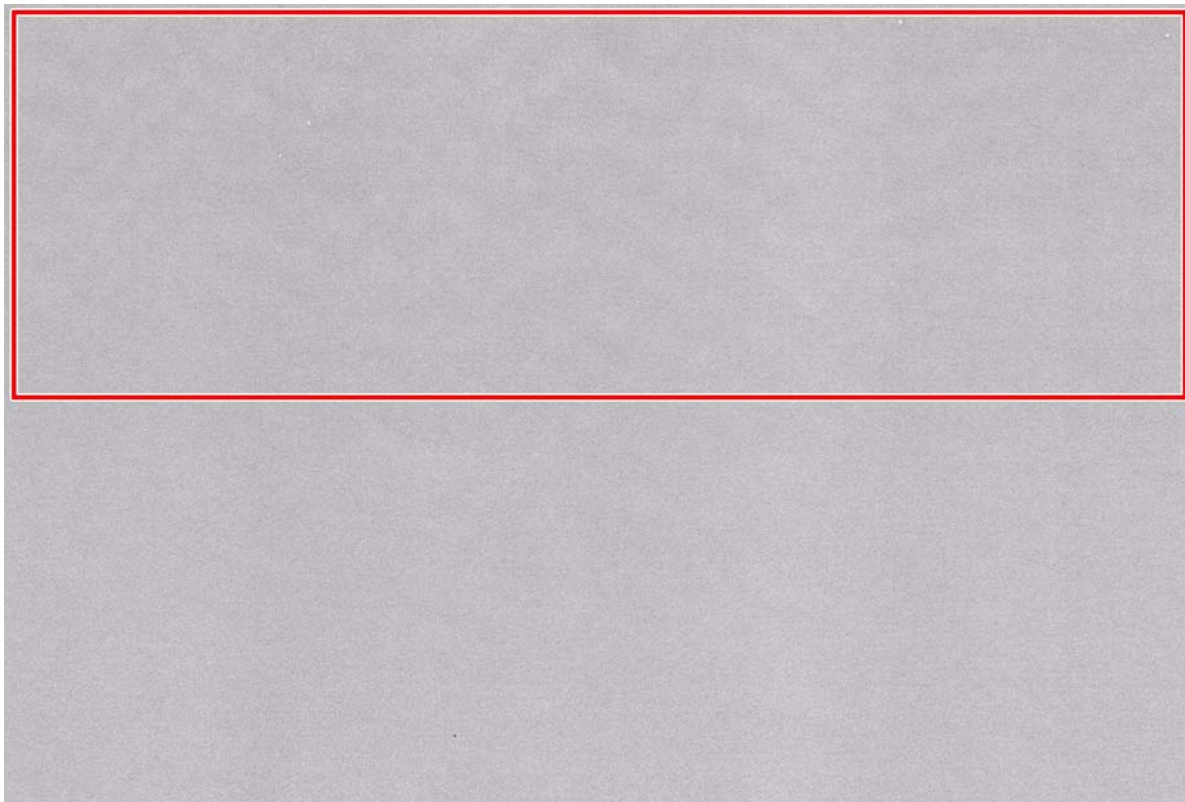
At the installation or after replacement of the developing assembly or the sleeve unit, when a halftone image is output, an uneven image appears at the leading edge of the image. The sample below is an image output with A4 paper of PG-TYPE "5".

On the developing assembly that has just executed Service Mode > Mode List > COPIER > Function > INSTALL > TONER-S, the thickness of the toner on the surface of the lower sleeve becomes uneven.

- If DCON is Ver.40.03 or later, executing Service Mode > Mode List > COPIER > Function > INSTALL > TONER-S continuously causes "TONER-S2" to be automatically executed ten times.

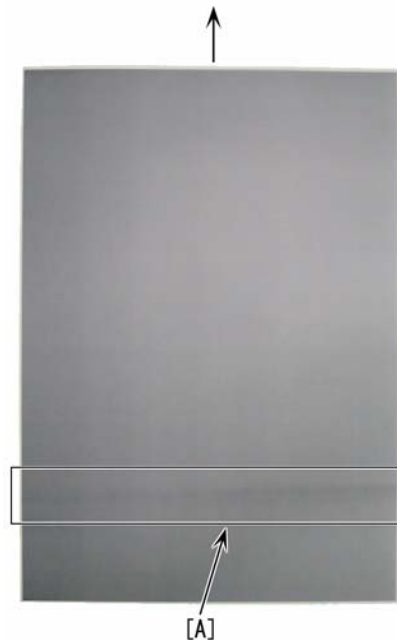
Approx. 10mm-width blurred image [A] appears on approx. 300mm from the leading edge on the large size heavy paper. If the similar symptom occurs, follow the steps below.

Paper is pulled between the secondary transfer roller and the fixing roller.

1. Set the front and backside of the paper reversely.
 2. If the symptom still occurs, check the version on Service Mode > COPIER > Display > VERSION > DC-CON, if the version is earlier than Ver.15.06, upgrade it to the version later than Ver.15.06, and proceed to step 3).
 3. To slow the speed of the fixing roller, Service Mode > COPIER > Option > FX-SPD-3, see the value set there. And, while checking the image outputted, decrease the value one by one. The setting range is “-5” to “5”. If the numerical value changes by “1”, the rotation speed will change by 0.5 %.
- [Note] If the speed of the fixing roller is overly decreased, uneven density might occur approx 235mm [B] from image leading edge or image trailing edge [C].

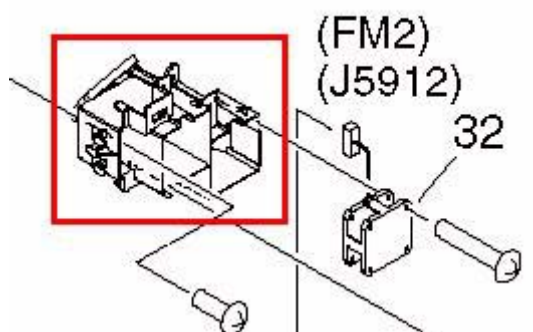
Check the duct that covers fan FM 2 and see if it is warped or hitting the bottom of the scanner unit.

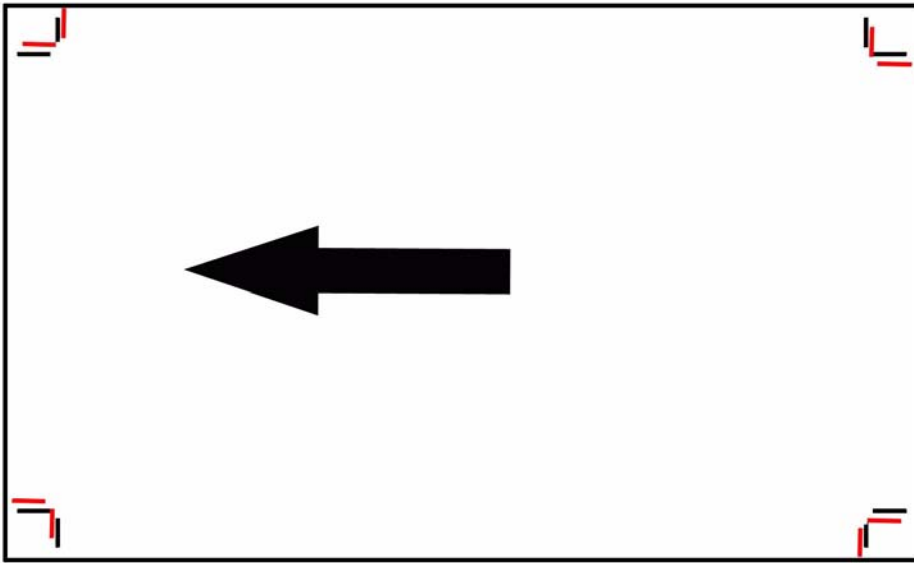
When 2-Sided Print was performed on SRA3 size paper, the register marks were displaced by 1mm to 2mm on the front and back of paper. The following figure shows that the register marks on the front is black and the ones on the back is red.

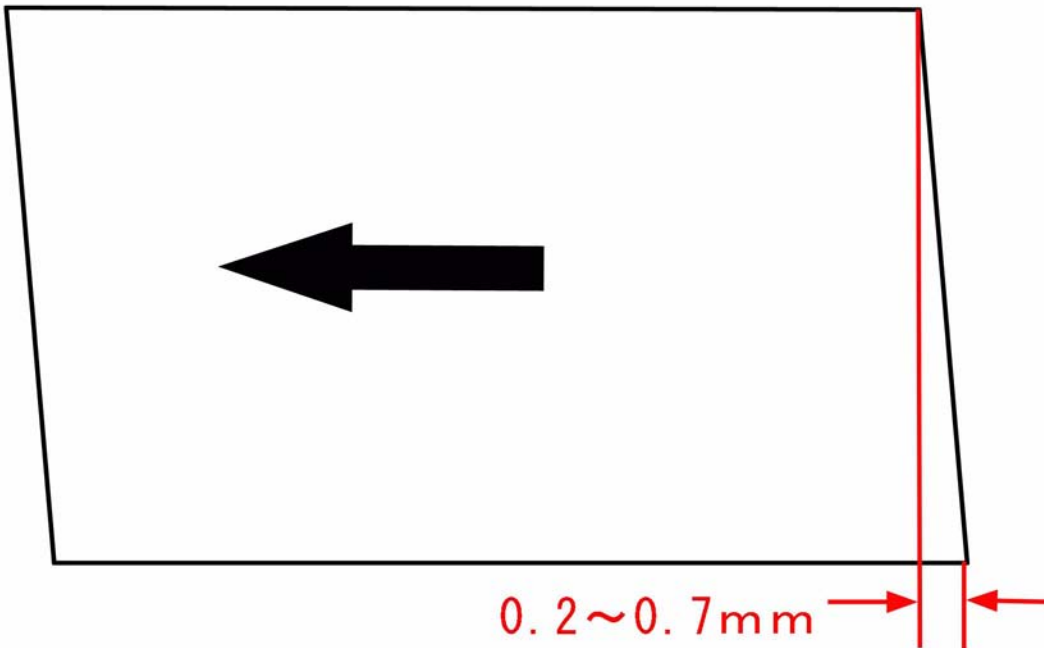
The paper was not correctly trimmed into rectangles. The following figure shows an example of the cases.

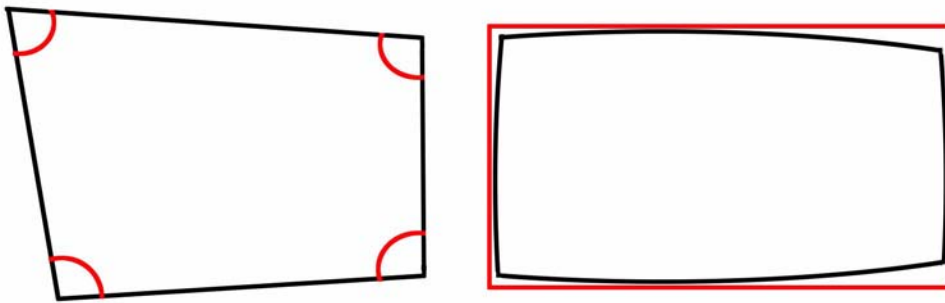
A) If any corner of the paper is not a 90-degree or any side of the paper is not straight, the image will be displaced on the front and back of the paper. Below is an example of image displacement.

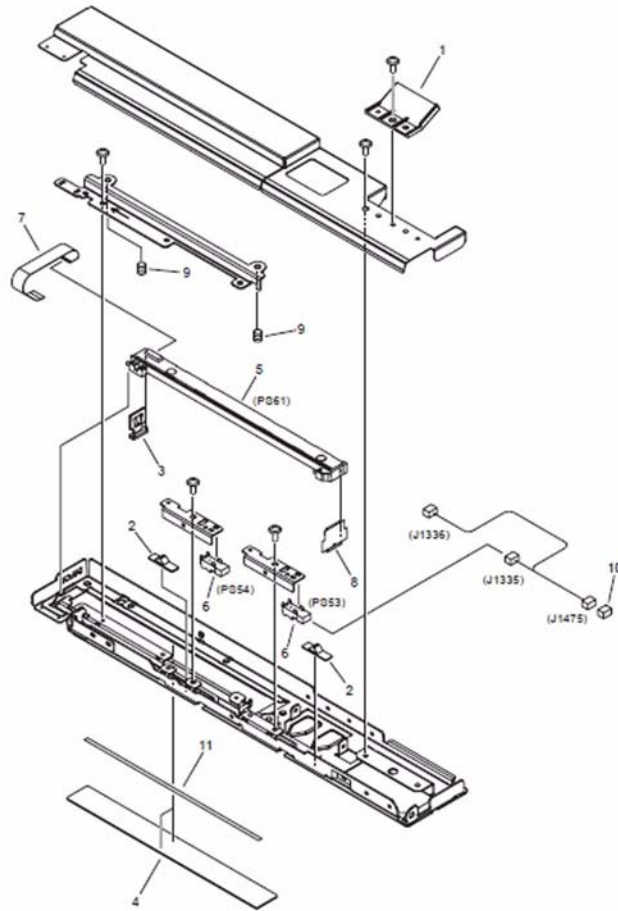
FIGURE 318
PRE-REG. GUIDE ASSEMBLY

Copies/prints come out dog eared on lead edge corner non-operator side. The slit glass from the CIS unit in the pre-registration transport area figure 318 item 4 falls down. The doublesided tape that secures it becomes weak.

The shifting issue was resolved by replacing the Pre-Registration Guide Assembly.

FM3-2634 PRE-REG. GUIDE ASSEMBLY

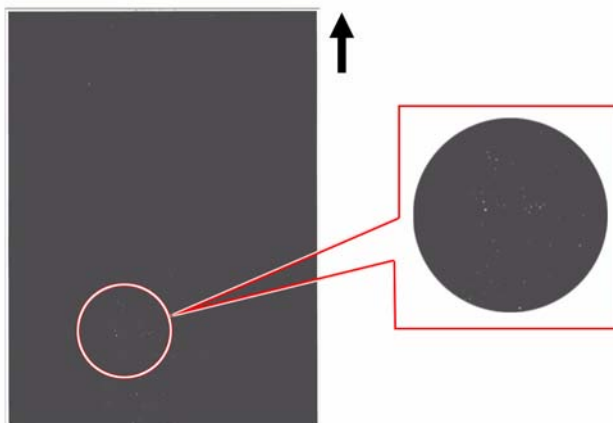
In the field, after approx. 200K sheets are fed, paper dust stick in the guide plate and wheel of the fixing feed unit, and white dots appears on solid black image area.

When the similar symptom occurs, clean each parts while referring to "Cleaning Fixing Feed Unit (200k sheet)" or S/M > Chapter 4 > Parts Replacement and Cleaning > Periodic Replacing Parts, Durable Parts, Cleaning Parts > refer to the item in Cleaning Fixing Feed Unit (200k sheet).

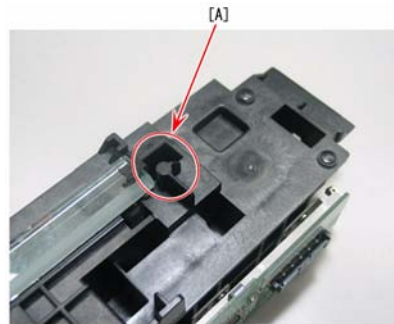
When reading an original, light diffused on the surface of original goes through a hole [A] on the backside of the scanner unit, and reflects by the flexible cable. Then, it returns to inside of the scanner unit, causing the symptom occurs.

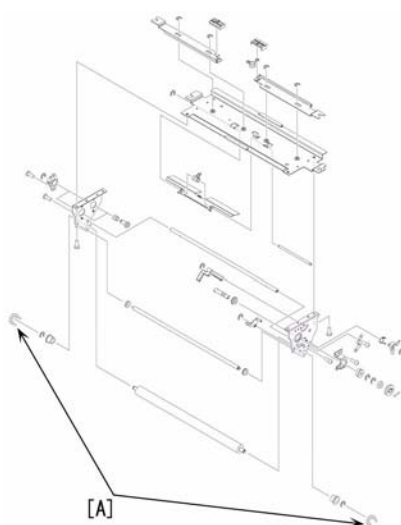
In the machine prior to the following serial numbers, a line on image may occur when the tension spring is damaged in the fixing cleaner assembly.

When the same symptom occurs in the machine prior to the serial No. above, replace the tension spring [A].

[Reference] In order that the load doesn't concentrate at the spring hook, the length of the spring is shortened and the extension length of the spring is prolonged.
FU6-2569 SPRING, TENSION

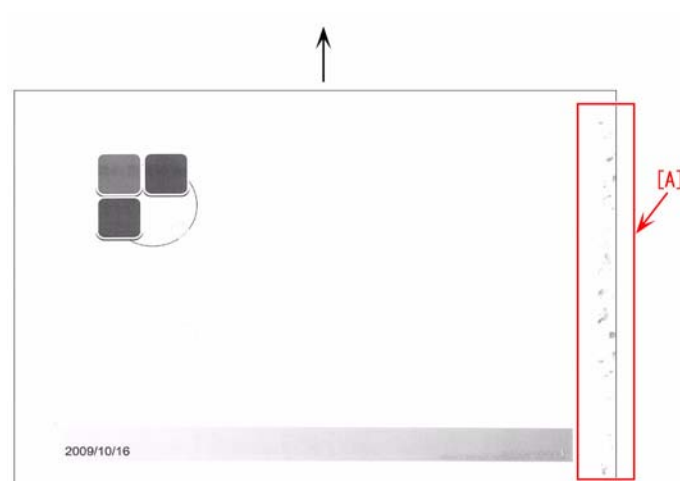
In the field, stained image [A] of 125mm pitch (the dimension of circumference of the I.T.B. drive roller) occurred in front of or rear side of image.

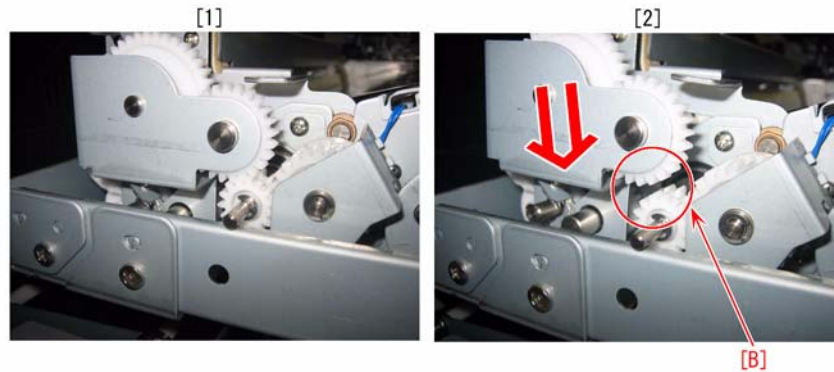
I.T.B. cleaner assembly was installed with the gears in I.T.B. cleaner assembly not engaged each other [B]. As a result, the drive to feed the waste toner was not given, then the waste toner overflowed from the I.T.B. cleaner assembly, causing stained image.

[1] shows I.T.B. cleaner assembly correctly installed and [2] shows I.T.B. cleaner assembly not correctly installed.

Check if the gears in I.T.B. cleaner assembly are engaged correctly each other. When they are not installed correctly as shown in [2], move I.T.B. cleaner assembly to the direction of the arrow and reinstall the assembly to make the gears engaged each other as shown in [1].

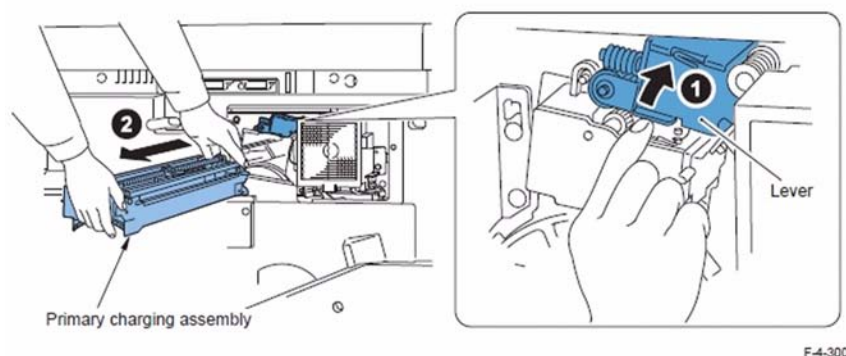
FM3-2814 PRIMARY CORONA ASSEMBLY

Cleaning the assembly, replacing the charging wires and pads may have also corrected the problem. However because the assembly was close to the expected life of 2 million it was determined best to replace the assembly.

Replacing the Primary Charging Assembly (FM3-2814) resolved the copy quality problem.

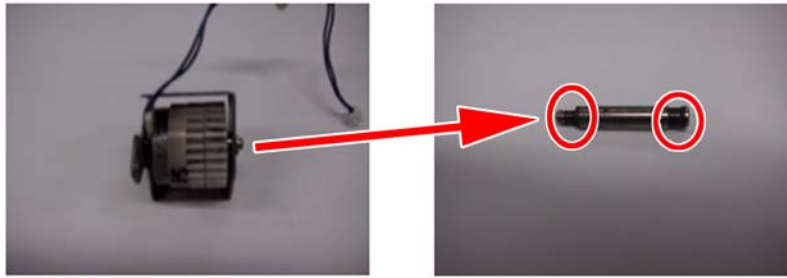
F-1-11

The shaft of the toner cleaner gear assembly that drives the ITB cleaning unit is worn.

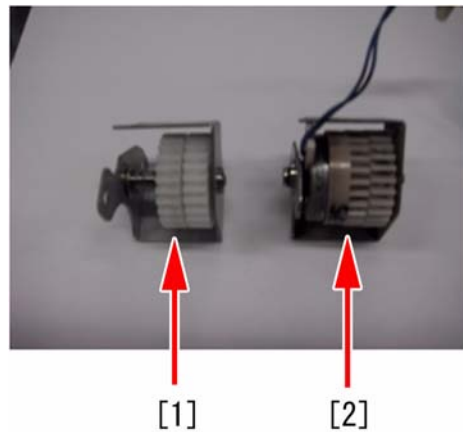
[Reference] There are new [1] and old [2] types of the toner cleaner gear assembly. Wearing of the shaft may occur in the old type. For the machines with a number greater than or equal to the above, the new type of the toner cleaner gear assembly is installed.

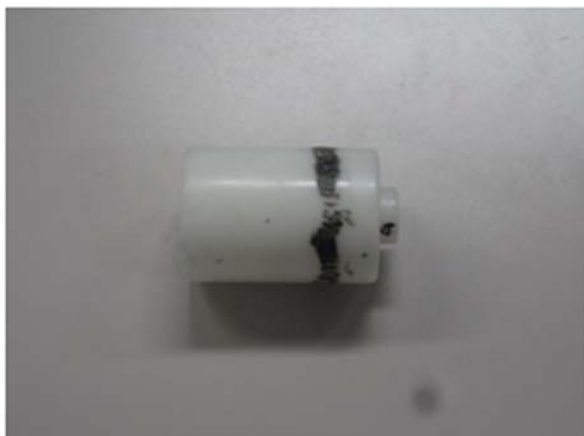
Since the driven roller in the paper feeding area was used over its service life or more than 200,000 images, dirt on the roller transferred to the paper, causing soiled image.

Remove the dirt on the surface of the driven roller with alcohol. If the dirt does not come off, replace the driven roller.

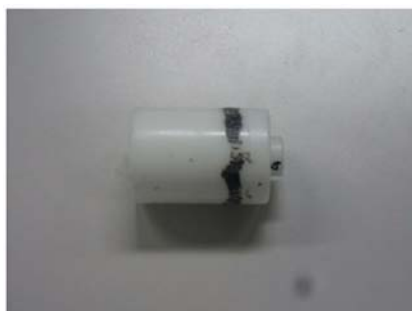
Soiling which can be peeled off by scratching with finger nail

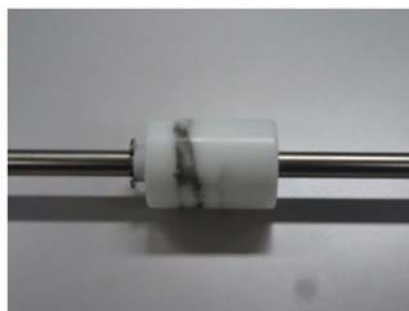
Soiling which cannot be peeled off by scratching with finger nail

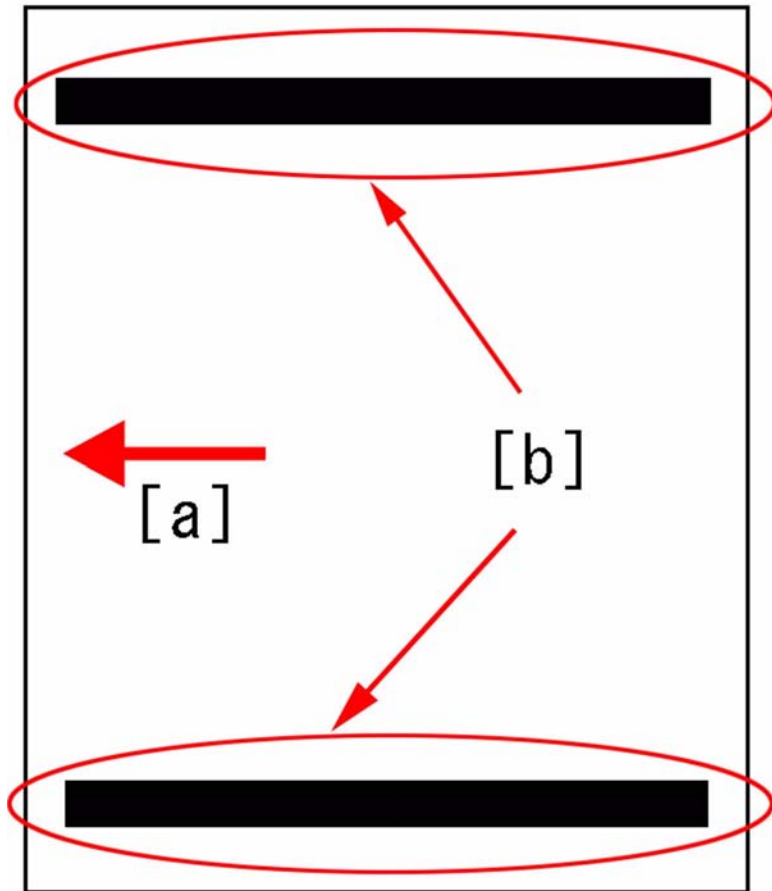
When scanning both sides simultaneously (feed direction [a]) at DADF on the color image reader-L1 with the serial numbers listed below, black band may appear in sub scanning direction [b]. (Black band [b] appears on one or both sides.)

On the scanner unit [1] inside of the DADF, the light-blocking sheet [3] attached on the mirror spring [2] comes off and floats [a], causing to block the light path. [A] shows the light-blocking sheet is attached securely, and [B] shows the light-blocking sheet coming off.

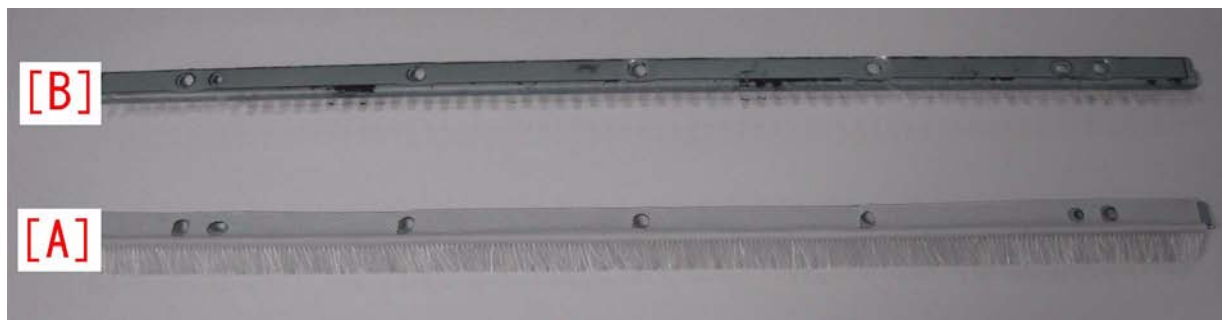
Stained image occurred due to toner dropping on ITB caused by poor document feed in the drum cleaning unit.

- Cleaner Screw Sheet: [A] is a new type with a shape that can secure the amount of toner on the toner feed screw. [B] is an old type.

Prepare a new type of the cleaner screw sheet (FL2-7448-000), 5 pieces of the stirring wire (FC9-7192-000), and 6 stepped screws (FS1-9010-020), and then follow the steps below.

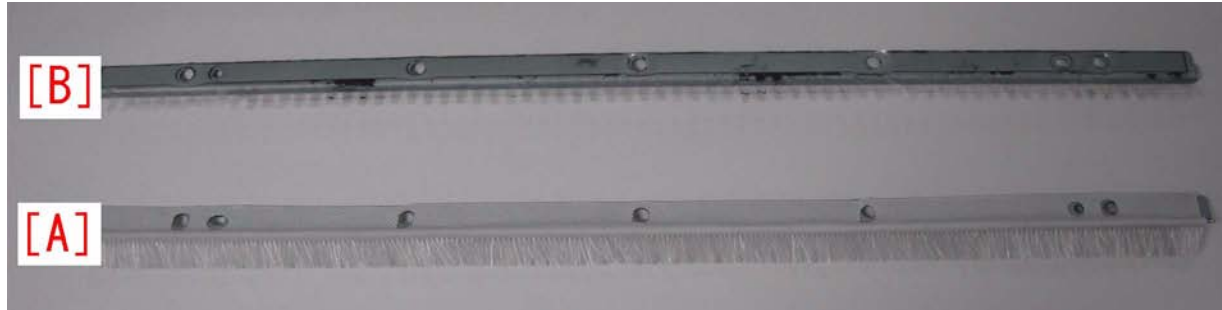
Toner feedability of ITB Cleaning unit was lowered, and toner dropped onto paper[1] to occur stained image.

-Cleaner Screw Sheet: The new type is [A], its shape is modified to stabilize the toner quantity. [B] is the old type.

Prepare a new type of Cleaner Screw Sheet(FL2-7448-000), and then follow the steps below:

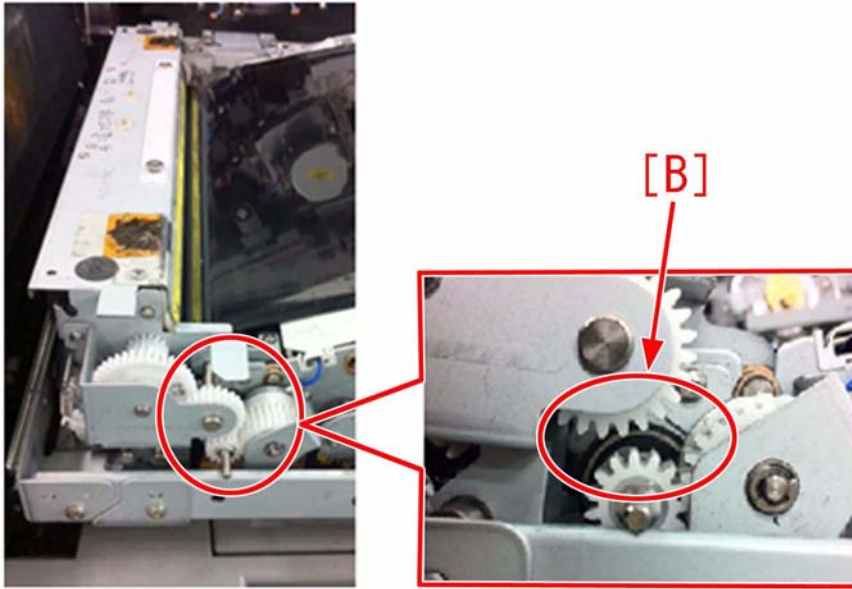
Streak stain appeared in the sub scanning direction [a].

Faulty ITB cleaning occurred due to the state [A] wherein the ITB cleaning unit was poorly mounted. In addition, overflow of waste toner occurred due to the state [B] wherein drive was not transmitted to the magnet roller's drive gear.

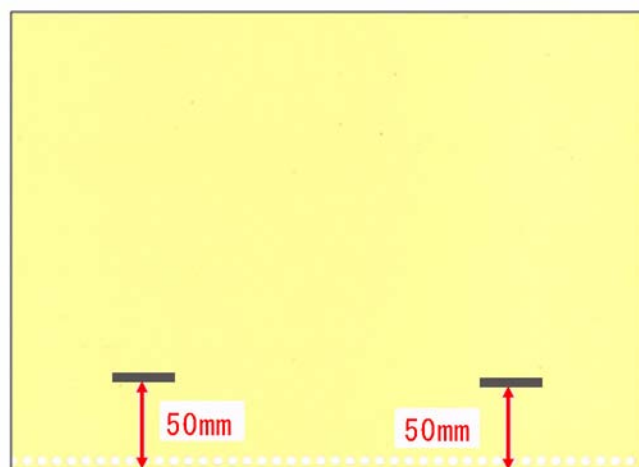
When using the puncher of the Professional Puncher-B1, there were 2 roller marks (18mm x 2mm) on the front side of paper 50mm from its edge. The sample below is an illustration.

In the process of the Professional Puncher-B1 punching holes on paper, the puncher feeds the paper up to the punch area, and stops feeding once to punch holes. During the process, the drive roller was performing idle rotation on paper, and the same soil on the surface of the drive roller was found on the paper.

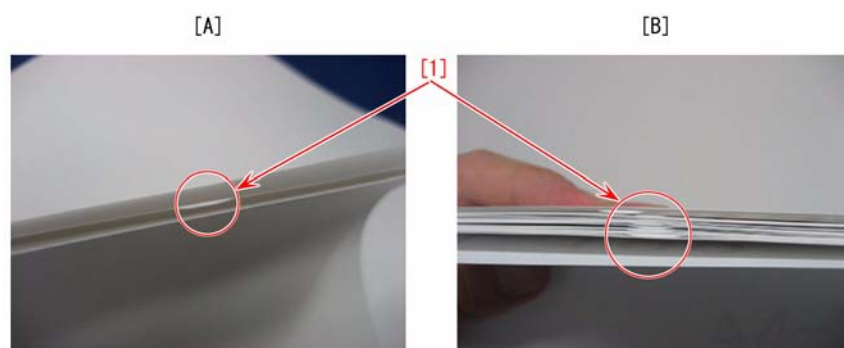
In the field, in a main body with Finisher AF1 or Saddle Finisher AF2 attached to it, the first or the second of buffered sheets, paper edge flipping [1] occurred. When a similar symptom occurs, execute the following field remedy.

Photo [A] shows a flip on the second sheet and [B] shows a bunch of edge-flipping sheets.

1. When the sheet curls lower, adjust it to 0 - 0.5mm upward curl.
 - Additional Functions > Adjustment/Cleaning > Curl Correction for Each Paper Source > select pick-up point to be adjusted > press + to adjust the correction > OK
2. Referring the steps shown below, adjust the buffer displacement amount to 4mm.
 - 2-1. Turn ON the power of the finisher.
 - 2-2. Turn ON the power switch of the host machine to be on standby.
 - 2-3. Open the front cover and put the door switch tool into the door switch [1].

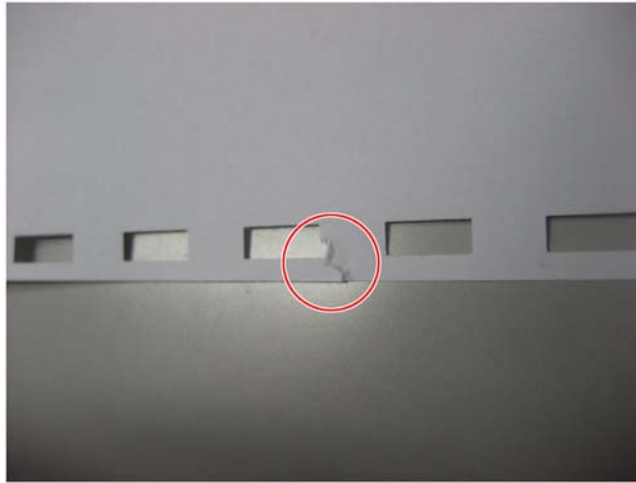
In the field, a punch hole on a sheet of paper delivered to the Tray B of the Finisher was ripped when using the following punch tools with Professional Puncher-B1.

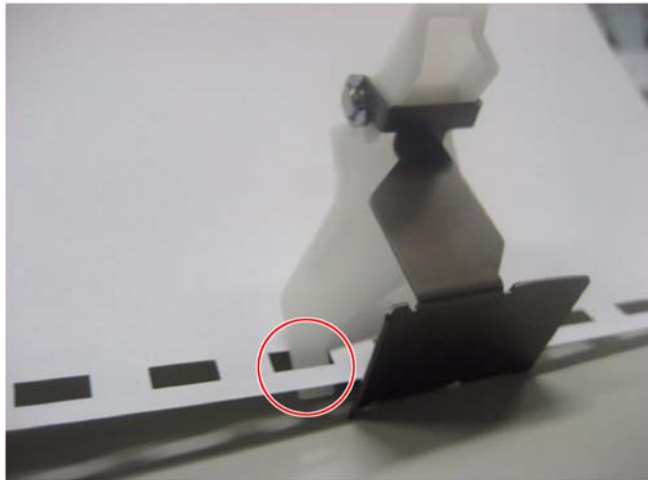
When the paper bumps into the Trailing Edge Stopper, the Operation Bin Lever of the Finisher accidentally gets into the punch hole and catches the paper.

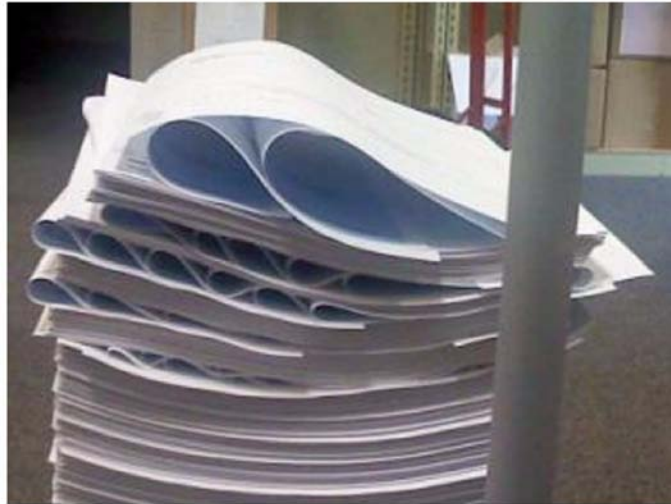
In the field, stack failure occurred because papers delivered to the Stacker-E1 curled upward. If a similar symptom occurs, perform the following Field Remedy.

1. Press Additional Functions > System Settings > Paper Type Management Settings.
2. Select the paper type that you want to edit from the list -> press "Details/Edit".
3. Press "Change" next to "Curl Correction Level".
4. Press "-" or "+" under "Face Up Output" or "Face Down Output" to correct the level of paper curl -> press "OK".

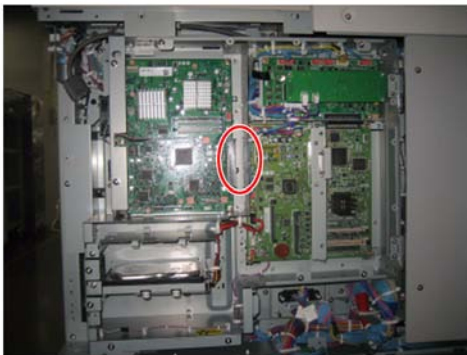
The connection failures of the Main Controller 1 and the Main Controller 2.

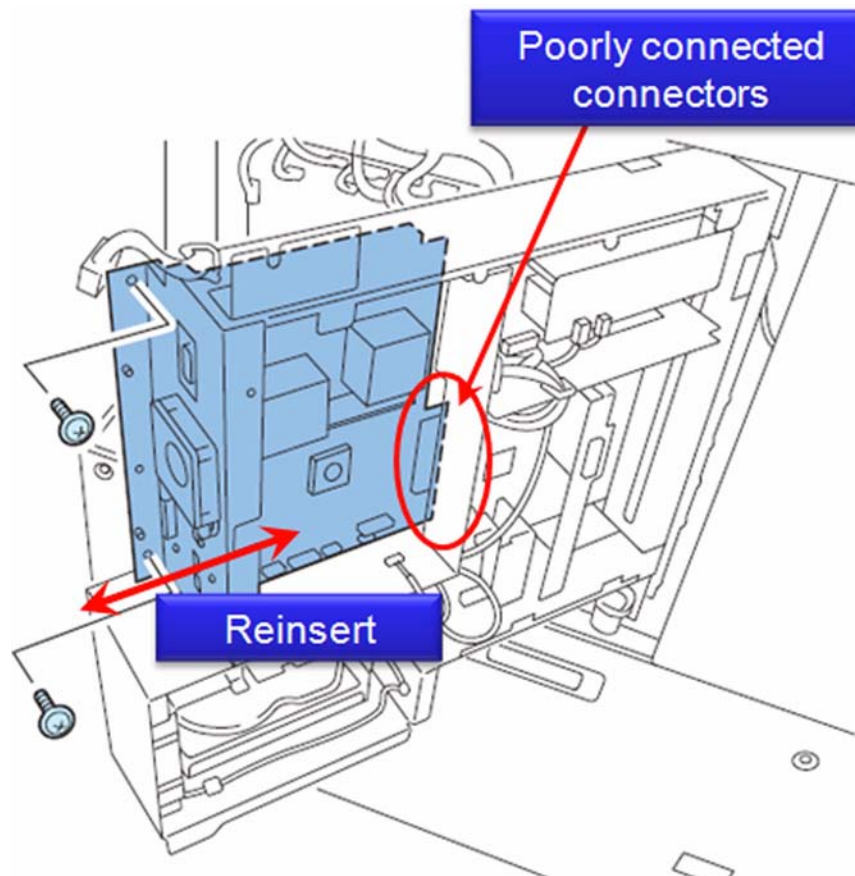
F-1-25

- [Execute/Memory Lamp] on the Control Panel is not lit after the main power is turned ON.
- The progress bar is not displayed.
- There is no operation sound.

- a. Insertion failure of the Main Controller PCB 1 Unit
- b. Assembly was done while the Controller Box Unit was distorted.

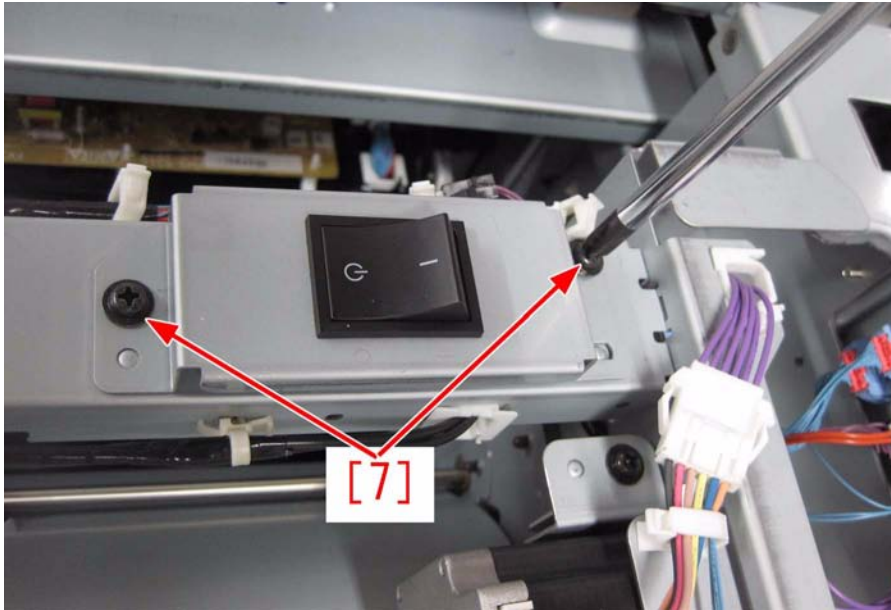
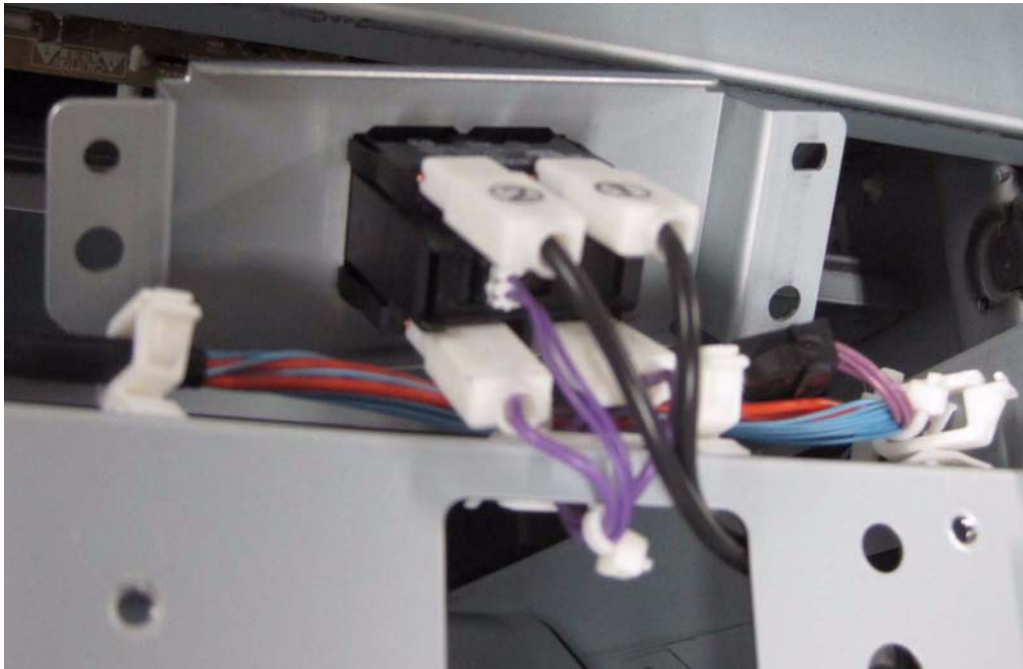
Main power switch gets turned off shortly after turning on the switch due to failure of the main power switch

Poor connection in the DC circuit of the main power switch caused a shutdown from the main controller, and then the main power switch got turned off.

6) Remove the main power switch stand.
- 2 screws [7]

7) Remove a connector and 4 terminals, and replace the main power switch.
- 4 claws

8) Attach the main power switch stand by following the procedure 6 and later in the reverse order.
[Caution] After checking that the main power switch is turned off, insert a plug in an outlet.
[Replacement part]
FK2-2509 main switch

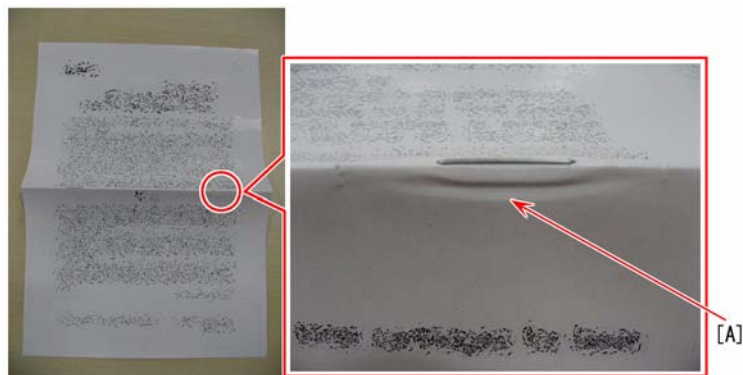
In the field, wrinkle [A] occurred in the saddle stitch folding area when saddle stitch was performed with a small number of high conflict resistance paper (coated paper, etc.). When a similar symptom occurs, execute the following field remedy.

Paper folding for saddle stitch was performed in the condition that the saddle stitching position and the folding position were misaligned.

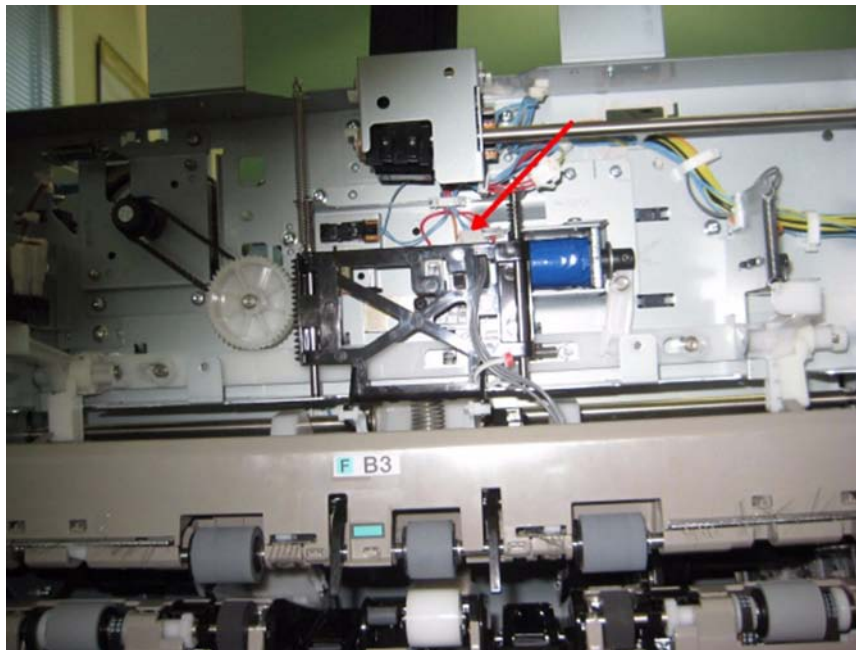
Photo interrupter S118 detects when the swing guide is at the down position. The wiring harness to the intermediate connector J1091 can break down and cause S118 to malfunction. If poor stacking occurs, observe the swing guide and look to see if it does not drop all the way to feed the paper back into the dispose assembly.

If you observe erratic swing guide operation, replace harness FM4-0340 (Parts Figure L11 Item #35).

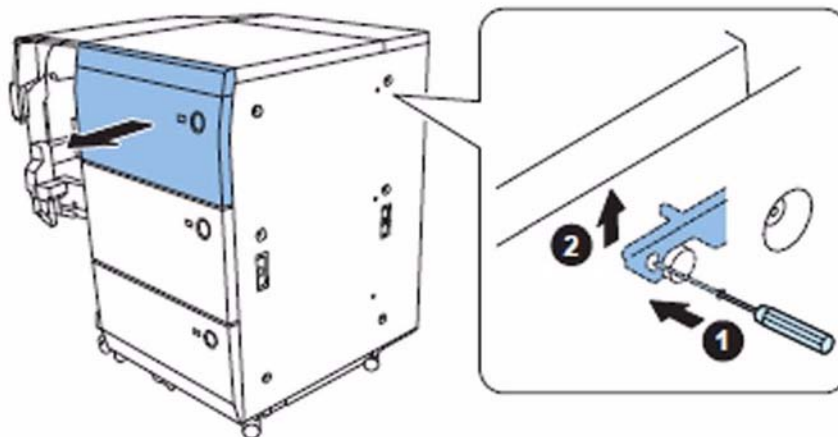
When attempting to open one of the deck drawers, the open door switch will not display the blinking green led and no lifter operation. The deck drawer must be opened manually from the side panel hole access.

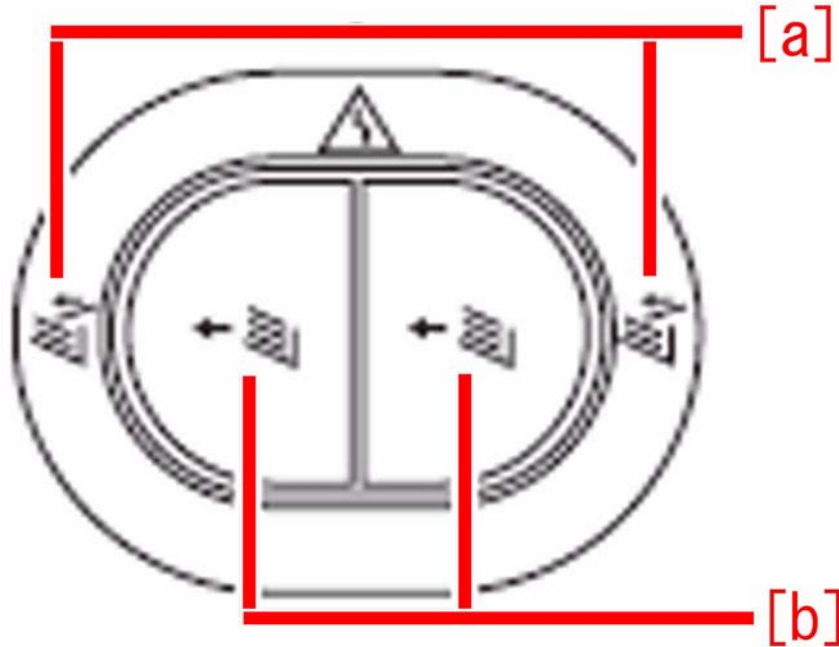
In the system software STACK Ver.15.01 or later for the high capacity stacker-E1, the loading status indicator [a] lights even though the tray is not full. [b] is the front cover open button status indicator.

The following specification change was made in the system software STACK Ver.15.01 or later for the high capacity stacker-E1.

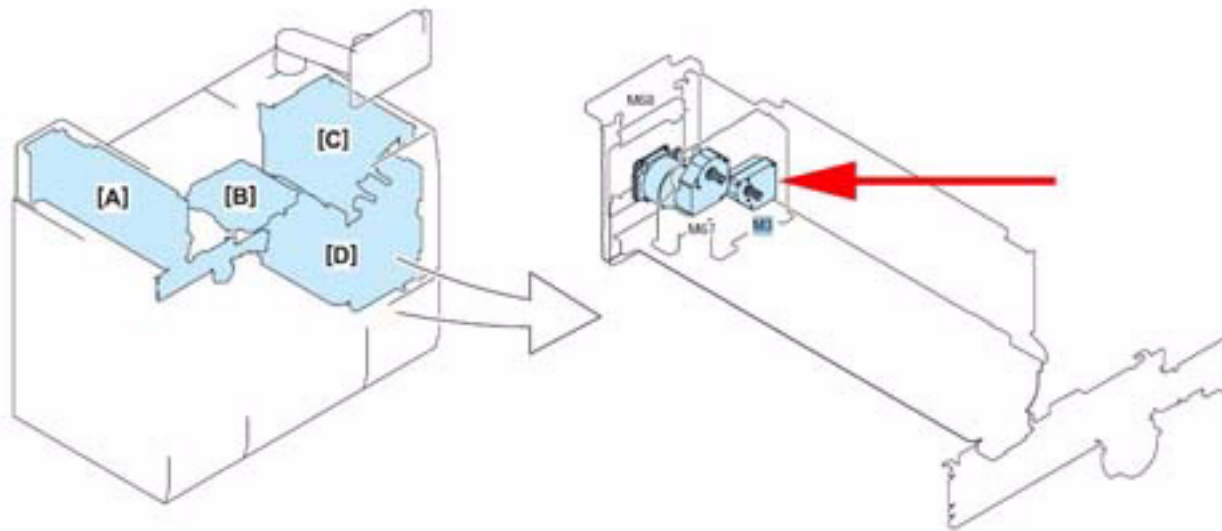
The display shows a message to replace the toner bottle. When the toner bottle was removed it was confirmed to be empty. Tried three different new toner bottles.

It was observed that the bottle never rotated.

The solution was to replace both the Hopper Driver PCB (FM3-5243) and Hopper Motor M3 (FK3-0824). The following image shows the location of the Hopper Driver PCB.

The following image shows the location of the Hopper Motor M3.

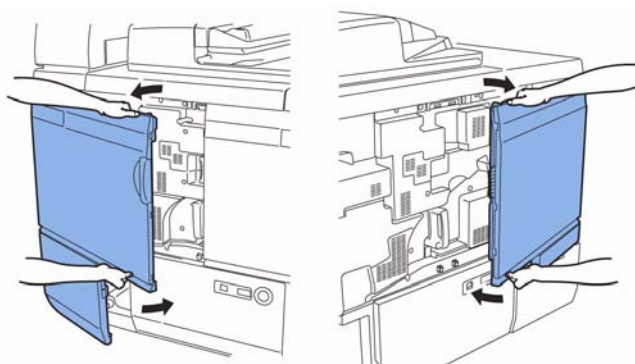
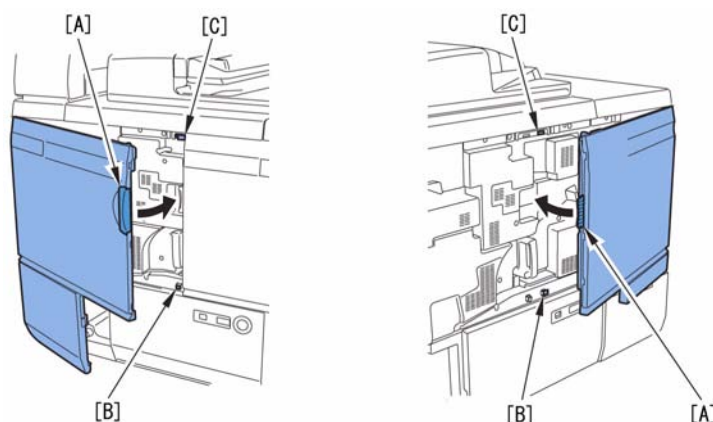
Assumed cause is, front cover is closed or opened when the fixing feeder lever is in the “down” position, or burden in the cover during operation.

1. Press the front cover lightly.
2. If the symptom still occurs, put your hands on the upper and lower sides of the cover, and stretch to the direction of arrow to correct the distortion.

3. When you close the cover while pressing the handle, make sure that the lower magnet catch comes before or at the same time as the upper one.

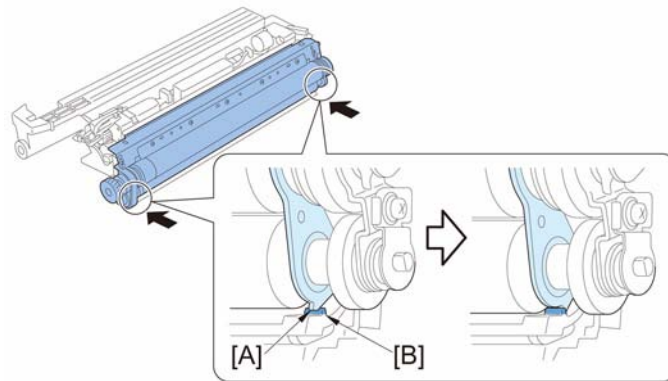
1.1.3.3.4 Toner scattering inside machine due to improper installation of Developing Sleeve Unit

Check that the protrusions [A] on the right and left sides of the Developing Sleeve Unit Side Plate are inserted in the inner side of the Rib [B] of the Developing Assembly. If the Developing Sleeve Unit is not properly installed, reinstall it.

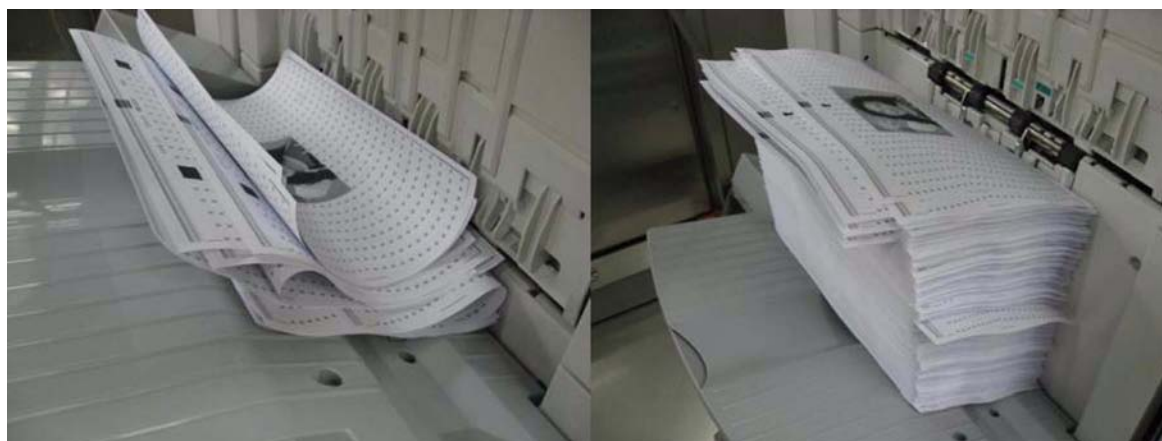
When multiple sets of 1 page original were output, the output paper stacked faultily.

Paper may have curl depending on types or conditions of paper. The curl causes faulty stacking.
[Reference] Since the output method for 1 page original and multiple pages original is different, the frequency of occurrence is different.
