Troubleshooting Guide

imagePRESS 1135/1125/1110 Series

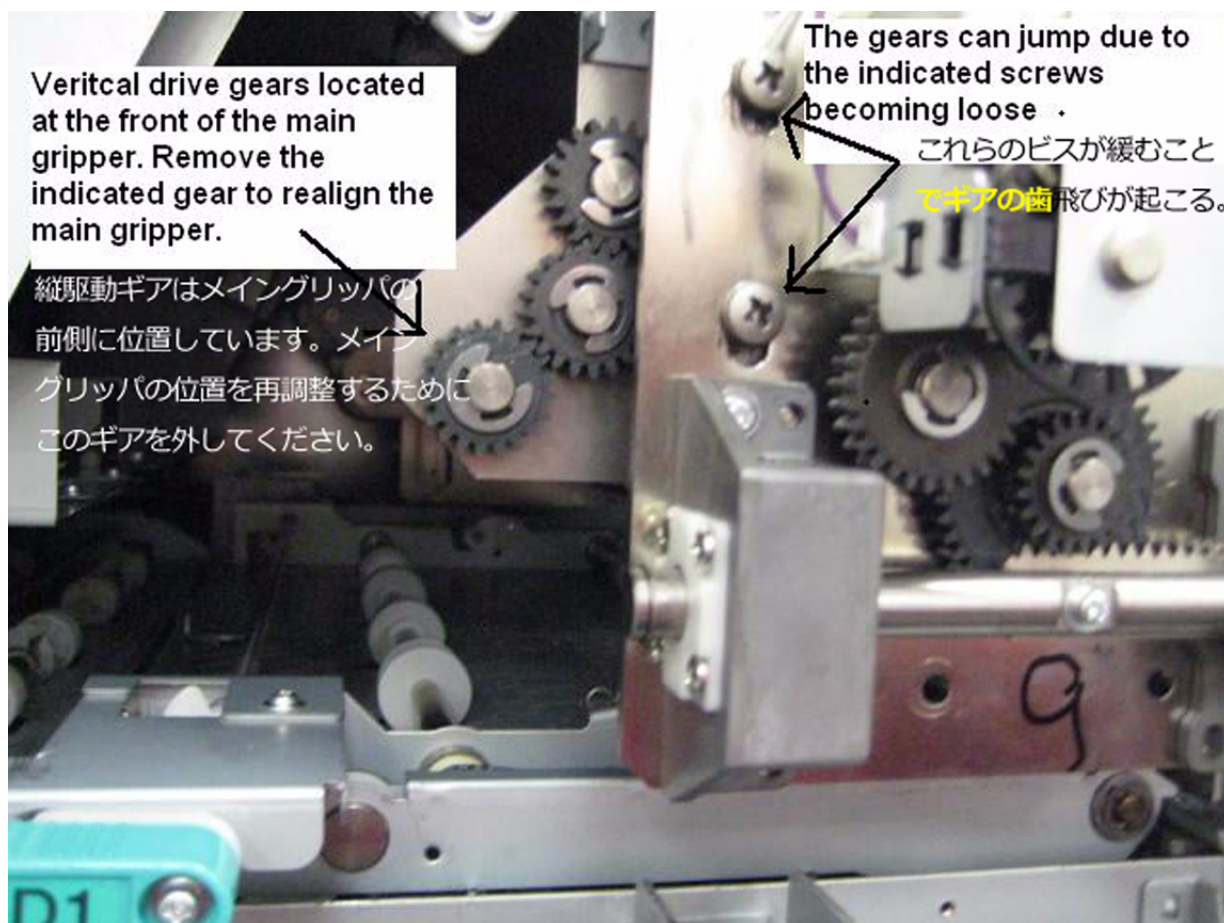
Figure 3

The cause of the uneven glue application is the improper alignment front to rear of the main gripper assembly. Use the Dip Switch (SW2) and PSW1 on the Service PCB to adjust the position of the main gripper.

[Caution] The main gripper may be misaligned when 2 screws in the figure 3 become loose. Before adjusting, check that these 2 screws are tightened securely. Additionally, the Main Gripper Plate in the rear side may have some glue attached on it. If any glue is on it, remove before making this adjustment.

If the front or rear does not touch the guide, remove the Vertical Drive Gear shown in the figure 3 and adjust so that the front and rear of the main gripper touches the Stack registration guide.

5) Reinstall the Driving Gear and turn ON the power of the Perfect Binder.

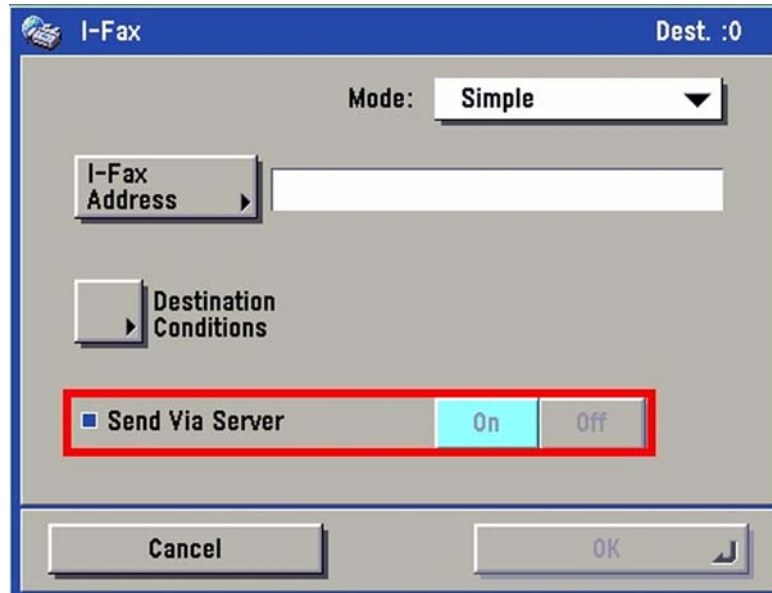
Figure 1. Send Via Server is greyed out.

When performing Universal Send to I-Fax destination which is another imagePRESS copier device, the setting to turn ON or OFF Send Via Server option is deactivated or is greyed out. To enable this option, perform the following procedure:

- 1) Press Additional Functions > System Settings > Communication Settings > E-mail/I-Fax Settings > Use Send Via Server "On/Off" and turn this setting ON.
- 2) Press Done until the console screen is out of User Mode Settings.

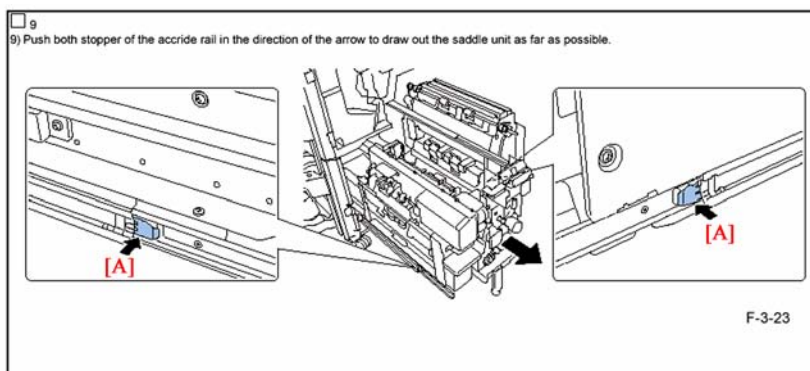
In the field, option for imagePRESS 1110, trimmer unit is installed in the saddle unit of Saddle Finisher-AG2, accride rail stopper [A] is pushed, saddle unit is fully pulled out (service position) to the front, and after the unit rear cable and drive belt are installed, when the saddle unit is to be put back to its original position, movable cable guide is damaged, and it can't be set to the original position.

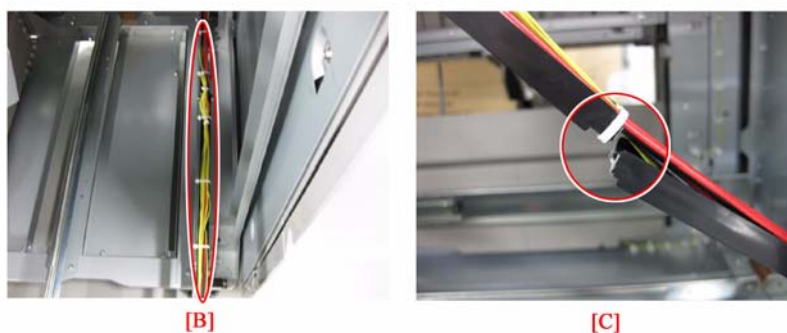
When the saddle unit is pulled out to the front up to the service position, the movable cable guide (communication cable guide) would become straight and tight [B]. If in this condition, you push hard and put it back to original position, the guide [C] might become damaged.

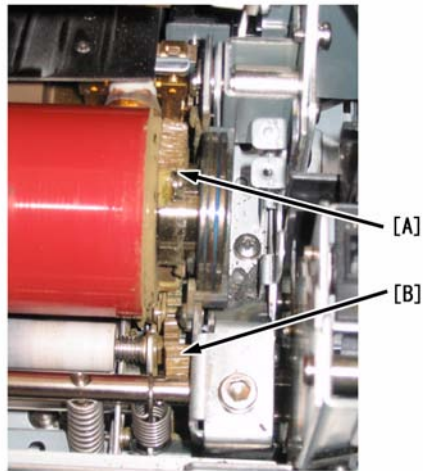
If the insulating bush is installed wrong direction, the roller moves back and forth and results in breaking the 51T gear [A]. In the field case, Refresh roller gear [B] was also broken.

1. In case the 51T gear is broken, replace and install a gear in right direction.
2. Possibly refresh roller gear is broken. If so, replace the refresh roller assembly.
FU7-0842 GEAR, 51T
FM3-2876 REFRESH ROLLER ASSEMBLY

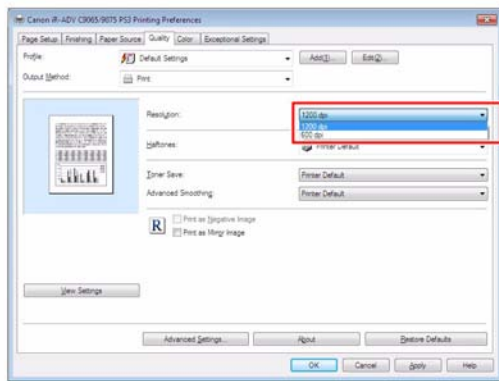
F-1-32

In Printer properties > General tab > Preferences > Quality tab, even when "Resolution: 1200dpi" is selected, there was no difference in the quality of output image between "Resolution: 600dpi" and "Resolution: 1200 dpi."

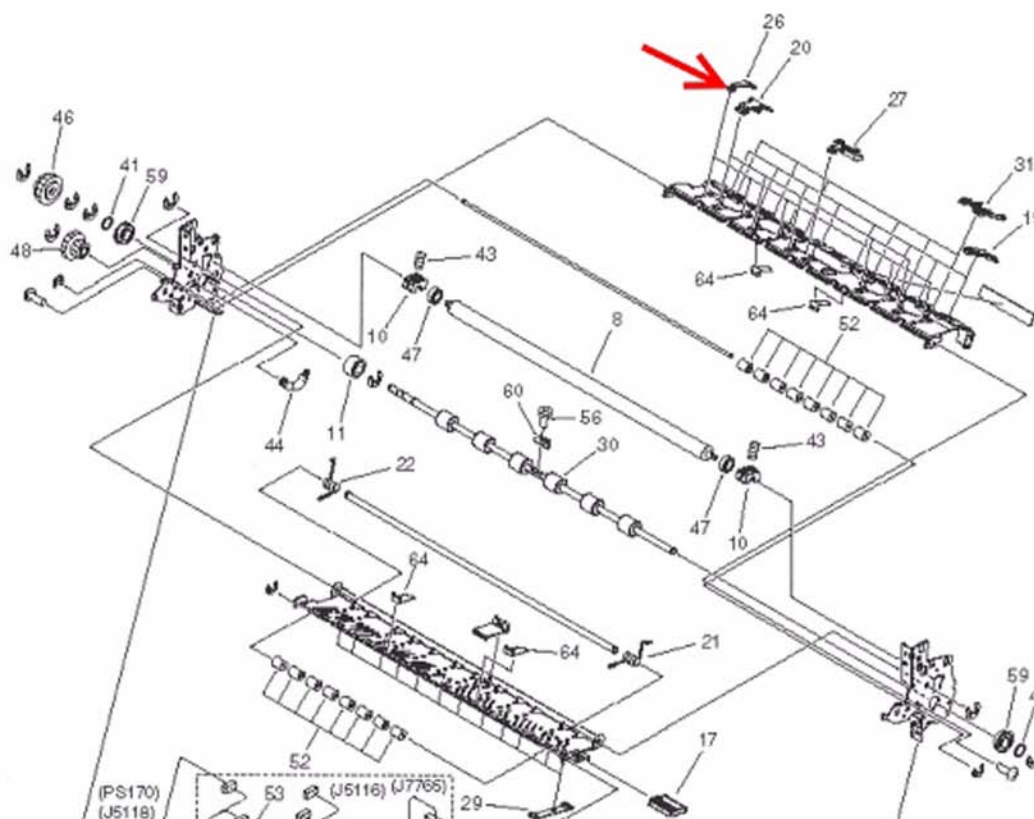
1.1.5.2	Connection Problem..... 1-154
1.1.5.2.1	Cannot connect to network (TCP/IP), ping does not get through at installation 1-154
1.1.5.2.2	Network Troubleshooting TCP/IP Checklist [G]..... 1-155

An inspection of the Inner Paper Delivery Assembly, revealed a paper cut in the small Paper Delivery Rib, P/N FC7-9740. The Delivery Ribs were replaced, and the imagePRESS no longer was jamming, or dog earring the pages. The parts in question is illustrated below:

FC7-9740 RIB, PAPER DELIVERY, SMALL

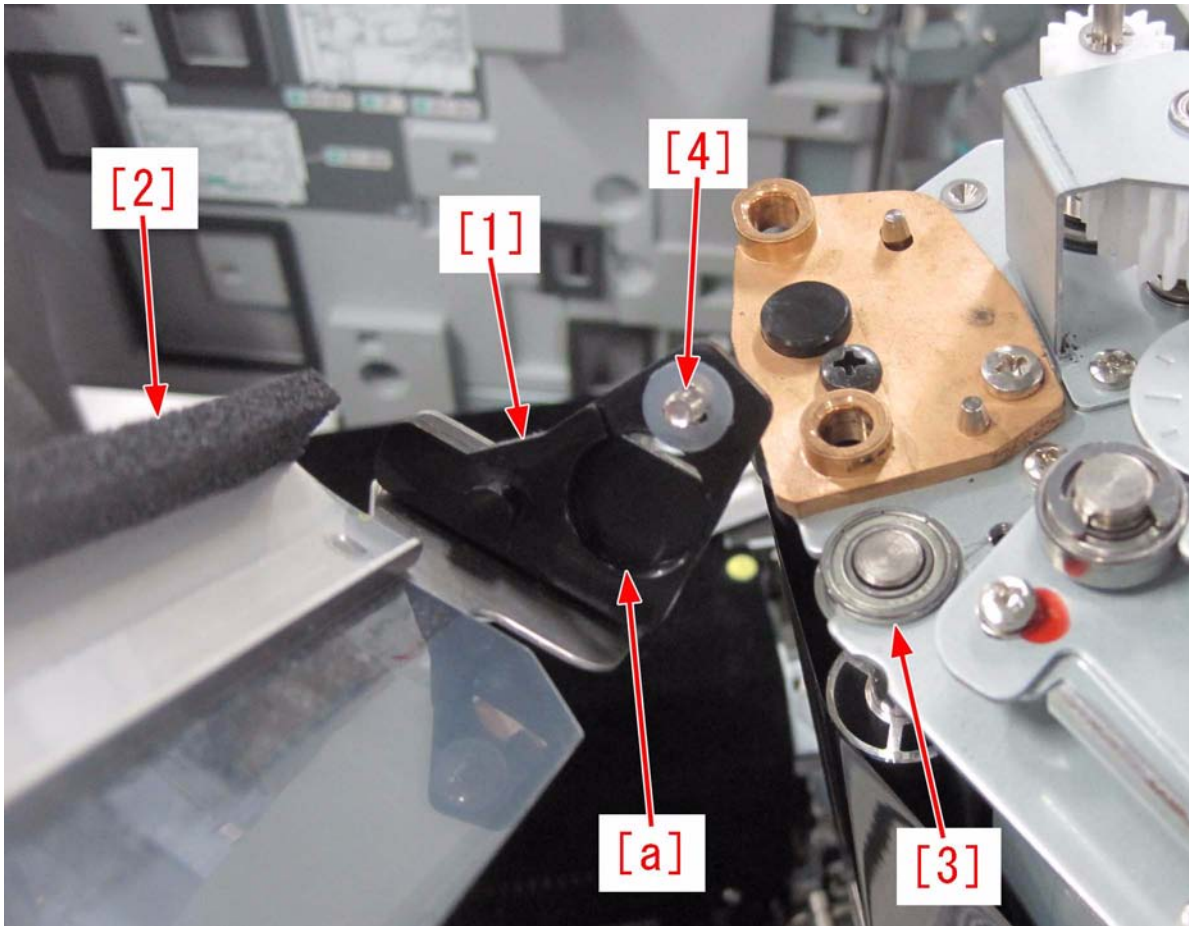
[Caution] When attaching the secondary transfer inlet upper guide [2], correctly align the positions of the bearing [3] and the round cut-off [a], and then tighten screws [4]. Tightening the screws in a state that the bearing [3] and the round cut-off [a] are misaligned will lead to breakage of the entrance upper holder (front).

Remove the secondary transfer inlet upper guide and replace the entrance upper holder (front).

[Replacement Part]
FC7-9252 HOLDER, ENTRANCE UPPER, FRONT

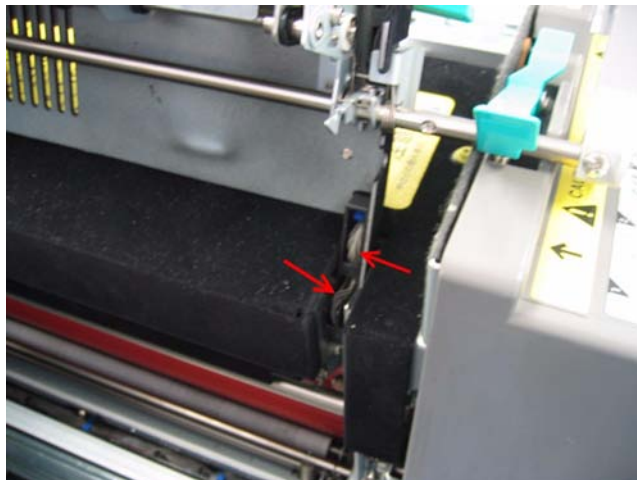
Check the harness that runs along the front of the Inner Paper Delivery Assembly. It has been found, the opening and closing of the Inner Paper Delivery Assembly may cause the wiring to flex and break. This may cause the 0113 jam code, or various other errors.

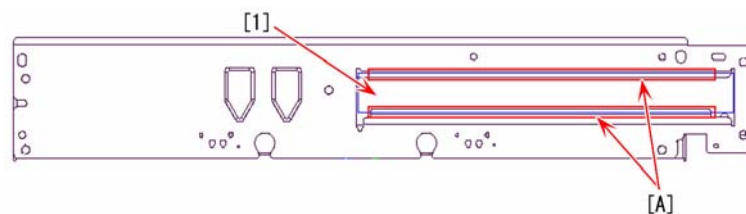
The C.I.S. glass of the pre-reg. guide assembly was attached with double-sided tape. It seems that the pressure force was insufficient, that caused the glass came off.

In the case that the C.I.S. glass of the pre-reg. guide assembly [1] comes off, apply pressure by pressing surely the adhesive surface [A] when attaching the glass.

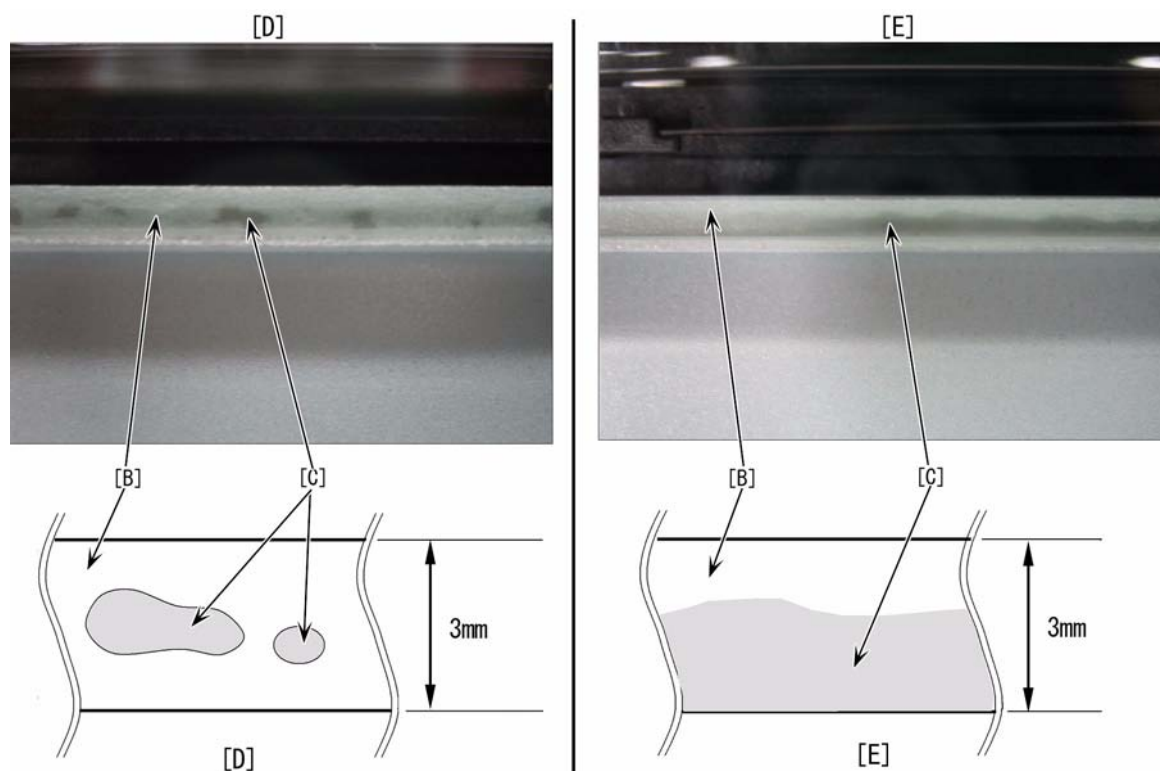
- When pressing the C.I.S. glass, use a clean lint-free paper and prevent fingerprints or grease from attaching it. In addition, be careful not to break the glass.
 - After attaching the glass, check that the adhesive surface looks white [B]. In the case that it looks darkened [C], it is not adhered properly. In such a case, press the adhesive surface again. In addition, if the end is not adhered, it may cause the state of the C.I.S. glass coming off.

In the illustration below, [D] indicate the state that the pressure force is sufficient, and [E] indicates the state that the pressure force is not sufficient.

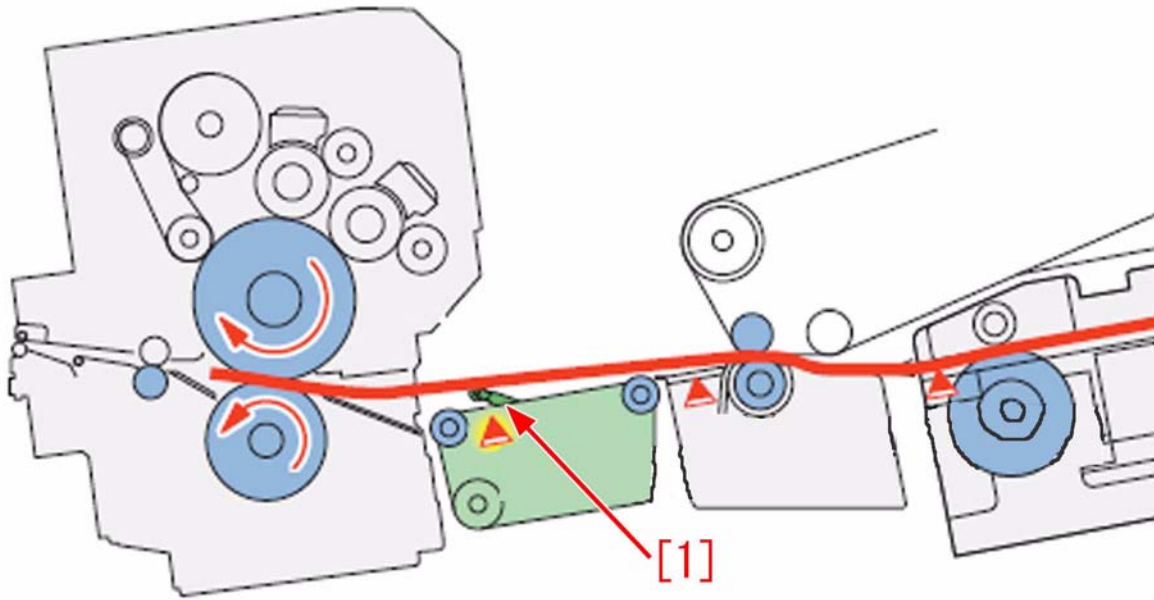
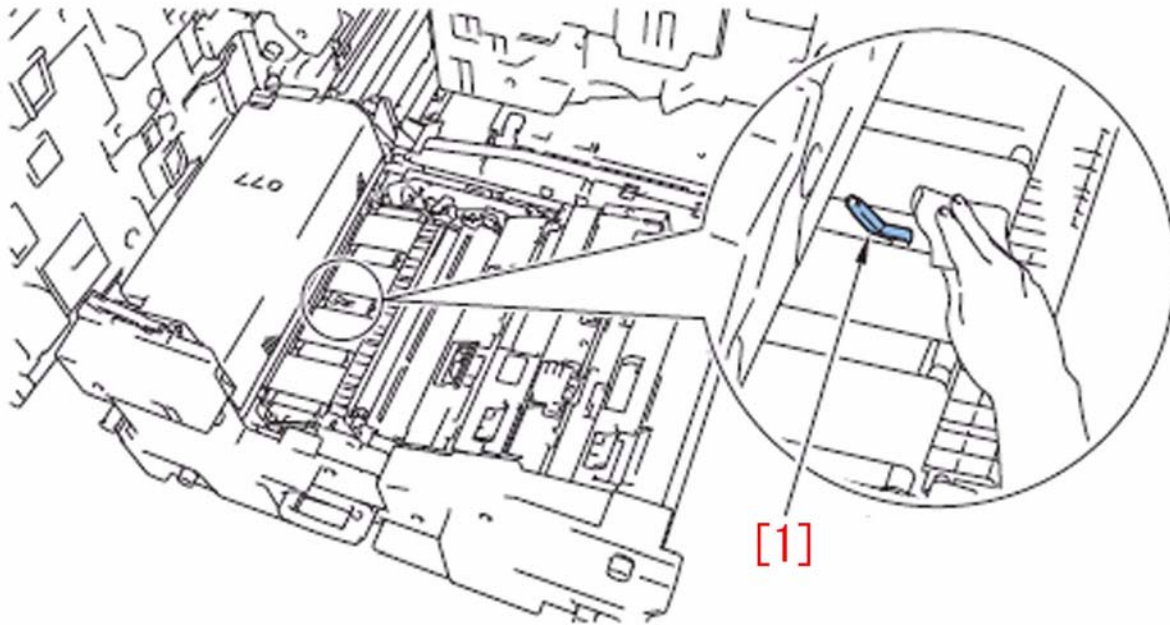
- The position of the sensor flag of the loop detection sensor [1]

Replace the pre-fixing paper feed unit.

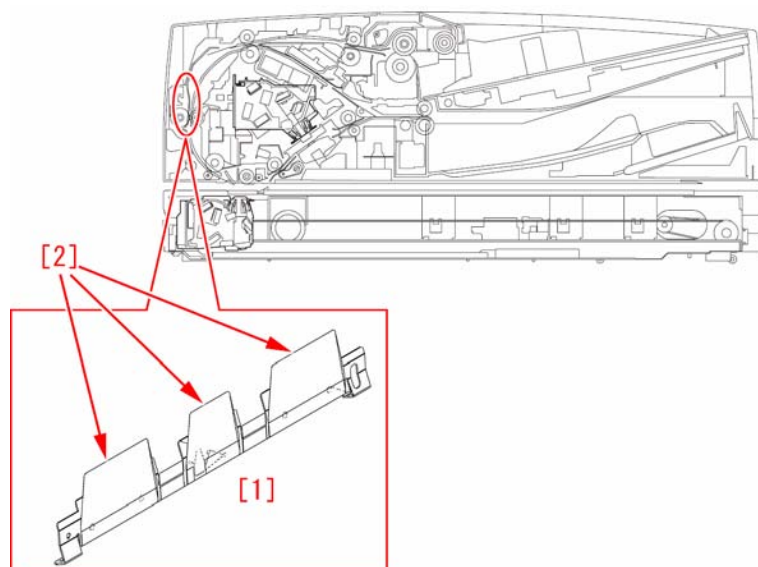
When removed accordion or folded/bent jammed originals, the symptom occurred due to the turned up sheet [2] of the registration guide [1].

Prepare the new type of the registration guide (FL2-9670-000) in which the measure against sheet-turns-up has been taken and also the new type of the paper feed guide (FL2-9671-000) that has been changed in conjunction with the shape change of the registration guide in order to replace the old parts with them by following the below procedure:

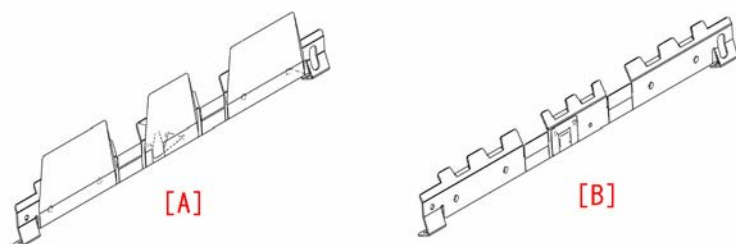
The pictures below show the old type [A] and new type [B] of the registration guide.

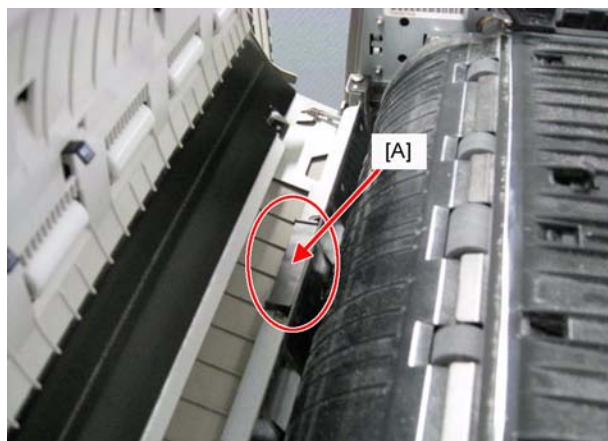
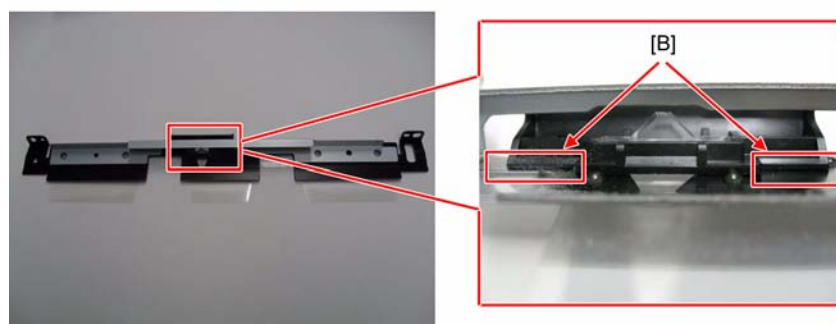
The Registration Sensor sheet [A] was caught in the jammed paper upon jam clear causing the double-stick tape [B] attaching the Registration Sensor to peel off resulting in the Jam Code remaining to be displayed.

1) In Service Mode > COPIER > I/O > FEEDER > P004-3, check the I/O display of the Registration Sensor. If it is "0 (paper present)", go to Step 2). If it is "1", the cause is different from this issue. So check for other causes.

3) If the double-stick tape attaching the Registration Sensor is peeling off, fix it. If there is no tape peeling off, replace the Registration Guide (the Registration Sensor.)

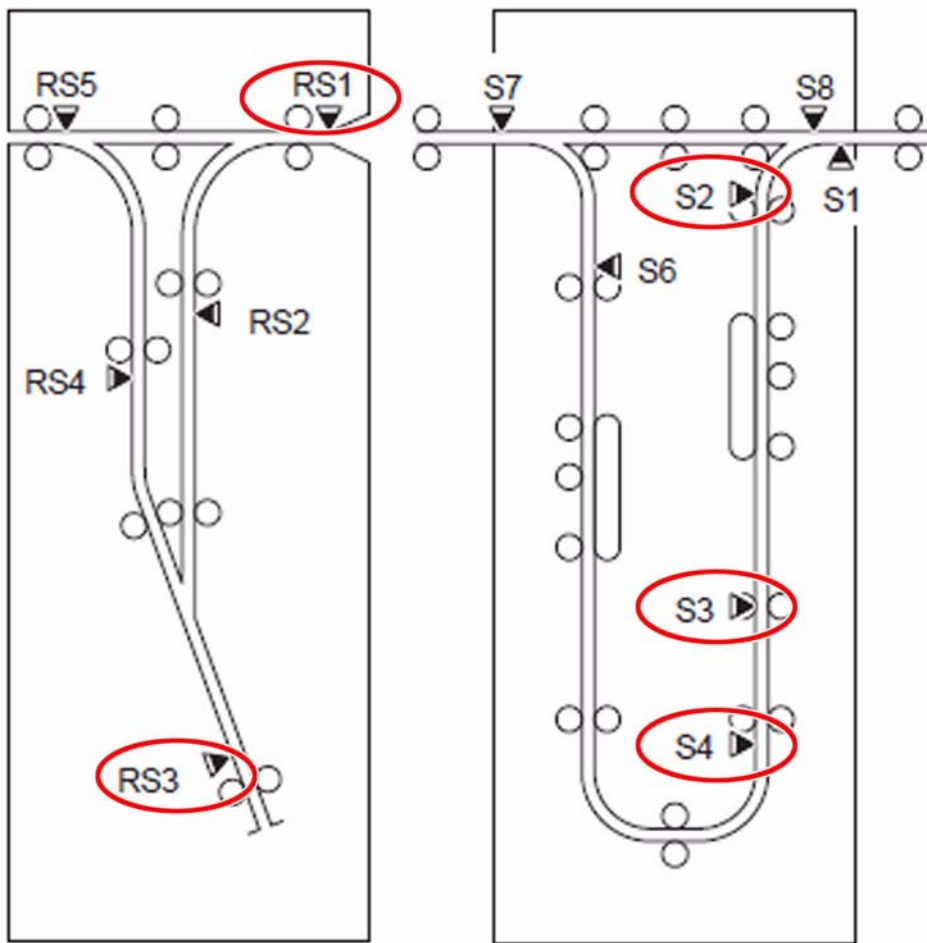
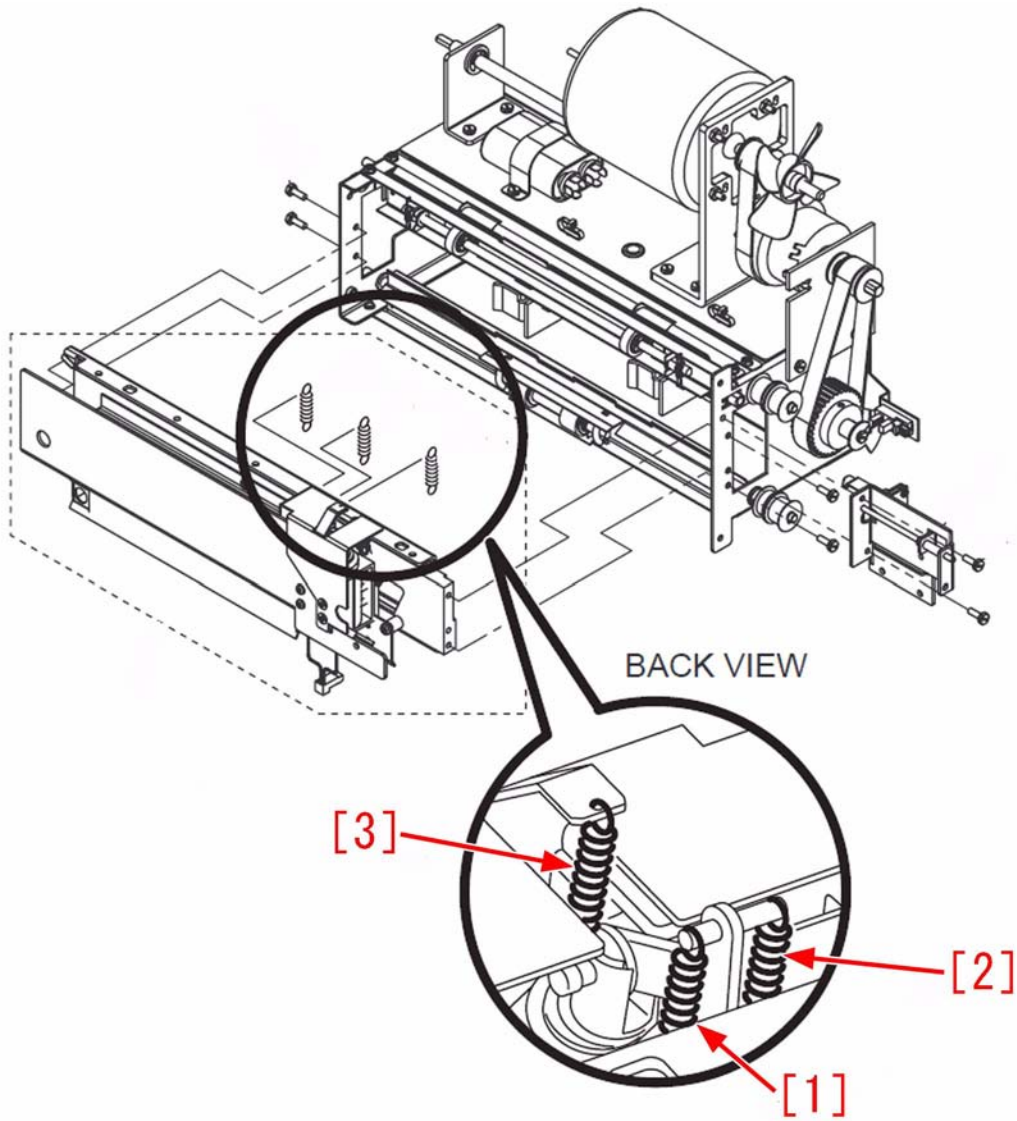
11B3/11B5/11B7/1F07/1FC2/1103/1764/1765/1766/175E/1777/1752 Jam consecutively occurred.

The jam occurred due to operational defect of the back gage caused by breakage and detachment of the brown spring [1] attached to the back gage unit. [Reference] The same symptom occurs when the red spring [2] or the blue spring [3] is detached.

The surface treatment of the brown spring is changed to the one that brown coating is applied on top of nickel-plating, which can make the spring difficult to be broken.

- 1) Remove the rear cover of the professional puncher-B1, and free the harness [1].
- 1 connector [2]
- 1 wire saddle [3]
- 1 rubber bush [4]

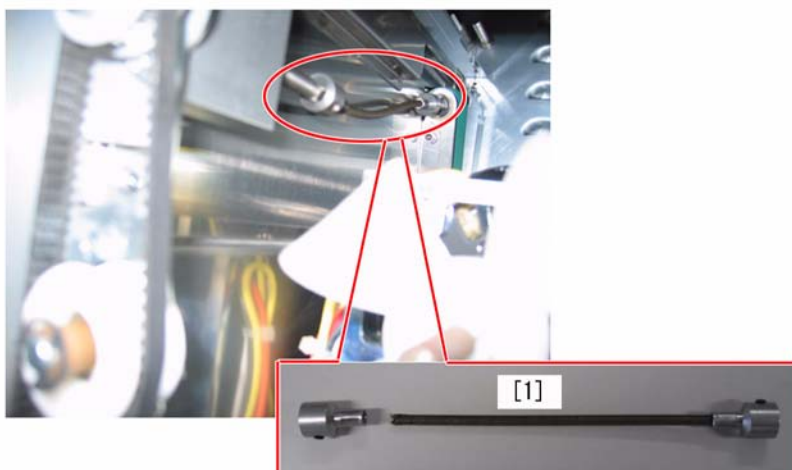
Due to the breakage of the aligner drive flexible shaft[1] in the aligner entrance drive assembly of the Professional Puncher-B1, paper was unable to be fed. Because of this, the Professional Puncher-B1 was unable to send signal of paper feed, which resulted in making the Professional Puncher Integration Unit-A1 detect timeout.

Replace the Aligner Drive Flexible Shaft.
FC3-3778 SHAFT, FLEXIBLE, ALIGNER DRIVE

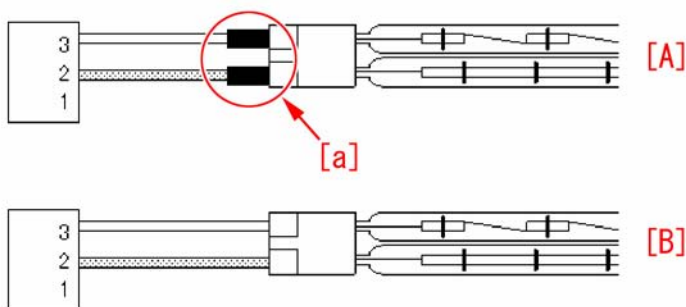
[Reference] The halogen heater[A] is the new type, and [B] is the old type. The new type has a tube in the area[a]. There is no tube on the old type.

Replace the halogen heater with the new type (FK3-3673).

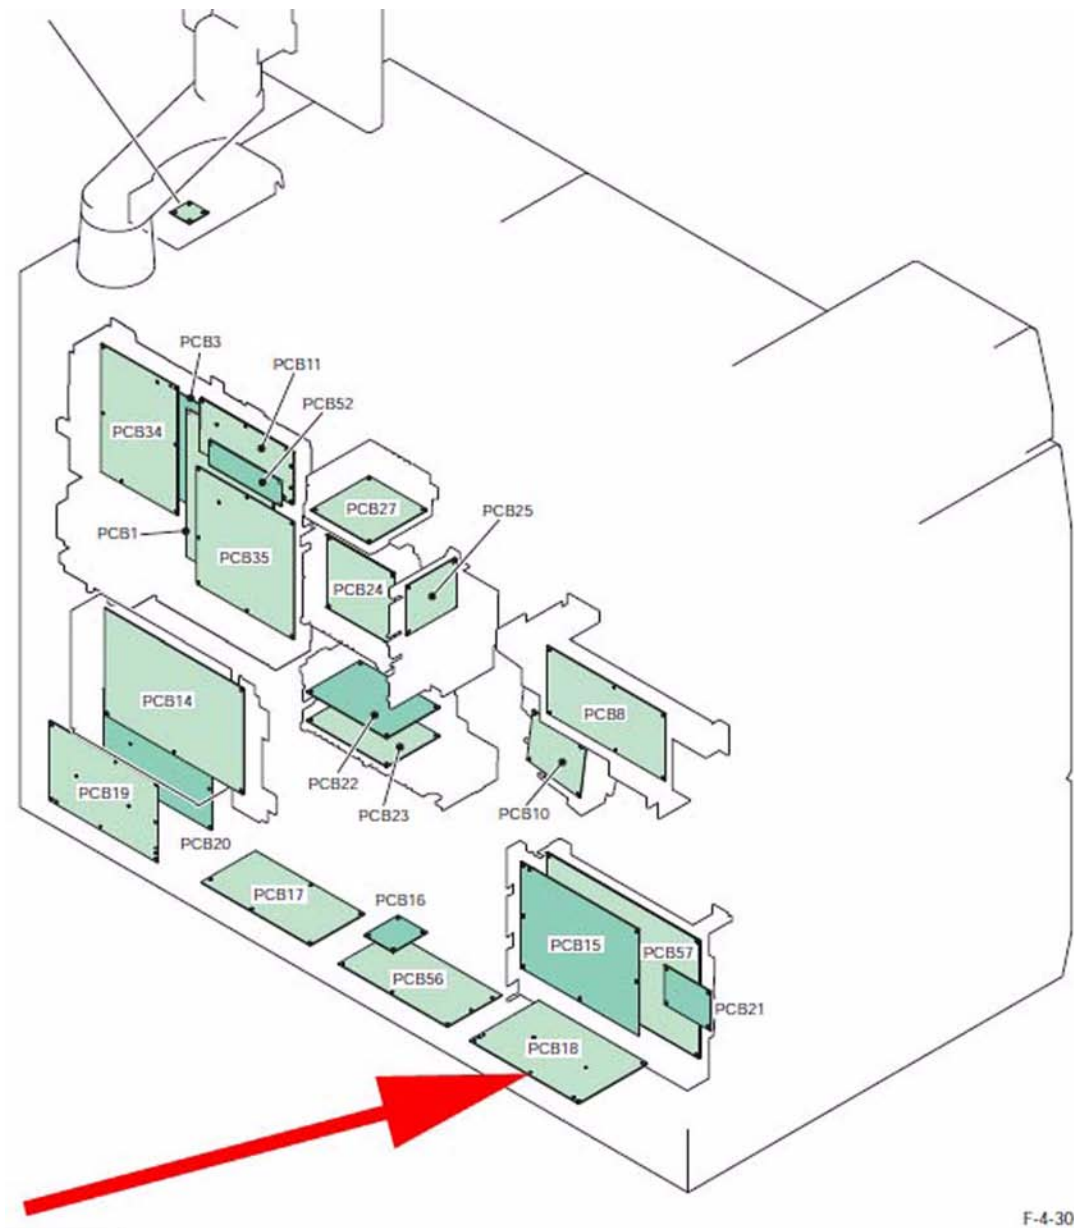
After following the troubleshooting steps in the Service Manual it was found that 24 volts DC was missing from the PCB18 24v power PCB. The missing 24 volts DC was on PCB18 connector J1472 at pins 3, 4 and 5. The Parts Catalog describes PCB18 as DC Power Supply Assembly (24v) and the part number is FM3-2423. The following image shows the location of PCB18.

FM3-2423 DC POWER SUPPLY ASS'Y, 1(24V)

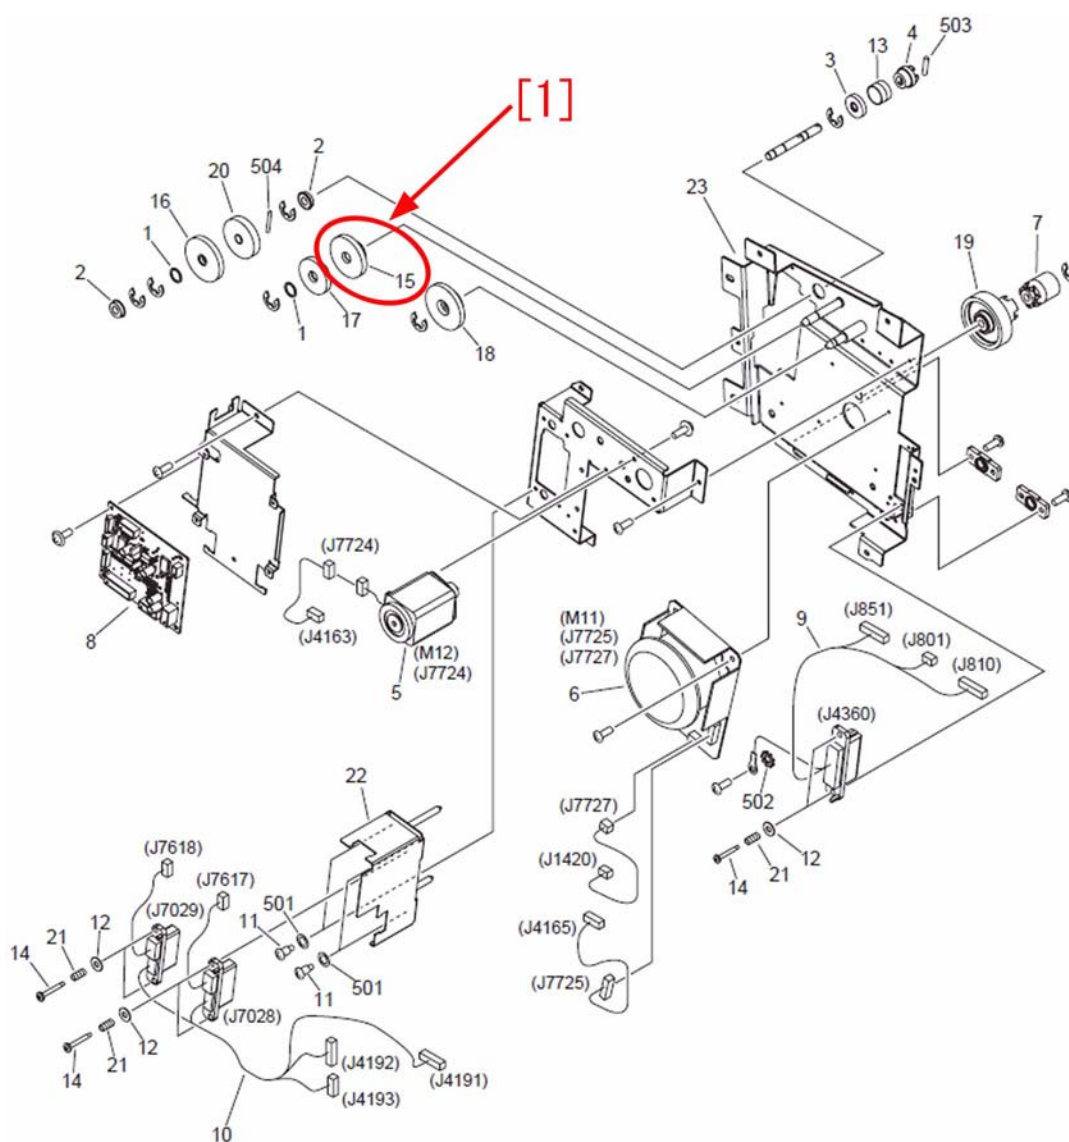
Because drive is not transmitted to the external heat roller due to breakage of 20T/42T gear [1] in the fixing drive assembly.

Replace 20T/42T gear.

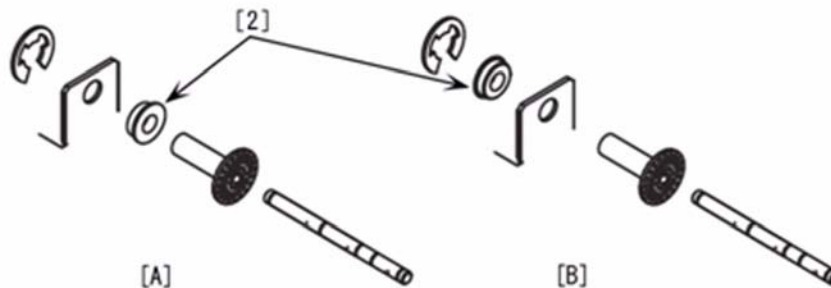
F-1-34

[A] shows the Bushing after the change and [B] shows the Bushing before the change.

- 1) Replace the Drive Shaft with a new one.

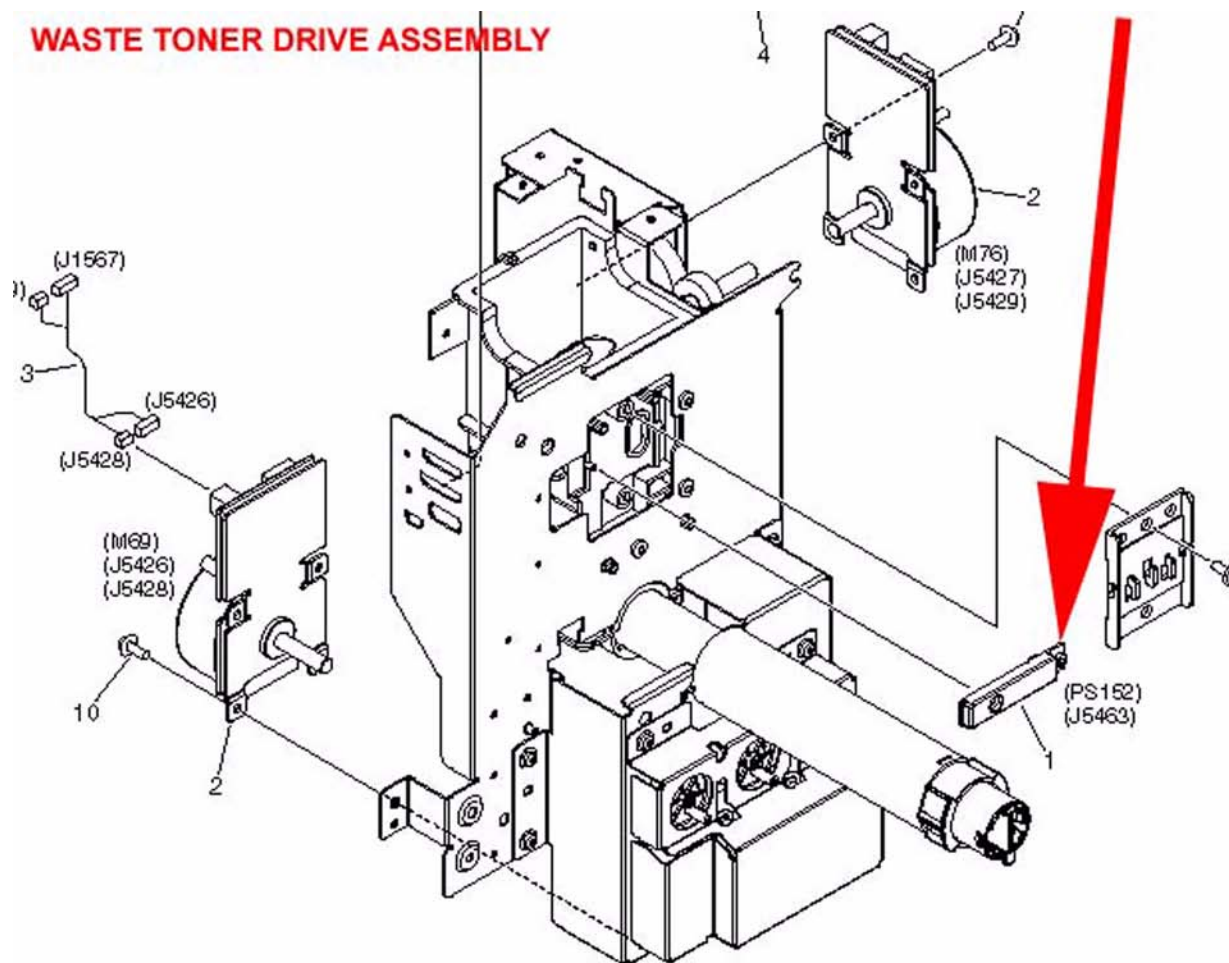
After the System Software was upgraded to version 54.01 the i button indicated the Buffer Full Sensor (PS152) exceeded the threshold value. The threshold value was confirmed in level 1 Service Mode > Copier > Display > Sensor > W-BUF-1 was 775.

Cleaning PS152 and removing toner from waste toner auger resolved the error code. It was noted that the W-BUF-1 value dropped to 400. The following image shows the location of PS152 in the Waste Toner Drive Assembly.

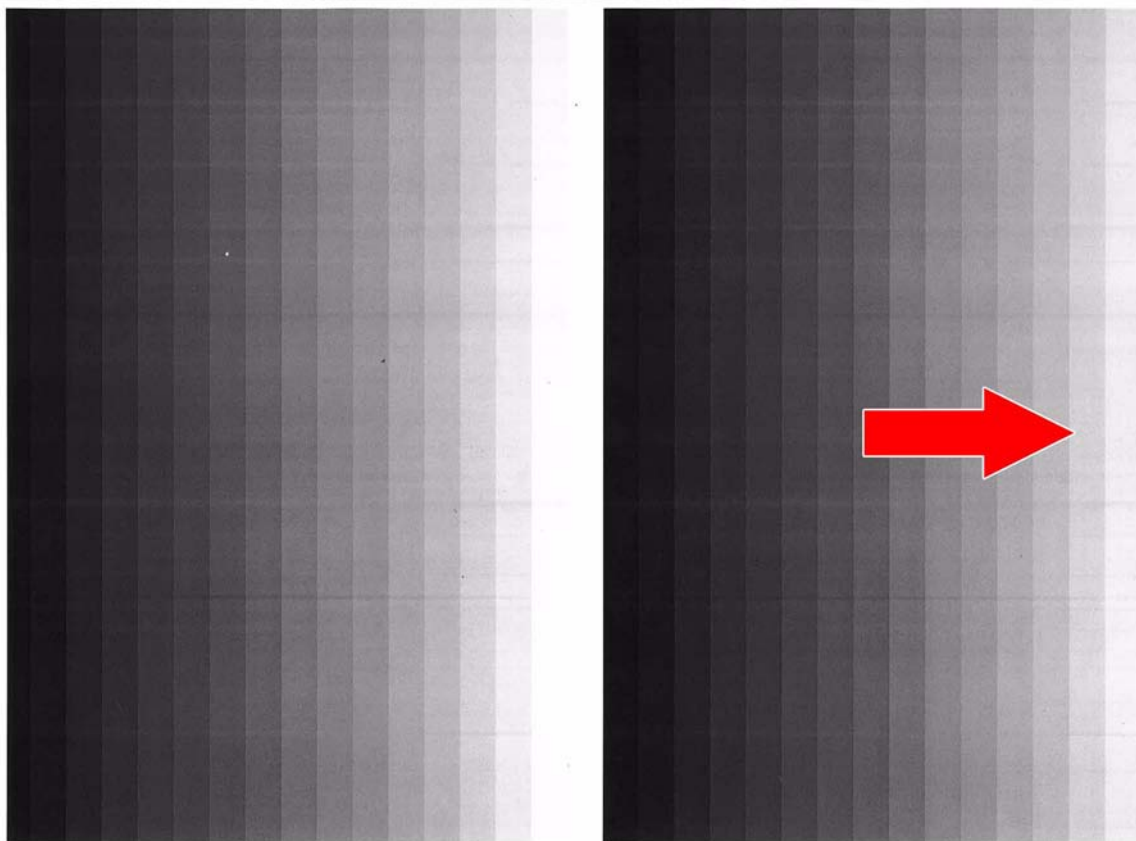
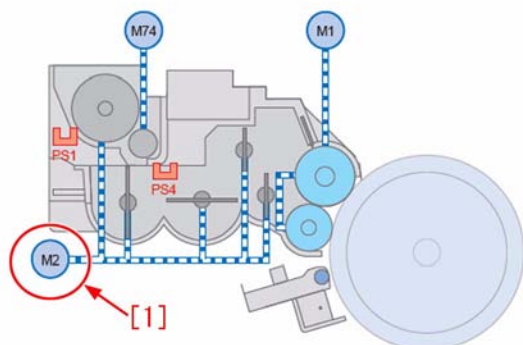
E023-0020 occurred while consecutive printing of low duty image was being performed. White streaks on image also occurred separately.
 - E023-0020: Error in the developing stirring motor: While the motor is driving, the lock has come off for 3 seconds continuously (come off 30 times with 100 mm seconds cycle including 2 seconds stability time).

The developing toner level sensor in the developing assembly may tend to detect toner empty despite presence of toner. Consequently, toner is oversupplied and the developing stirring motor [1] does not rotate due to overload. Also this excessive feeding may induce uneven coating on the developing screen to generate white streaks on image.

Prepare a new type of the stirring board (FL2-7710-010) and follow the procedures below. [A] is a new type with a shape that can stabilize the amount of toner to be supplied to the surface of the toner sensor. And [B] is an old type.

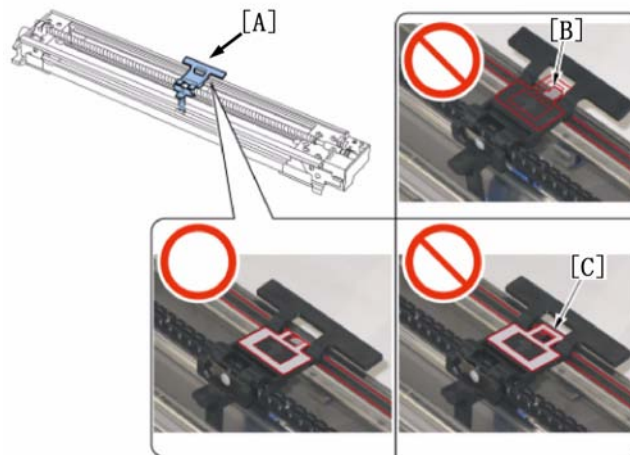
When replacing the wire cleaning pad, it is replaced by moving the cleaning pad arm [A] to the center of the primary charging assembly. After replacement, when the primary charging assembly is inserted to the machine, the cleaning pad arm is squeezed too hard, and the protrusion [B] part of the cleaning pad arm comes off the notch of the primary charging assembly frame, and the cleaning pad arm can't move as the result.

1. After replacing the wire cleaning pad, make sure that the protrusion [B] part of cleaning pad arm and the leading edge [C] of primary cushion sheet are inside the notch of the primary charging assembly frame.

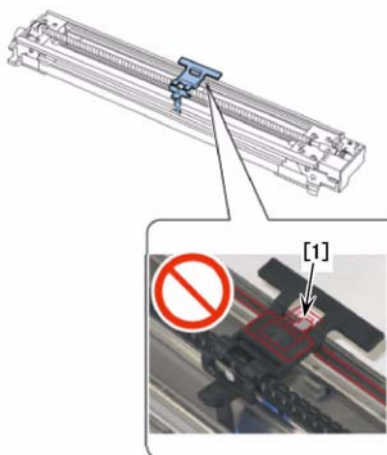
3. When the cleaning pad doesn't move smoothly, check if the protrusion [1] of the cleaning pad arm and the edge of the primary cushion sheet are out of the notch of the primary charging assembly frame.

4. When the protrusion of the cleaning pad arm and the edge of the primary charging assembly are out of the notch frame, re-install them to put them in the notch.

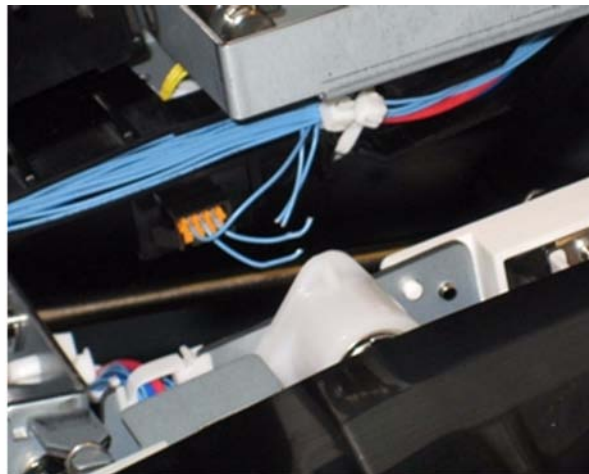
This error code may occur if the Transfer Unit is reinstalled while the ITB is in the "Locked" position. Note in the photo where the "White Cam" is in relationship with the wire harness for PS 127.

Ensure that the ITB is in the "Unlocked" position prior to reinstalling the Transfer Unit.

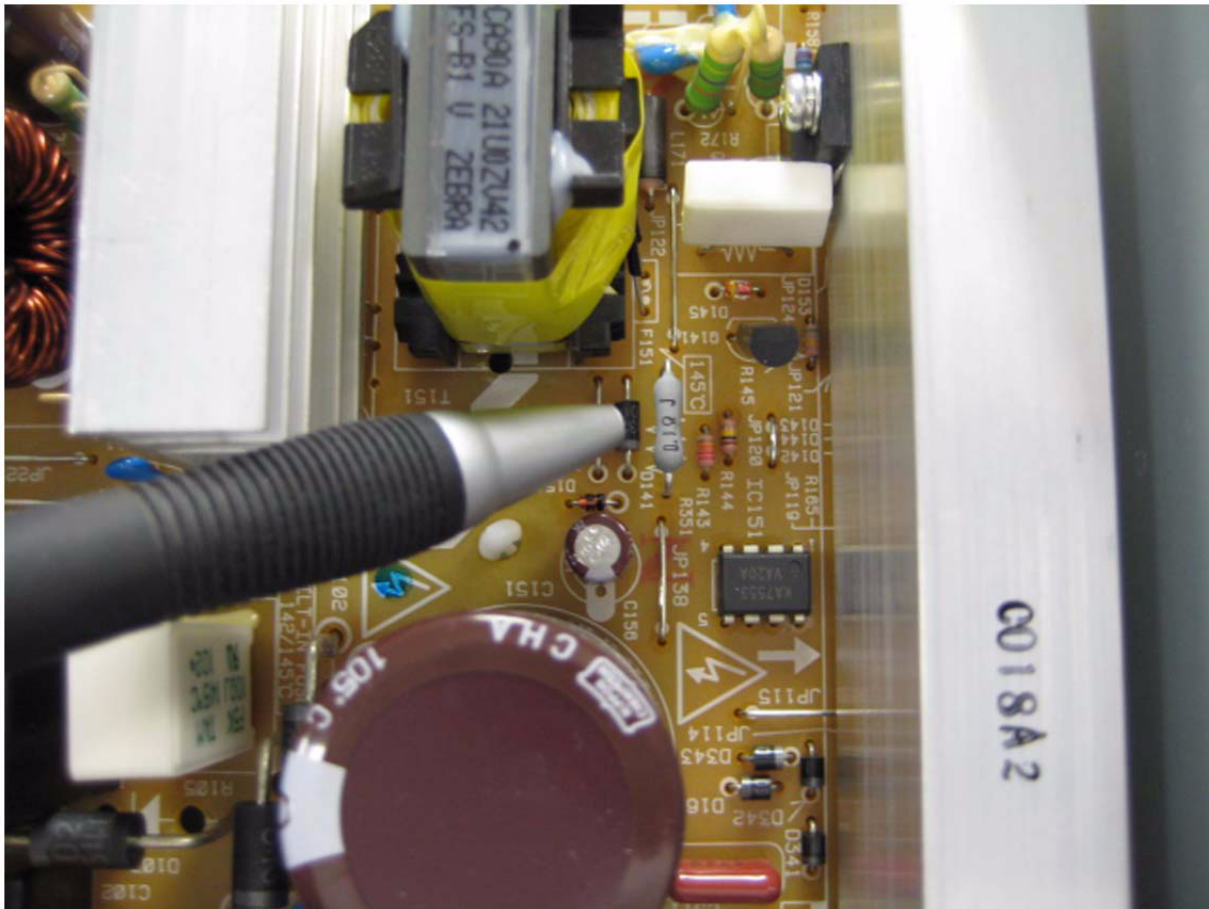
The E500-0001-31 is a communication error code between the copier and accessory. The location code of 31 points to the Professional Puncher / Integration Unit as the accessory involved. In this case F151 (a thermal fuse) on the Integration DC Power Supply had blown. Replacing the DC Power Supply (FM3-4667) in the Integration Unit resolved the issue.

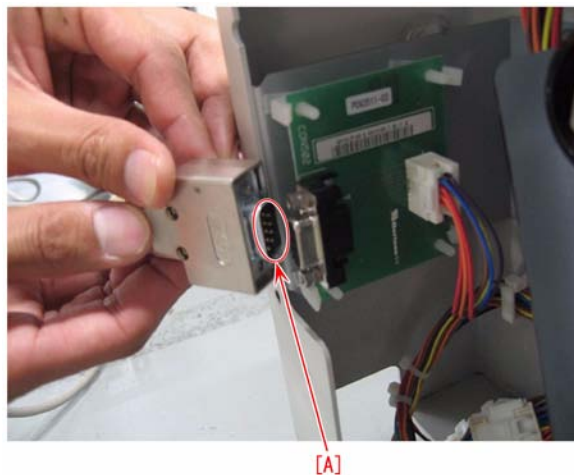
The connector pin [A] shorted out with the neighboring plate. The main cause of the short would be assumed shown below.

- When the signal cable at the trimmer side is removed, supply the power to the finisher.
- While supplying the power to the finisher, insert the signal cable at the trimmer side.

Replace the finisher controller PCB.

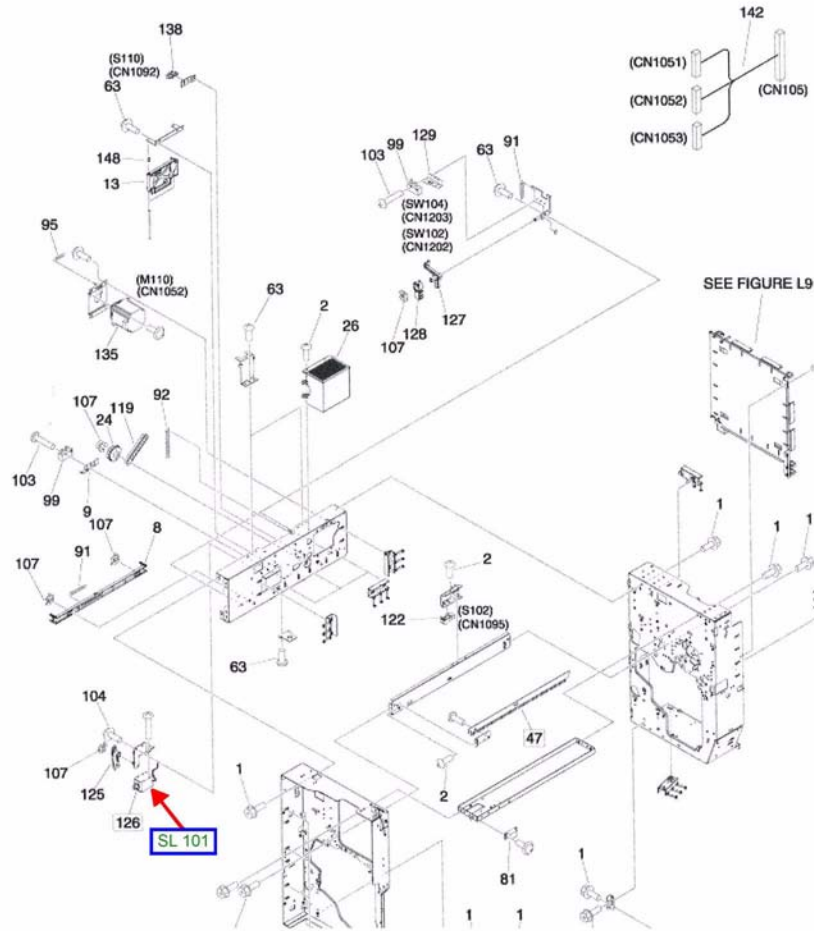
In the process of inspecting microswitch SW 103, it was discovered that solenoid SL 101 (Swing Guide solenoid) was not functioning properly. Replacing SL 101 resolved the ecode issue of E531-8001 from occurring. The part number for ordering and replacing SL 101 is FK2-8206.

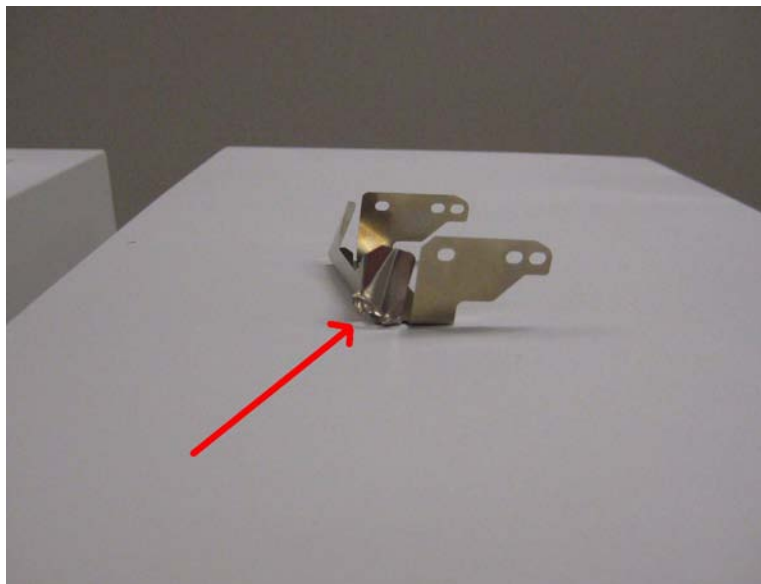
The spring guide located on the staple head deforms causing the copy sets to skew when double stapling. The guide may catch on the knurled belts causing an E57A-8001 error code. Replace the spring guide FC6-6243.

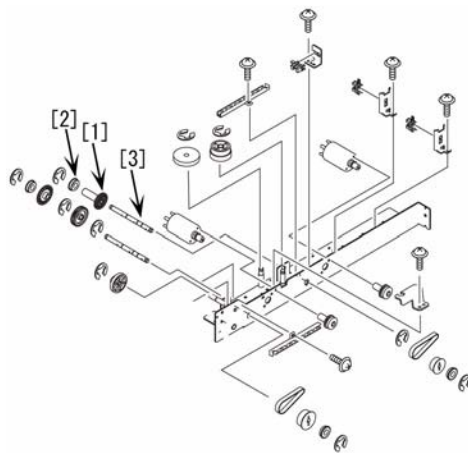
In the Dust Buffer Drive Assembly of the Waste Paper Case Assembly, the Gear [1] pushed the Bushing [2]. As a result the groove of the E-ring in the Drive Shaft was ground down. This caused falling out of the Bushing [2]

1. Replace the Drive Shaft with a new one.
