Troubleshooting Guide

imagePRESS 1135/1125/1110 Series

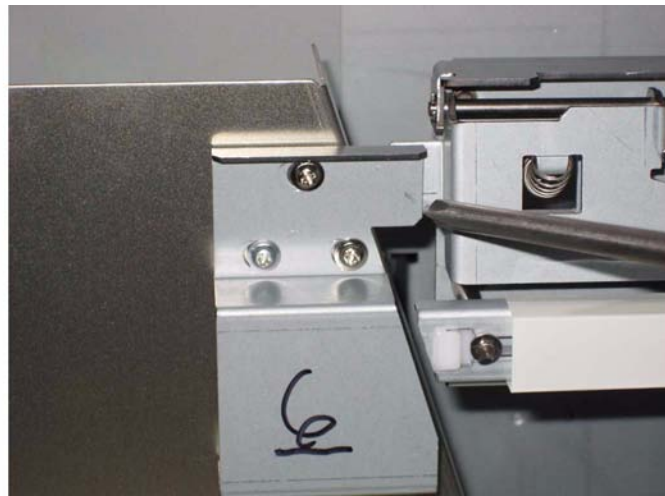
Error code E-5A2 is a waste paper buffer shift motor (M37) problem. Found the book stack tray drawer has a plate (at the rear) that engages with another plate on the waste paper bucket assembly. If the plate on the book stack tray does not engage with the plate on the waste paper bucket assembly it prevents the shift motor (M37) from driving properly. Make sure the plates look like photo below.

Adjust plate on book stacking tray to engage with plate on waste trim assembly. See photo above.

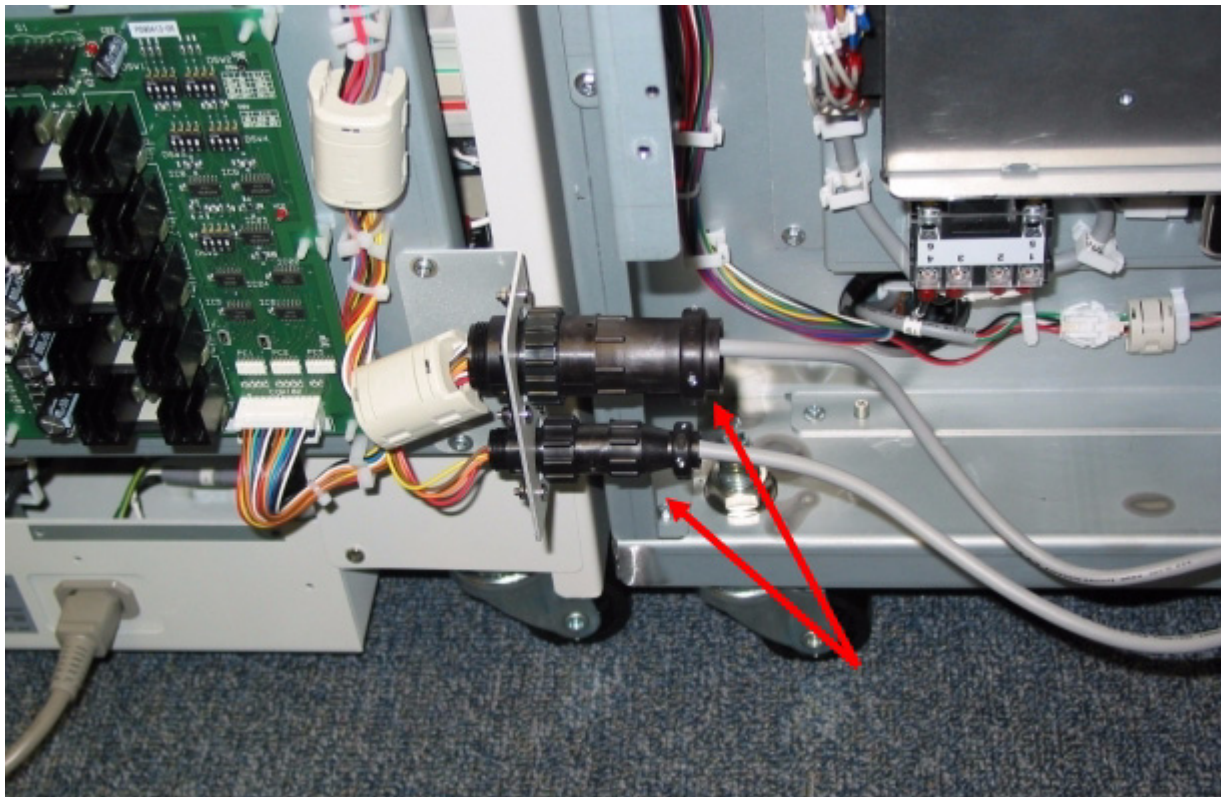
The code refers to the transport positioning motor M08 home positioning incompleteness. And the transport roller home position sensor PI14 is not activated. It has been found that if the communication cables are not locked down A E5AF-8071-02 can occur.

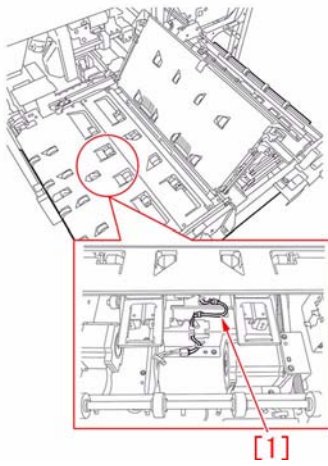
The spine bending closed sensor harness [1] of the cover transport assembly had open-circuit.

Prepare the spine bending closed sensor harness (4H3-0360-020) and the cable clamp (WT2-5977-000).
According to the following steps, replace the spine bending closed sensor harness.

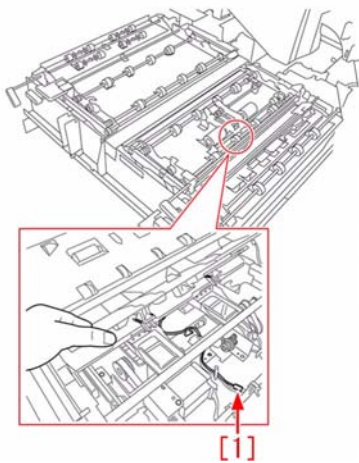
The spine plate pressure sensor harness [1] on the cover transport assembly broke.

Prepare the new type spine plate pressure sensor harness (4H3-0362-020) and the cable clamp (WT2-5977-000).
 Replace the spine plate pressure sensor harness in accordance with the following steps.
 1) Remove the 6 screws [1] and then remove the rear cover [2].

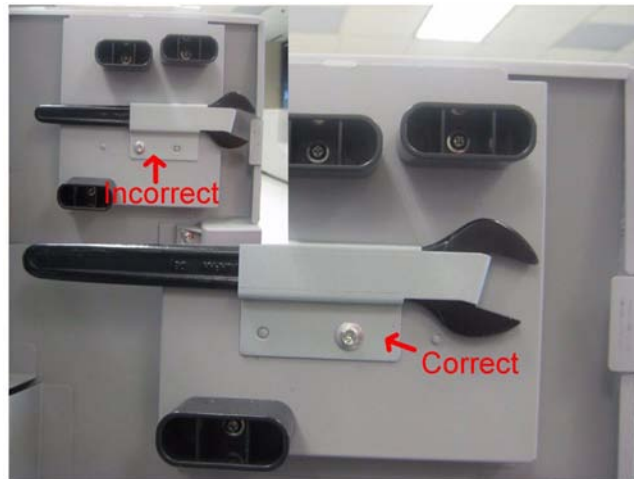
The wrench used for leveling is stored in the right front door. The wrench bracket has two attachment positions. In the incorrect position, the right door does not close properly causing an E5BD-8001 error code.

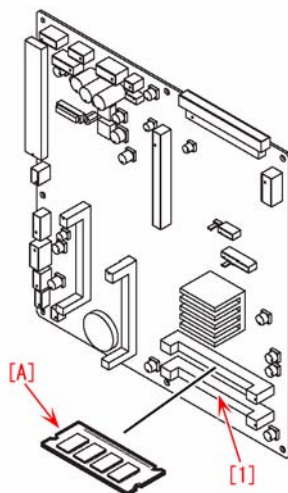
- E732-0001: Scanner communication error

- E733-0001: Printer communication error

When E732-0001/E733-0001 occurs after expansion of the optional expansion ROM, replace the DIMM [A] connected as default.
WA7-5193 DIMM

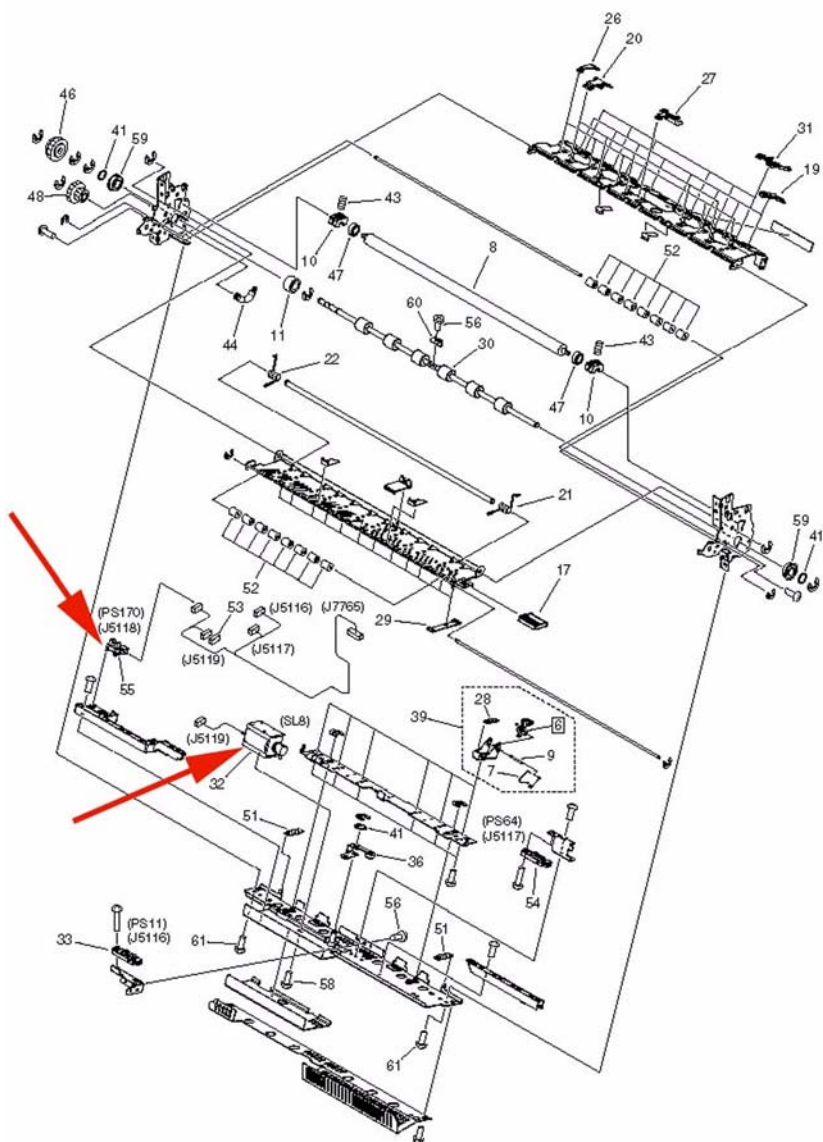
Solenoid SL8 (Lower separation claw disengage solenoid) was unplugged at J5119 and refitting the connector corrected the error code. Note that if PS170 (Lower separation claw disengage sensor) is unplugged the same error code would occur. The following image shows the location of SL8 and PS170.

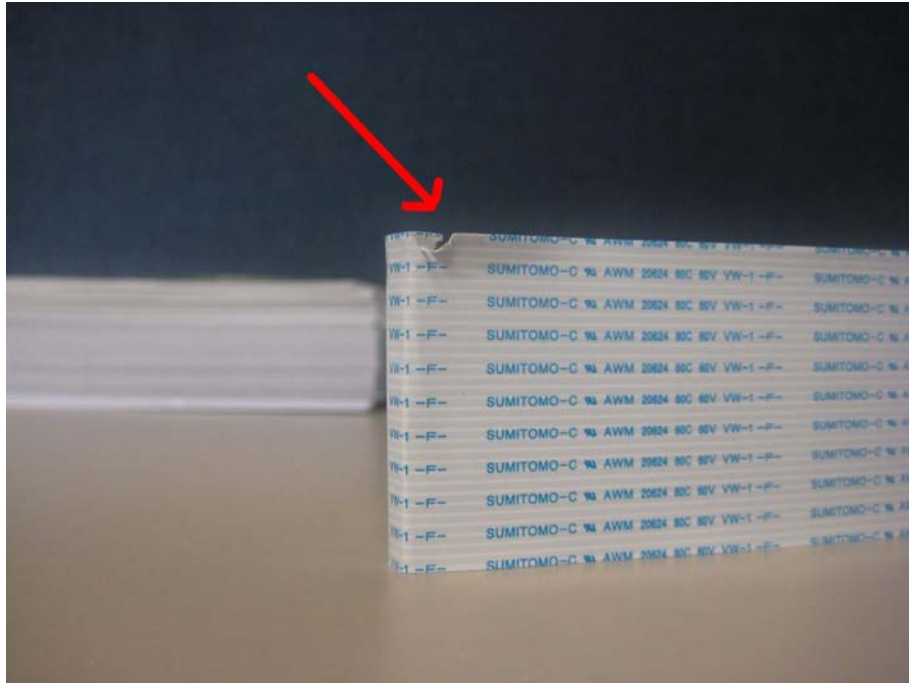
The POD drawer flat ribbon cable can develop a cut where the cable flexes. Check/replace flat ribbon cable FK2-2978.

FK2-2978 CABLE, FLAT, 1

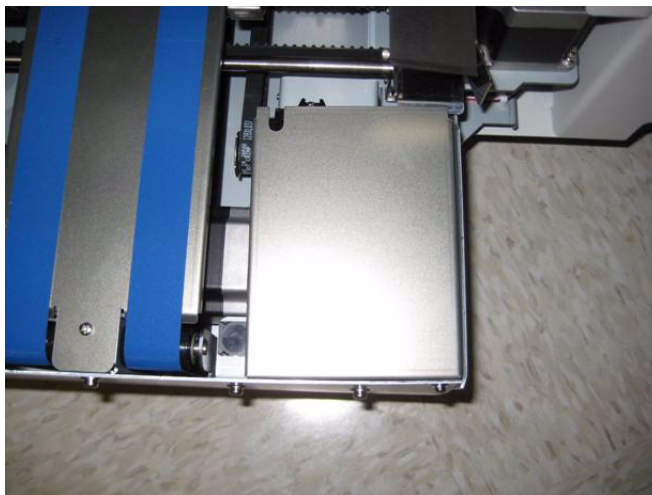
F-1-36

In this case the In-Feed Section was damaged causing the cover to partially cover P101(In-Feed Section Entrance Booklet Sensor). After removing the In-feed Section and adjusting the outer plates to confirm a square edge, the sensor was no longer blocked.
