A report from the NIOSH Fire Fighter Fatality Investigation and Prevention Program

Career Female Fire Fighter Dies After Becoming Lost and Running Out of Air in a Residential Structure Fire—Pennsylvania

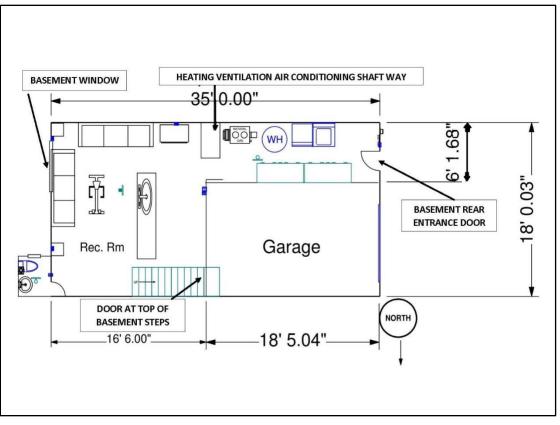
Diagram 3. Basement floor plan. (Courtesy of the fire department.)

Diagram 2). The basement could be accessed either by an interior door leading to stairs off the right side of the kitchen or an exterior door at the rear (see Photo 2) of the house via an alley. The basement had a recreation room with half bath in the front half of the house, utility area on the left rear, and a garage on the right rear area (see Diagram 3). The garage was accessed by a standard aluminum garage door and had no interior access to the utility or recreation area and was formed by concrete block walls. The garage area was used for storage.

Fire conditions were floor-to-ceiling in the basement recreation room and venting from the front basement window. Fire extended into the cockloft and throughout kitchen from the basement door.

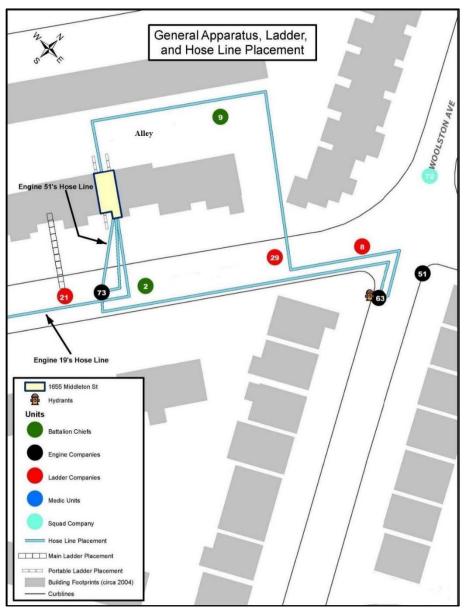
Diagram 4. Apparatus and hoseline placement. (Courtesy of the fire department.)

At 02:55 hours, Engine 63 arrived on-scene and proceeded to the rear of the structure, via the rear alley (see Diagram 4). The Engine 73 officer and nozzle operator were donning their facepieces in the dining room while the fire fighter/EMT was flaking out the hoseline outside the front door. At 02:56 hours, the Engine 73 officer radioed the Engine 73 driver to give them water. Looking through a 2-foot by 2-foot decorative cutout in the wall between the dining room and kitchen, the officer could see fire beginning to vent from the top of the basement doorway. A minute later, the Engine 63 officer reported nothing showing in the rear but immediately changed that to seeing fire through the window in the first-floor kitchen area with smoke conditions getting heavier from the first-and second-floor windows.

The Engine 63 crew returned to their apparatus and began to stretch a 3-inch supply line down the rear driveway, where they would connect it to a 1³/₄-inch hoseline.
