## Toshiba V8700

## Ferguson 3V23/JVC HR7700

## Toshiba V9600

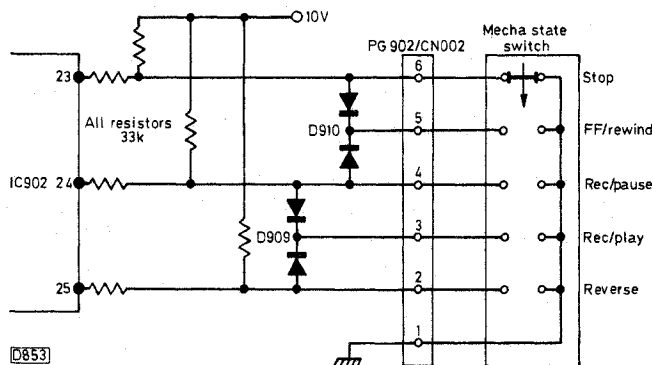
Fig. 1: Mecha state switch connections, Hitachi VT14.

This machine would intermittently fail, with the "operate" light not lit. Voltage checks during the fault condition revealed that the regulators Q101, Q102 and Q103 were all off. These regulators are controlled by IC902 on the system control panel, via an inverter. IC902's power

control pin 3 was low instead of high as it should have been, but changing IC902 made no difference. Further checks with the machine in the stop mode under the fault condition revealed that pin 24 of IC902 was low instead of high (pin 23 should be low, pins 24 and 25 high, see Fig. 1). The mecha state switch was checked and found to be in the correct position, the fault being due to D910 being leaky. Incidentally PG902/CN002 are numbered incorrectly in the official circuit – Fig. 1 is correct.

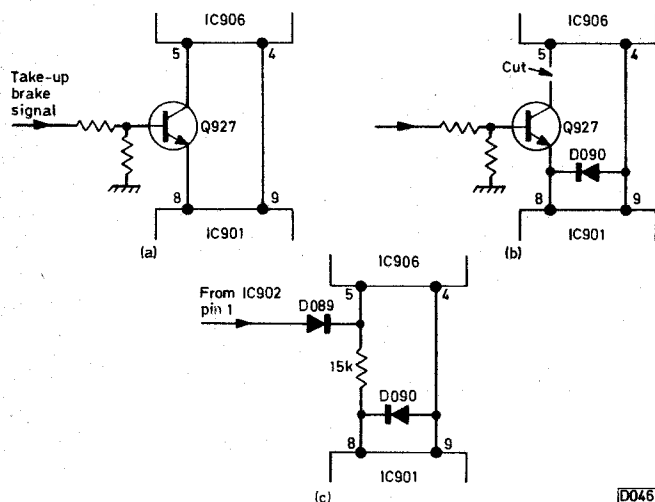
**Fig. 2: Modifications to the control circuit: (a) original version; (b) version in the faulty machine; (c) the later version.**

on for fast forward: as Tr1 heated so Tr4 turned on more until eventually Q902 turned on. At this time the only circuit I had for the machine was one that didn't show Q927: telephone calls to Hitachi confirmed that there had been modifications to this part of the control circuit.

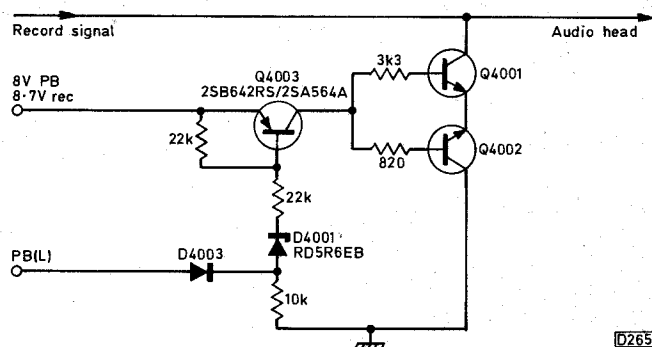
Fig. 1: Audio record/playback switching circuit used in the Panasonic NV333.

The problem was occasional failure to record the audio track, though erase was o.k. It caused some difficulty as the fault was intermittent. In fact we checked with Panasonic's technical department to find out whether there were any problems in the audio record section. A man told me that the modification to overcome intermittent recording was to short out R4049. Ah! But this is the bias oscillator transistor's emitter resistor, and there were no erase problems. The man insisted that in the event of intermittent audio recording this modification would provide a cure. For anyone else's information, after checking D4001 and then Q4003 by replacement the fault went away.

The circuit operation here is not obvious (see Fig. 1). In the playback mode line PB is low. Zener diode D4001

conducts and so does Q4003 since the emitter of this pnp transistor is at 8V and its base is returned to chassis via D4001. Thus Q4001 and Q4002 are on, earthing the record drive side of the audio head. In the record mode line PB is held high at 6V. This, via D4003, cuts off D4001 and all three transistors. If Q4001/2 are on in record then either D4001 or Q4003 is leaky. S.B.

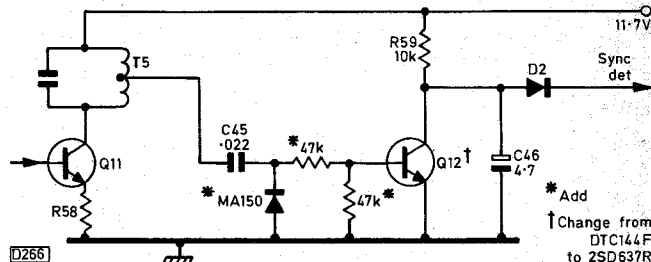
Fig. 2: Modifications to the sync detect circuit on the i.f. board, Ferguson Model 3V36.

Ray was having problems with a search tuning fault on this 3V36. It wouldn't stop when it found BBC-1 though it would stop on the other stations. Investigation revealed that the sync detect line wasn't going low when BBC-1

was found, so attention was turned to the sync detecting circuit on the i.f. board. Adjusting coil T5 made the line go low on BBC-1 but then it didn't go low on BBC-2 – we also found that if the coil was tuned too far a buzz developed on sound! When I looked through past issues of *Ferguson Feedback* I found a modification for sound buzz – change Q12 to type 2SD637 and add the components shown in Fig. 2. Doing this cured the fault. What a team! P.B.

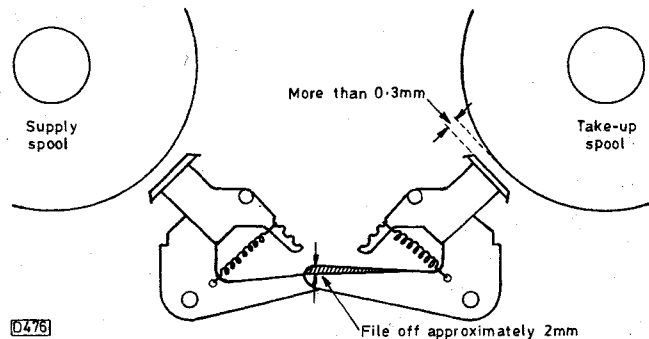
Fig. 2: Mechanical modification to cure tape damage due to looping when the machine stops after rewind.

The brake modification applies to all models. The problem is tape damage after rewind, caused by the fact that the supply spool brake comes on fractionally before the take-up spool brake, or the latter slips slightly, when the machine stops after rewind. The result is a tape loop which gets trapped in the cassette flap when the cassette is removed. There are two modifications for this, a mechanical one and an electronic one. The former consists of filing

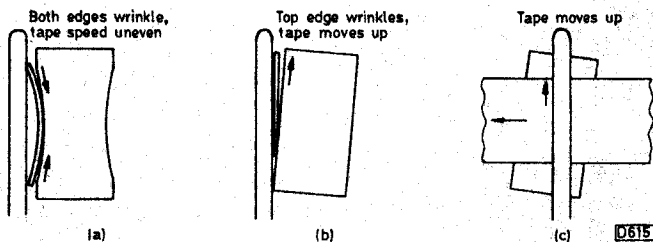
Fig. 5: Pinch roller problems (exaggerated).

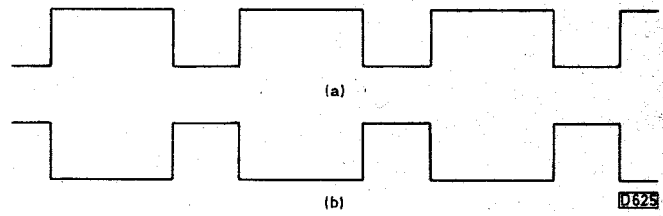
Check the waveform at the collector of Q9003 (see Fig. 2) with a 10:1 probe. If it's missing, check transistors Q9003/4 and Q9001/2 in that order, then zener diode D9006 and diode D9005. If all seems to be in order but the oscillator circuit won't start up suspect the start-up capacitors C9009/C9010. One or other may have dried up. So far we've had no problems with IC9001.

Fig. 2: Waveform at pin 1 of IC9001 (a) and at the collector of transistor Q9003 (b).

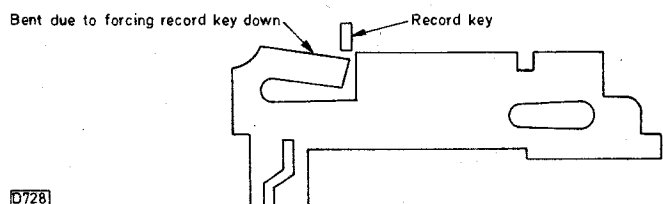
So much for the good news, now for the bad – though it's not all that bad. The key assembly suffers from a few problems that are not too difficult to put right. The most common problem applies mainly to the 3292/HR3300. It shows up when the machine apparently trips out on completion of the loading sequence. What might at first appear to be an electronic fault is actually due to wear on the play key lever (see Fig. 2) as a result of which the lock plate has a very precarious hold on it: when the loading mechanism clunks to a halt the shock jars the play key free. The cure is to replace the lever or swap it over with either the stop or pause key, as the locking latch is not used with these. The key colour will be different of course. The trouble may recur when this latter course of action is taken, as its root cause is the soft material used for the key levers. This point was put right with the

Fig. 4: Problem that occurs with function plate E.

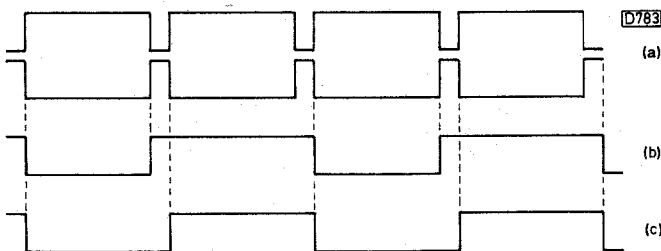
This machine would play for five seconds then stop. The head was spinning and the wheels were going round, so it appeared that an input signal to the mechanism control chip was missing. We found that the drum FF signal was correct but the take-up reel sensor signal was irregular. It would start at the correct amplitude and then diminish. In addition, when of the correct amplitude there was a ripple on the lower edge (see Fig. 2).

Fig. 1: Audio f.m. waveform with dropout between the head switching points (a). Incorrect 3:5 ratio audio flip-flop signal (b). Correct audio flip-flop signal (c).

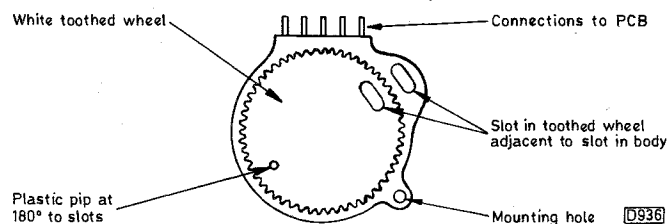
A point worth making about this and other machines that use the G mechanism is that there is nothing in the manual on replacing the mode switch. It's of the rotary type, and there will be no problems provided you carefully note the position of the old one before removing it. If you do get caught, Fig. 2 shows the position in the tape ejected mode. **N.B.**

Fig. 2: Mode switch in the tape ejected mode.

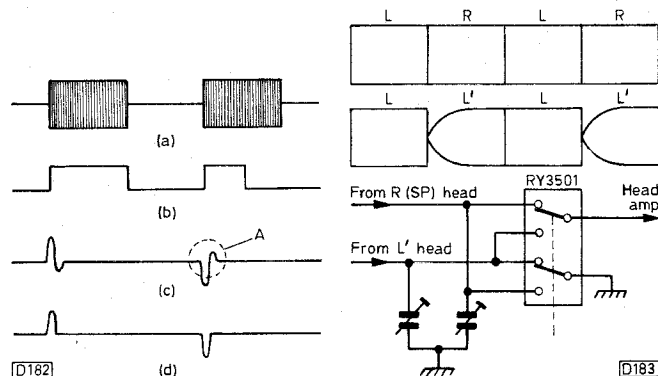
Fig. 1 (left): Waveforms associated with the Hitachi VT11 fault described above.

Fig. 2 (right): F.M. output waveforms and head switching relay, see the Panasonic NV788 fault.

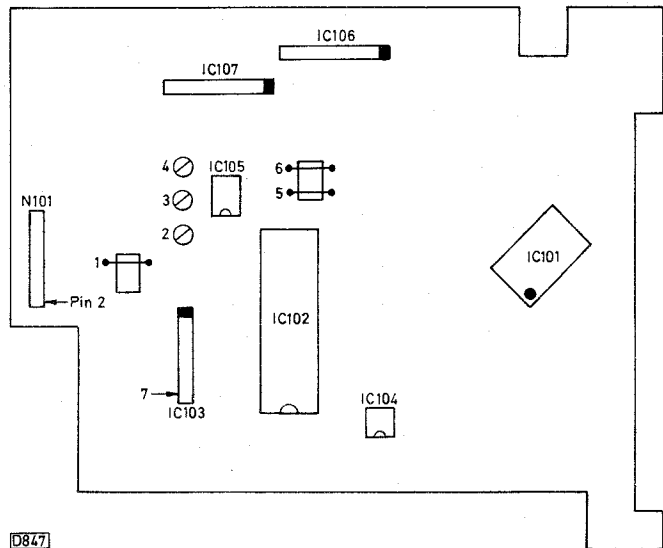
Fig. 4: Layout of the servo/microcomputer control board, Hinari Models VXL8/9. 1 TP3 record CTL; 2 head switching-1; 3 head switching-2; 4 preset tracking; 5 TP1 drum flip-flop; 6 TP2 chassis; 7 IC103 pin 7, playback CTL.

The most convenient place at which to scope the switched 5.1V supply is at pin 2 of connector N101 at the rear of the servo/control PCB (see Fig. 4). We don't recommend that you place your probe on this pin directly however as there's a possibility of shorting it to pin 3 which carries the unregulated 16V supply. If this occurs the microcomputer control chip IC101 is certain to fail.

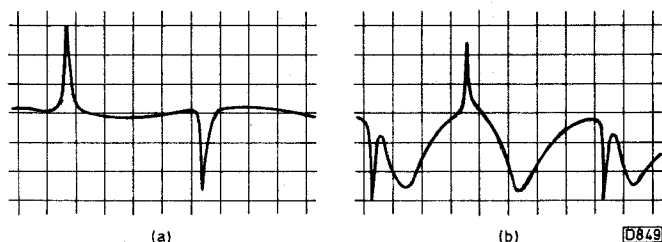
Fig. 6: CTL waveforms. (a) Correct waveform at pin 7 of IC103 (first CTL amplifier output). For reliable operation it should be greater than 1V p-p. (b) Typical CTL waveform when bridge rectifier D506 is defective. Scope settings Y 0.2V/div, X 5msec/div.

whenever we service one of these machines we clean the head and replace D506 as a matter of course.

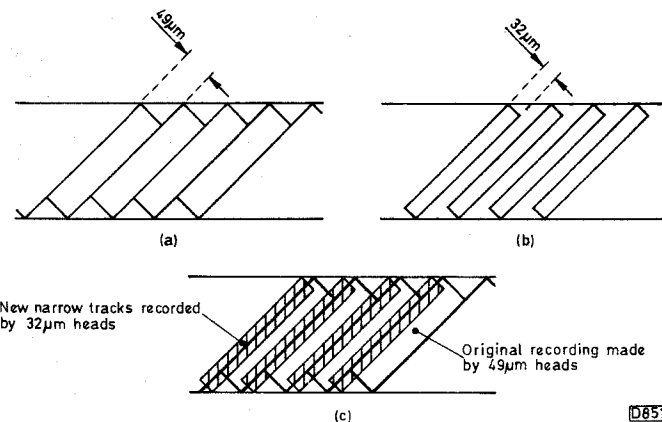
Fig. 8: Standard track pattern for VHS SP recording (a). Track pattern with a machine (e.g. VXL8) that has thinner head cores (b). Effect of over-recording 49µm tracks with thinner heads in the event of failure of the full erase head (c) – the original tracks are only partially removed.

As mentioned earlier, the VXL8 is a budget machine. Thus although it has LP operation there are only two heads. To optimise these for both speeds the cores are 32µm instead of the usual 49µm for VHS. This gives a rather unusual recording pattern on the tape in the SP mode. In effect, a small guard band is left between tracks – see Fig. 8.

When the full erase function fails and a previously recorded tape is re-recorded there's a good chance that the new tracks will be laid down not directly over the original ones but partially in between. When this tape is played back it's actually possible to select which picture you view by using the tracking control! Moving it to the left selects one recording, moving it to the right selects the other one. In some cases the two pictures are of surprising clarity. Some might think this to be impossible. That's what we thought until we saw it for ourselves. For those who can lay their hands on one of these machines to experiment, it's well worth disconnecting the full erase head and over recording a tape just to see the effect. For best results use a tape that has been recorded on a model that has standard thickness heads.

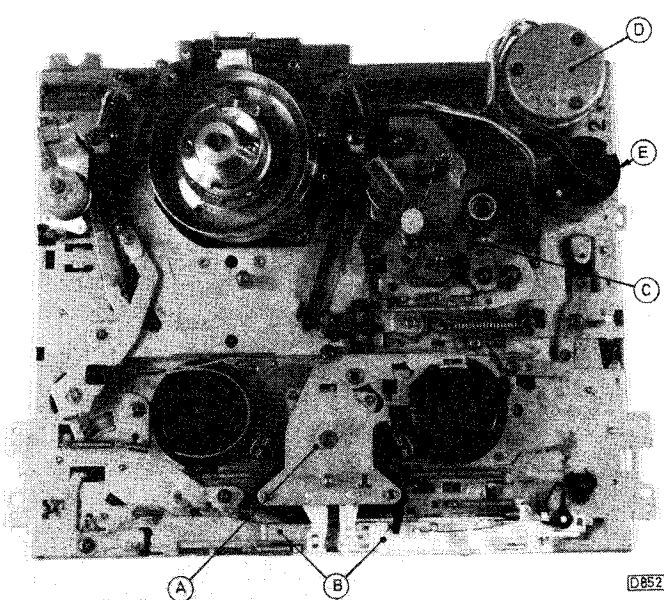
A problem we've had on a couple of occasions is where the reverse guide arm located near the pinch roller (see Fig. 9) is bent, probably due to abuse by the owner. This results in the tape riding up or down the capstan, crinkling

the tape edge. Straightening this is not a simple task and care must be taken not to score the polished surface as this will impair tape travel. It may be necessary to replace the guide, perhaps with one from a scrap deck.

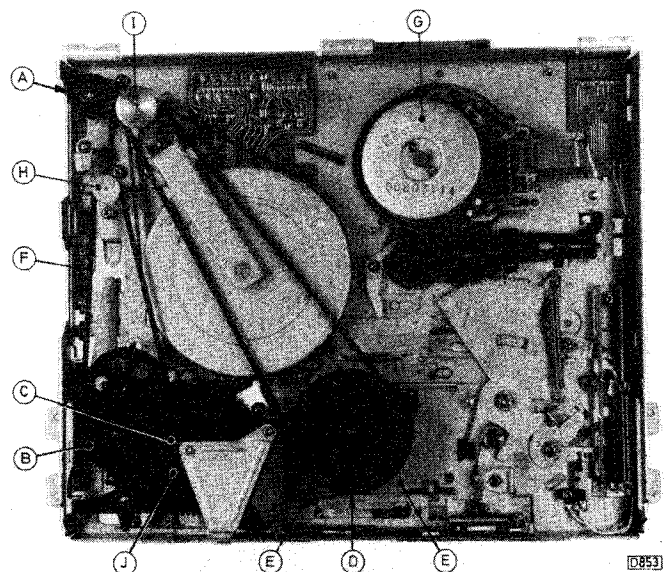
Wow on sound, perhaps during only the first quarter of an hour of a tape and more pronounced in the LP mode, is one of the most common complaints with these machines. There are several possible causes, e.g. the pinch roller slipping or the capstan motor binding, but experience has shown that excessive take-up torque is the most common cause. Excessive take-up torque can also lead to the tape riding up or down the capstan with the result that one edge of the tape is chewed. As set up by the manufacturer the take-up torque is unusually high, around 200g-cm. It can be reduced to around 100g-cm by dismantling the take-up clutch assembly, taking about one and a half turns off the tension spring then cleaning the assembly, including the two felt pads, with isopropyl fluid.

The clutch is beneath the spool drive pulley (itemised in Fig. 10). To remove it you must first take out the spool drive pulley and the forward and reverse drive gears. Take care not to mix up the two gears when reassembling them as they are different. The clutch can now be extracted. A gentle pull on the smaller black gear will separate the clutch assembly, but take care that the spring doesn't launch itself into orbit at this point! Fig. 12 shows the

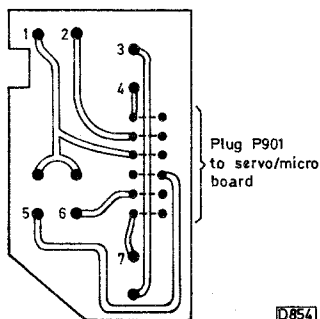
There's a small PCB with three microswitches on its underside at the top right-hand side of the cassette housing. These switches are linked to the microcomputer control chip IC101 for correct operation of the cassette lift. We've found it useful to check the logic conditions at these switches on occasions when we've had a machine with the lift either inoperative or not working correctly. Fig. 11 shows the PCB layout: with an operational housing the conditions at the pins marked are as follows:

If these conditions are incorrect the cause is most likely to be a dirty switch contact.

Fig. 11: Cassette lift microswitch PCB. See text for logic conditions at the pins. The pin numbers shown relate to solder joints on the PCB and are included for identification only. The pins on plug P901 are twin terminals, shown here linked by broken lines.

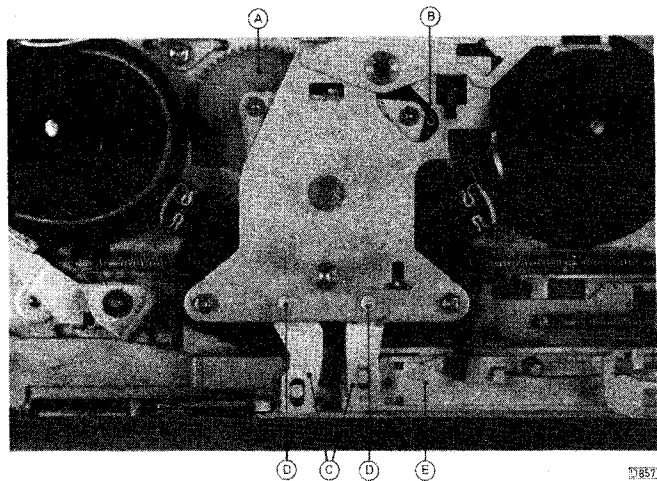
Another problem we've had on a number of occasions is where the machine refuses to go into fast wind or rewind after coming out of the play mode though you can hear the motors running. The fault is often intermittent. It's caused by seizure of the operating levers at the front of the deck. Fig. 14 shows these levers in closer detail. There are two white nylon gear levers operated by slide bars located centrally between the supply and take-up spools. These gear levers are slotted to locate on to pins on the slide bars. The fault occurs when the pin in the left-hand gear lever sticks in the slot.

We used to rectify the fault by dismantling the gear assembly and widening the slot on the left-hand lever fractionally, using a needle file. More recently however we've noticed that the pivot on the left-hand gear lever (D in Fig. 14) has a very small amount of play when this fault is experienced. We now feel that filing the slot simply counteracts the effect without removing its cause. So we've taken to replacing the left-hand gear lever which we obtain from CPC under part no. HN62D085909305. Should you encounter this fault condition you should inspect this whole area, looking for signs of wear.

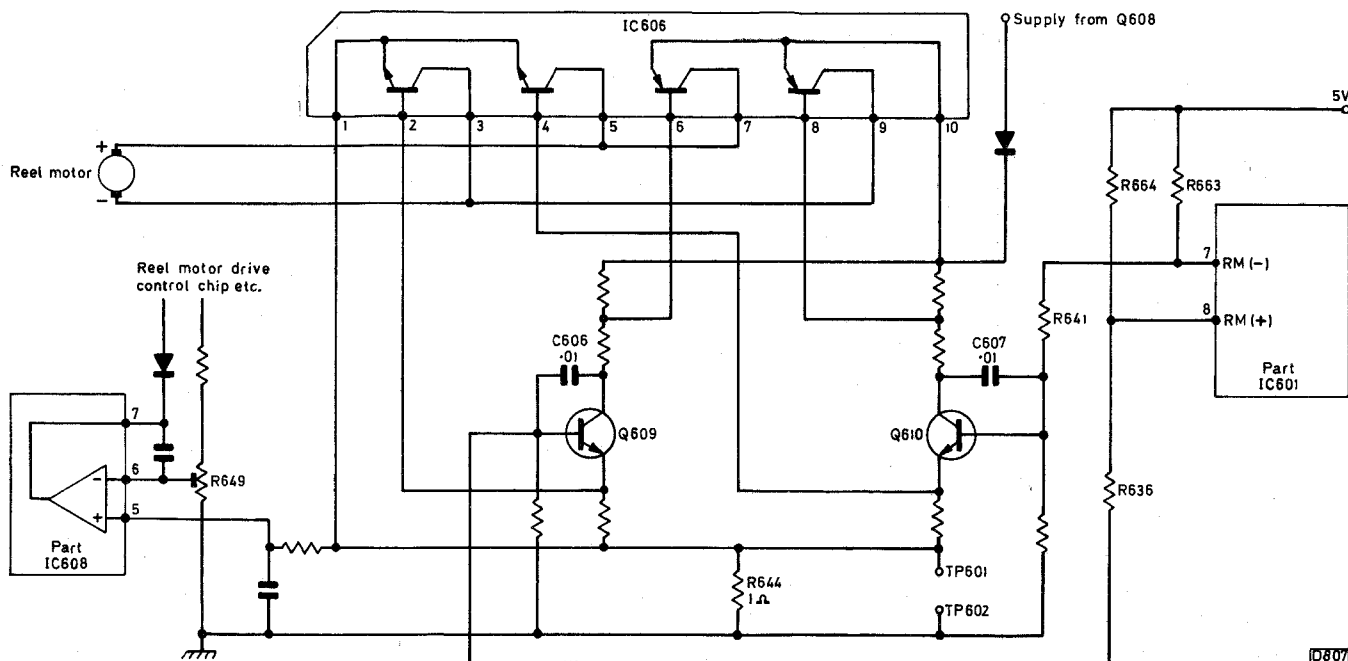
Fig. 1: Reel drive circuitry used in the Solavox Model NCVR5000.

Suspecting the reel motor, I noticed that it was a special "fat-looking" type. The day was saved however when I discovered that the manual mentions a "reel motor current" (torque) adjustment. So I connected the meter's positive lead to TP601 and its negative lead to TP602, i.e. across the 1 $\Omega$ , 1W reel motor and drive circuitry current sampling resistor R644 on the servo-logic PCB, put the machine in the still mode and adjusted R649 for a reading of 190mV.

was rewarded with good take-up torque plus powerful fast forward and rewind. Potentiometer R649 is at the right-hand edge of the board and can be tweaked without removing the tuner/i.f. panel.

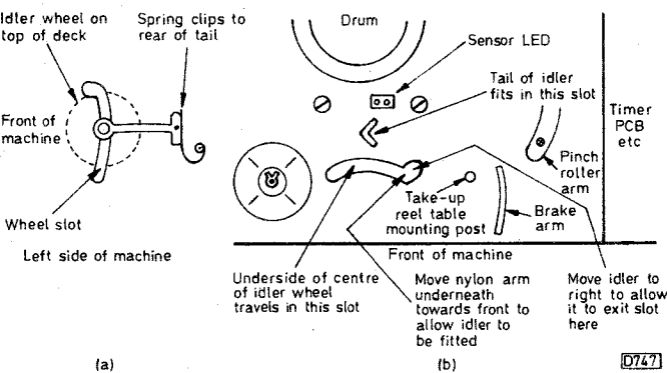
Fig. 1: Replacing the idler. (a) Underside of the mechanism (simplified) showing the nylon arm and spring positions when fitting the idler. Machine is on its left-hand side. (b) A simplified view of the upper side of the mechanism, with the take-up reel table and the idler removed.

Idler replacement is a bit more involved and tricky than one would like. Remove the top and bottom covers, then the front and the cassette carriage. The metal plate has to come out next. Remove the retaining circlip at the top of the take-up spool, after which the spool can be pulled off – take care not to lose any washers underneath it. Next remove the reel motor underneath in its plastic frame. This is done by taking out the three brass reel bolts/screws that hold it. At this point take a careful look at the idler from underneath: note the position of the spring at the rear of its arm. Use a screwdriver blade to move the nylon lever to

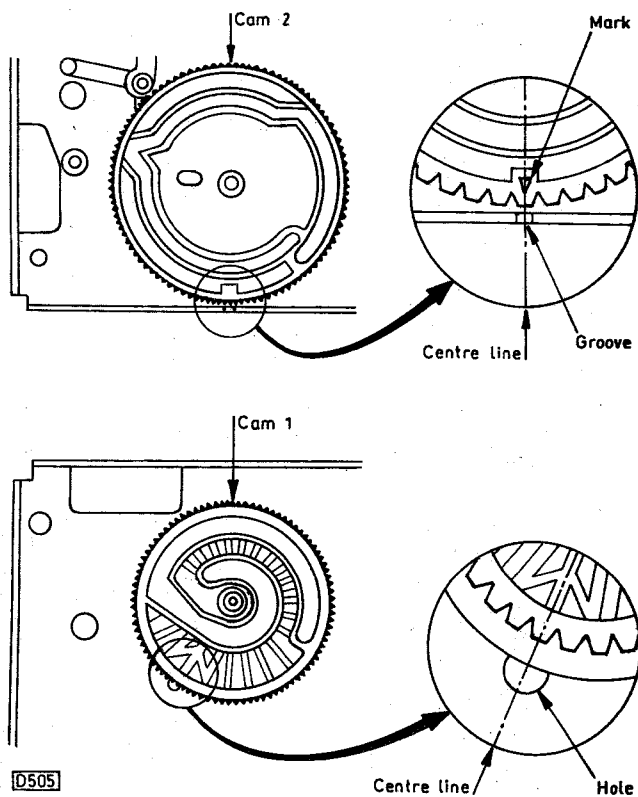
Fig. 1: Correct alignment of Cam 1 and Cam 2.

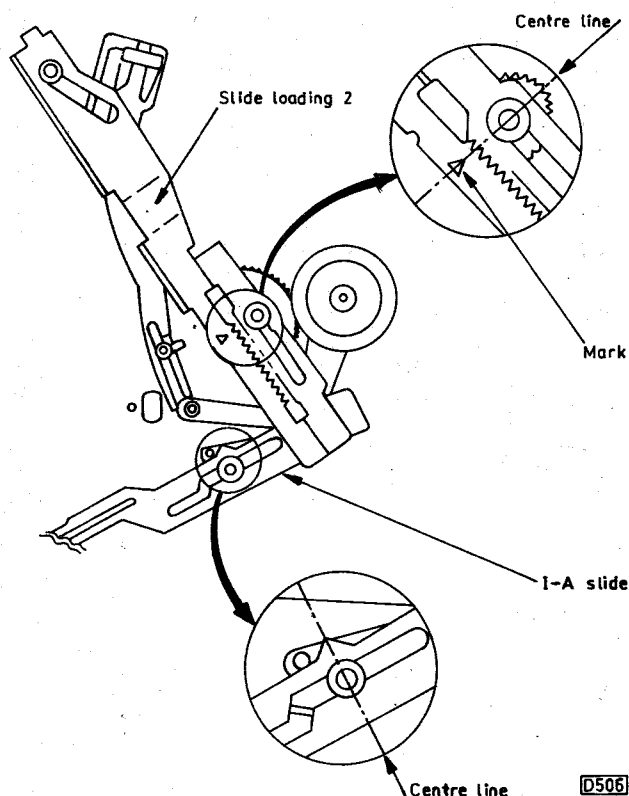
**Fig. 2: Correct alignment of the supply and take-up loading gears.**

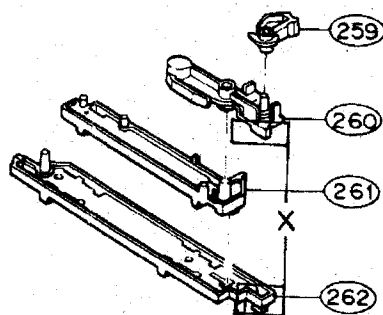
command, this lever must have returned to its rest position. Instead, it tends to remain protruding about 1mm towards the front of the deck. To improve reliability:

**Fig. 1: Trigger/brake components, 259 trigger hook, 260 trigger lever, 261 brake plate, 262 brake actuate base. Round off the edges of items 260 and 262 in the areas marked X.**

(1) Carefully round off the sharp edges of the trigger lever and brake plate mouldings in the areas indicated by an X in Fig. 1, using a sharp knife in a scraping action.

(2) Increase the spring torque by bending the bottom end of the spring an extra 60°.

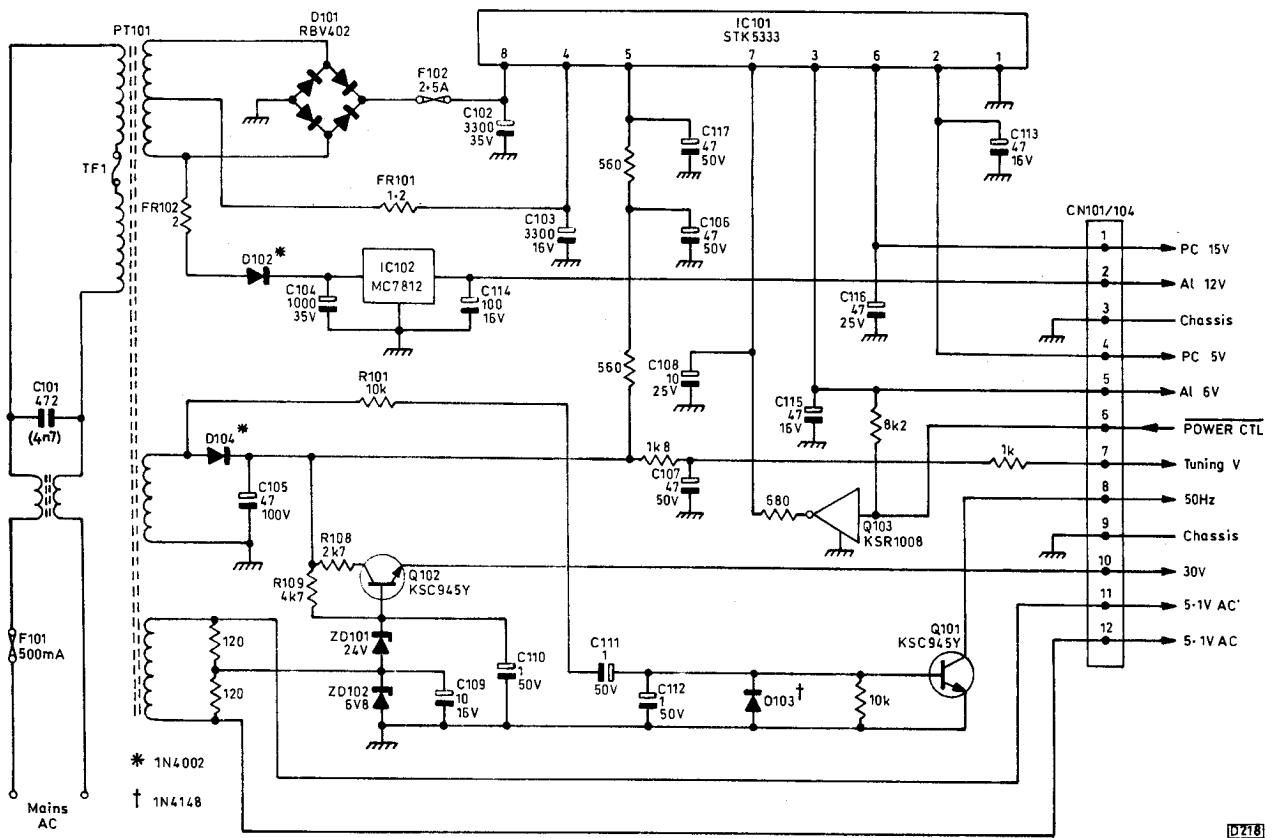
**Fig. 1:** The power supply/regulator circuitry used in the Samsung Model VI710. Supply line switching is carried out on the main PCB.

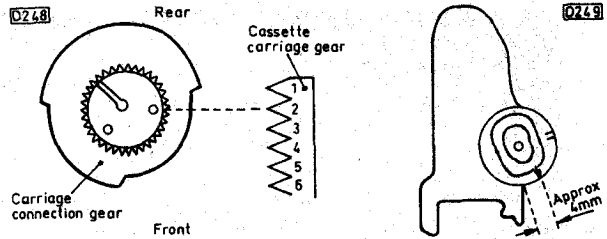
**Fig. 1 (left): Carriage connection gear phase alignment.**

**Fig. 2 (right): Mode switch alignment.**

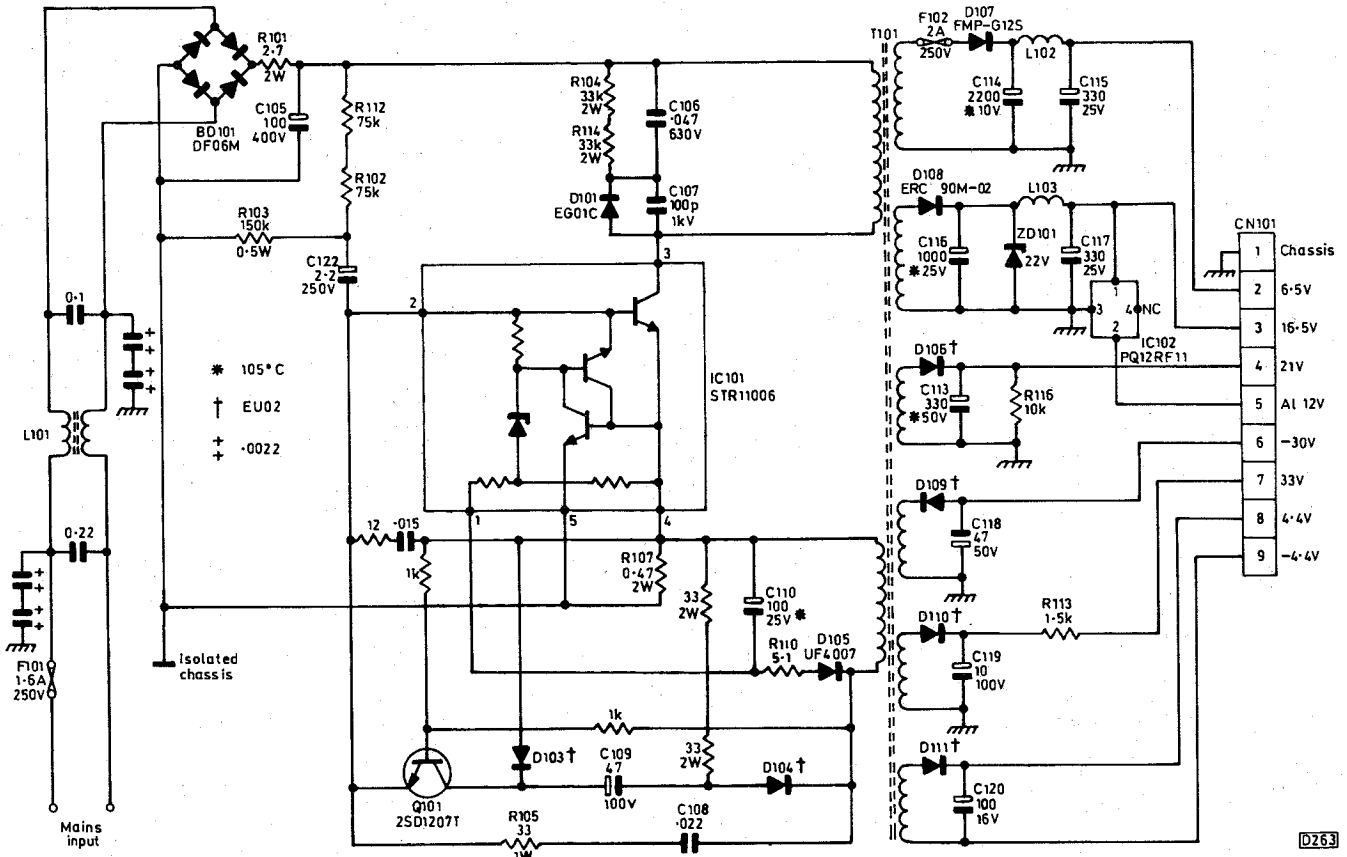
**Fig. 1:** Circuit diagram of the chopper power supply used in the Samsung Models VIK310, VIK320 and VIK350. Model VIK375 uses an almost identical circuit, the difference being that a single 68k $\Omega$ , 5W resistor is used in the R104/R114 position.

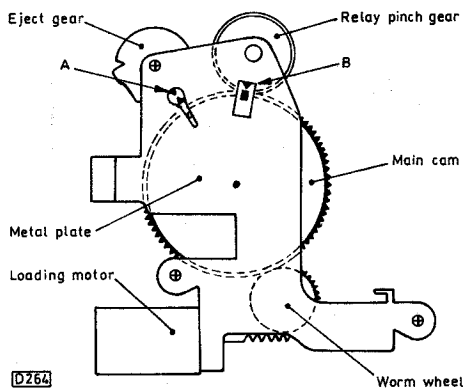
Tape wrinkling can also be a problem. As with any machine, a good test for tape wrinkling is to put it into fast-forward search then review search then back into play. The obvious cause is the pinch roller. When replacing this item, be sure to use the complete unit available from Samsung. I've tried using a plain pattern roller and have still had problems because the shaft on which the roller sits was slightly out of true (bent!). This will wrinkle the tape.

**Fig. 2: The loading block assembly, shown in the correct position for the eject mode. Broken lines indicate the cam and worm wheel hidden beneath the metal chassis plate. A and B: the timing arrows on the eject gear, relay pinch gear and main cam, also the hole in the latter, should line up as shown for correct mechanical synchronisation.**

there's no review arm height adjustment, and if the old one is only slightly bent there will be tape wrinkling problems.

The review arm is critical. If in doubt, replace it. At least you know that a new one will be right. I say this because

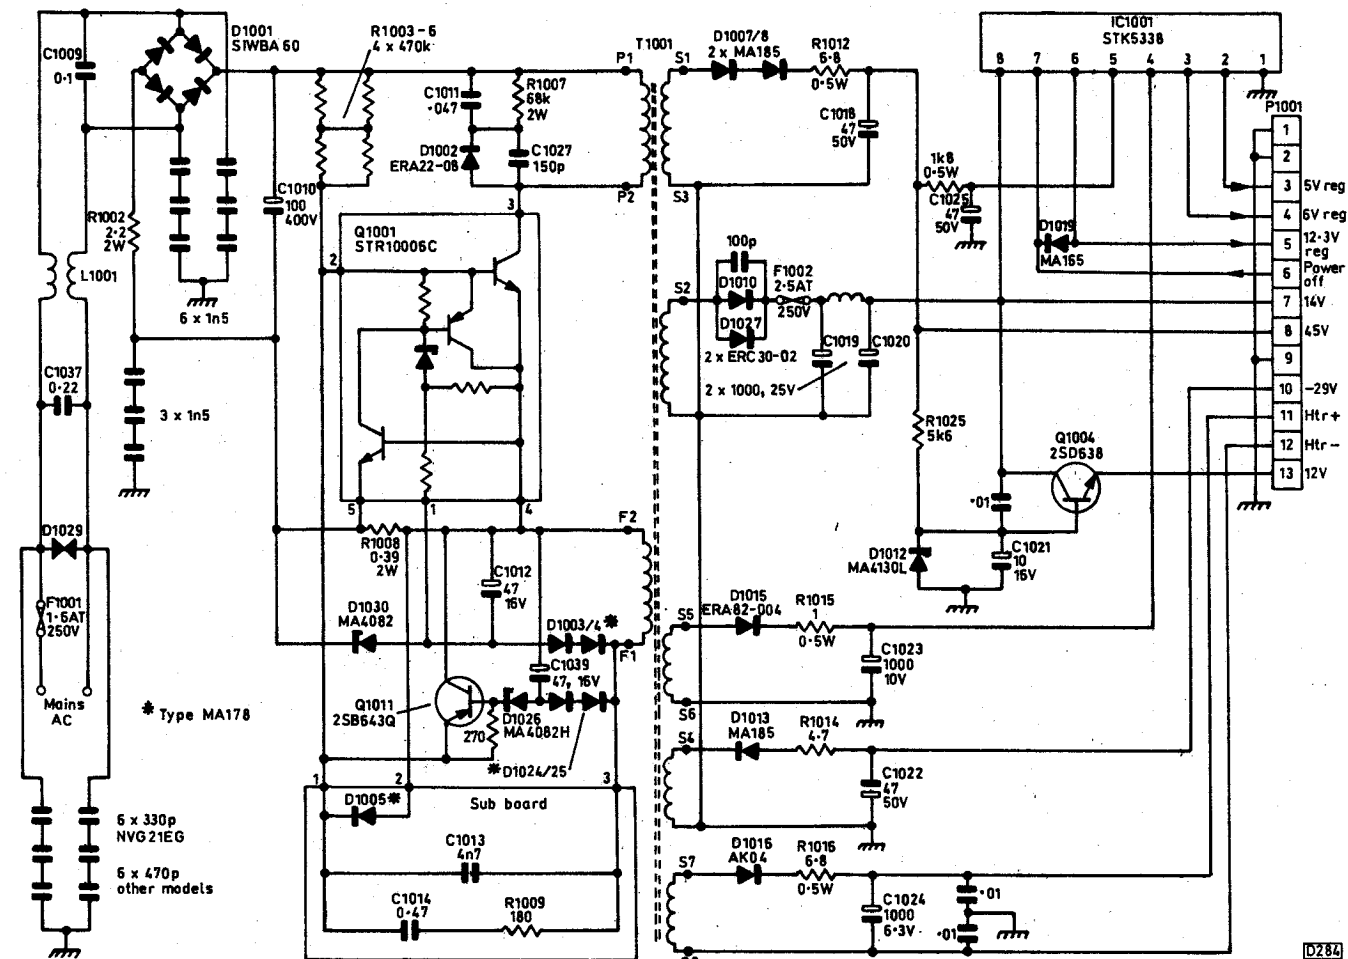
**Fig. 1: Power supply circuit used in the Panasonic Models NVG21 and NVG25. D1029 is type ENB461D-05A.**

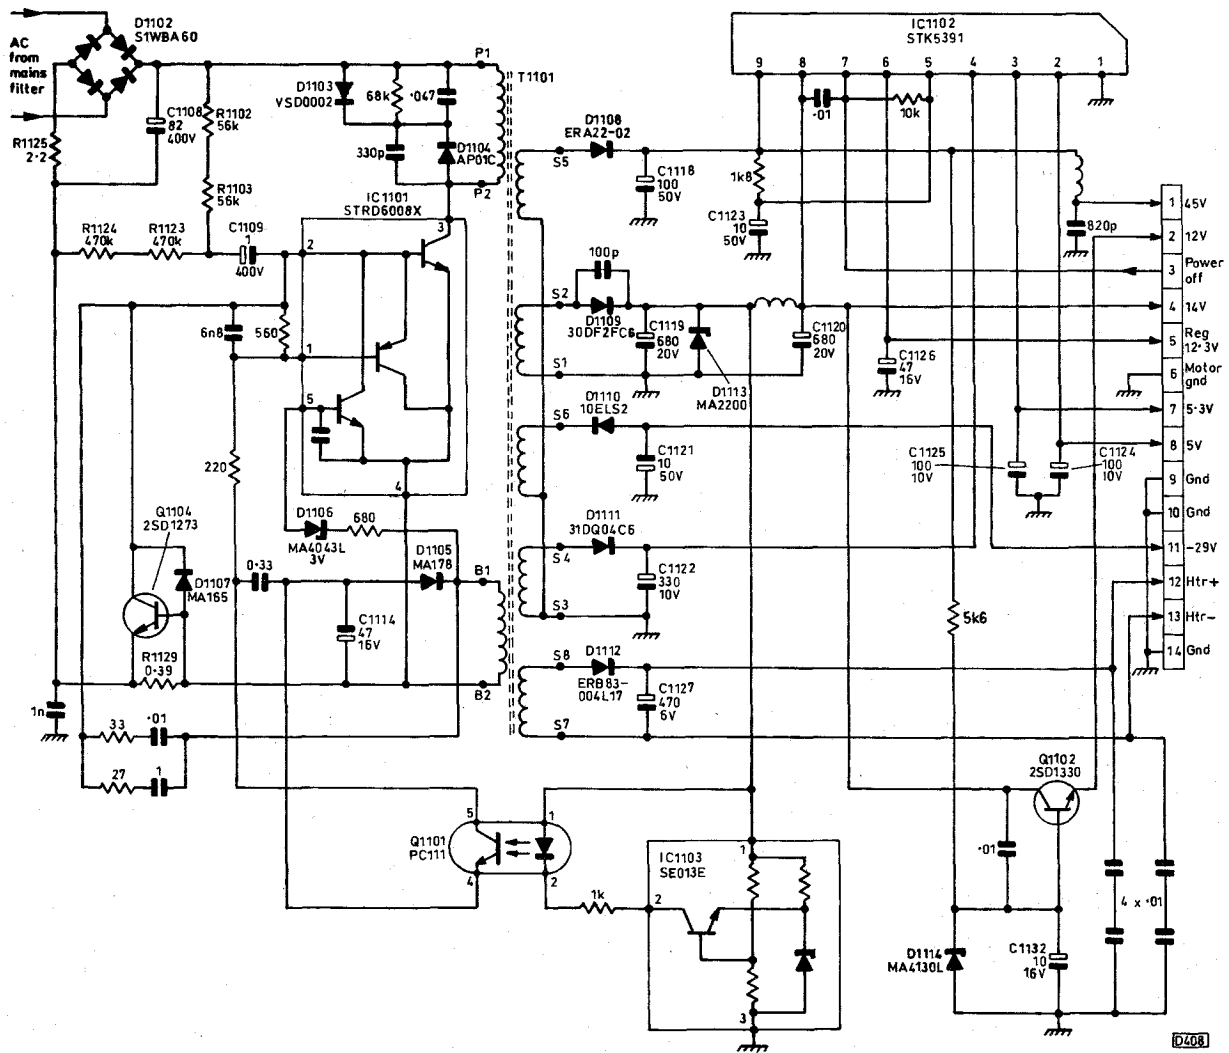
**Fig. 1: Power supply circuit used in the Panasonic Models NVJ30/J35/F65/F70.**

The servo circuitry is also reliable. With Models NVJ30/J35 the most common problem is C1122 (330 $\mu$ F, 10V) in the power supply going open-circuit. This can produce several symptoms, ranging from wow on sound to an unstable capstan then drum motor drive problems.

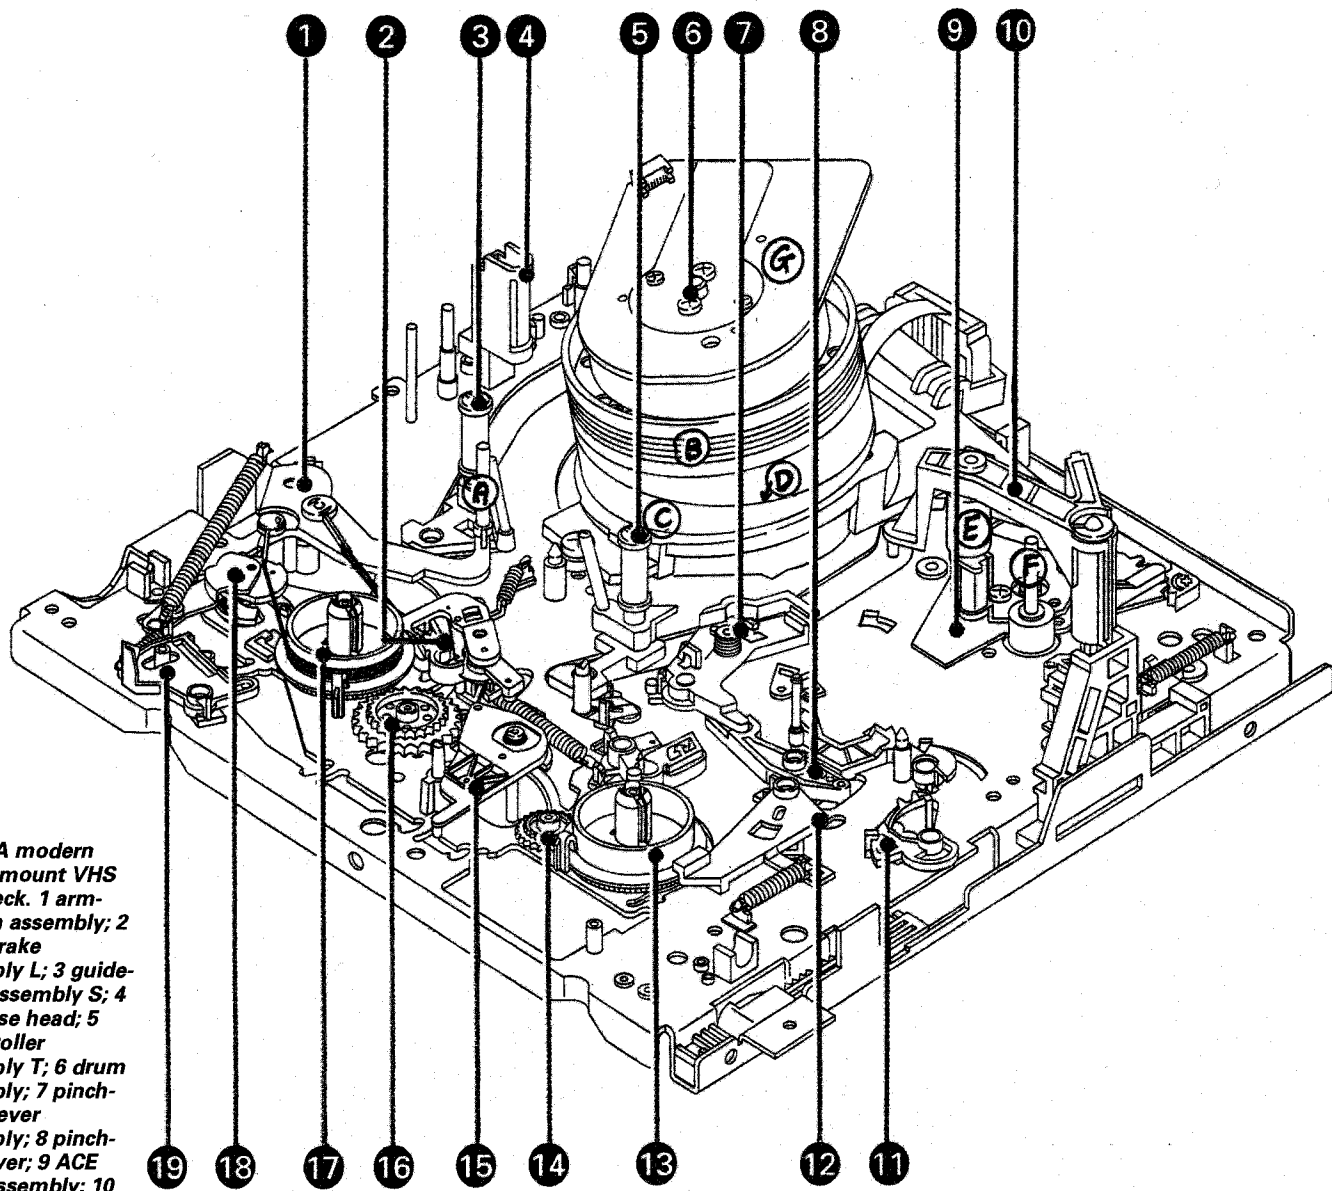
With most modern decks the tape is threaded as soon as the cassette goes down. Whether or not this is the case, if tape threading is a laboured business or the movement stalls, it's likely that the supply spool is not free to turn and, as a result, the tape is stretched taut. See if the reel brake is on, because of a misphased or broken mechanism, and if necessary check the back-tension band whose felt strip may have parted company with the plastic band and is now stuck fast to the periphery of the turntable.

The tape guides act as threading poles initially. They can become jammed at some point in their travel because of hard grease in their guiding slots. The solution is to clean with solvent and relubricate with light grease. The guides might stop short of their precision end-stops: this causes tracking problems. Particularly in older JVC

decks, the cause of this can be slackness in the joint between the articulated loading drive arms and the pole bases. Slackness and wear in arm-joints or drive pinions can result in the guides being 'floppy' at the loading end: the result is poor or erratic tracking. If you pull backwards a tape-guide which is in the fully-loaded position and then let it go, it should snap back into place under spring pressure: only when this is so can you be sure that the tape path around the head drum will be consistently reliable.

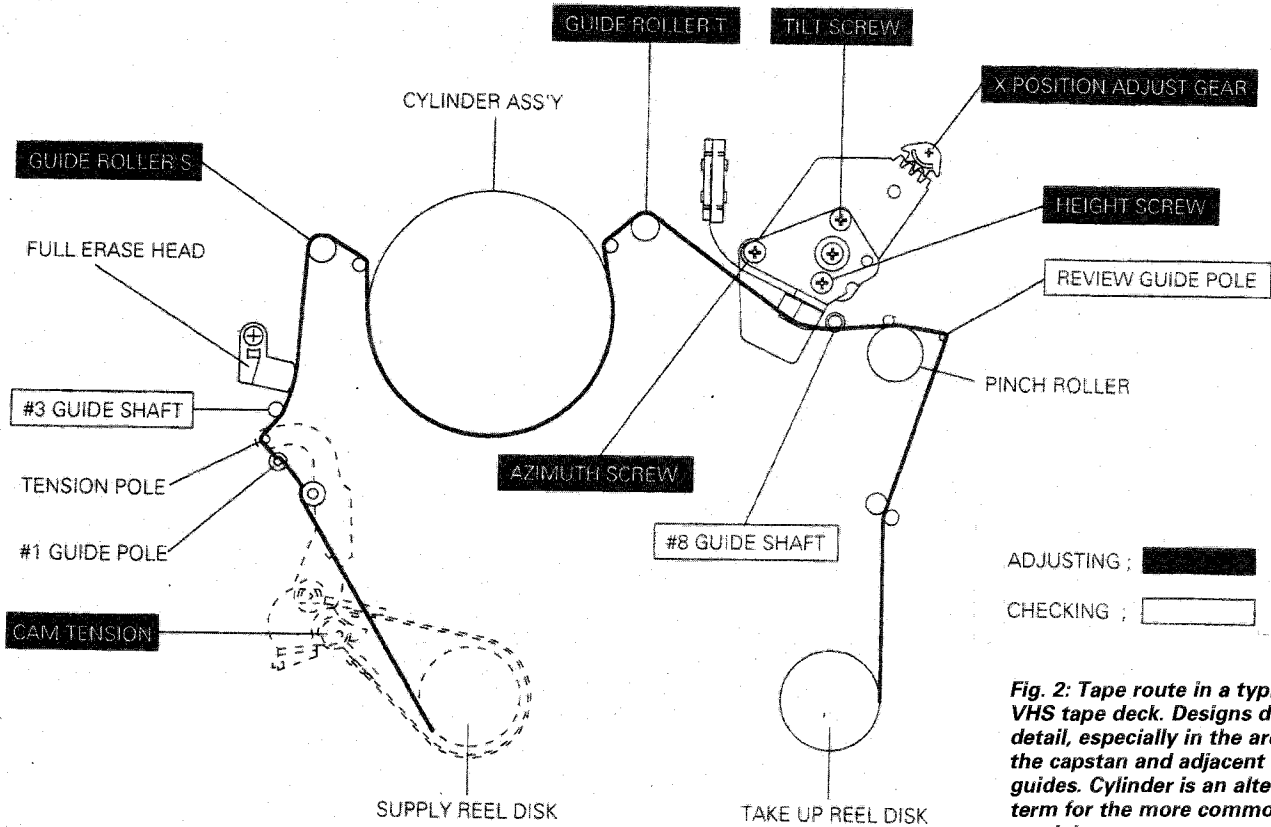
**Fig. 2: Tape route in a typical VHS tape deck. Designs differ in detail, especially in the area of the capstan and adjacent tape guides. Cylinder is an alternative term for the more commonly used drum.**

The most common symptoms produced by insufficient back tension are noise on the picture and/or picture judder/roll because of poor head-tape contact at the beginning of the head's tape scan. The effect is worse with a recording made by the same machine. Too much back tension can cause hooking and bending in the picture, and excessive tape and video head wear: in extreme cases the capstan and pinch roller skid on the tape, which becomes taut then stops moving or slows, with mistracking and wow on sound in the latter case.

If the back-tension pole is not perfectly vertical the tape will ride up or down it. The result is tape crinkling or an incorrect tape path across the full-erase head to the drum-entry guide. The only effective way of dealing with this is to fit a new lever assembly.

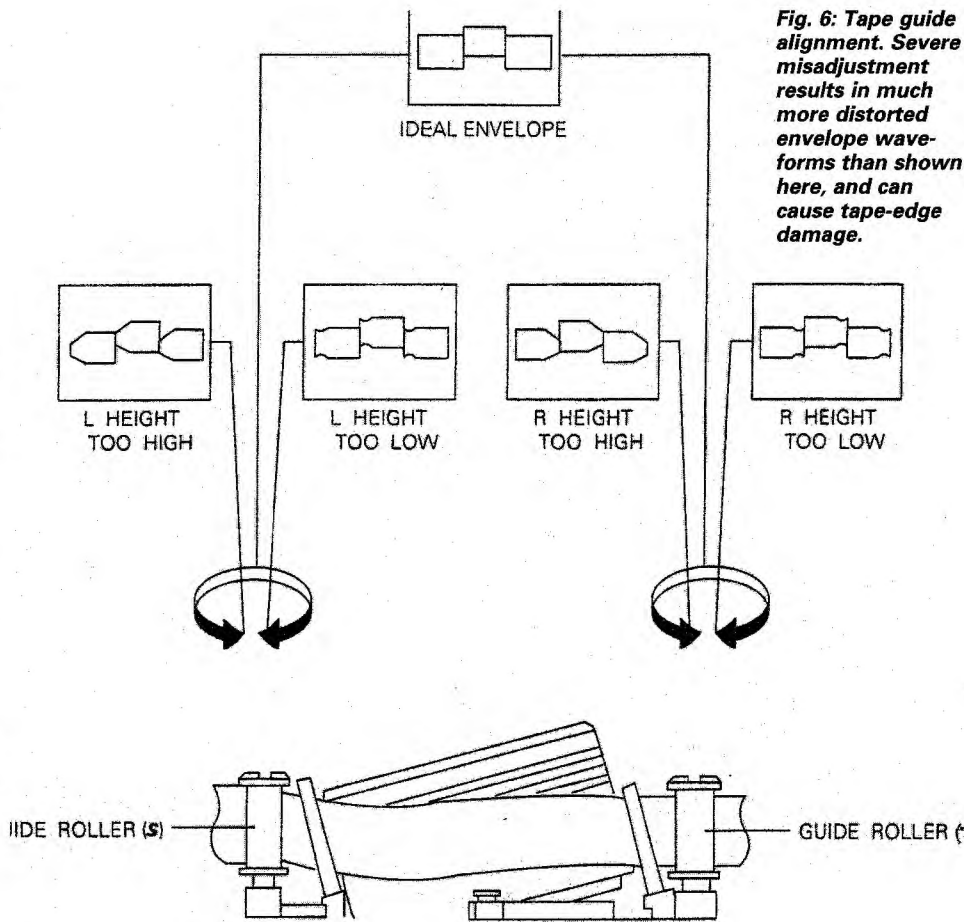
The comments above about the entry guide apply equally to the exit (T) guide on the other side of the drum. This should be adjusted for a good square envelope waveform at the end of the head scan, see Fig. 6. Once again, before you try adjustment check the guide's physical conditions and its positioning at the end stop, and ensure that the tape just touches the rabbet while running.

If tracking is erratic and the envelope waveform sags at or near the middle of the head scans it could be that both tape guides are set fractionally too high, with the result that the tape is poised slightly above the rabbet on its way around. A gap in the waveform at either end of the scans can be caused by incorrect adjustment of the head-switch timing. A gap at the start of the scans, in the record mode only, is caused by the ACE head assembly being too high. As a result the CTL head takes 'bites' out of the start of new video tracks.

**Fig. 6: Tape guide alignment. Severe misadjustment results in much more distorted envelope wave-forms than shown here, and can cause tape-edge damage.**

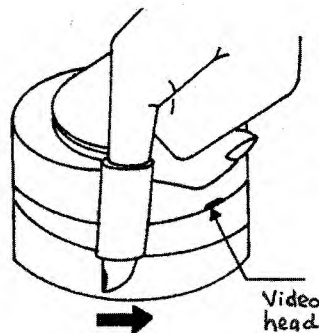
**Fig. 9: Video head cleaning by hand. Keep the forefinger, wrapped in fine chamois leather, still while using the other hand to rotate the drum anticlockwise.**

To clean the rotary heads use a soft cloth or buckskin or a proprietary cleaning stick, stroking only in the heads' normal direction of travel, see Fig. 9. In stubborn cases, and with care (and perhaps nothing to lose!), try the effect of a piece of card, similar in thickness and finish to a business card, soaked in isopropyl alcohol: press it hard against the upper drum's periphery while you rotate the drum anti-clockwise by hand. Make sure that the drum surface is dry before testing with a tape.

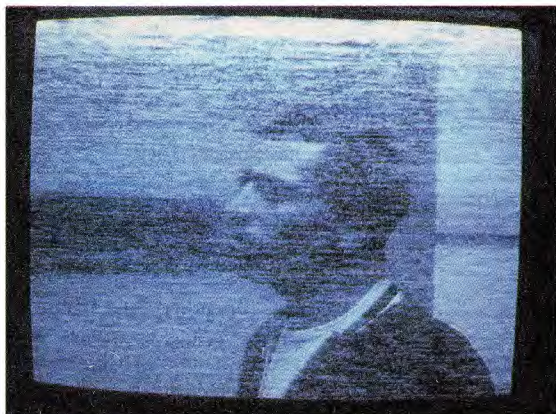
Dirty video heads cause the familiar coarse-snow effect on the playback picture, see Fig. 7; also, unless both heads are equally affected, a 25Hz flickering effect. Worn heads can produce the same effects but more often give rise to black and/or white

**Fig. 7: Effect produced by dirty video heads.**

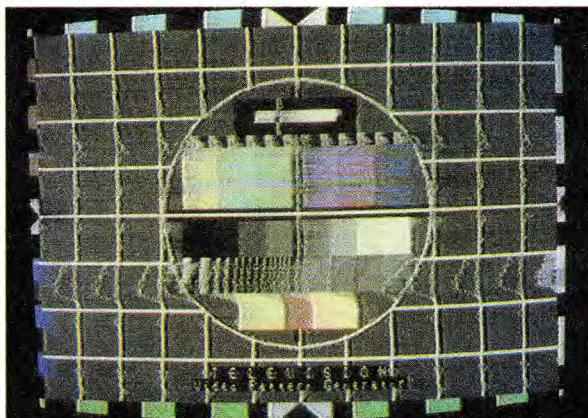
streaking from vertical edges in the picture. Fig. 8 illustrates this effect. When this occurs with only the machine's own recordings, some temporary relief can be obtained by reducing the luminance signal writing current. But head drum replacement is the only lasting cure.

**Fig. 8: The ragged picture, image pulling and 'worms-and-dots' streaking effects shown in this off-screen shot are caused by worn video heads.**

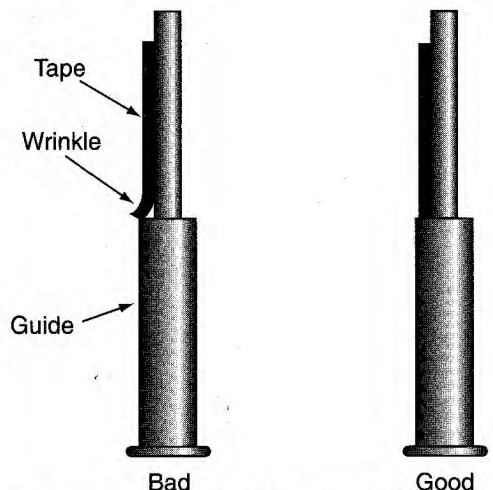
**Fig. 13:** Tape damage at the flange of a guide: the same can happen at the top edge if the tape rides upwards and a flange is present there.
