## Toshiba V8700

## Ferguson 3V23/JVC HR7700

## Toshiba V9600

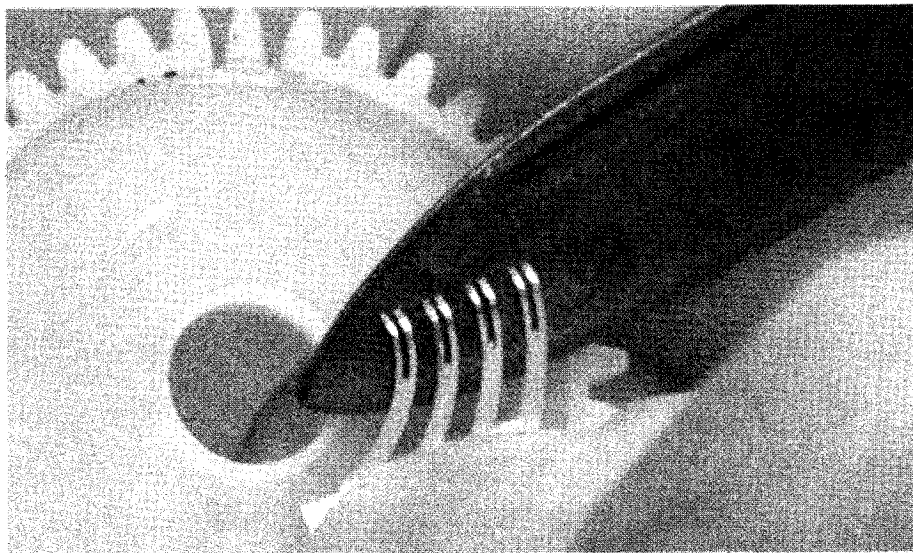
**Fig. 2: Retensioning the wiper blades – take great care over this.**

The next action is to retension the sprung fingers. Fig. 2 shows how this is best done. Use a finger nail, screwdriver or whatever to prevent strain on the plastic rivet heads that anchor the wiper to its disc, while bending the fingers upwards with a penknife blade or something similar. Make sure that you keep the blade parallel and at right-angles to the wiper's fingers. Don't push them too far: an additional 10° or 15° is usually about right to ensure good contact without excessive wear.

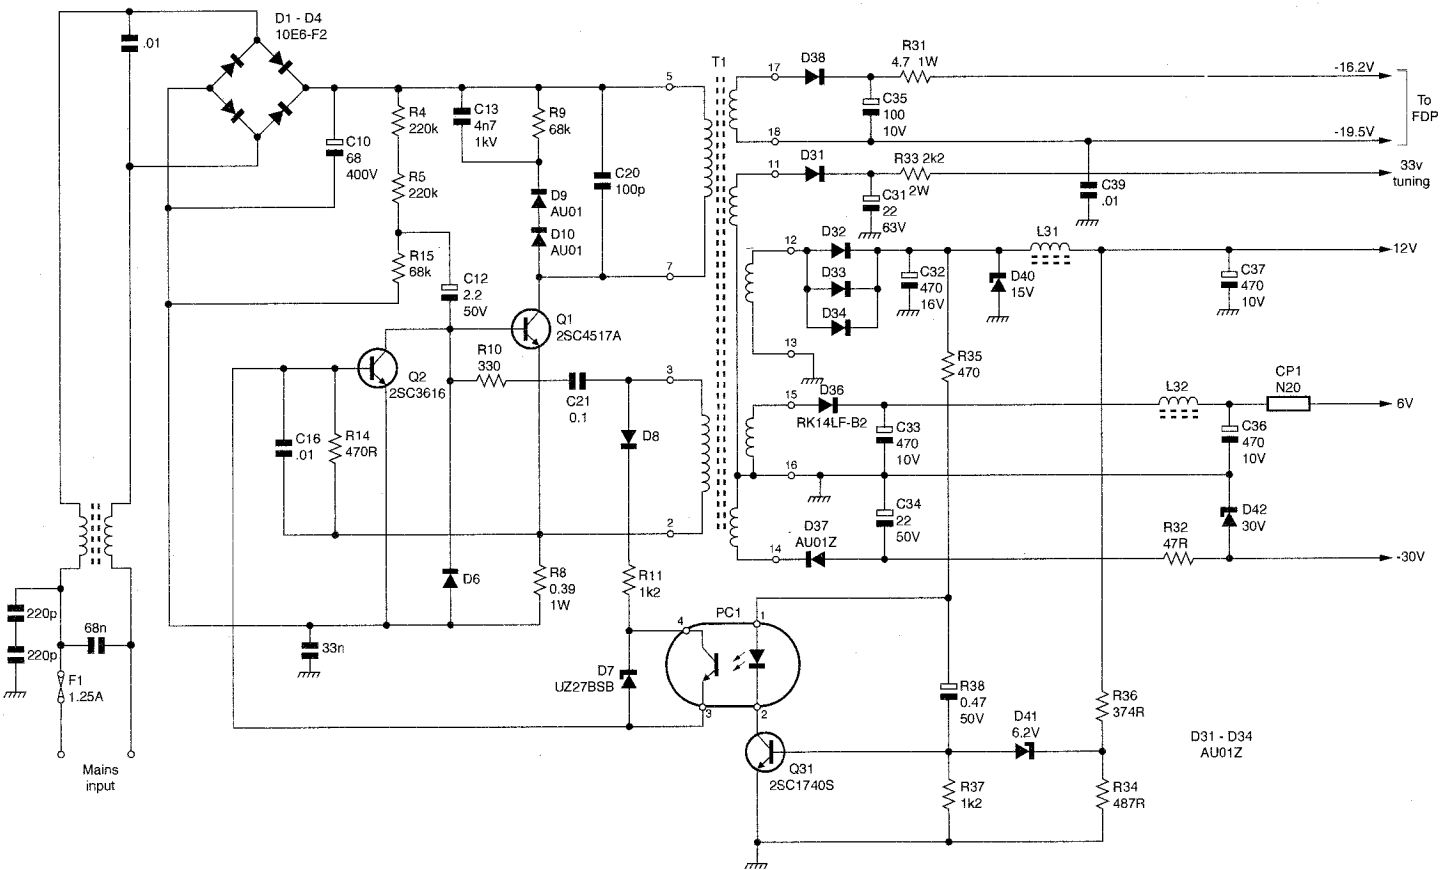
Figure 1: Circuit diagram of the chopper power supply in JVC HRJ200 series VCRs (board 01).

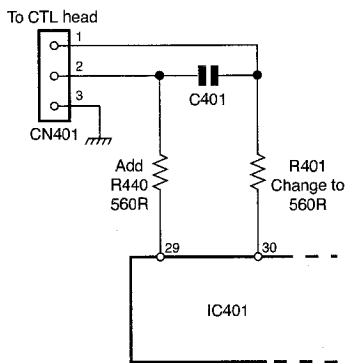
**Figure 3: Modification to the control head circuit to prevent intermittent failure of CP1.**

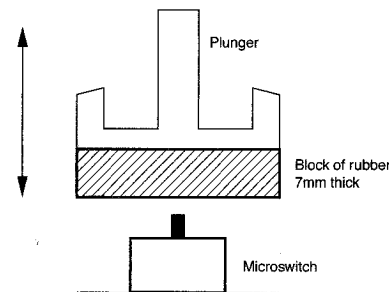
This machine would accept a cassette then, after a few seconds, eject it. The cassette-down microswitch is on a little sub-panel and is operated by a white plastic 'plunger' on the carriage. The bottom part of this plunger is made of very thin, flexible plastic, and this had broken away completely. If a complete new carriage had been required the repair would have been uneconomical (from the customer's point of view anyway). But the rest of the machine appeared to be in showroom condition, so I decided to have a go at repairing the broken part.

**Fig. 1: Repair to the carriage-down microswitch operating system in the JVC HRJ420.**

Two large blocks of thick foam rubber material are stuck to the screening cans. I cut away a small square, 7mm thick, and glued it to the underside of the plunger (see Fig. 1). This provided a complete cure and, six months later, the machine has not been back to me again. **M.McC.**
