YASHICA FIXES FIXES REPAIR MANUAL

YASHICA CO., LTD., TOKYO

ASSEMBLING CHART

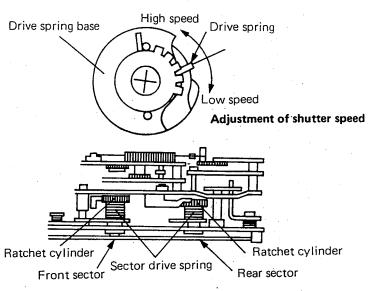
Adjustment of curtain travel

The drive spring engages with the drive spring base; yet its position is to be moved. However, the shutter speeds change in the same tendency from high speed down to low speed. For example, such defects as a second being over and 1/125 sec being under cannot be repaired.

The tension of the drive spring is changed by turning the ratchet cylinder (by use of a minus (—) screw driver). This repair is possible only in the case of the shutter single, where it is impossible to measure shutter speeds, so that the repair must be carried out depending on intuition.

* When adjusting the curtain travel, be sure to confirm shutter speeds.

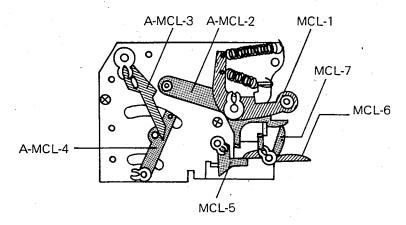
MC Base Plate Ass'y

- QRL-1 (065201) is set with winding operation.
- QRL-4 (147725) moves in the direction of arrow (up) by pressing the shutter release button, the tip of QRL-2 (065202) is released, striking against QRL-6 (139731), and A-MCL-2 (065212) is released, which causes A-MCL-3 (065213) to move, springing up the mirror plate by means of MCL-4 (065214).

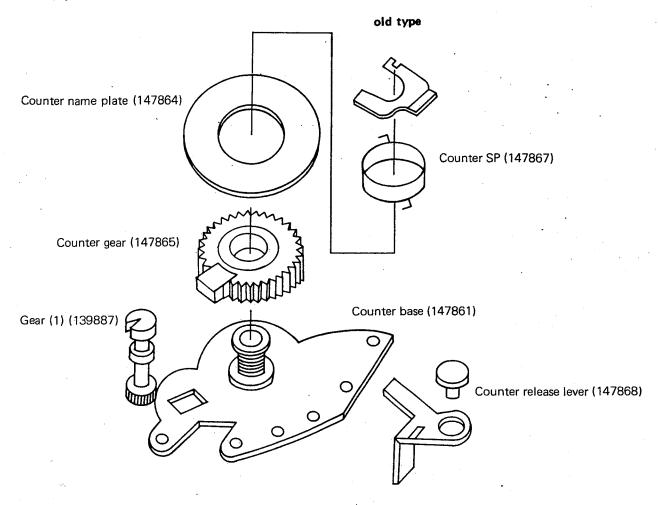
When the counter counts 36 frames or less and then the back cover is opened, the counter is not reset.

- 1. and 2. Loosen the top cover nut little by little, and if the counter returns, replace the counter SP hook with a new one.
 - Confirm that there is a play between the counter SP hook and the gear.
- 3. Remove the counter SP hook and check the entanglement of SP. If there is a play in the counter SP hook, or the counter does not return from time to time though the gear is operated by fingers, press the end of the side without notch of the SP hook by use of a screw driver. Again operate the gear by fingers. The protrusion of SP is caused by deformation of the reset SP; correct it to its normal shape or replace it.
