Appendix 7 – Pole mounting 9900UXI101

A.7.1 – Definition

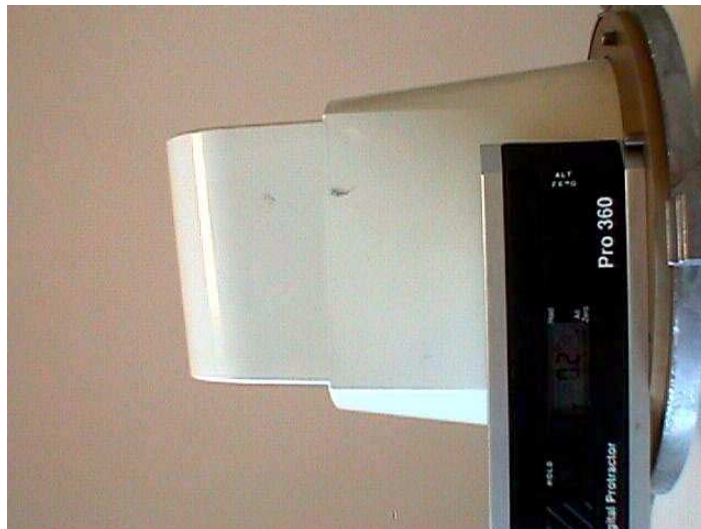
Figure 67 – Checking antenna positioning

1. Using a control system (graduated level or inclinometer) positioned on the straight part of the antenna (*Figure 67 – Checking antenna positioning*), ensure that it is perfectly horizontal (tilt 0°).
