Appendix 4 – Mounting coaxial connector

Mounting on cable LDF4
Alcatel Code: 77096434

N Connectors

for HELIAX® LDF4-50A Coaxial Cable

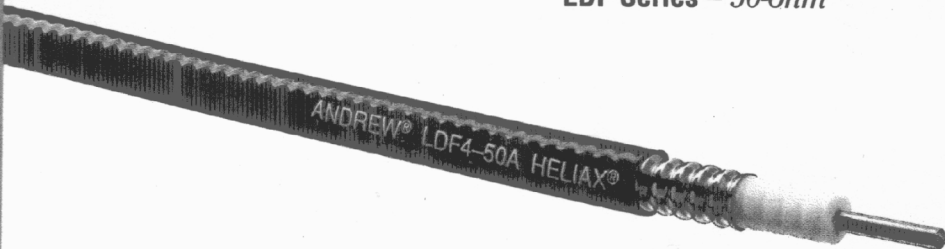
LDF4-50A

HELIAX® Coaxial Cables

**1/2" Foam Dielectric,
LDF Series – 50-ohm**

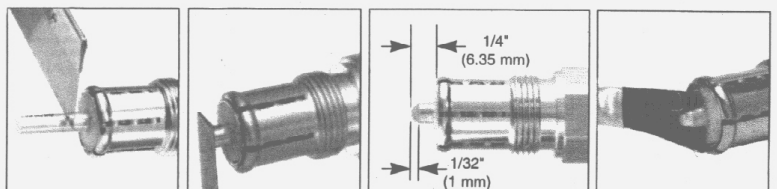
Trim inner conductor. Remove debris.
Cortar el conductor interno. Retirar los restos.
Coupez le conducteur intérieur. Enlevez les débris.
Innenleiter abschneiden. Metallspäne entfernen.
Limpe o condutor interno. Remova os detritos.
切整內心導體。去除殘渣

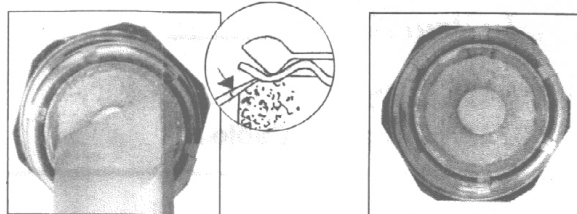
6

Compress foam.
Comprimir el material de espuma.
Comprimez la mousse.
Verschäumung zusammendrücken.
Comprima a espuma.
壓緊泡沫塑料

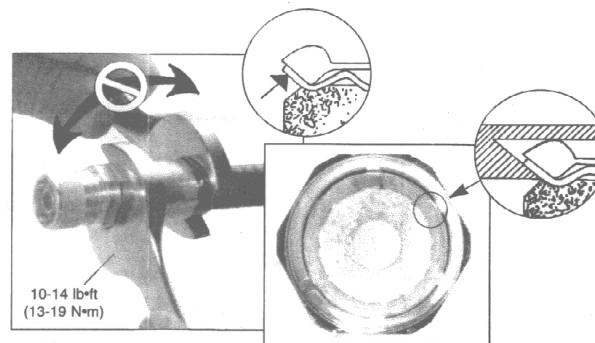
7

Flare outer conductor, examine flare, remove debris
Acampanar el conductor externo, examinar la forma de campana y retirar los restos.
Evasez le conducteur extérieur, examinez l'évasement et enlevez les débris.
Außenleiter aufweiten, Öffnung prüfen und Metallspäne entfernen.
Flangear o condutor externo, examinar o flangeamento e remover os detritos.
擴張外導體，檢查擴張表面，去除殘骸。

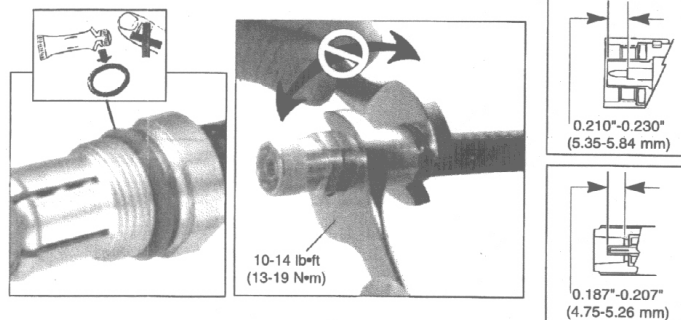
8

Add O-ring and grease. Reassemble connector.
Añadir la junta tórica y grasa. Montar nuevamente el conector.
Mettez en place le joint torique et graissez. Réassemblez le connecteur.
O-Ring vor Montage einfetten. Steckverbindung wieder zusammenbauen.
Coloque o anel em O ring e graxa. Reinstale o conector.
加 O 型圈和油脂。重新裝配接頭
