## Software Maintenance Release Note

# Maintenance Version 291-10

for AR415S, AR440S, AR441S, AR442S, AR450S, AR725, AR745, AR750S, AR750S-DP, and AR770S routers and AT-8600, AT-8700XL, Rapier i, Rapier w, AT-8800, AT-8900, x900-48, AT-9900, and AT-9800 Series switches

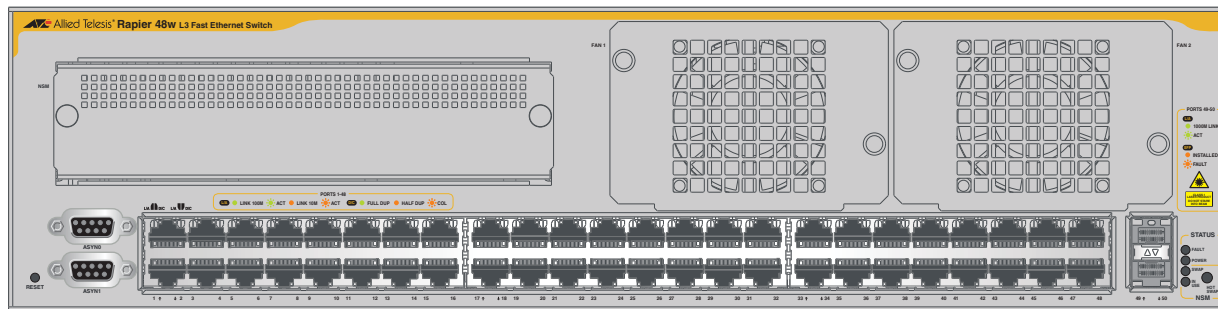
## Rapier 48w front panel

- 48-port 10BASE-T/100BASE-TX (RJ-45 connectors)
- Two 1000BASE SFP ports
- Two asynchronous serial console ports with DB9 connectors
- One Network Service Module bay, with support for various WAN interface cards
- Auto-negotiating Layer 3 Managed Switch
- Enhanced switching core
- Replaceable air filters and fan-only modules (FOMs) for NEBS applications

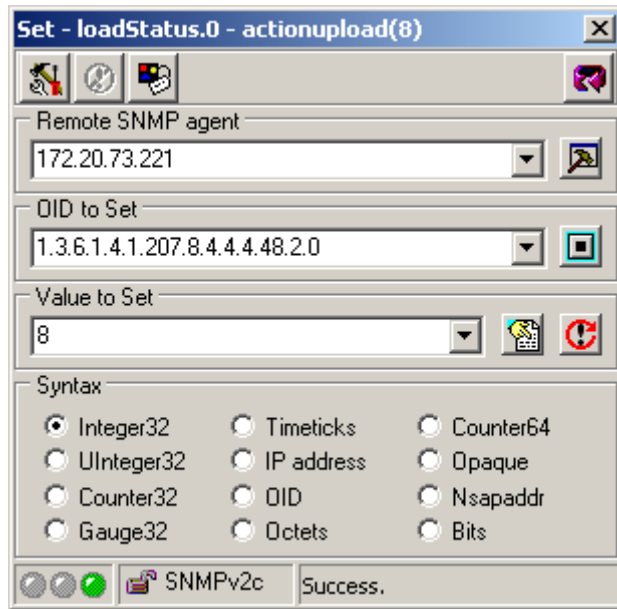
### 3. Upload the file

To upload the file, use SNMP SET loadStatus and set it to a value of 8. The following screenshot shows this.
