Troubleshooting-Installing an RF link

Issue : 5.3.x

Axxcelera Broadband Wireless
175 Science Parkway
Rochester, New York 14620

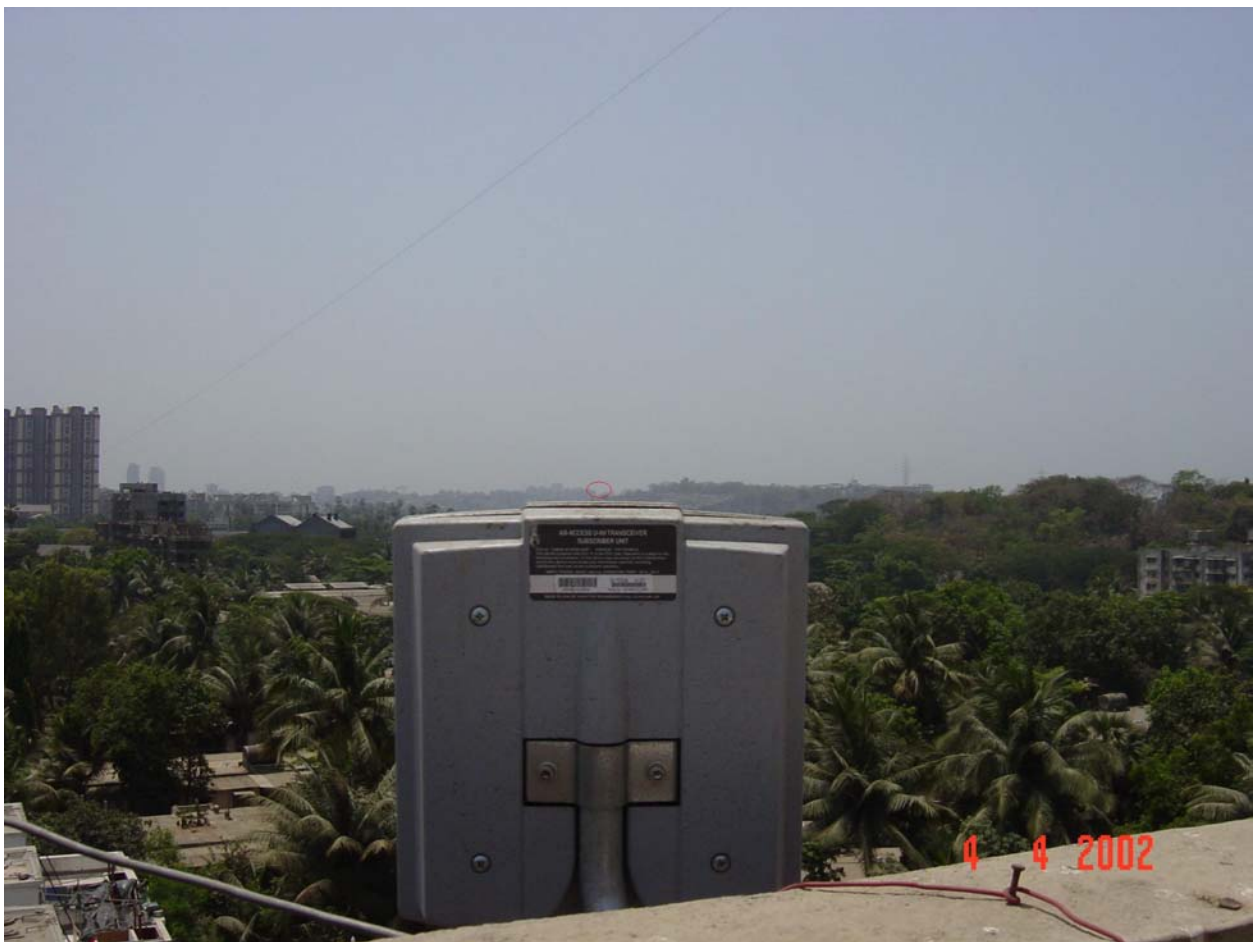
The regular SU has a 20x20 (azimuth x elevation) so it usually very easy to eyeball the alignment. The extender SU has a 10x10 (azimuth x elevation) so it may be a little more difficult to align. This can be done by standing behind the unit while looking just over the top of the unit and adjusting the radio to point directly at the AP. As you can see in this picture the SU has been aligned by just eyeballing the tower. On the day this picture was taken there was a little bit of haze in the air so the tower is harder to see so it has been identified by a red circle. With the 20x20 antenna this is generally good enough to get a quality RSSI.

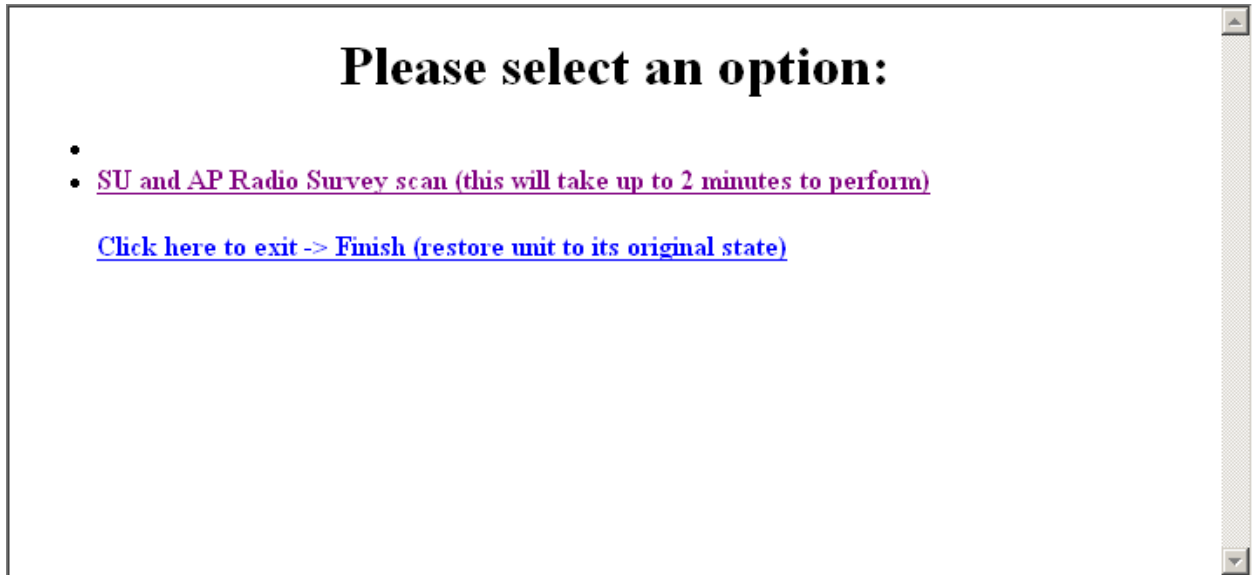
- Click on **SU and AP Radio Survey scan**.

- The survey page is displayed. It will take up to 2 minutes to appear so be patient.
