Cisco ONS 15310-CL and Cisco ONS 15310-MA Troubleshooting Guide

Product and Documentation Release 7.0
Last Updated: September 3, 2007

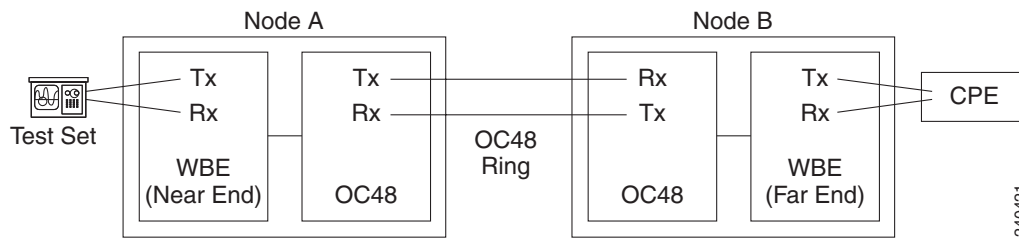
Figure 1-2 Diagram of FEAC Circuit

The "far end" in FEAC refers to the equipment connected to the WBE card and not to the far end of a circuit. In Figure 1-2, if a WBE-28/WBE-84 DS3 (near-end) port is configured to send a line loop code, the code will be sent to the connected test set, not the WBE-28/WBE-84 DS3 (far-end) port. FEAC functions will be available only when the DS3 port is configured in CBIT Framing.

The Send Code column on the WBE-28/WBE-84 cards Maintenance tab only applies to OOS-MA,MT ports configured for CBIT framing. The column lets a user select No Code (the default) or line loop code. Selecting line loop code inserts a line loop activate FEAC in the CBIT overhead transmitting to the connected facility. This code initiates a loopback from the facility to the ONS 15310-MA. Selecting No Code sends a line-loop-deactivate FEAC code to the connected equipment, which will remove the loopback.

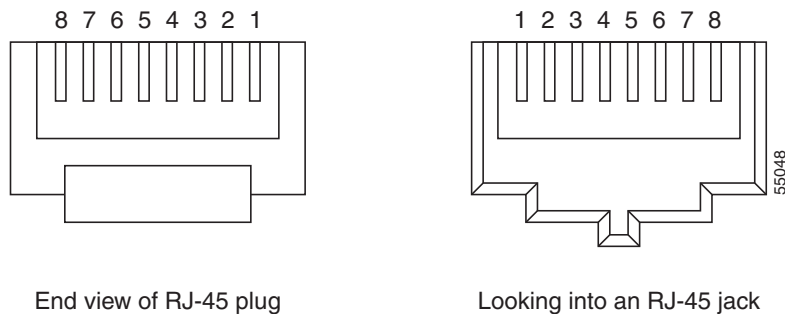
Figure 1-5 RJ-45 Pin Numbers

Figure 1-5 shows the layout of an RJ-45 connector.

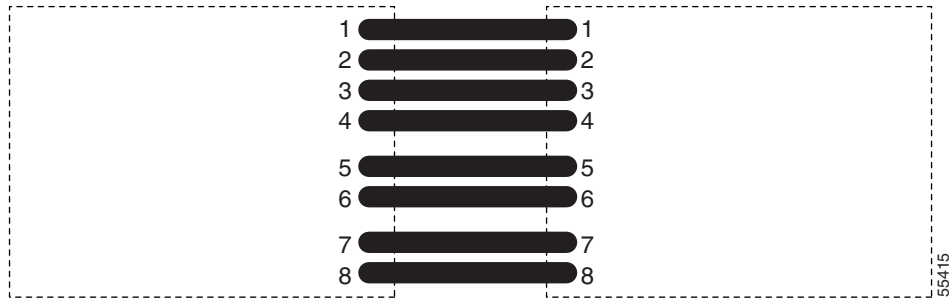
Figure 1-6 LAN Cable Layout

Figure 1-6 shows the layout of a LAN cable.

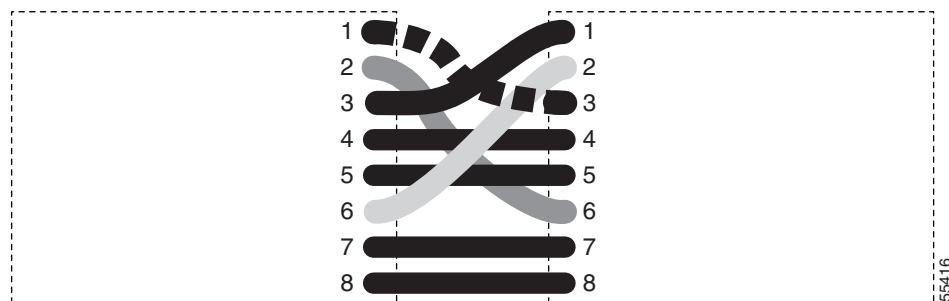
Figure 1-7 Cross-Over Cable Layout

Figure 1-7 shows the layout of a cross-over cable.

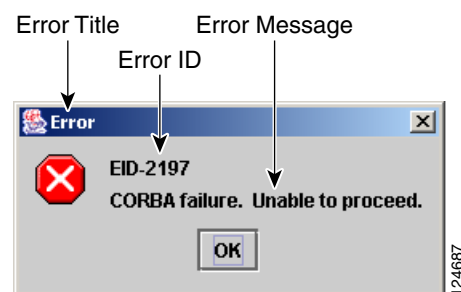
Figure 4-1 Error Dialog Box

This chapter lists the Cisco ONS 15454, 15454 SDH, 15600, 15327, 15310-CL and 15310-MA error messages. The error dialog box in [Figure 4-1](#) consists of three parts: the error title, error ID, and error message. The table lists two types of messages: error messages (EID-*nnnn*) and warning messages (WID-*nnnn*). Error messages are alerts that an unexpected or undesirable operation has occurred which either indicates the risk of loss of traffic or an inability to properly manage devices in the network. Warnings are alerts that the requested operation could lead to an error. Warnings are sometimes used to convey important information.
