**Firmware Version:** 3.0.0.16  
**Published:** Oct 26, 2011

**Revision History and System Requirement:**

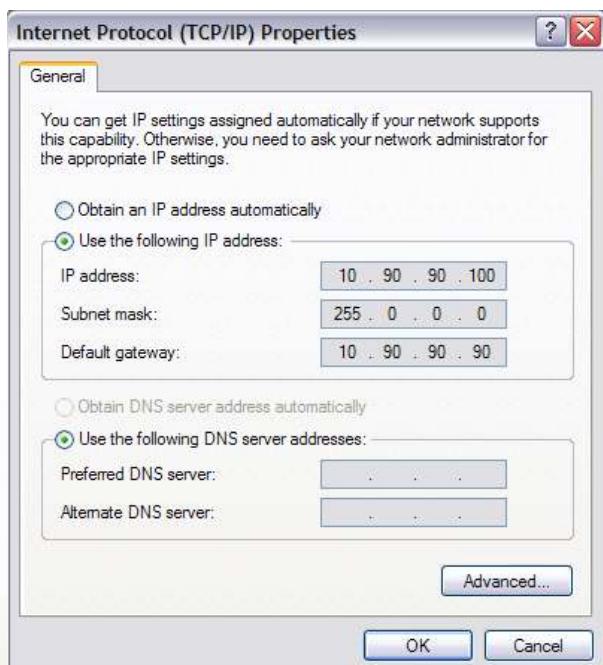
Make sure the PC on which the TFTP server resides is configured in the same network as the switch and the AP. Verify that the PC is accessible from these devices. For example, if the WS (10.90.90.90) and the APs are in the 10.0.0.0/8 network, you can configure the PC network interface as follows.

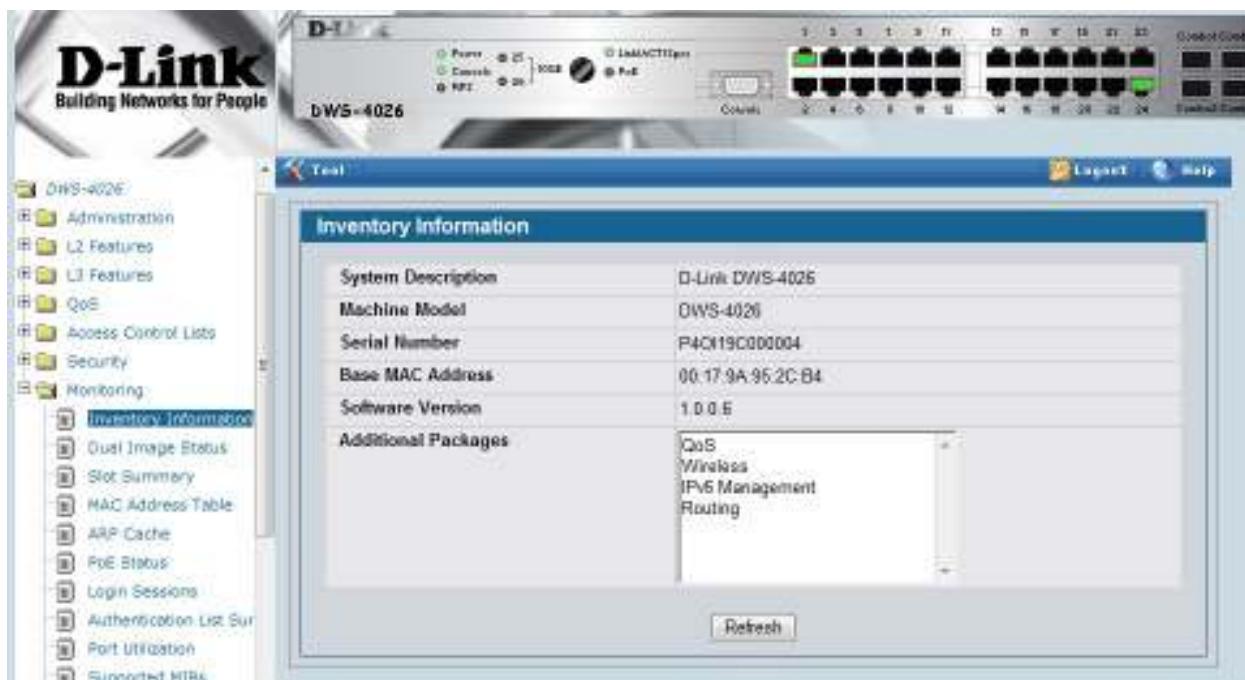
Verify it on the web UI at LAN->Monitoring->Device Status page as follows.

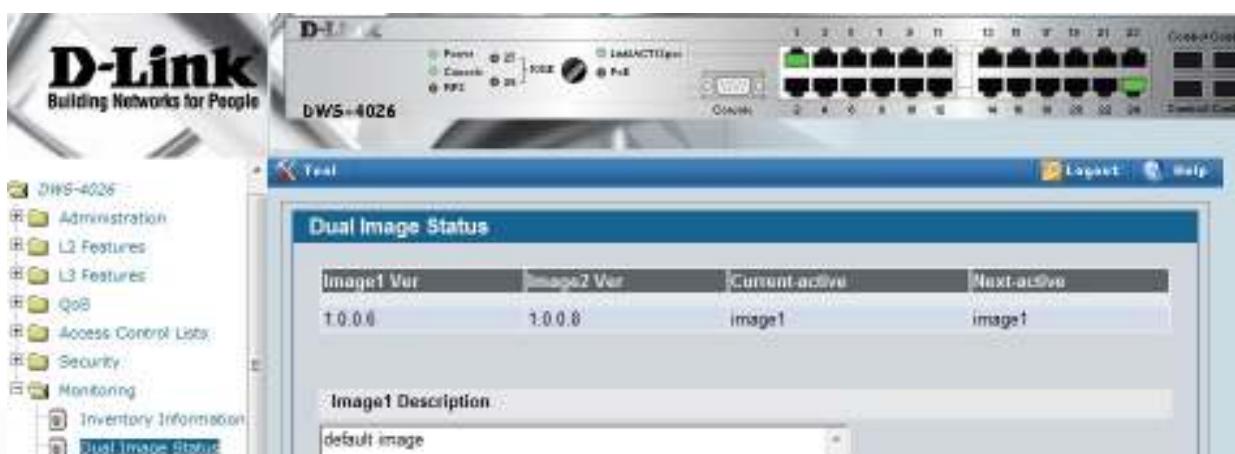
The versions of both the images on the switch are displayed at LAN->Monitoring->Dual Image Status page as follows.

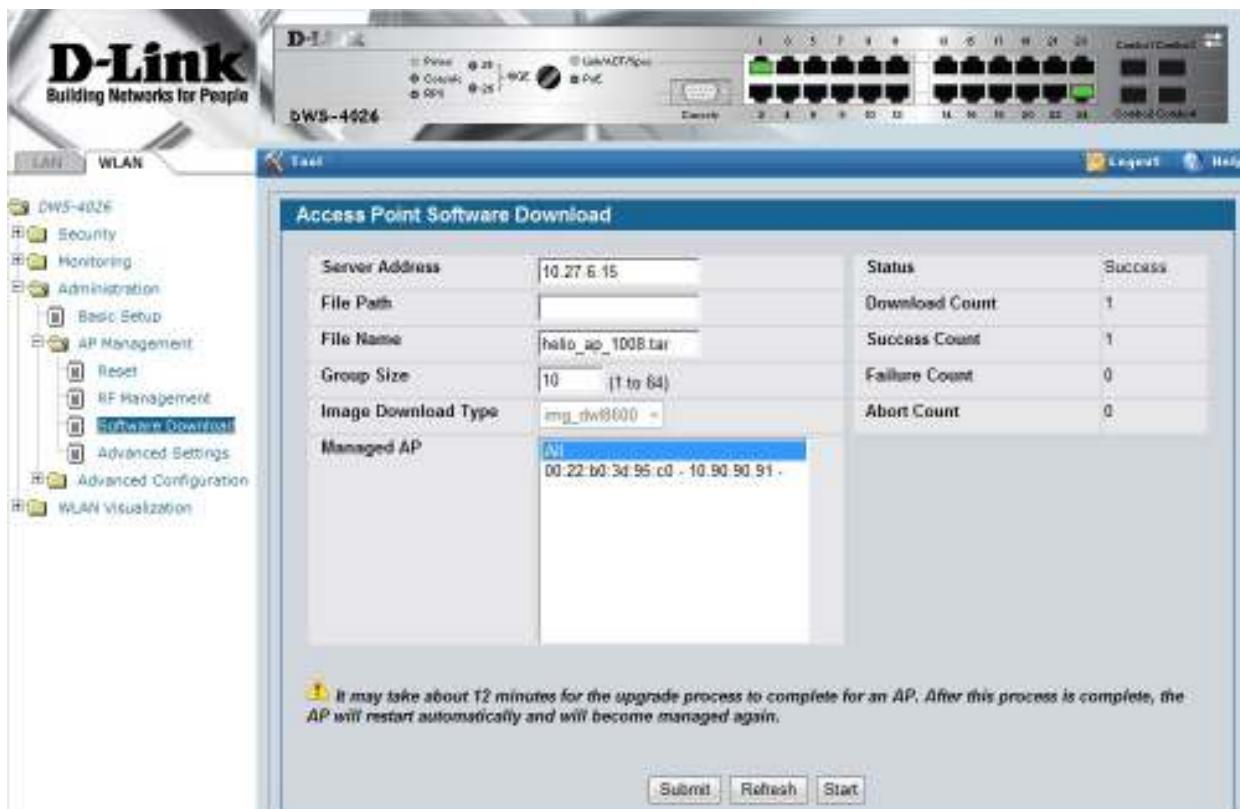
Download the 1.0.0.8 image on the AP using WLAN->Administration->AP Management -> Software Download as follows. Make sure that the TFTP server is accessible from the APs as the WS is going to direct the APs to the TFTP server to get their upgrade image.

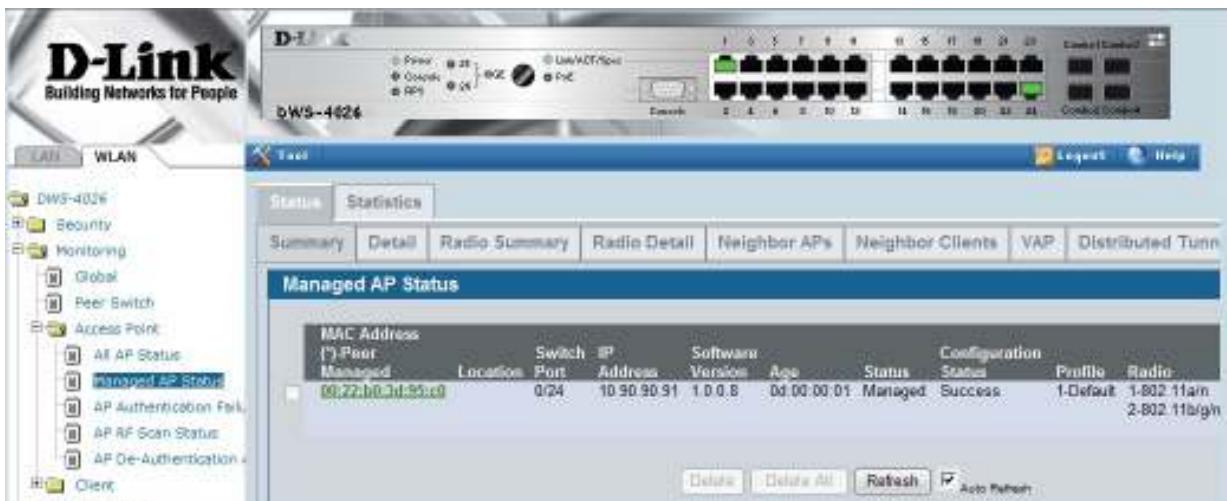
Once the APs are upgraded, they should become managed by the WS that is still running 1.0.0.6. Verify on the WLAN->Monitoring->Access Point ->Managed Access Points page as follows. (Verify the Software Version of the APs is 1.0.0.8.)

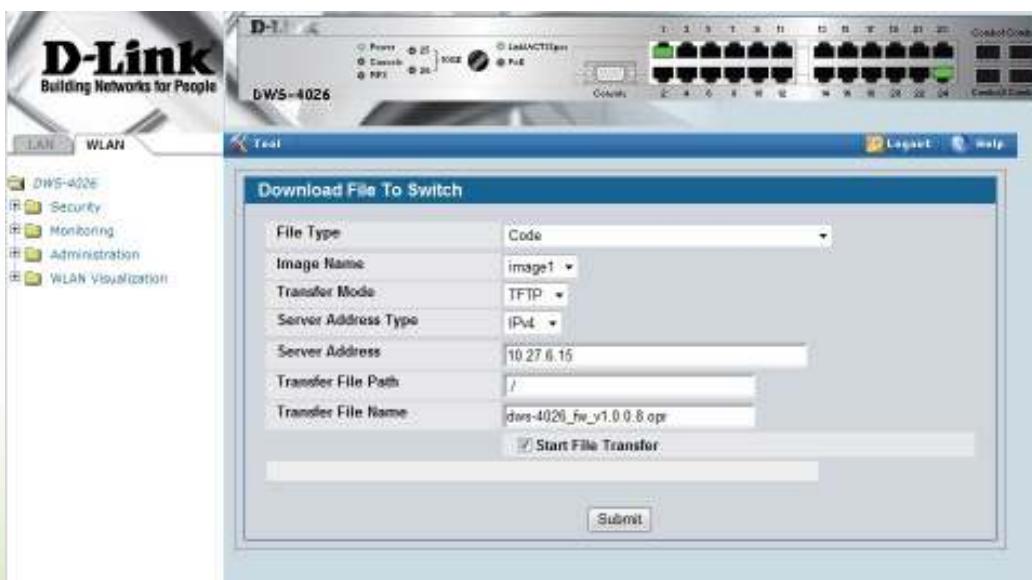
Download 1.0.0.8 WS firmware image using the Tool->Download File web page as follows. Make sure the Image Name selected is same as the Next Active Image. Next Active Image can be verified from LAN->Monitoring->Dual Image Status page

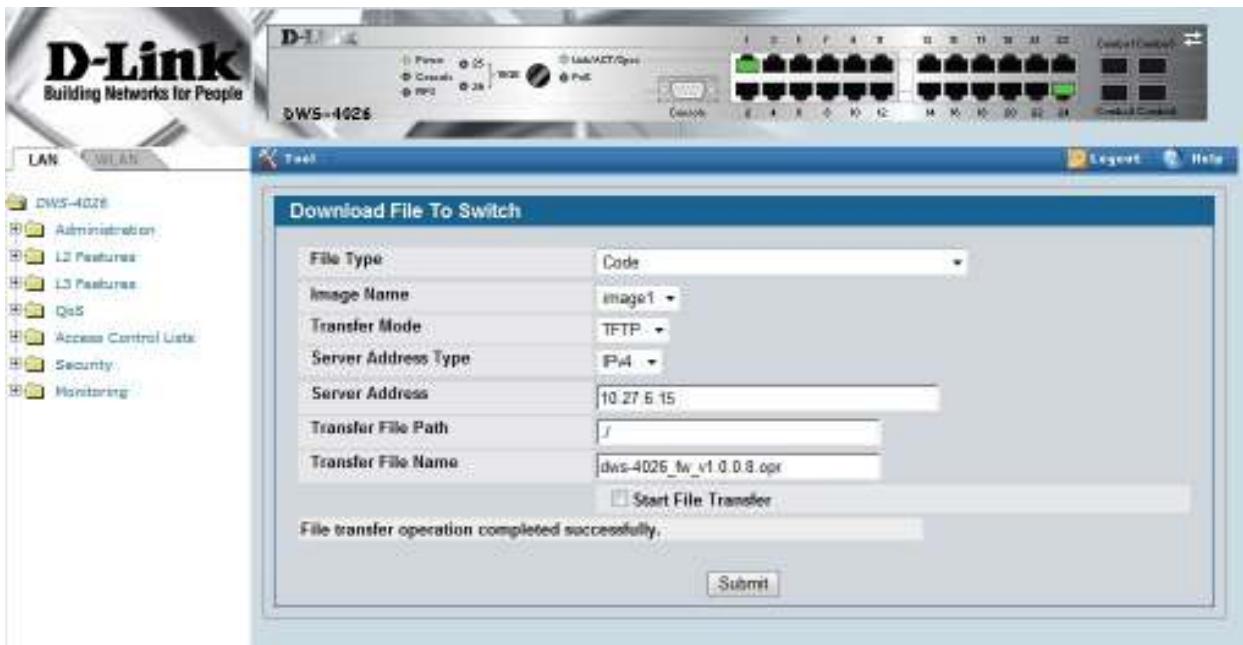
You should see the success message as follows when the transfer is complete.

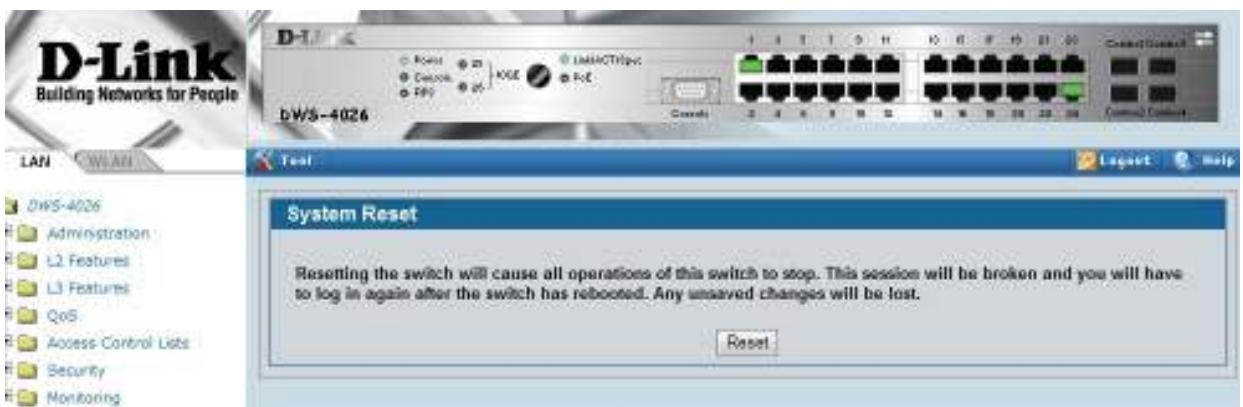
Now reboot the WS using Tool->Reboot System as follows. Respond appropriately if want to save the configuration changes before the reboot.

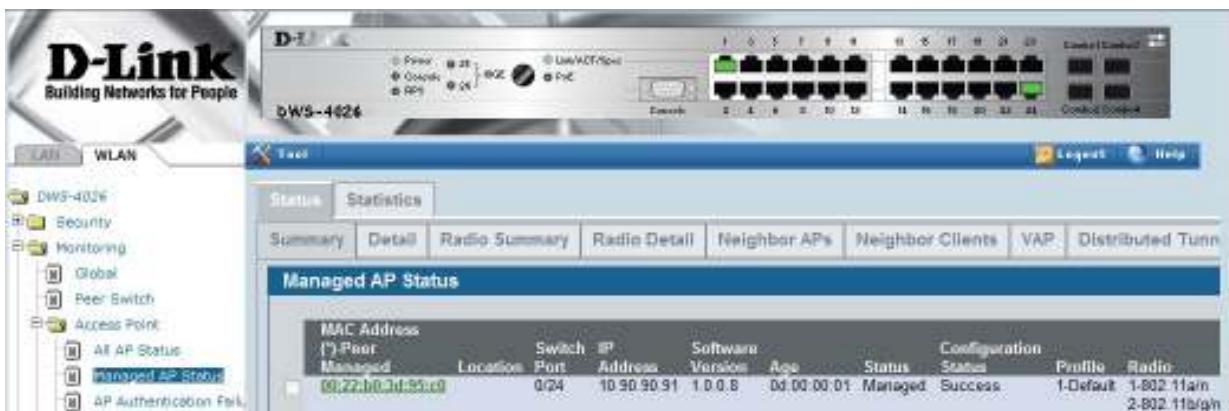
After the switch is back up, you should see all the APs with version 1.0.0.8 managed as follows on the WLAN->Monitoring->Access Point ->Managed Access Points page.
