# A More Detailed Electronic Mechanism for Sudden Unintended Acceleration

Ronald A. Belt  
Plymouth, MN 55447  
4 August 2013

**Abstract:** Long term unintended acceleration events with engine speeds approaching 5000 to 6000 RPM are explained in terms of the author's previous theory of sudden unintended acceleration. It is shown that these events have a common origin with vehicle surging events at low speeds and that both can happen while the driver's foot is off the accelerator. This means that brake override systems are completely ineffective in preventing sudden unintended acceleration in vehicles having electronic throttles. It is shown that unintended acceleration is a problem inherent to the electronic throttle systems of all automobile manufacturers. The root cause of unintended acceleration in vehicles having electronic throttles is identified, and a solution is presented.

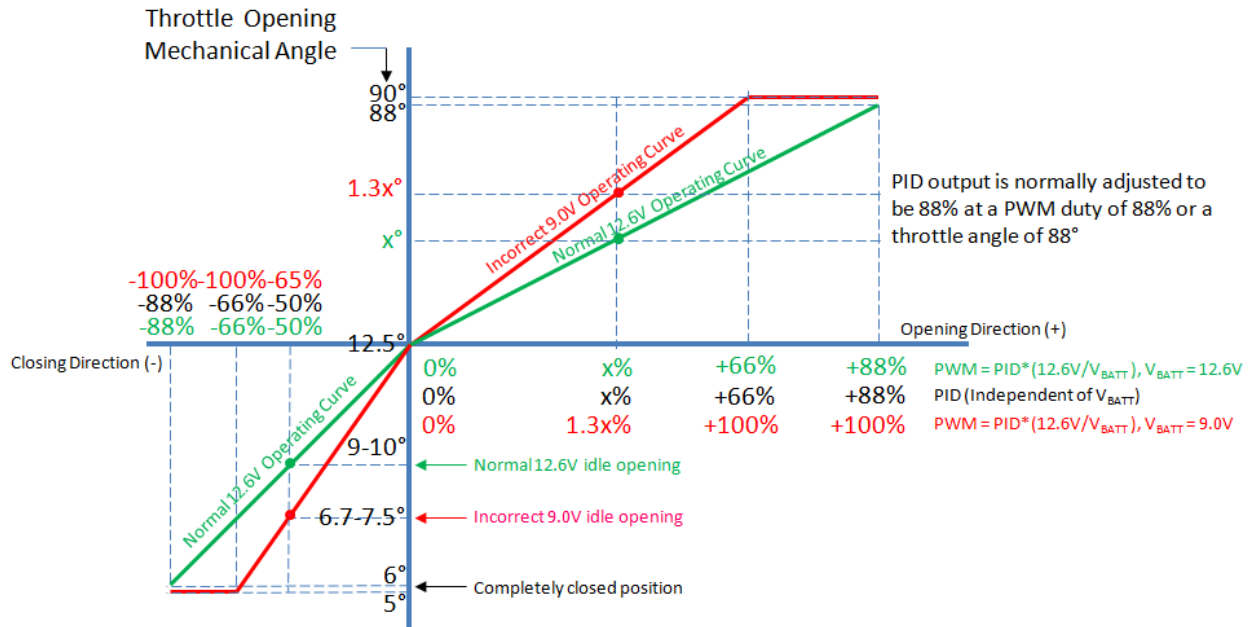
Figure 2. Incorrect battery voltage duty cycle compensation causes throttle opening angles above the limp home discontinuity to increase above their normal values while the idle opening below the discontinuity decreases.

2. Effects of PID Loop Gain Changes on Throttle Operation. Figure 2 shows how the throttle operation is affected by PID loop gain changes. Concentrate first on the green curve, which shows the normal throttle operation. The PID output is first adjusted with the throttle completely closed (-100% PWM duty cycle), to position the PID output zero point at the limp home position. Then the PID output is adjusted to be maximum (+100% duty cycle) when the throttle is hitting the throttle stop at 90° open. The maximum PID output is then re-adjusted to be 88% when the throttle opening is 2° less than the maximum throttle opening, or 88°. This means that in normal operation the throttle never hits the maximum throttle stop. Notice that on the x-axis during normal operation the PWM duty cycle is the same as the PID output in percent when the battery voltage is being compensated correctly.

Now look at the red curve, which shows what happens when an incorrect battery voltage compensation value is applied to the duty cycle. The gain from PID output to throttle opening angle is increased by the ratio  $12.6V/V_{BATT}(A/D)$ , which for  $V_{BATT}(A/D) = 9.0V$  (for example) implies an increase of 1.3x. This means that when the PID controller is outputting a value x in the throttle opening, the throttle motor is really receiving the command 1.3x. The effect is to make the throttle open 30% more than the PID output would indicate, which applies to all PID inputs, including the accelerator position sensor. In the positive PWM direction, or opening direction, this means that the driver will notice an increase in the engine response, making it seem more “jittery” if the incorrect battery voltage compensation value is large enough. It also means that the throttle will now reach 100% open with less

accelerator pedal effort than before, and may even hit the mechanical throttle stop, because the duty cycle change allows the throttle to open more than the electrical limit set by the PID controller output. This may have consequences on the integrity of the throttle gears, because something must give if the throttle motor rams the throttle valve into the mechanical throttle stop. The most likely place in the gear train to suffer shock damage is the teeth of the smallest diameter gear.

In the negative PWM direction, or closing direction, an increase of 1.3x in the duty cycle means that the idle speed is reduced by about 30%, making the engine idle at a lower RPM. This makes the engine more susceptible to fluctuations and disturbances, and may even cause the engine to stall if an incorrectly compensated duty cycle causes the throttle valve go to its fully closed position.

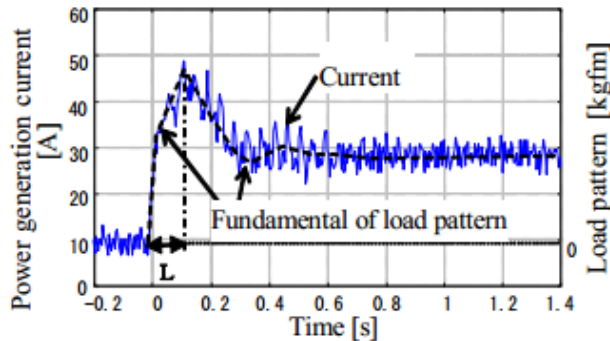
Figure 3. Load current and load torque generated by turning on four high beam headlights at  $t=0^7$

It is interesting to see what happens to the throttle opening when the vehicle's head lights or air conditioner are turned on. Figures 3 and 4 show what the load on the engine and the electrical current load look like in these two cases<sup>7</sup>. If these loads are not accompanied by an increase in engine torque output, then the vehicle's idle speed will decrease, which might cause the engine to stall. Therefore, the ECU opens the electronic throttle slightly to increase the engine torque output to offset any load that has been turned on. Figure 5 shows that when the headlights are turned on, the throttle opens about 9 degrees initially, and stays open about one degree as long as the lights stay on. Figure 6 shows when the air conditioner is turned on, the throttle opens with two peaks of about 10 degrees and 8 degrees, and stays open about two degrees as long as the air conditioner continues to run. The driver never notices these changes, however, because the throttle opening amounts are carefully adjusted by the automobile manufacturer to produce an increase in engine torque output that exactly cancels the load placed on the engine from these events. The only change that the driver sees is shown in Figure 7, which shows a small drop in idle RPM, followed by a

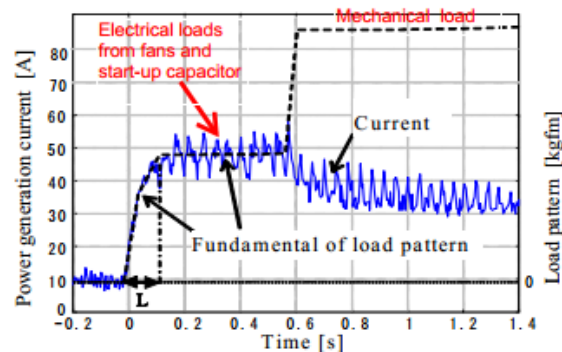
Figure 4. Load current and load torque generated by turning on the air conditioner at  $t=0^7$

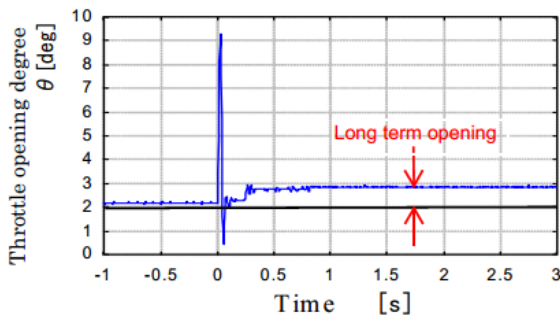
Figure 5. Throttle angle upon turning on four high beam headlights at  $t=0^7$

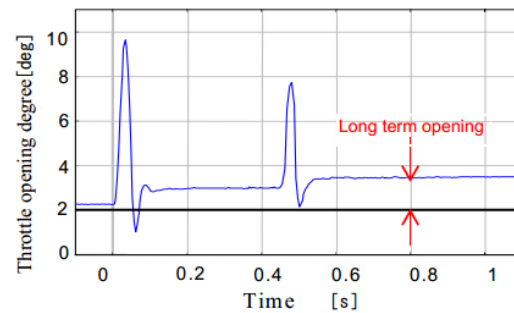
Figure 6. Throttle angle upon turning on the air conditioner at  $t=0^7$

Figure 8 illustrates a typical air conditioner idle-up response (previously shown in Figure 6) that has been modified by an incorrect throttle motor duty cycle battery voltage compensation coefficient that is small enough to keep the long-term idle-up response below the limp-home position. In this case one will experience lunging, lurching, and surging from the two peak throttle openings, but will not experience long-term unintended acceleration. Figure 9 illustrates the same air conditioner idle-up response modified by a larger incorrect throttle motor duty cycle battery voltage compensation coefficient that is large enough to raise the long-term throttle response above the limp-home position. In this case one will experience long-term unintended acceleration in addition to the two luges, lurches, or surges. When the long-term throttle response remains above the limp-home position, the incorrect throttle motor duty cycle battery voltage compensation coefficient then causes the throttle opening to increase to its maximum value by mapping the air conditioner long-term load to a target throttle opening that is always larger than the equilibrium value associated with the current engine speed (illustrated by the dashed line in Figure 9). This causes the engine speed to increase each time the throttle controller traverses the throttle control loop, which takes only 2 milliseconds. The result is that the engine goes to full throttle within less than one second.

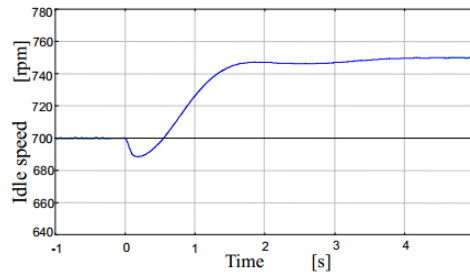
Figure 7. Effect of either event on idle speed (RPM)<sup>7</sup>

long term increase in idle RPM that may vary from 50 RPM to 200 RPM. The actual drop and long term increase vary somewhat with load and engine design. This process of canceling a sudden load on the engine by an increase in the throttle opening is called an “idle-up” in the auto industry.

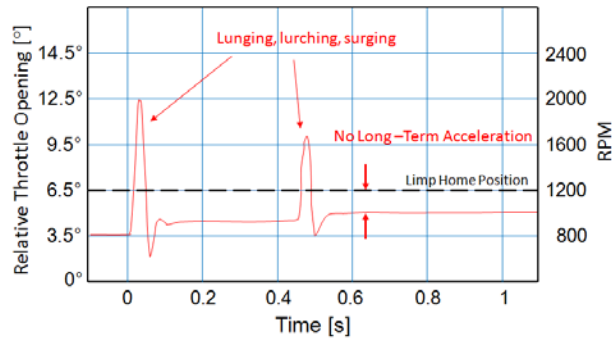
Figure 8. Lunging, lurching and surging result when the incorrectly compensated throttle motor duty cycle produces a throttle opening that exceeds the limp home position for only a short duration.

10. Some drivers have observed the coincidence of RPM increase with the air conditioner turning on. This is explained by the theory by how an incorrect throttle motor duty cycle battery voltage compensation coefficient modifies the air conditioner long-term "idle-up" response. The same mechanism can explain both short-term luges, lurches, and surging, as well as long-term accelerations lasting several seconds to several minutes. This is illustrated in Figures 8 and 9 below.

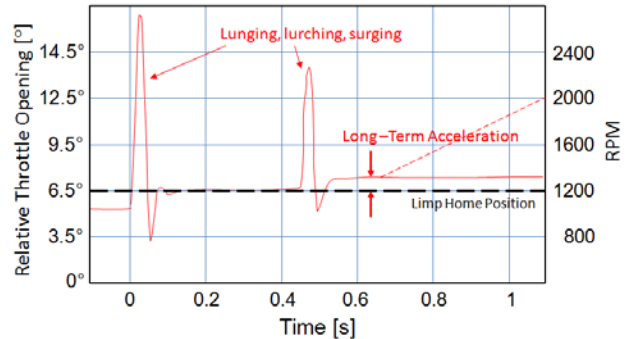
Figure 9. Long-term unintended acceleration results when the incorrectly compensated throttle motor duty cycle produces a throttle opening that stays above the limp home position. The incorrect compensation coefficient then causes the throttle map to further increase the throttle opening each time the control loop is traversed (dashed line).

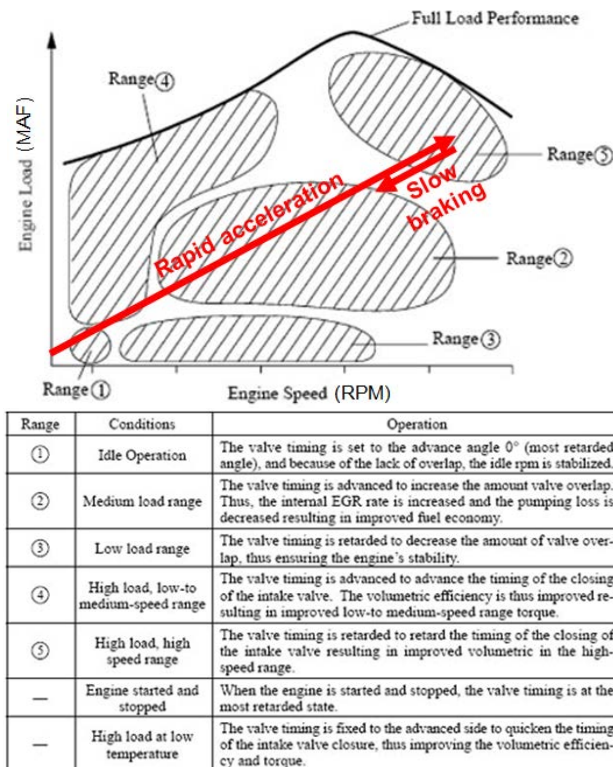
Figure 10. Variable valve timing map showing changes made during unintended acceleration and braking when the VVT-i system is operating normally<sup>16</sup>

Variable valve timing (VVT) is controlled by a map as described in Figure 10. In this map the intake opening advance angle command is provided as a function of the engine load and engine speed. The engine load is represented by the output of the MAF sensor, which measures the amount of air that the engine is consuming as a result of the throttle being opened. This map is unlike the throttle opening map, in that the engine load (or MAF sensor) is used in place of the driver-requested torque (or cylinder air charge). The engine load is a dependent variable that depends on the engine torque. The latter is an independent variable controlled by the driver or the ECU.

1. Normal VVT-i Operation During an Unintended Acceleration Event. Recall, now, how an incorrect throttle motor duty cycle battery voltage compensation coefficient caused the engine speed to increase in Table 1 and the throttle valve to open. Let's see how this affects the operation of the VVT-i system shown in Figure 10<sup>16</sup>. In Figure 10 as the throttle valve opens up, the engine load increases as measured by the MAF sensor on the Y-axis. The engine speed in Figure 10 is the same engine speed as in Table 1. This means that while the engine speed is increasing, the path shown by the red line in Figure 10 is being traversed. Therefore, the engine torque starts out small in the idle range 1, gets larger while traversing the medium load range 2, and ends up smaller again in the high load, high speed range 5. This means that for most of the engine speed transition, the engine is providing the maximum torque available. It also means that if the driver applies the brakes to reduce the vehicle speed, then the load on the engine increases because the brakes create a slowing torque that gets transferred back to the engine through the torque converter.<sup>1a</sup> This causes the engine speed to decrease, changing the VVT-i operating point from range 5 to range 2. According to the table, this causes the VVT-i map to increase the intake cam advance, which creates a higher output torque. The net effect of applying the brakes, then, is to increase the engine torque, which is exactly what happens when an active cruise control system encounters a hill. The driver perceives this as the engine accelerating against the brakes just like the accelerator gets pulled down more by the active cruise control system when it encounters a hill (in an older vehicle with a mechanical throttle). This explains driver observation number 12, which says that some drivers have observed that applying the brake caused the engine to accelerate. This occurs when the VVT-i system is operating normally.

<sup>1a</sup> The term “load” used here means a torque applied to the engine, which slows the engine down like when the air conditioner is turned on. The term “load” shown on the x-axis of Figure 10 is the output of the MAF sensor, which measures the air flow through the throttle valve, and is therefore a measure of the torque produced by the engine. The two loads are related by a minus sign.

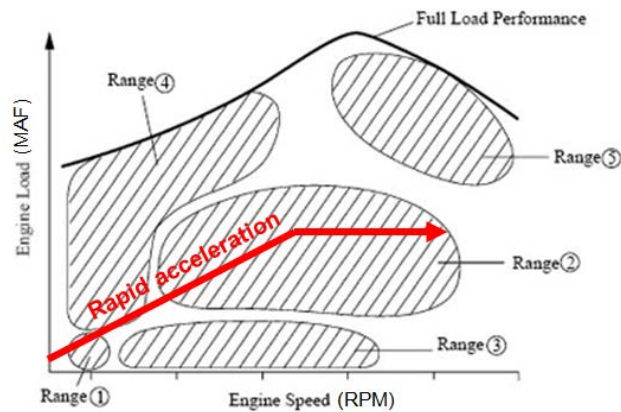
Figure 11. Variable valve timing map showing changes made during unintended acceleration and braking when the VVT-i system is operating with an incorrect battery voltage compensation coefficient

modifies the PWM duty cycle of the oil control valve that changes the valve timing. This battery voltage compensation coefficient can increase the oil control valve output when the coefficient is incorrect as a result of sampling the battery voltage during a negative voltage spike. In this case, as the engine speed increases, the oil control valve sees a larger opening command than the PID controller is sending out, just like with the throttle valve in Table 1. This causes the intake valve opening to advance with increasing engine speed. However, this time the intake valve opening advances to a maximum value in range 2 and then stays at the maximum value instead of decreasing again in range 5, as shown in Figure 11. This means that the intake valve timing does not increase when the brakes are applied because the intake valve opening stays at its maximum value. Therefore, the driver does not observe the engine accelerating as the brakes are being applied.
