ASK 21

Flight Manual
Instructions For Continued
Airworthiness
Repair Manual

ALEXANDER SCHLEICHER GMBH & CO., SEGELFLUGZEUGBAU
D-36163 POPPENHAUSEN (WASSERKUPPE)

REPAIR MANUAL

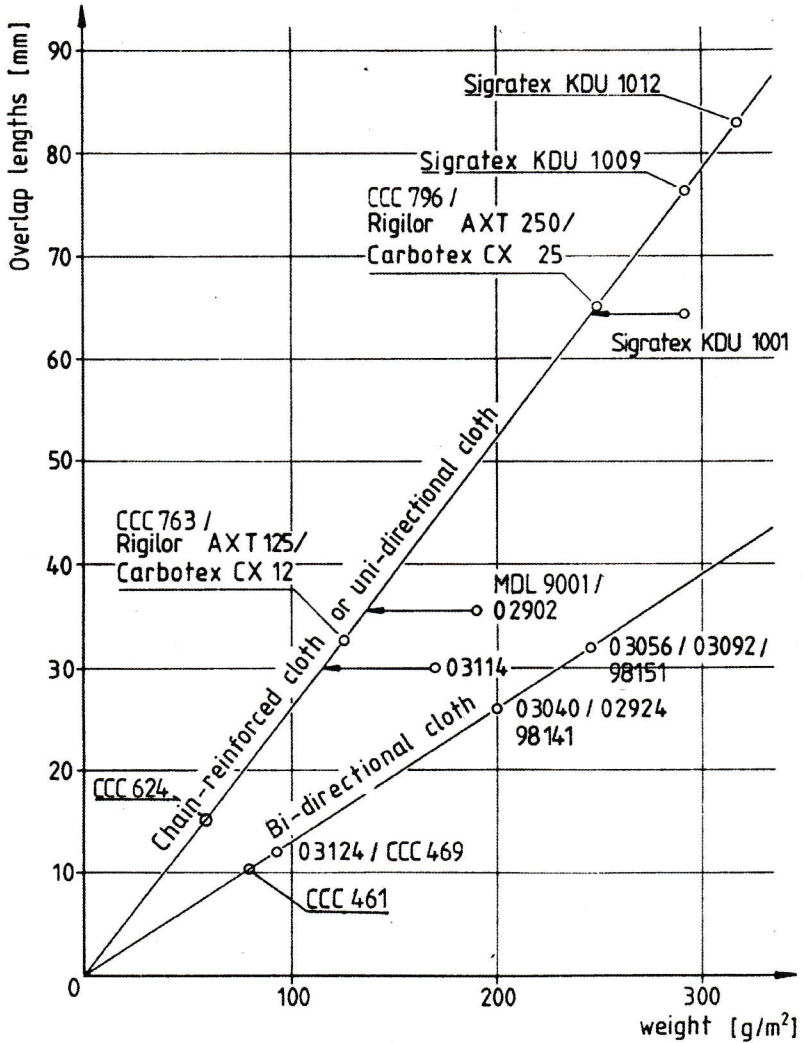
Diagram: overlap length for Carbon fiber

Scarf lengths are half as long as overlaps.
