DCN Next Generation 4.10 Release Notes

DCN Next Generation Release 4.10

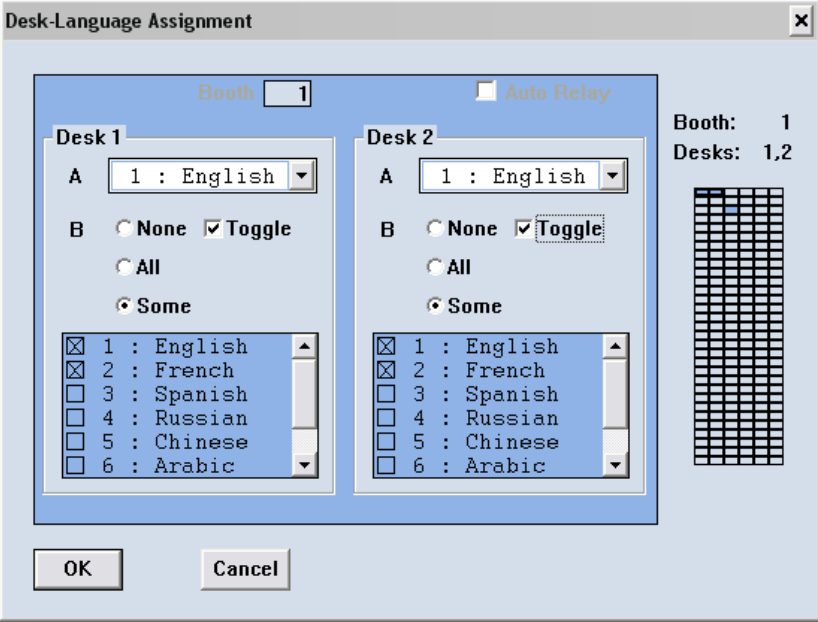
Reference	What
<p>LBB 4172/00 (IN_en.pdf) Page 11. Assigning languages to output B</p>	<p>B toggle (2nd B output) on Interpreter desk).</p> <p>The B toggle function on the interpreter desk can be enabled by using software module LBB 4172/00 (only supported for DCN-IDESK SW ≥ 1.40.xxxx).</p> <ul style="list-style-type: none"> Select at least two languages for the B-output and check Toggle.

<ul style="list-style-type: none"> When the B toggle is enabled the interpreter can toggle output B by pressing the B button. The preset of the B output can be changed by press and hold the B-output button and turn the rotary. Changing the preset can only be done when the microphone is switched off. <p>Note: The software setting is stored in the CCU so the toggle function is still available when the PC is shutdown and after a CCU shutdown.</p> <p>Note: When the B output is changed using interpreter desk menu h the Toggle function is disabled and needs to be enabled using LBB 4172/00.</p>

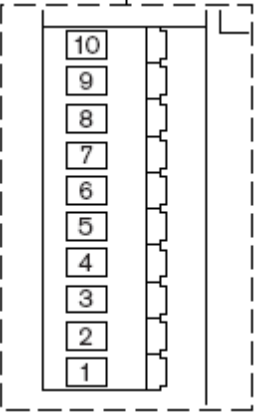
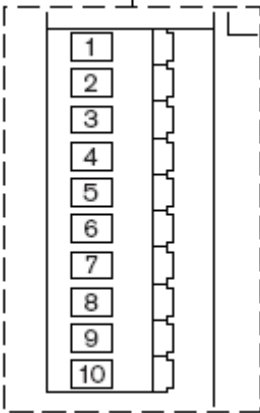
Reference	What
<p>DCN NG IUI Figure 34.3 Internal settings</p>	<p>Numbering of connector block DCN-EPS is the other way around</p> <div style="display: flex; justify-content: space-around; align-items: center;"> <div style="text-align: center;"> <p>Correct</p>

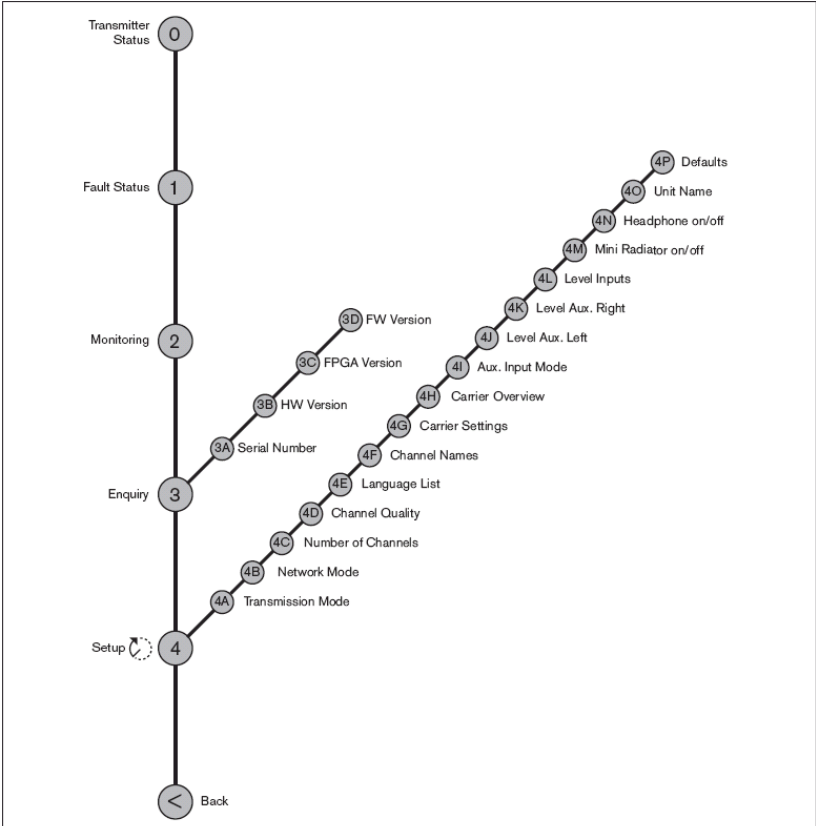
Reference	What
Integrus IUI Several places	Increase coverage of LBB 4511/00 and LBB 4512/00 radiators The information related to the increase of the coverage is valid for the radiators with hardware version 2.00 and higher.
Integrus IUI Figure 1.5	Footprint increased with 30%.
Integrus IUI Paragraph 2.4	Added menu 4B Network mode Menu 4B (Network mode) has been added.

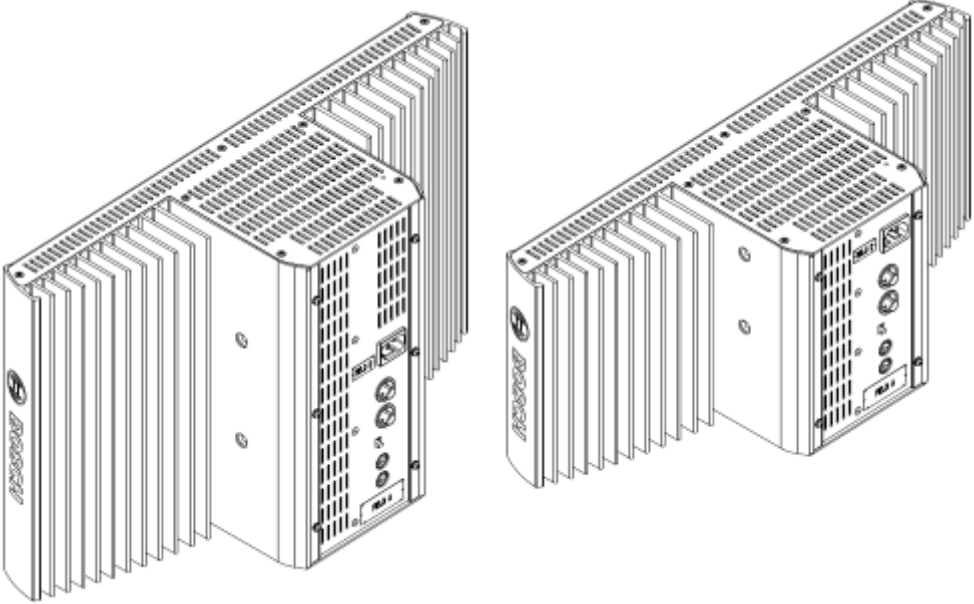
IUI Integrus Paragraph 3.1.1	<p>The LBB 4511/00 has an infra-red output of 22 Wpp, while the LBB 4512/00 has an infra-red output of 42 Wpp.</p>
IUI Integrus Paragraph 3.1.3	<p>A hole for a safety eye is added to the radiator (hardware version 2.60). Mount the safety eye properly in the hole. Make sure that:</p> <ul style="list-style-type: none"> - the minimum strength of the safety cord, mounting material, shackle and supporting building structure should withstand 1,500 N. - a proper length safety cord is used (not more than 20 cm longer than needed). <div style="text-align: center;">

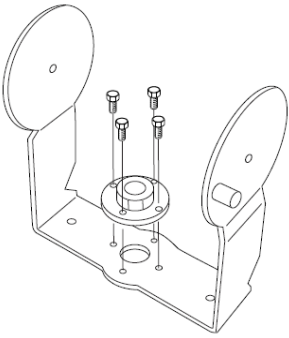
IUI Integrus Paragraph 3.1.3	<p>When a radiator is used with a wall mounting bracket, the mounting plate should be mounted as indicated in figure 3.3.</p> <div style="text-align: center;">

</div> <p>When a radiator is used on a floor stand, the mounting plate should be mounted at the other side of the suspension bracket. This in order to reduce the force on the screws.</p>
