Mobile/Desktop 5th Generation Intel[®] Core[™] Processor Family

Specification Update

*Supporting the 5th Generation Intel[®] Core[™] Processor based on
Mobile H-Processor Line and Desktop H-Processor Line*

Revision 019

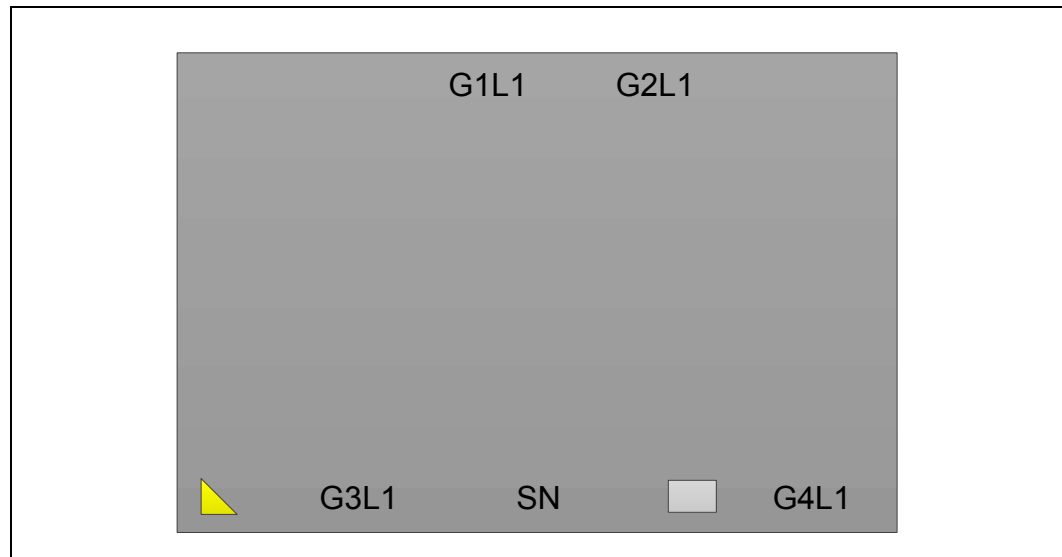
Figure 1. Mobile H-Processor Line BGA Top-Side Markings

The processor stepping can be identified by the following component markings.

Pin Count: 1364 Package Size: 37.5 mm x 32 mm
