TANDBERG

TC series software

Software Release Notes

Software Version TC2

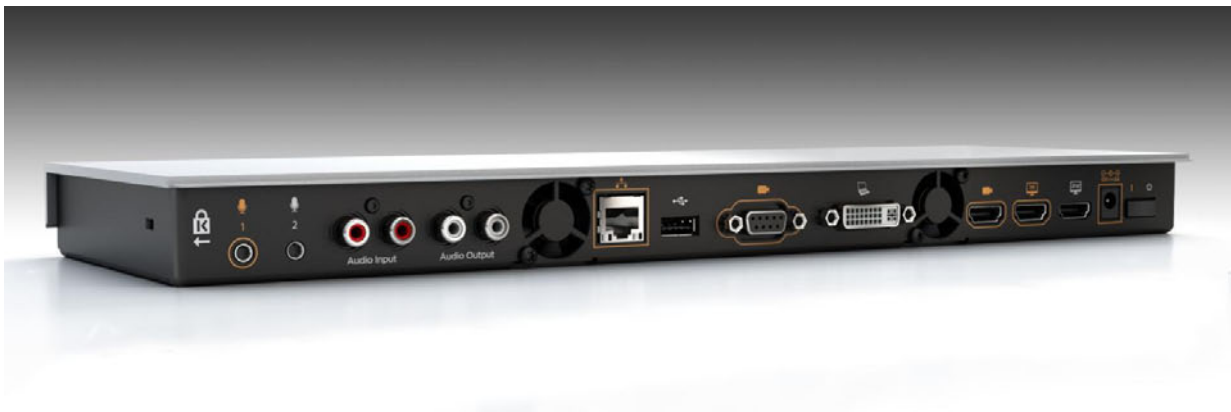
The TC 2.0.0 release introduces support for the new Codec C20. This codec will provide you with absolute quality 1080p30 and 720p60 HD video, ease of installation and management. For more information please visit: <http://www.tandberg.com>, where user manual, technical specifications and administrator guide will be available for download.

NOTE: The TANDBERG Codec C20 cannot run software versions lower then TC 2.0.0
