G500H Flight Display System Instructions for Continued Airworthiness Bell 407

Reg. No	S/N	_
	STC SR02295LA

Dwg. Number: 190-01150-21 Rev. 2

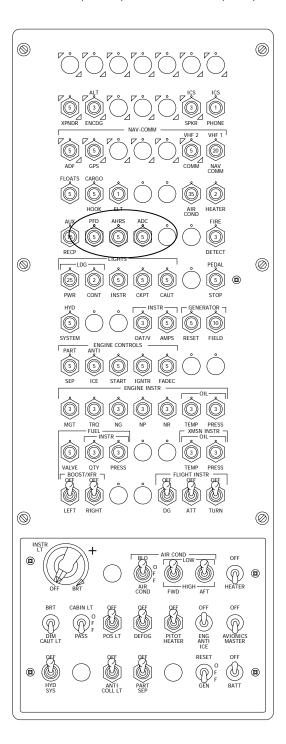
All installed G500H equipment is connected to a power bus that receives power as soon as the battery master switch is turned on.

Separate circuit breakers have been installed in the overhead circuit breaker panel for each for the GDU 620 (PFD), GRS 77H + GMU 44 (AHRS), and GDC 74H (ADC) as circled below:
