This document is designed for use by the installing agency of the Garmin G500H PFD/MFD System as Instructions for Continued Airworthiness in response to Title 14 CFR Part 27.1529 and Part 27 Appendix A. This ICA includes information required by the operator to adequately maintain the Garmin G500H system installed under STC TBD.

This document identifies the Instruction for Continued Airworthiness for the modification of the rotorcraft for installation of the Garmin G500H PFD/MFD System installed under STC TBD.

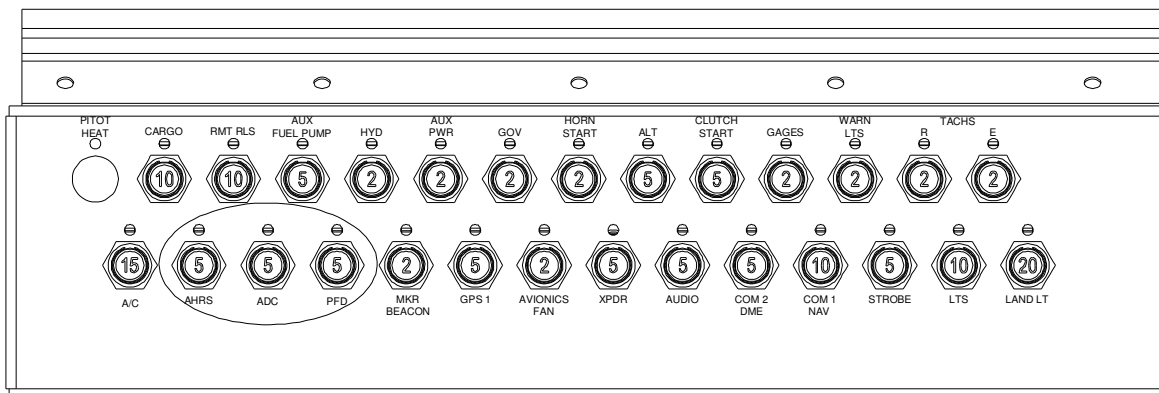
Separate circuit breakers have been installed in the circuit breaker panel for the GDU 620 (PFD), GRS 77H / GMU 44 (AHRS), and GDC 74H (ADC) as circled below:

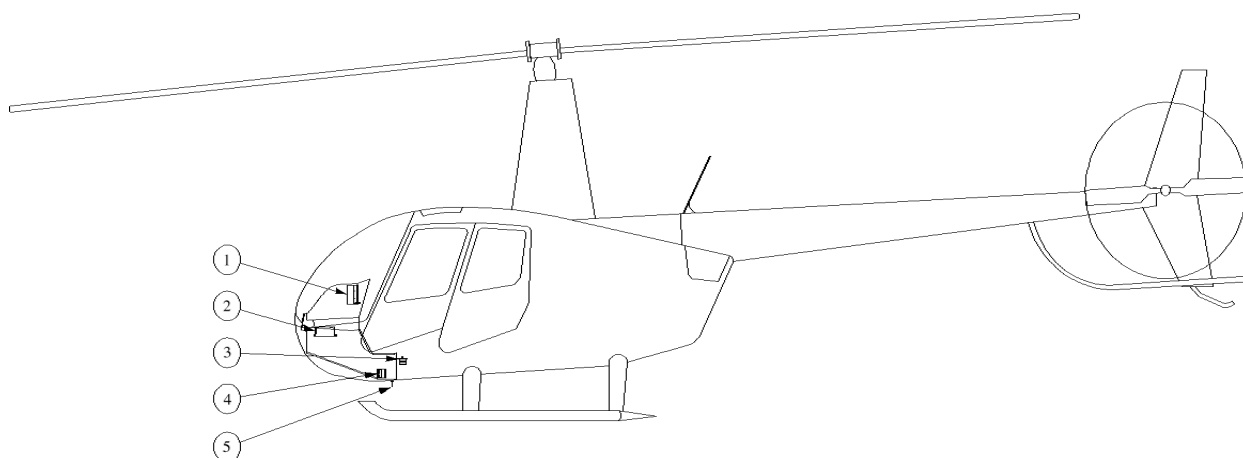
The installed G500H equipment can be accessed as described below:

1. GDU 620: FS 30.00, WL 42.5 Access or remove by removing the six screws in the bezel of the GDU 620.
2. GRS 77H: FS 19.25, WL 30.0 Access or remove by tilting the instrument shroud to its open position by removing four glareshield retaining screws.
3. GMU 44: FS 41.5, WL 19.75 Access or remove by lifting the pilots seat bottom.
4. GDC 74H: FS 39.25, WL 15.75 Access or remove by lifting the co-pilots seat bottom. Then remove the screws holding the divider plate to the forward half of the co-pilots seat box. Remove the divider plate to gain access to the GDC 74H.
5. GTP 59: FS 42.5, WL 13.5 Access or remove by removing the center access panel on the bottom of the helicopter.
